# Site Inspection Report

**Site: LAWRENCE TOTEMS CONSOLIDATION LINE**  
04/27/2022

## SITE INSPECTION REPORT

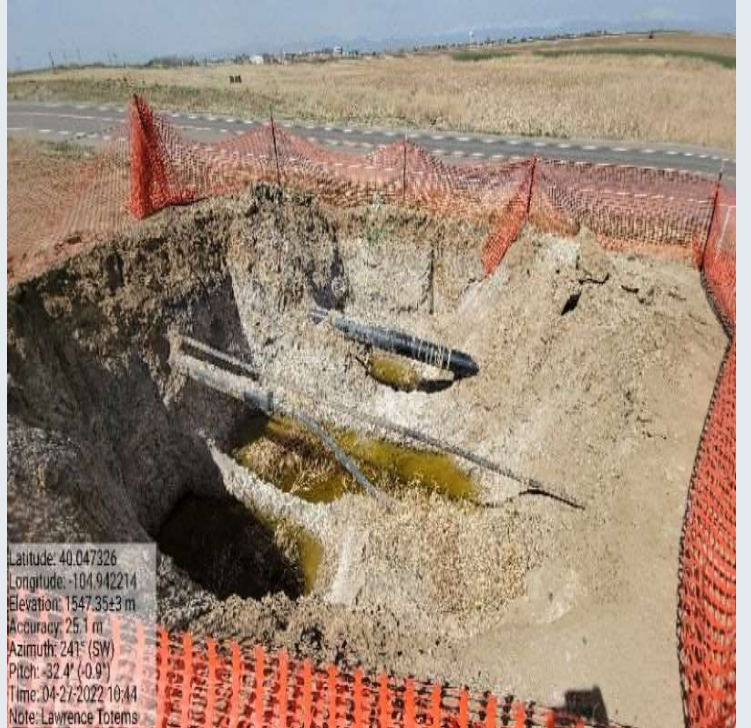
Remediation Activity Checklist	
	Photo
<b>Question:</b> Open excavation? Approximate size (Length x Width x Depth, ft) <b>Response:</b> 23x20x9 <b>Notes:</b>

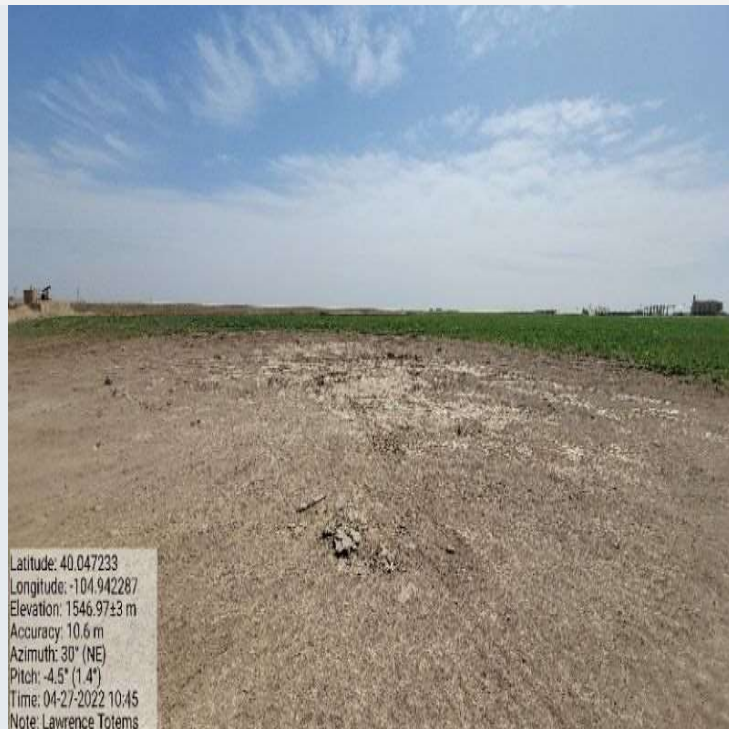
**Question:** Stockpiled waste and approximate volume (cubic yards)

**Response:** No

**Notes:** Stockpile has been completely removed

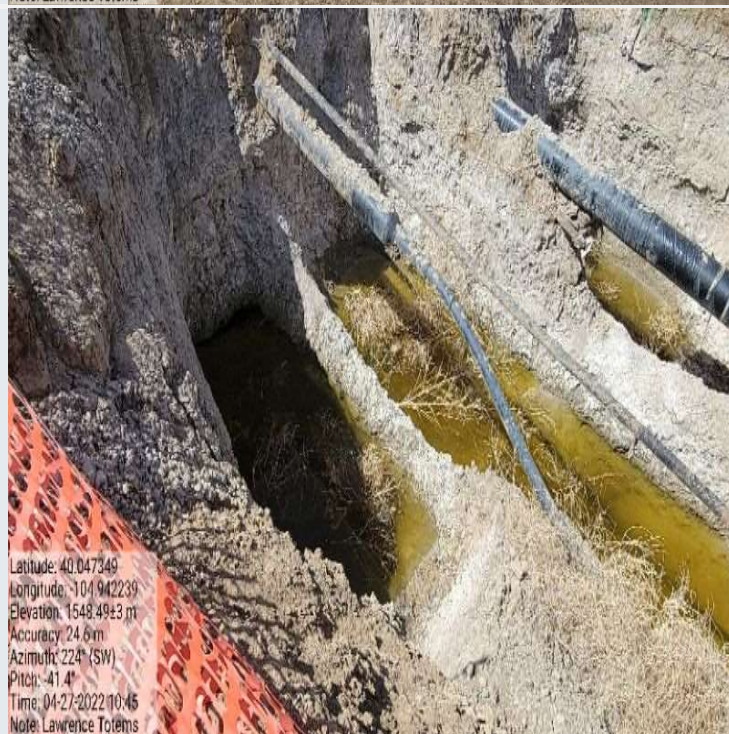
**Question:** Groundwater present? (Depth, ft) Note: Free product/Sheen

**Response:** Yes

**Notes:** Sheen

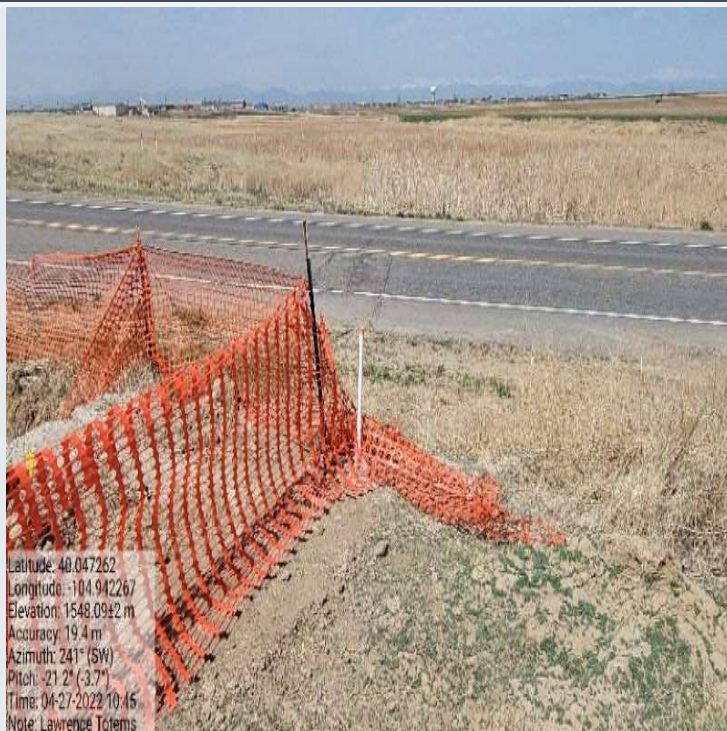
**Question:** Monitoring well(s) present? If so note number and approximate location

**Response:** Yes

**Notes:** Plug has been added to monitoring well.

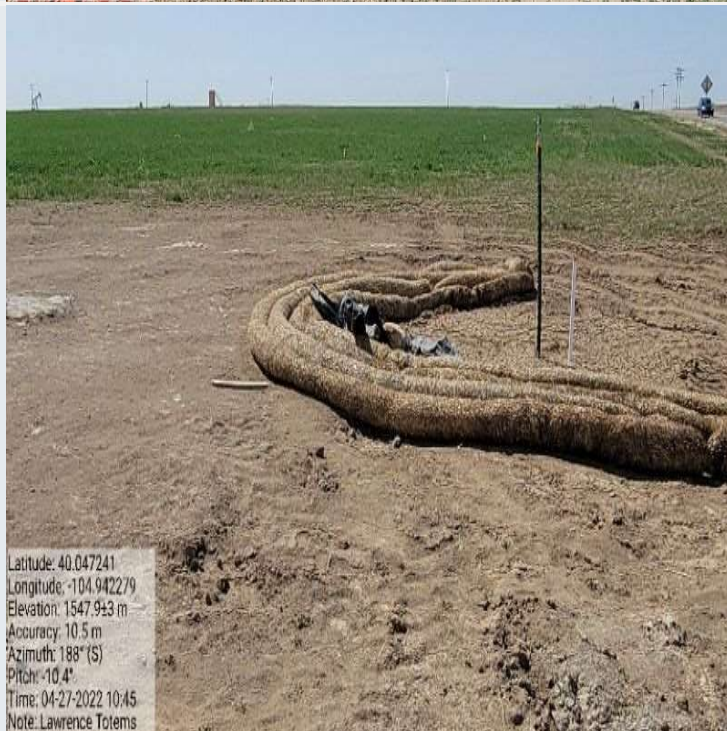
**Question:** Monitoring well(s) present? If so note number and approximate location

**Response:** Yes

**Notes:** Plug has been added to monitoring well

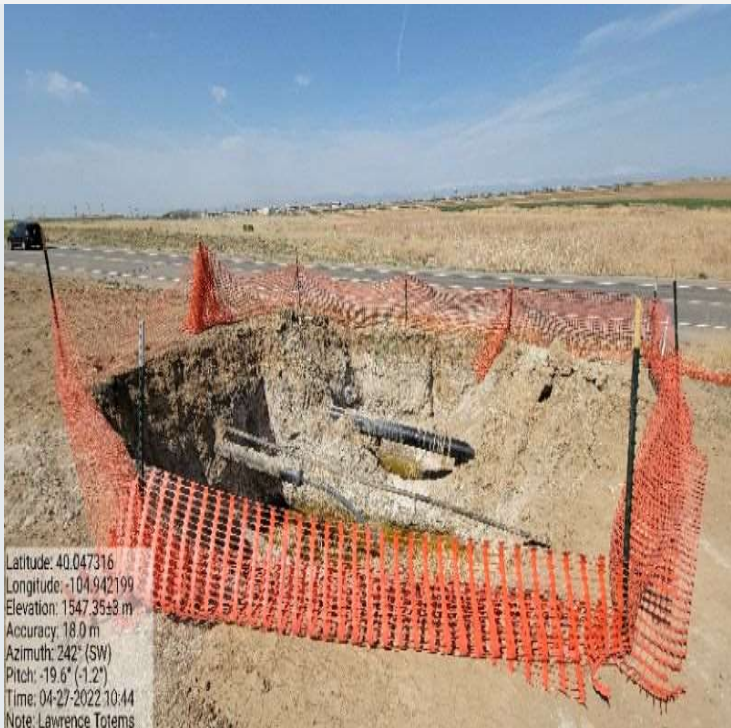
Photo
<b>Question:</b> Waste signage present, legible is accurate and up to date (in accordance with rule 913.b.(5)B.iv)? <b>Response:</b> N/A <b>Notes:</b>	No Photo
<b>Question:</b> Emergency sign in compliance with 605.g? <b>Response:</b> N/A <b>Notes:</b> Not inspected.	No Photo
<b>Question:</b> Ground surface appears clean (no evidence of new equipment leaks, oil leaks, spills, or releases)? <b>Response:</b> Yes <b>Notes:</b>	No Photo
<b>Question:</b> Site properly fenced (in accordance with rule 913.b.(5)B.i)? <b>Response:</b> No <b>Notes:</b> Fencing around open excavation is beginning to fall.

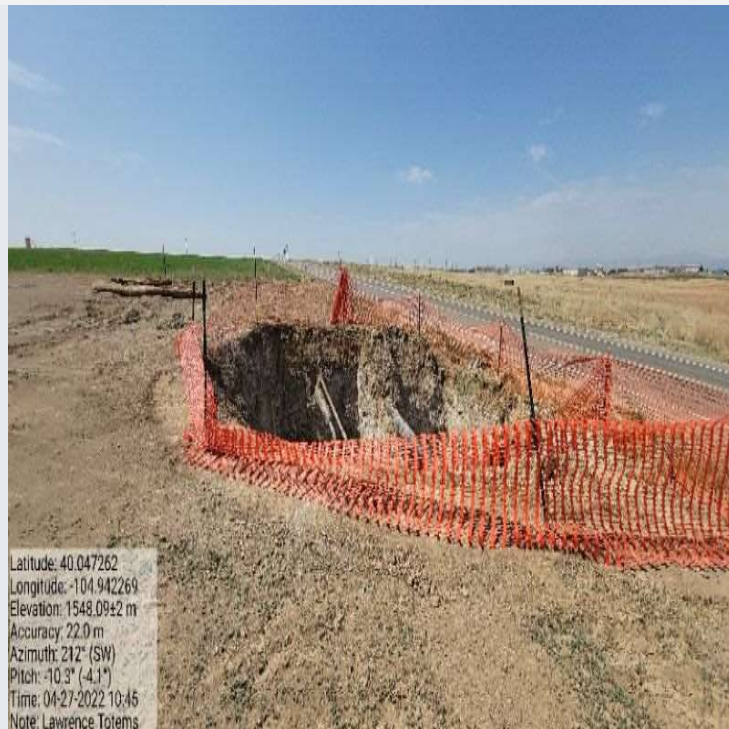
**Question:** Is fencing adequate/appropriate for site and well maintained?

**Response:** No

**Notes:** Fencing around open excavation is beginning to fall.

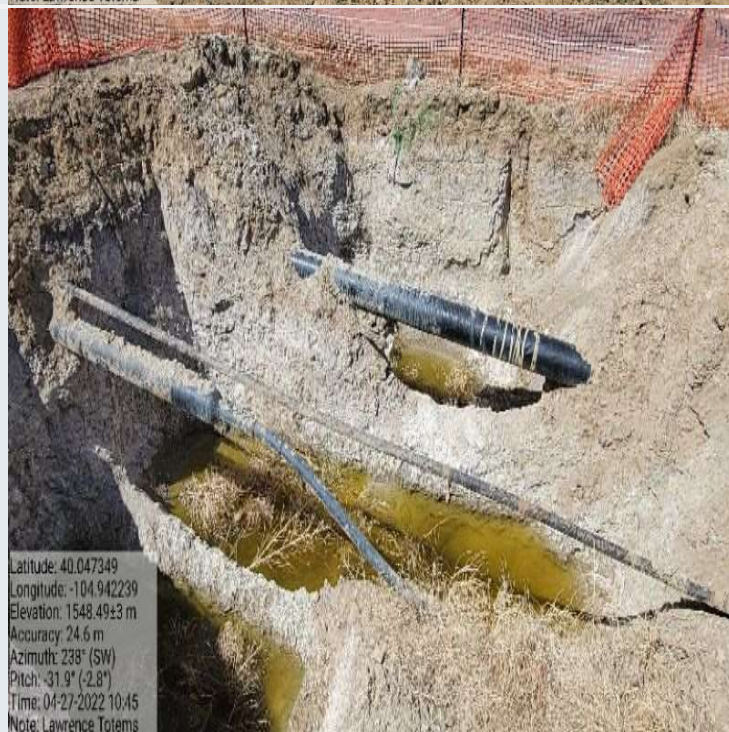
**Question:** Exposed buried/underground flowlines?

**Response:** Yes

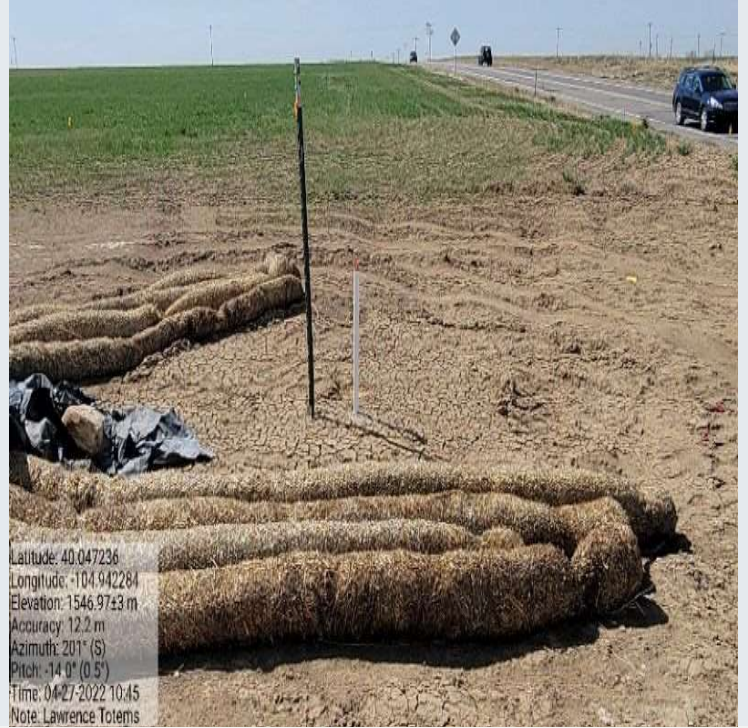
**Question:** Site is free of unused equipment, weeds, debris/trash?

**Response:** No

**Notes:** Unused straw wattles and liner stored onsite.
