Site Inspection Report

Site: SUCKLA-BROWN UNIT 17 HEADER
04/29/2022

SITE/LOCATION	DATE	TIME	INSPECTOR
SUCKLA-BROWN UNIT 17 HEADER	04/29/2022	01:08 PM	COGCC Subcontractor
Comments			
Work Activity Notes			
Changes since previous inspection?		Drive by inspection	No
Actively being worked?	No		
Fieldwork Oversight Performed?	No	Oversight Type	N/A
Were Oversight Samples Collected?	N/A	Sample Details	N/A

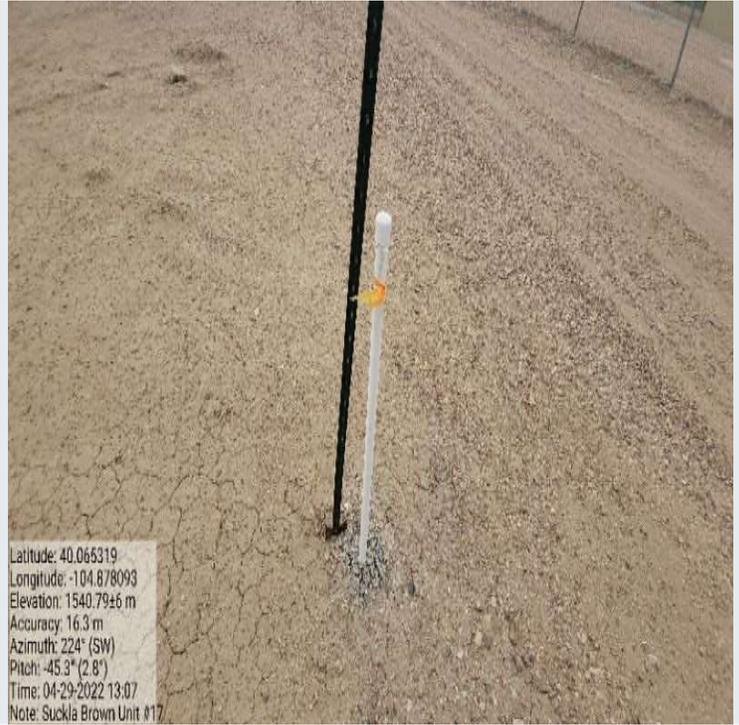
Question: Monitoring well(s) present? If so note number and approximate location

Response: Yes

Notes: 4

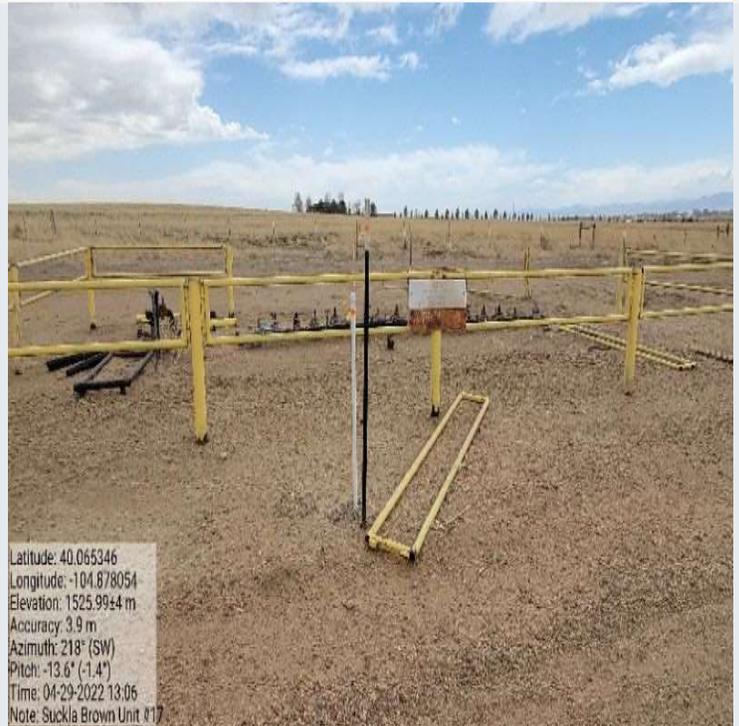
Question: Monitoring well(s) present? If so note number and approximate location

Response: Yes

Notes: 4

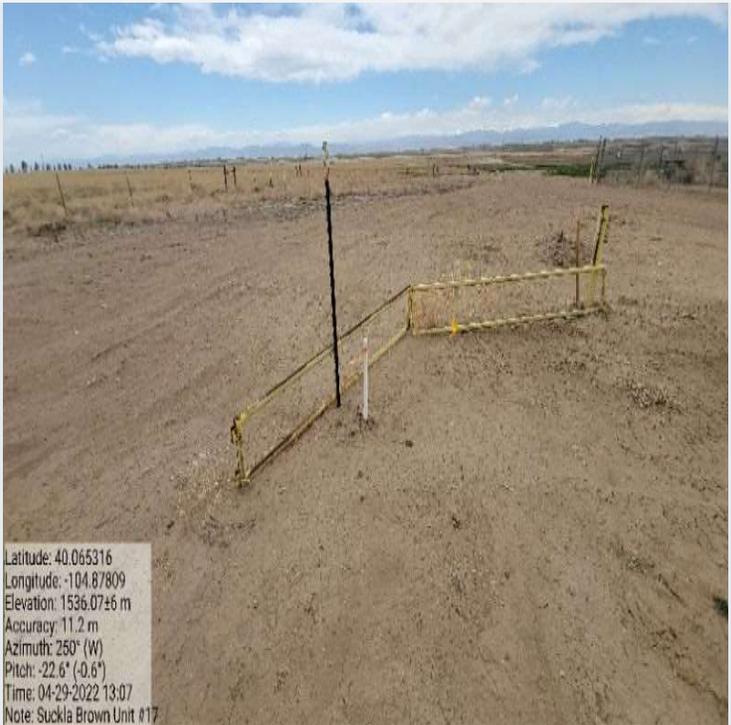
Photo
<p>Question: Monitoring well(s) present? If so note number and approximate location Response: Yes Notes: 4</p>

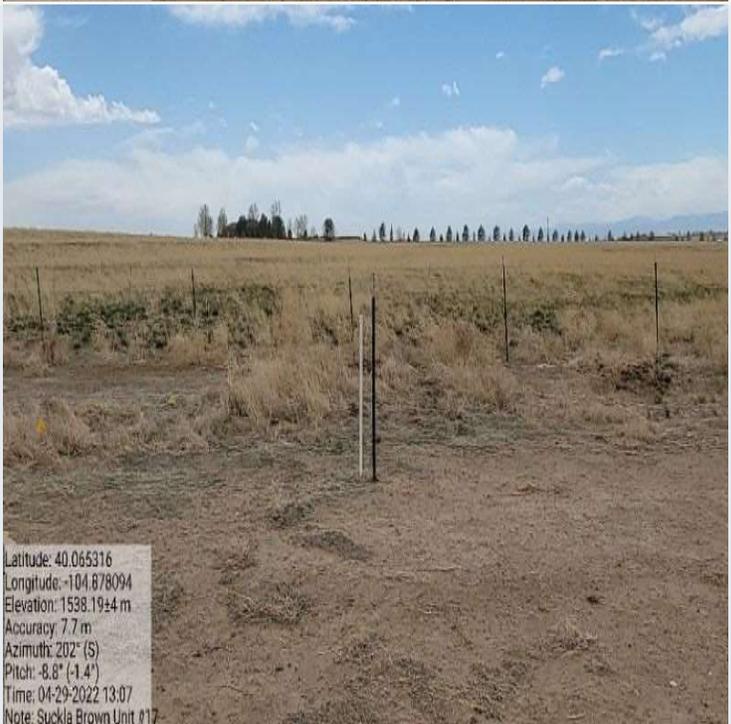
<p>Latitude: 40.065316 Longitude: -104.87809 Elevation: 1536.07±6 m Accuracy: 11.2 m Azimuth: 250° (W) Pitch: -22.6° (-0.8°) Time: 04-29-2022 13:07 Note: Suckla Brown Unit #17</p>
<p>Question: Monitoring well(s) present? If so note number and approximate location Response: Yes Notes: 4</p>

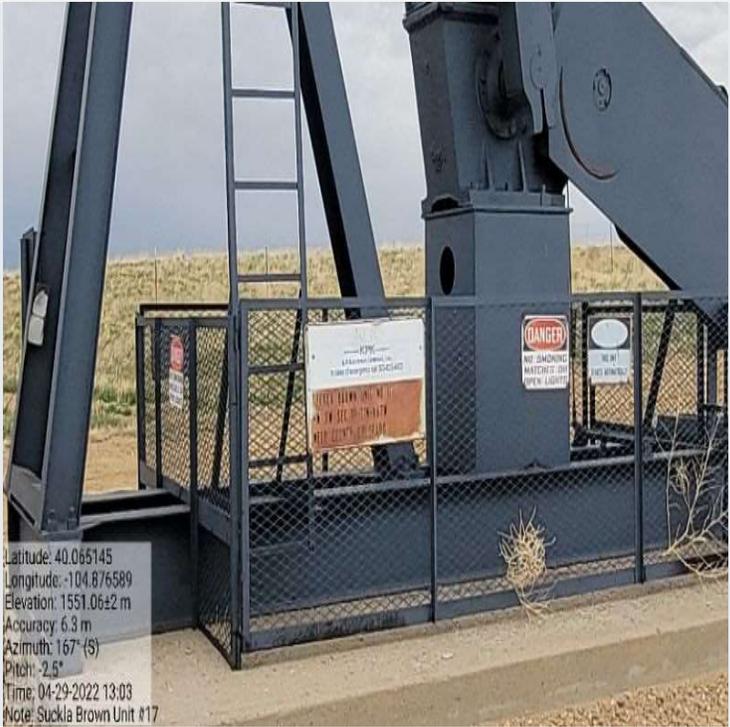
Photo
<p>Question: Waste signage present, legible is accurate and up to date (in accordance with rule 913.b.(5)B.iv)?</p> <p>Response: N/A</p> <p>Notes:</p>	<p>No Photo</p>
<p>Question: Emergency sign in compliance with 605.g?</p> <p>Response: Yes</p> <p>Notes: Corroded</p>

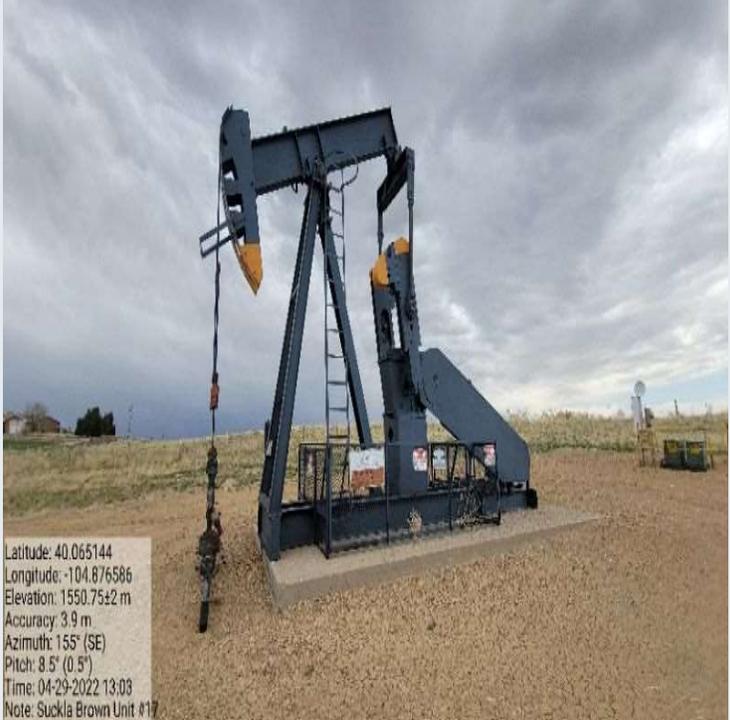
Photo
<p>Question: Ground surface appears clean (no evidence of new equipment leaks, oil leaks, spills, or releases)?</p> <p>Response: Yes</p> <p>Notes:</p>	<p>No Photo</p>
<p>Question: Site properly fenced (in accordance with rule 913.b.(5)B.i)?</p> <p>Response: Yes</p> <p>Notes:</p>	<p>No Photo</p>
<p>Question: Is fencing adequate/appropriate for site and well maintained?</p> <p>Response: No</p> <p>Notes: Fencing does not surround entire pumpjack.</p>

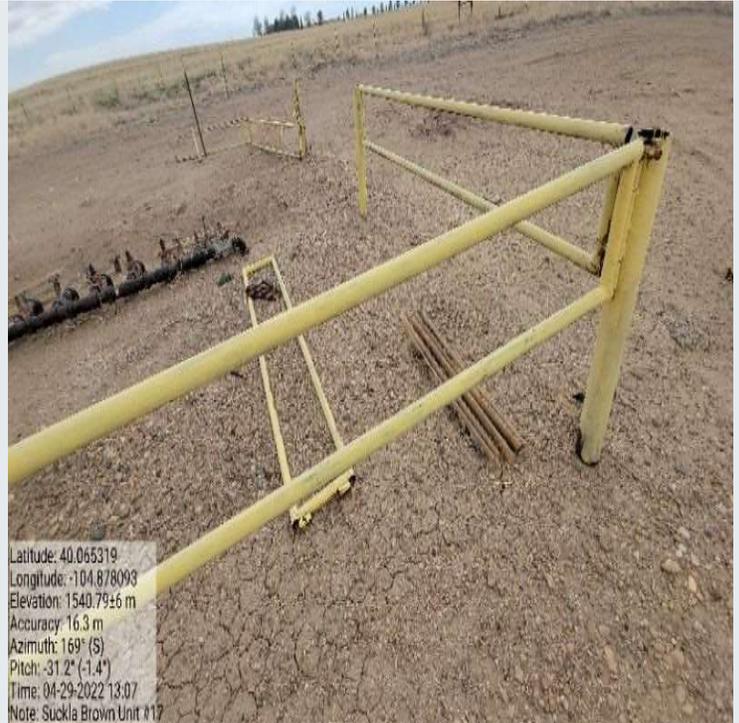
Question: Is fencing adequate/appropriate for site and well maintained?

Response: No

Notes: Pieces of the fencing are scattered on location

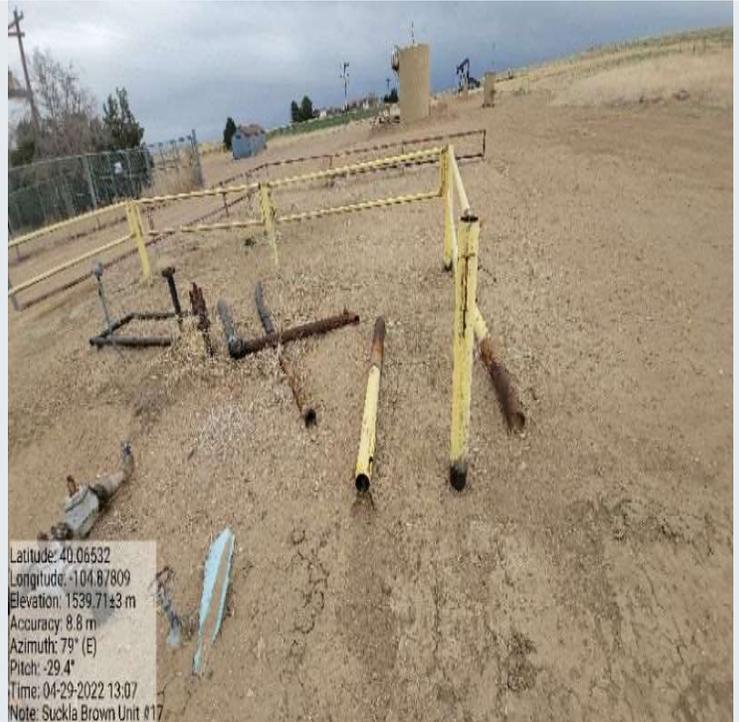
Question: Is fencing adequate/appropriate for site and well maintained?

Response: No

Notes: Pieces of the fencing are scattered on location and do not adequately protect equipment.

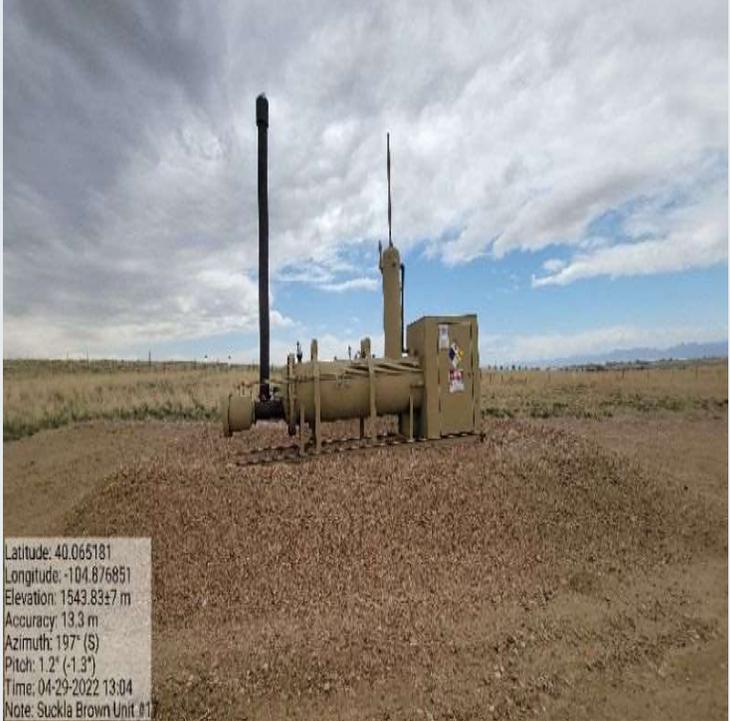
Photo
<p>Question: If flowlines are exposed are they properly capped (bullnose plug, etc.)? Response: Yes Notes:</p>	<p>No Photo</p>
<p>Question: Site is protected from vehicular traffic? Response: Yes Notes:</p>	<p>No Photo</p>
<p>Question: Is an earthen berm secondary containment present and in good condition (no evidence of erosion, animal burrowing, etc.)? Response: Yes Notes:</p>

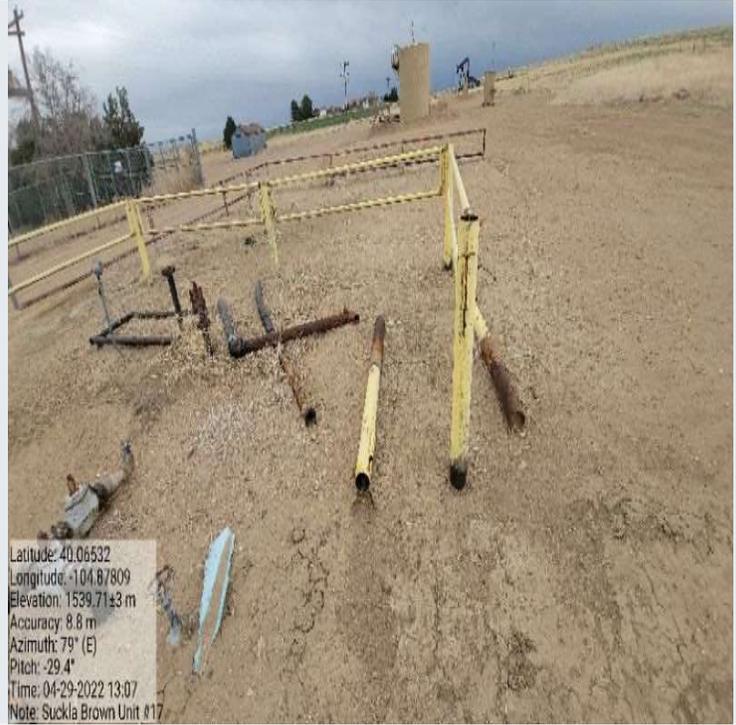
Photo
Question: Evidence of pollutants being discharged off-site? Response: No Notes:	No Photo
Question: All stormwater erosion control measures and BMPs are present and in good/working condition? Response: N/A Notes: No BMPs installed.	No Photo
Question: Site is free of unused equipment, weeds, debris/trash? Response: No Notes: Unused equipment/debris throughout location.
