Site Inspection Report

Site: FACILITY #4 WEST A CONSOLIDATION
05/03/2022

SITE INSPECTION REPORT

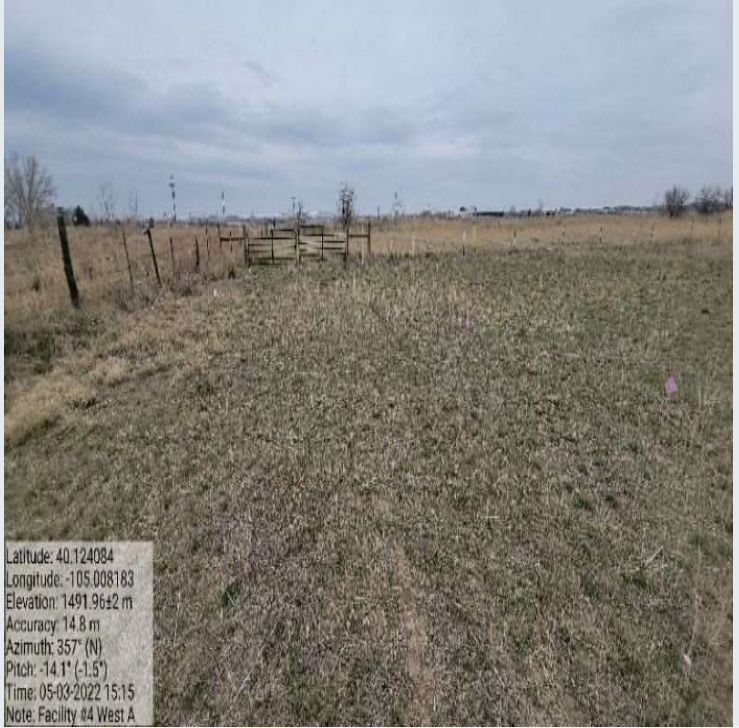
Site Condition Checklist	
Question: Waste signage present, legible is accurate and up to date (in accordance with rule 913.b.(5)B.iv)? Response: N/A Notes:	Photo No Photo
Question: Emergency sign in compliance with 605.g? Response: N/A Notes: Not inspected.	No Photo
Question: Ground surface appears clean (no evidence of new equipment leaks, oil leaks, spills, or releases)? Response: Yes Notes:

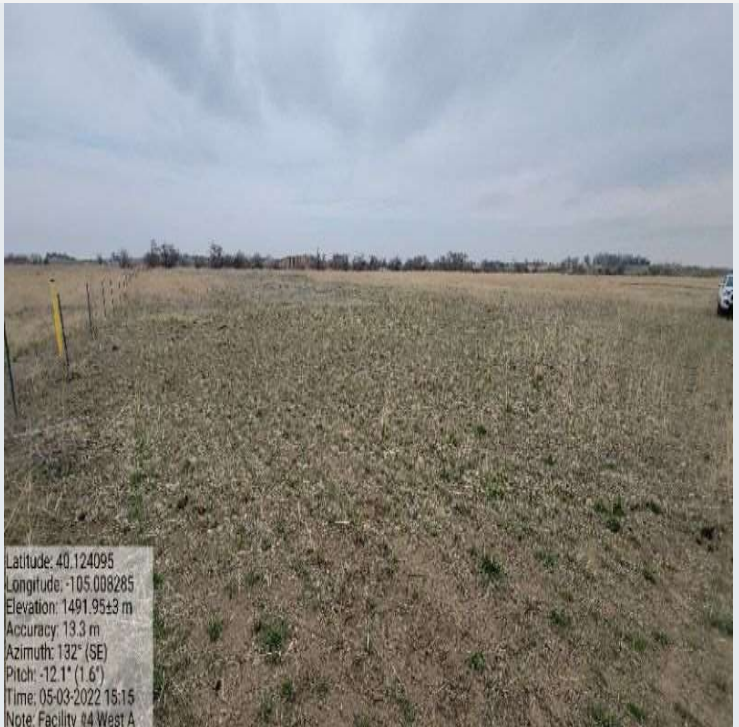
<p>Latitude: 40.124084 Longitude: -105.008183 Elevation: 1491.96±2 m Accuracy: 14.8 m Azimuth: 357° (N) Pitch: -14.1° (-1.5°) Time: 05-03-2022 15:15 Note: Facility #4 West A</p>
Question: Ground surface appears clean (no evidence of new equipment leaks, oil leaks, spills, or releases)? Response: Yes Notes:

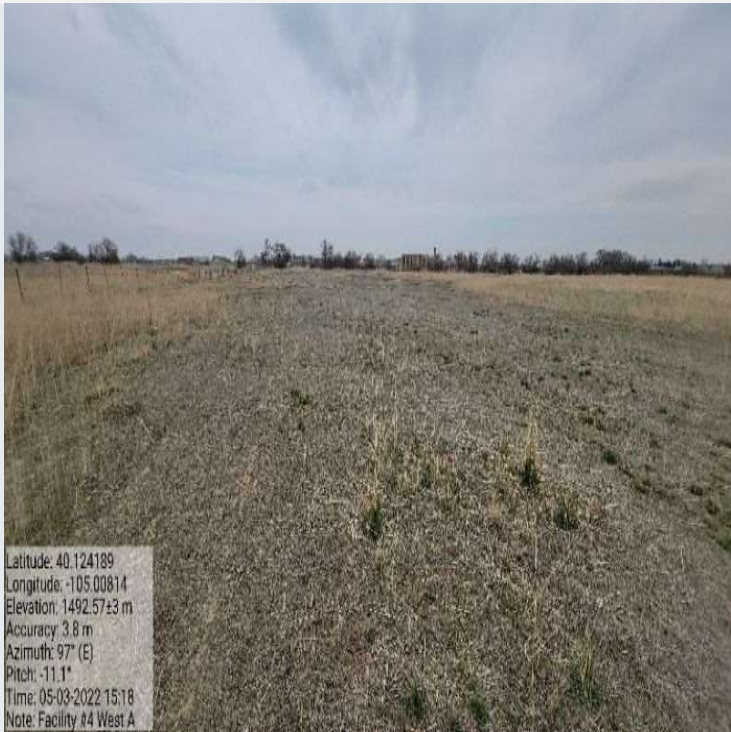
Site Condition Checklist	
	Photo
<p>Question: Ground surface appears clean (no evidence of new equipment leaks, oil leaks, spills, or releases)?</p> <p>Response: Yes</p> <p>Notes:</p>	  <p>Latitude: 40.124123 Longitude: -105.008288 Elevation: 1492.88±3 m Accuracy: 12.9 m Azimuth: 359° (N) Pitch: -31.0° (-2.9°) Time: 05-03-2022 15:16 Note: Facility #4 West A</p>
<p>Question: Ground surface appears clean (no evidence of new equipment leaks, oil leaks, spills, or releases)?</p> <p>Response: Yes</p> <p>Notes:</p>
