Inspection Photos

ID: 412161

Operator: WAPITI OPERATING LLC

Inspection Date: 5/3/2022

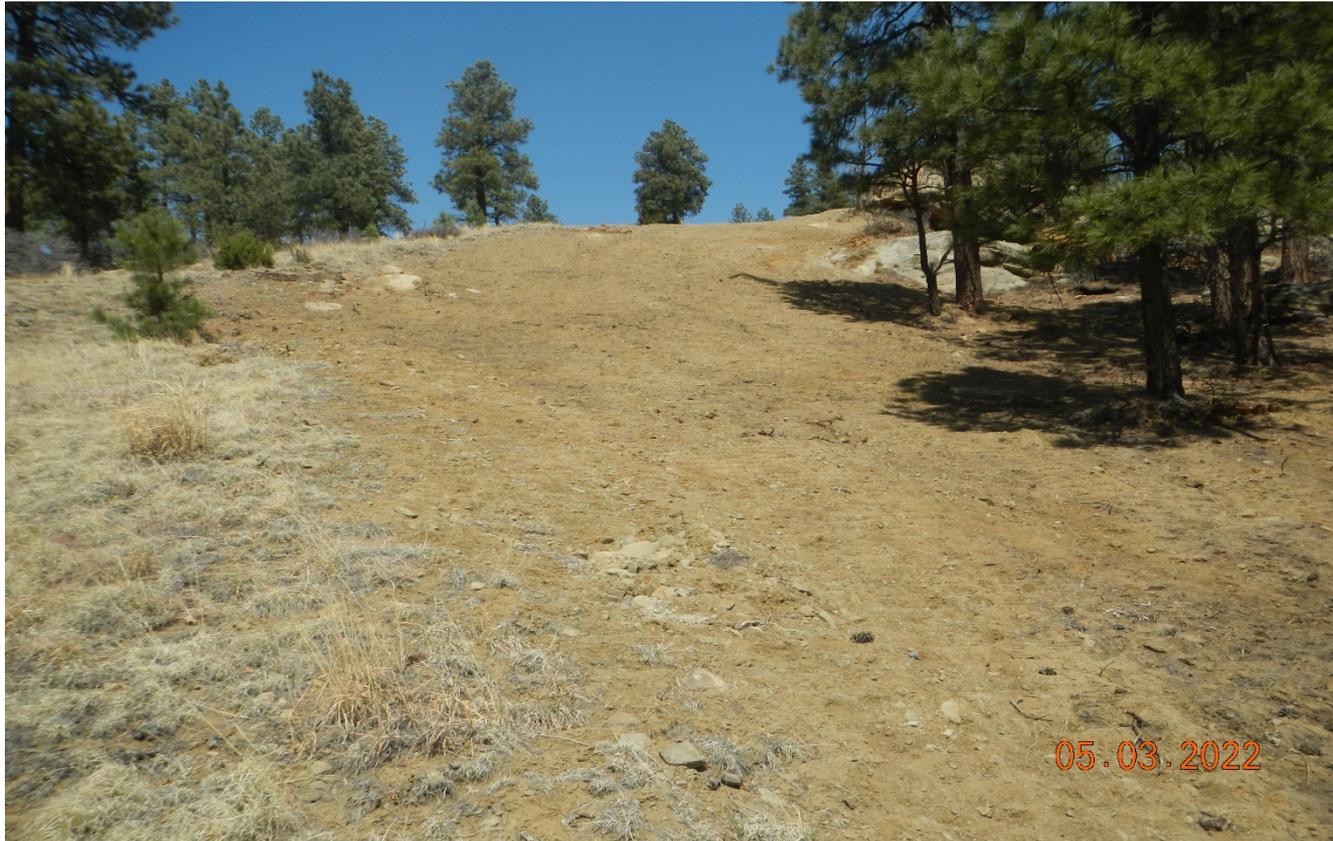
Photo 1. Facing northeast. There has been recent disturbance along the gathering pipeline at Lat/Long:37.05440,-104.76614.This area needs to be reclaimed and stabilized.

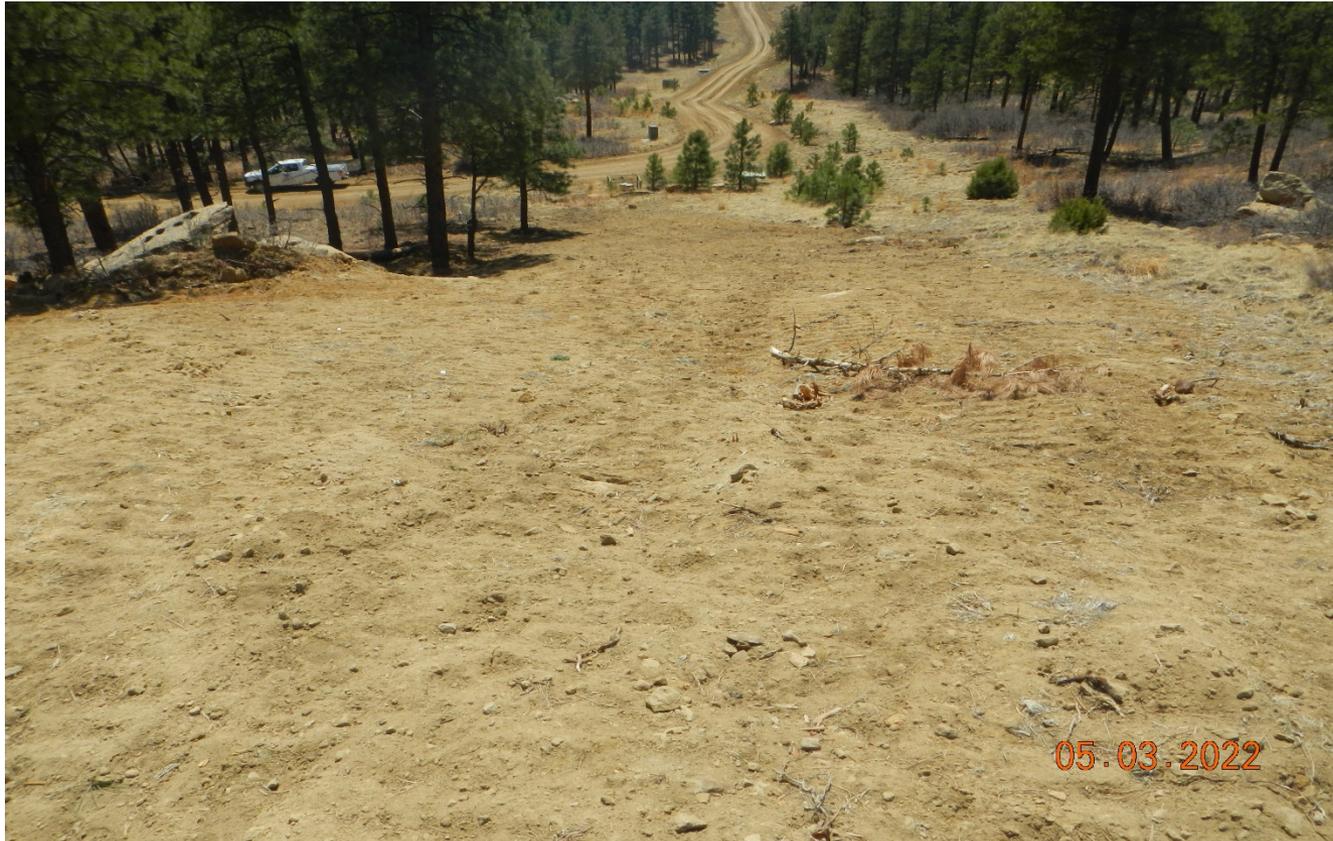
Photo 2. Facing southwest along the pipeline disturbance. The disturbed soils are susceptible to erosion and need to be seeded and stabilized.

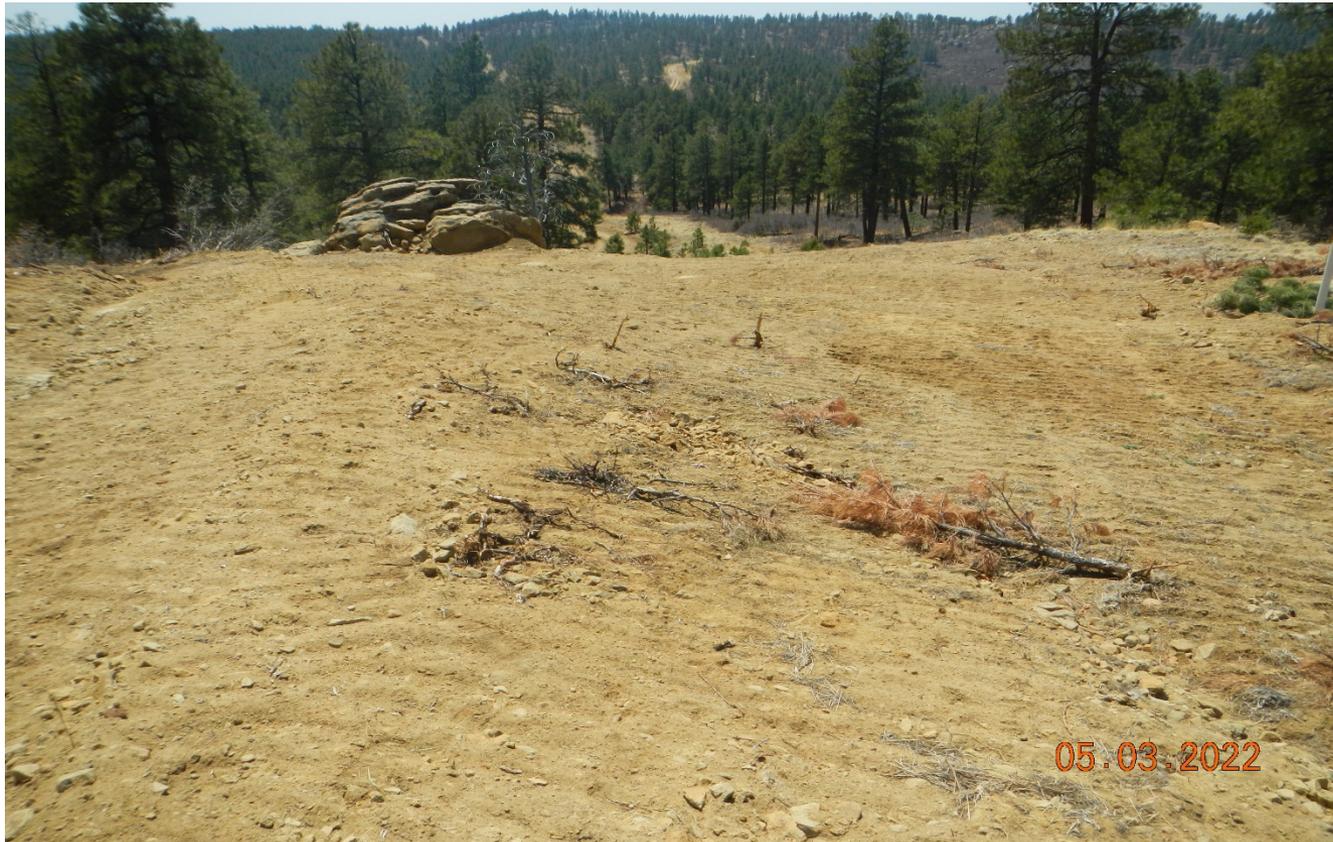
Photo 3. Facing southwest along the pipeline disturbance. The disturbed soils are susceptible to erosion and need to be seeded and stabilized.
