Inspection Photos

API: 071-06811

Operator: WAPITI OPERATING LLC

Inspection Date: 5/3/2022

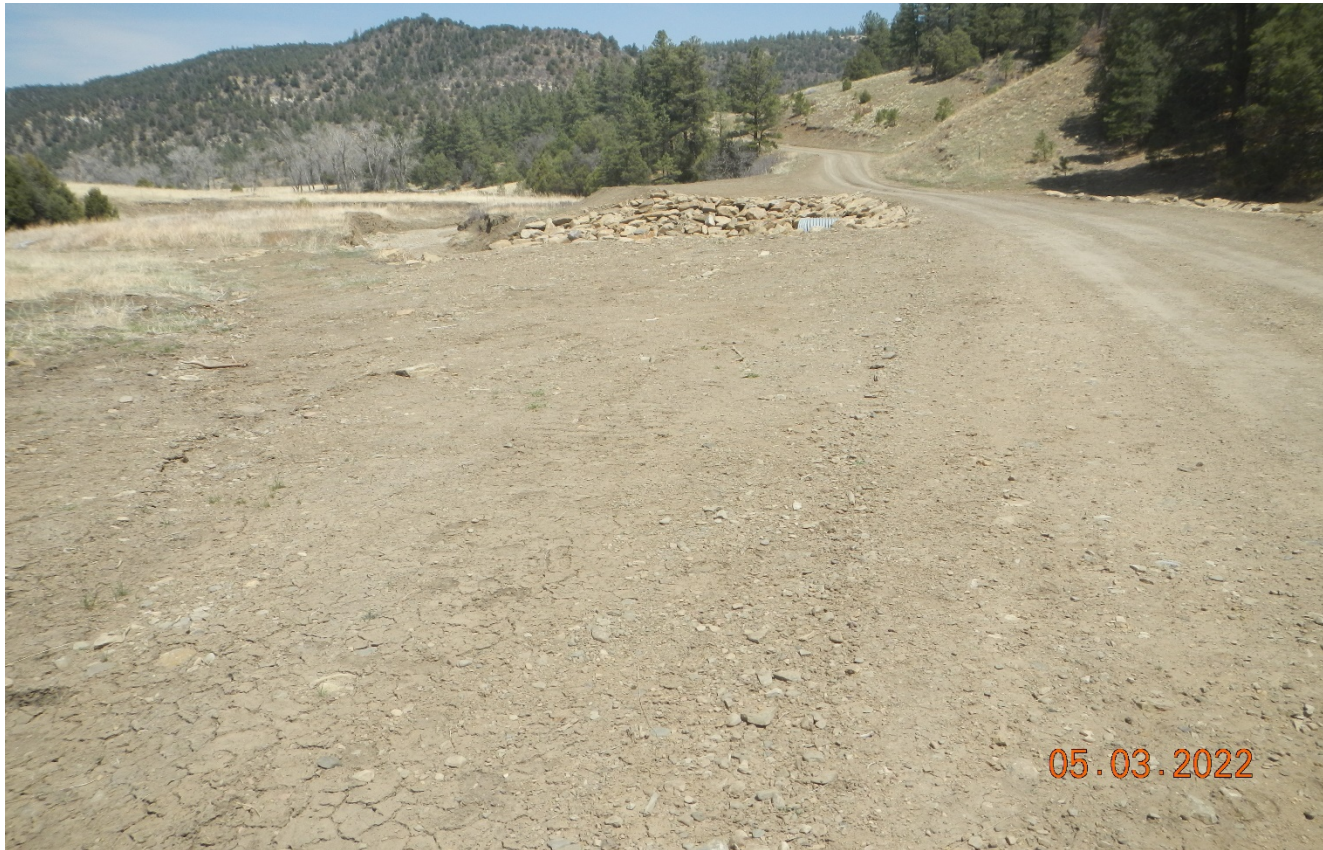
Photo 1. The disturbed bare soils along the roadside at the creek crossing have not been seeded and stabilized. Previous corrective action was not completed.

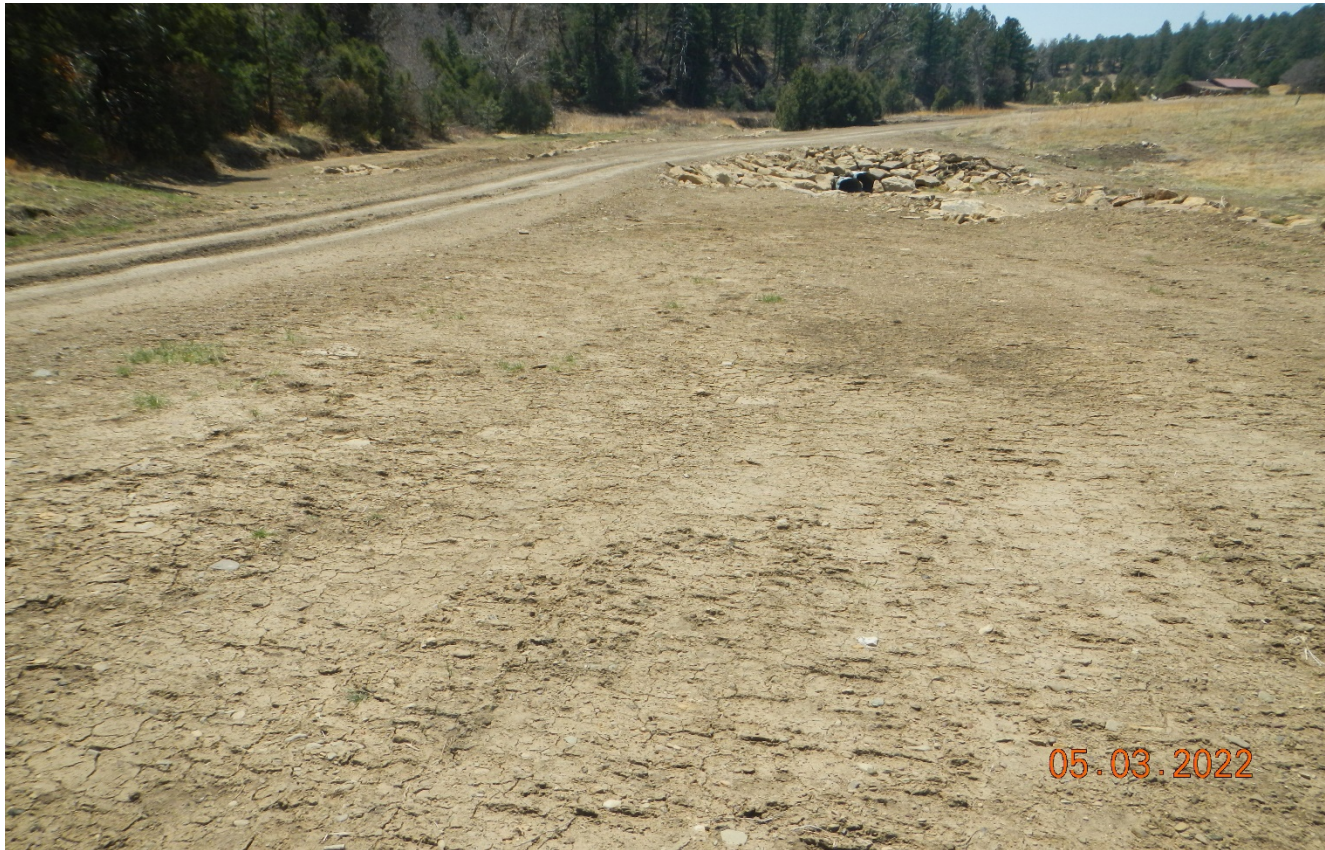
Photo 2. The disturbed bare soils along the roadside at the creek crossing have not been seeded and stabilized. Previous corrective action was not completed.

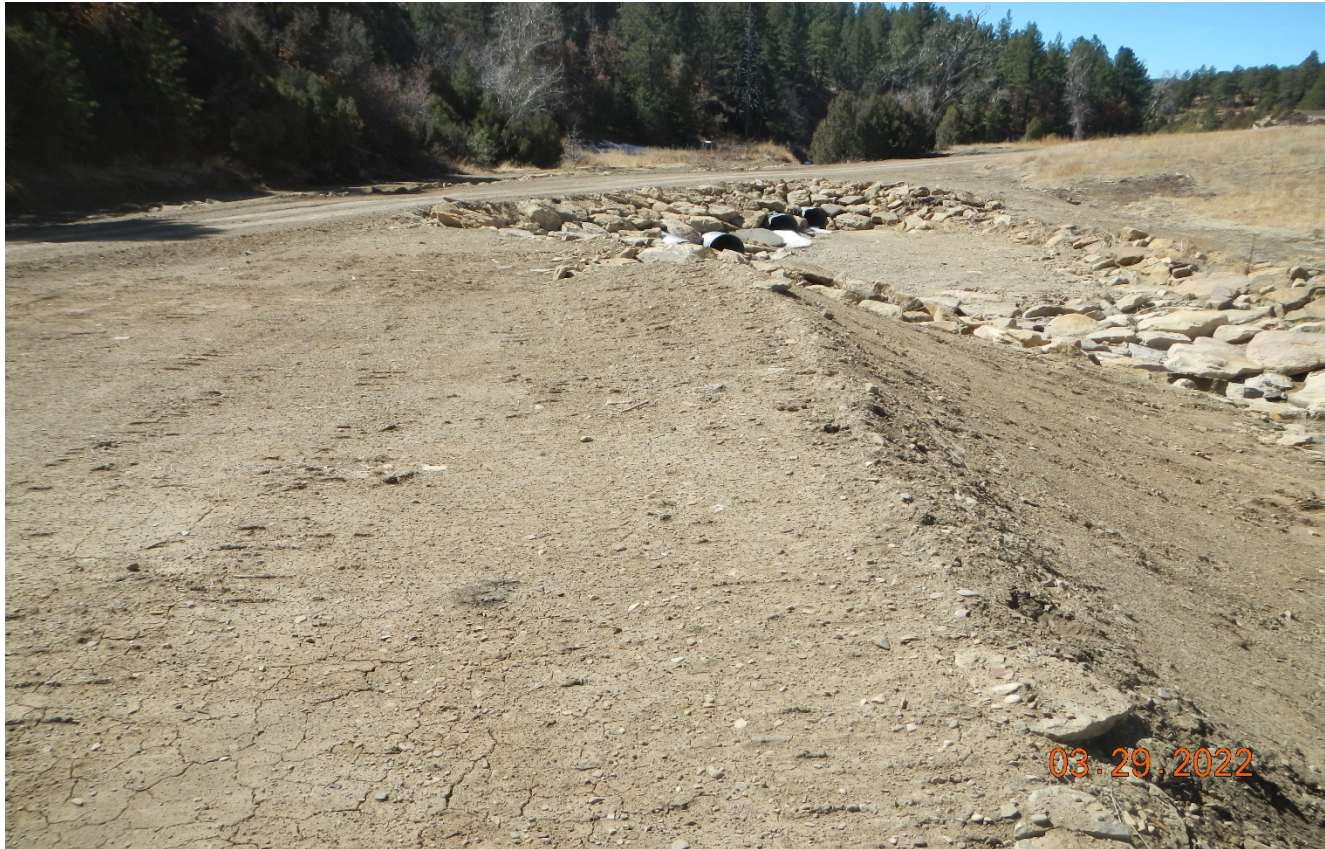
Photo 3. Facing at south side of the road at the additional culvert inlet. Disturbed bare soils have not been seeded and stabilized.

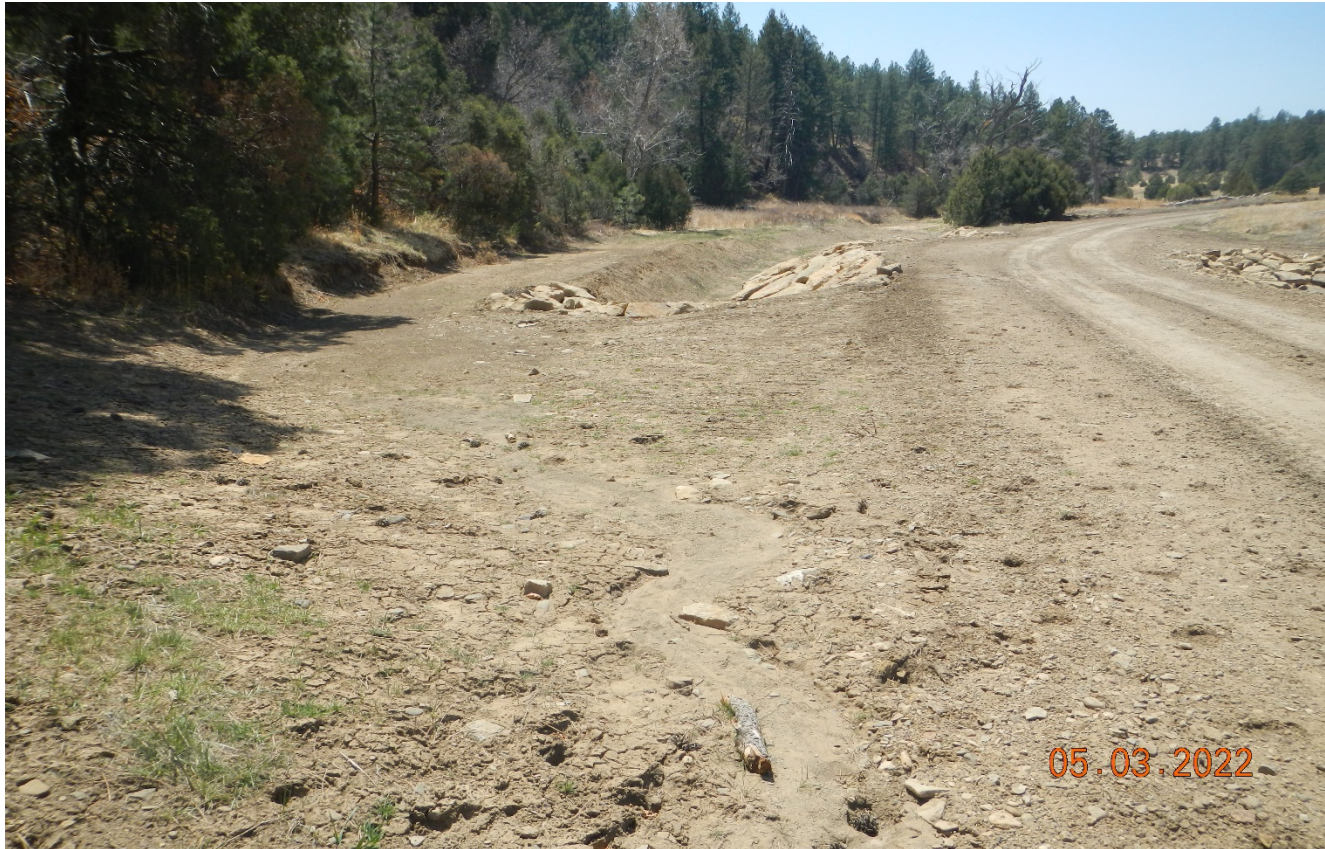
Photo 4. Facing at south side of the road at the additional culvert inlet. Disturbed bare soils have not been seeded and stabilized.

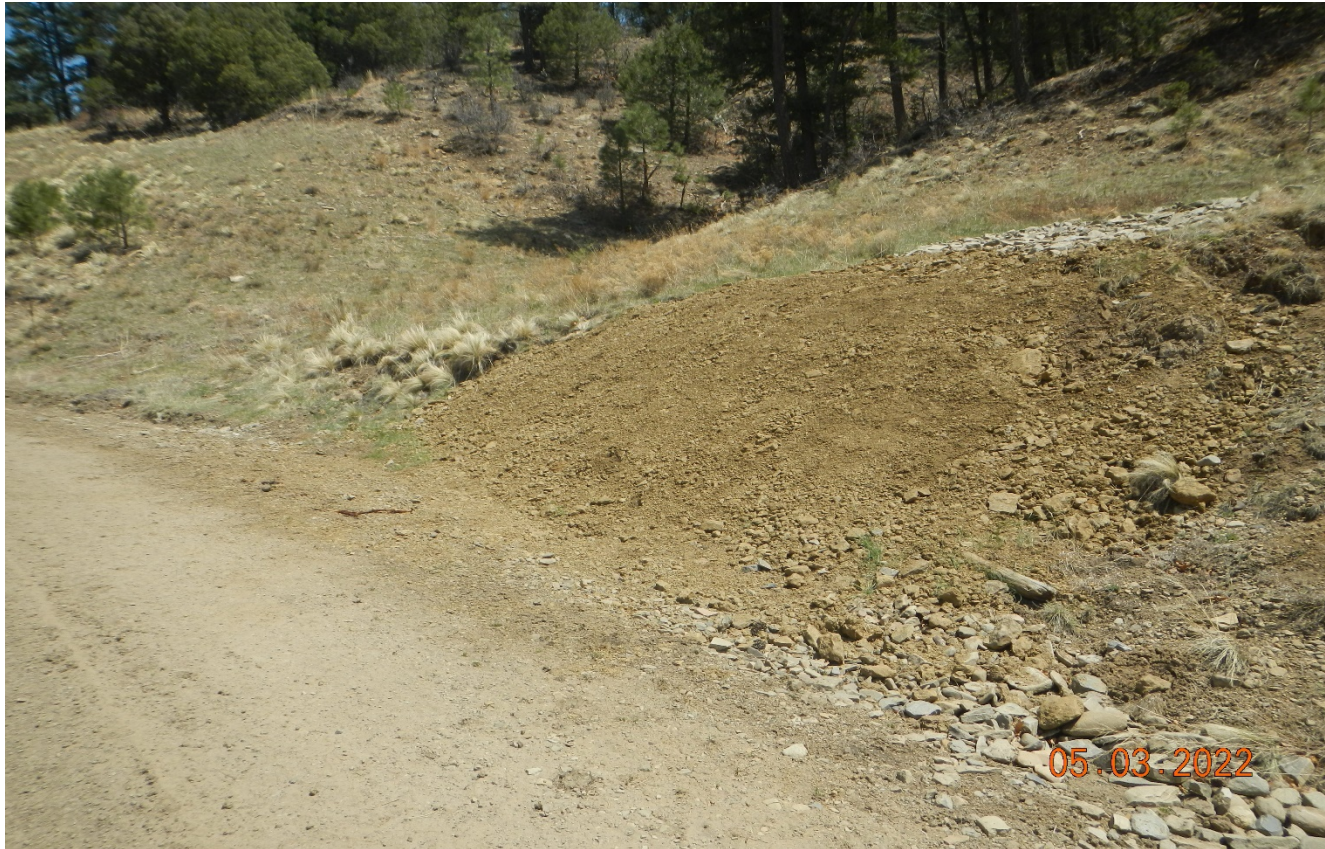
Photo 5. Facing southeast along the road. This area of erosion has been repaired but needs to be seeded and stabilized.
