Inspection Photos

API: 071-09838

Operator: WAPITI OPERATING LLC

Inspection Date: 5/3/2022

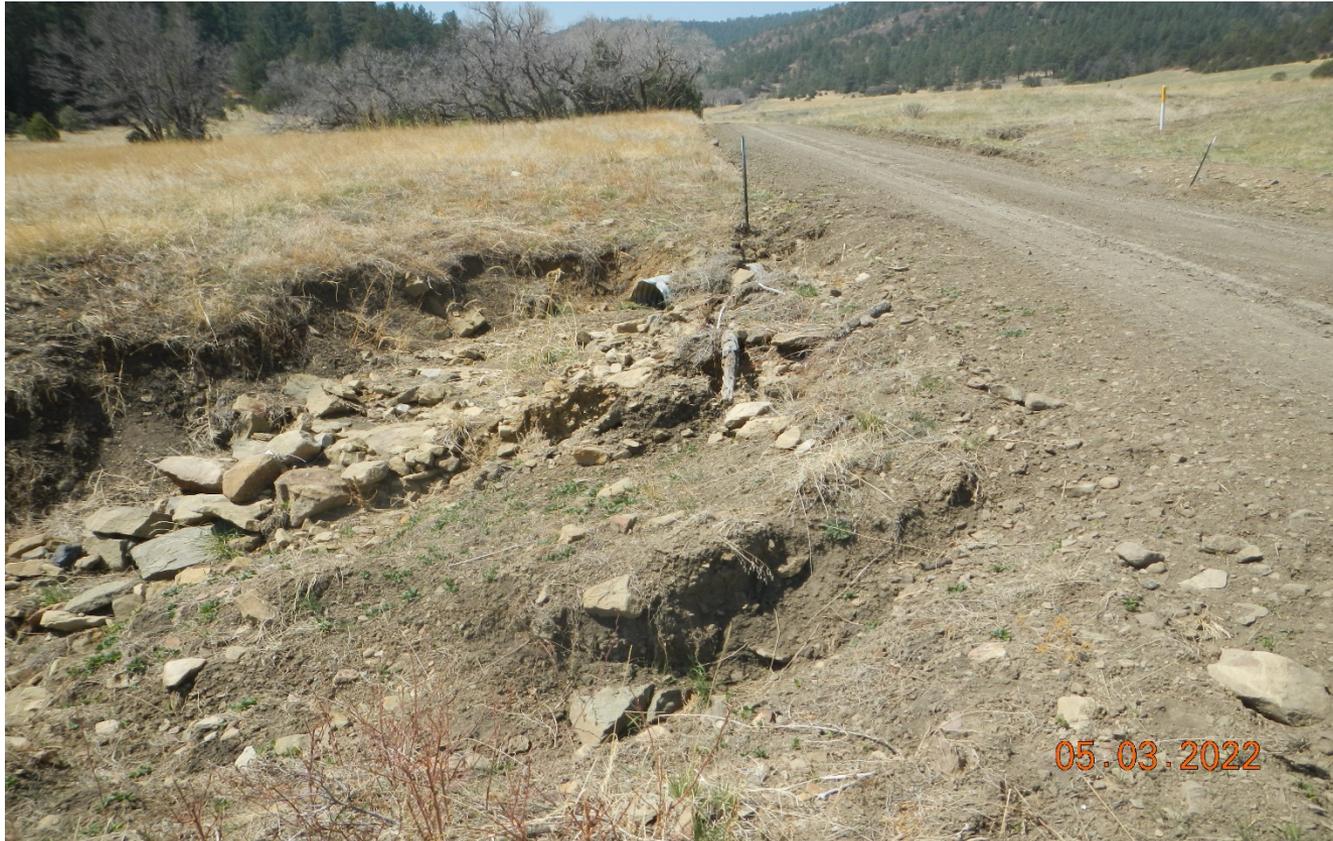
Photo 1. The culvert outlet is eroded and has not been repaired. No culvert outlet protection installed. Lat/Long:37.02423,-104.82919
Previous corrective action not completed.

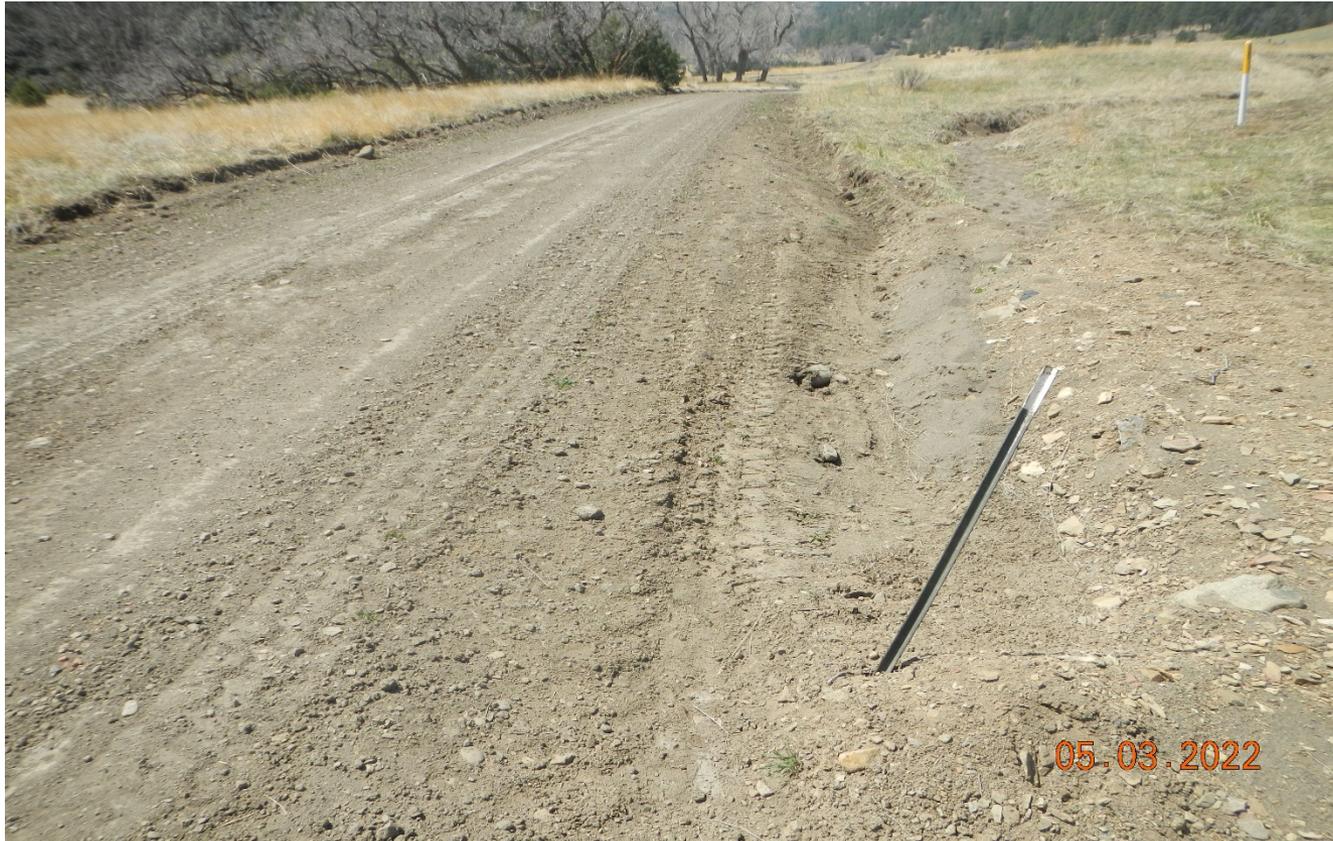
Photo 2. Facing southwest along the main road near the well site. Stormwater has washed across the road causing erosion. The culvert is filled in with sediment and has not been repaired. Previous corrective action not completed.

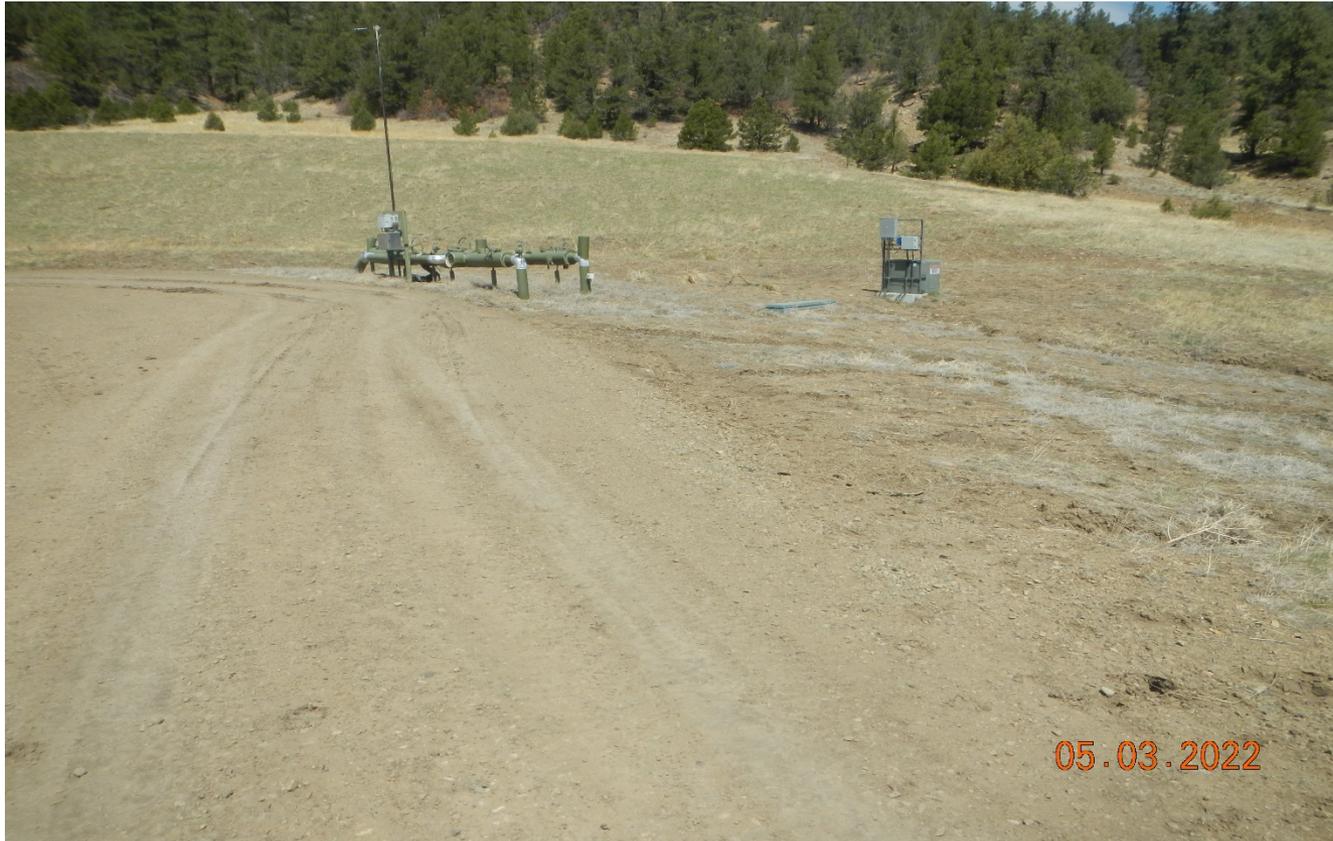
Photo 3. Facing toward the northeast side of the location. The area on the right side of the photo is not stabilized or revegetated.

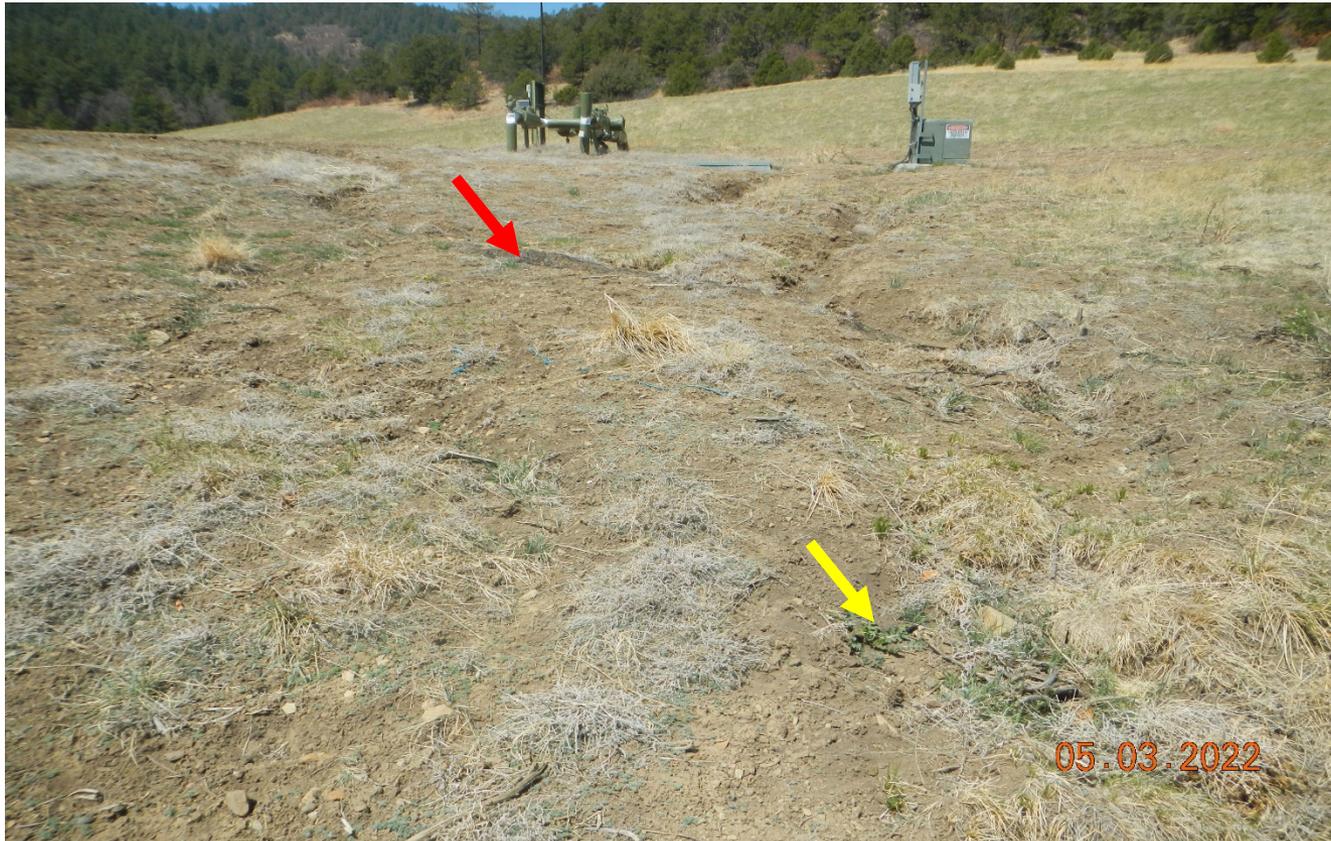
Photo 4. Facing toward the northeast side of the location. This area is not stabilized and there is an erosion. The wattles are degraded shown at red arrow. Previous corrective action not completed. There are noxious weeds beginning to grow (Yellow arrow – Musk thistle)

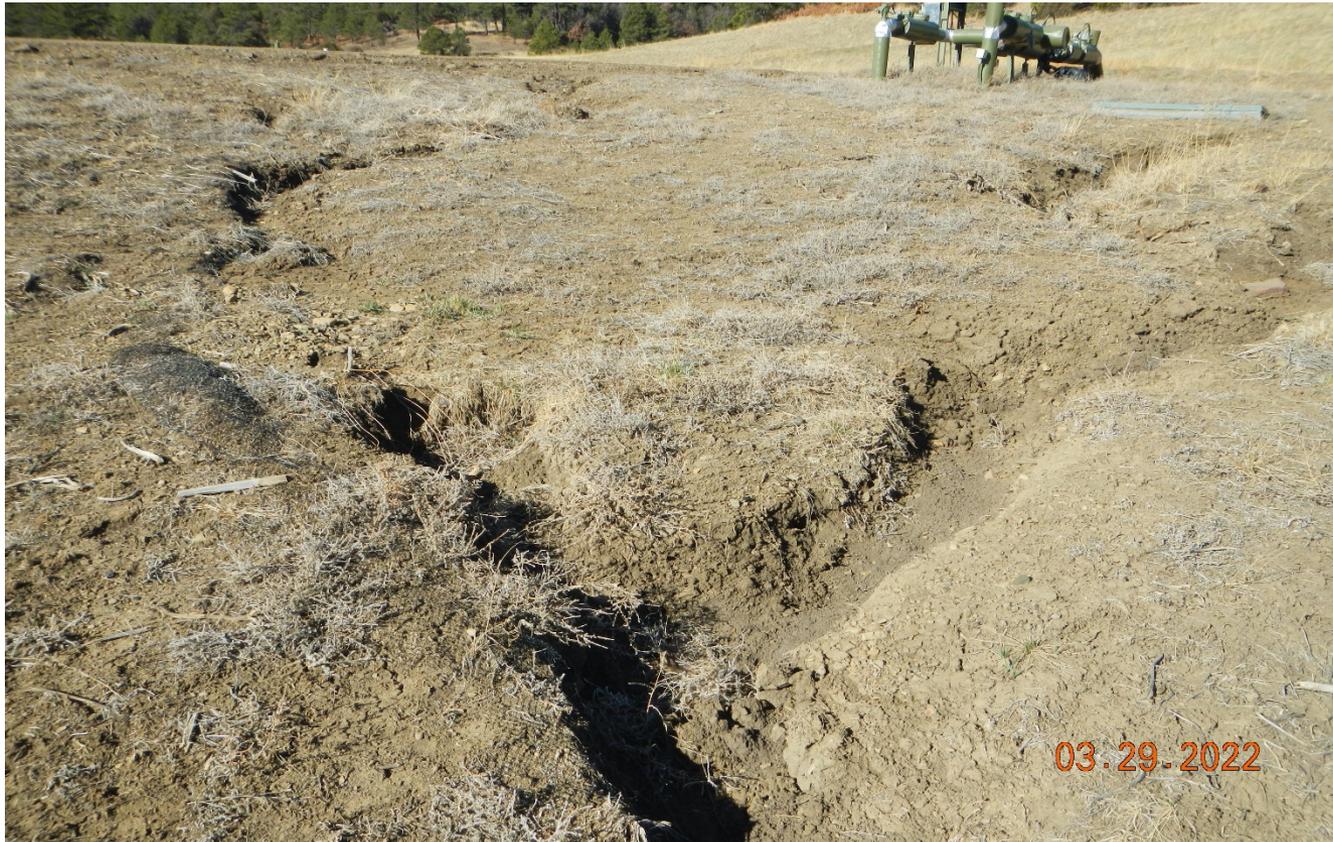
Photo 5. Facing toward the northeast side of the location. This area is not stabilized and there is an erosion channel that will need to be repaired. Previous corrective action not completed.
