# Inspection Photos

API: 071-07915

Operator: WAPITI OPERATING LLC

Inspection Date: 5/3/2022

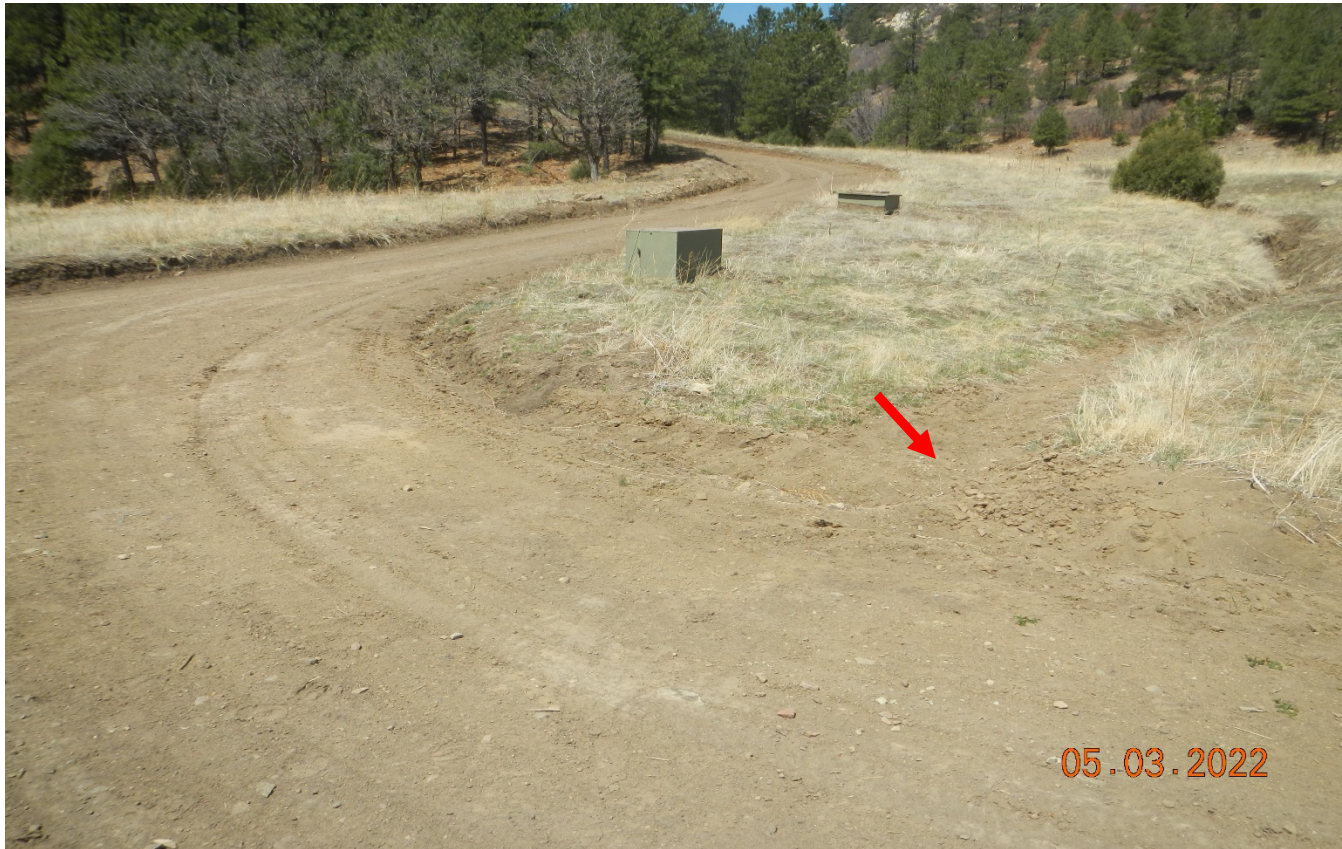
**Photo 1.** Facing west toward the access road ascending the hillside. The road has been graded. The culvert inlet shown at red arrow is filled in with sediment. The culvert outlet is shown in photo 2.

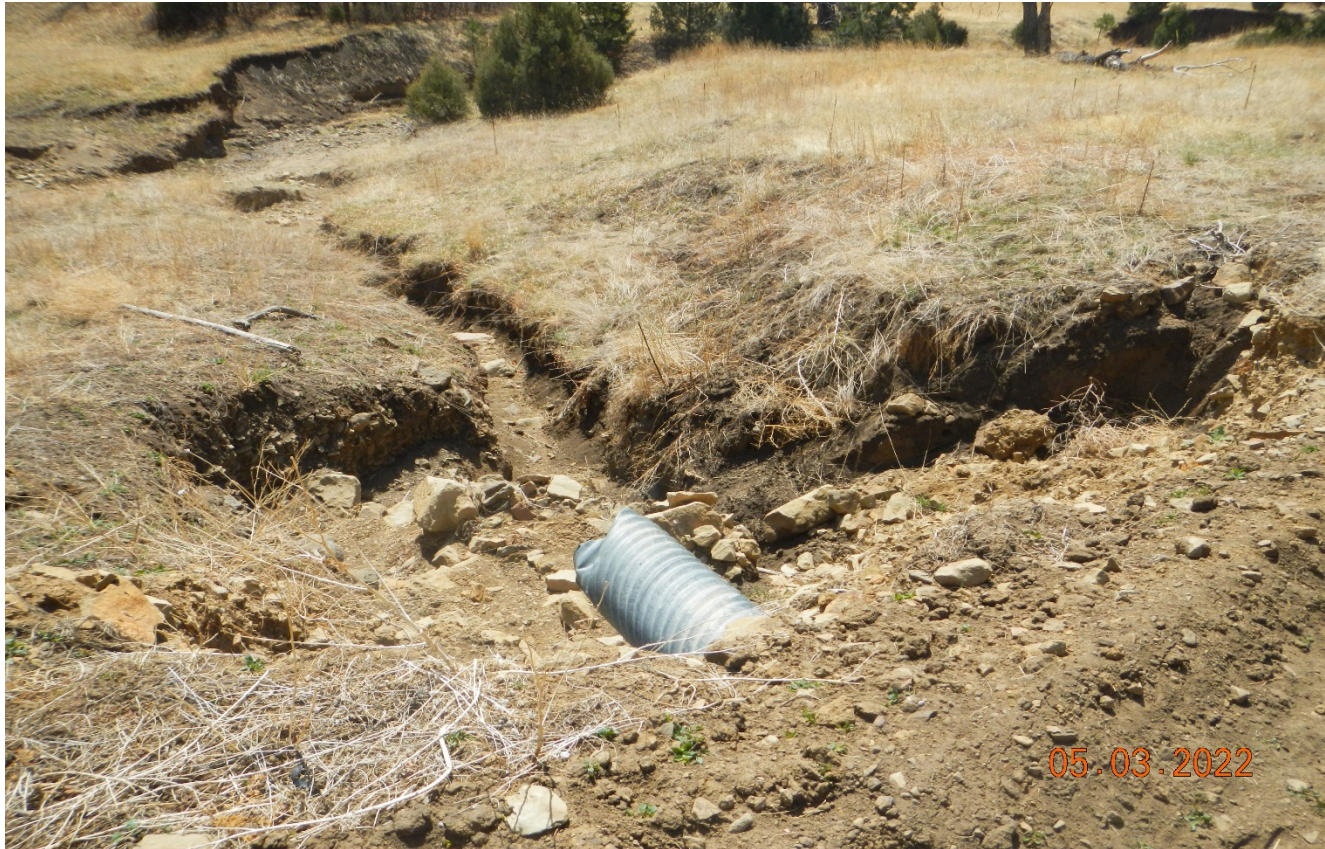
**Photo 2.** The culvert outlet is eroded and does not have outlet protection. Previous corrective action not completed.

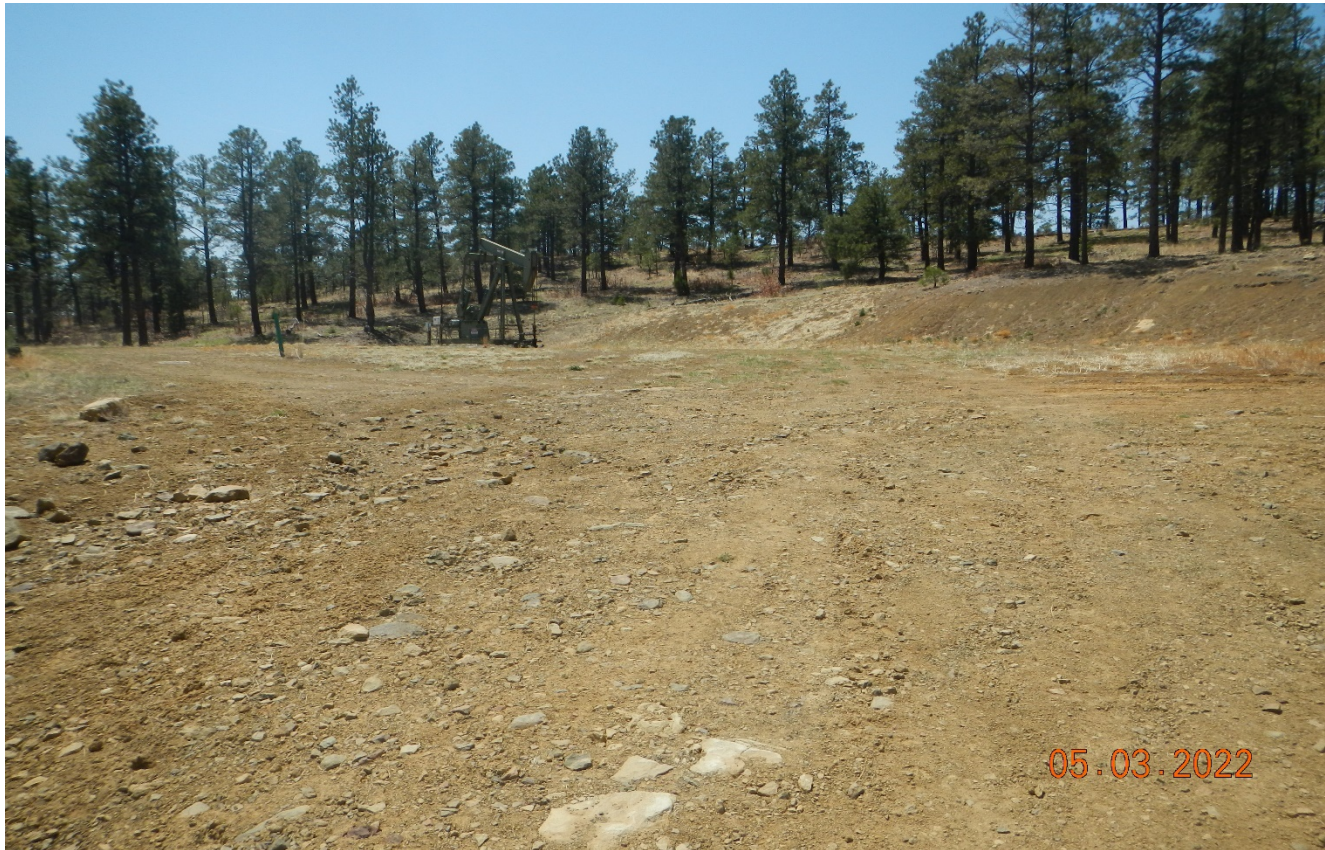
**Photo 3.** Facing southwest toward the location.

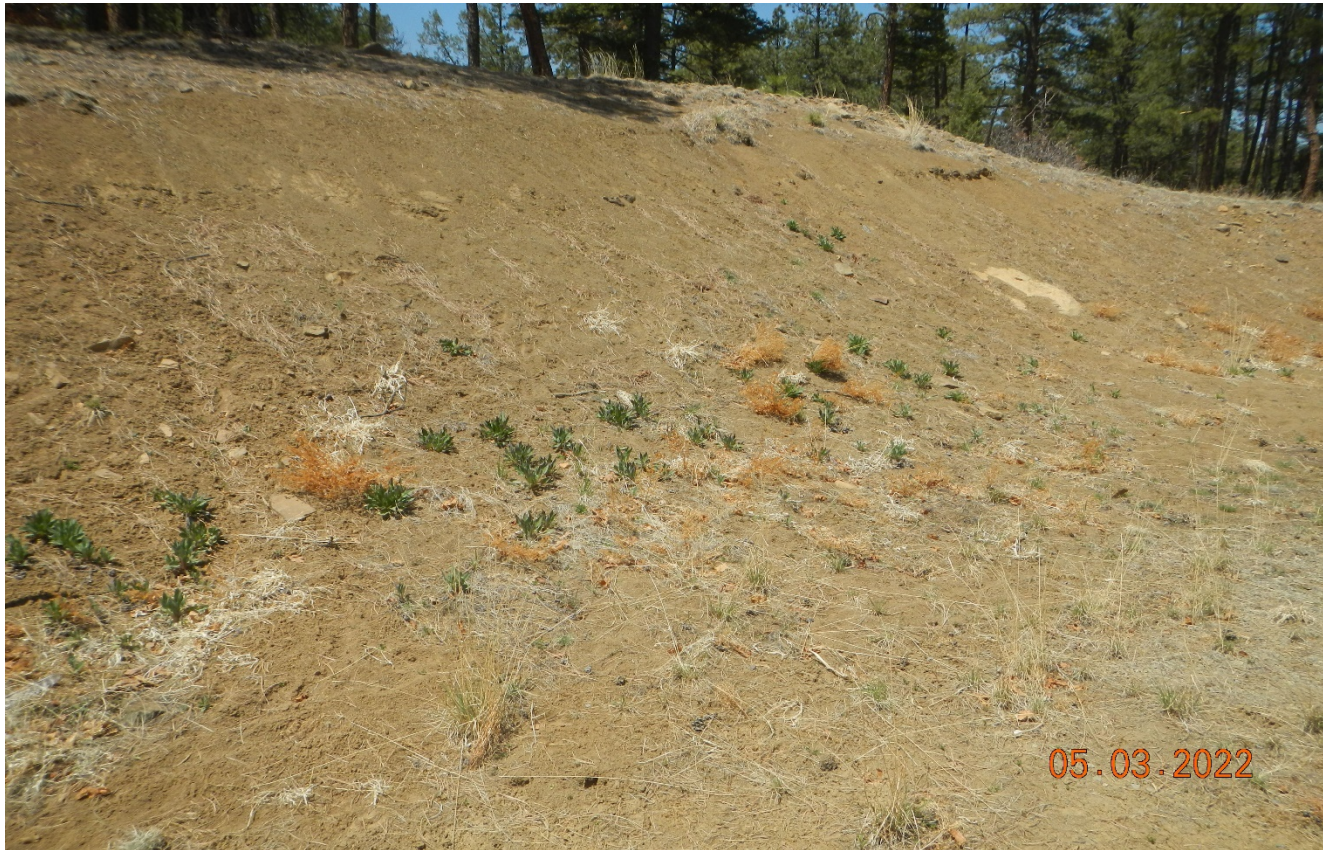
**Photo 4.** There are noxious weeds sprouting up along the cut slope at the location which will need to be controlled. (Hounds tongue).
