# Inspection Photos

API: 071-08769

Operator: WAPITI OPERATING LLC

Inspection Date: 5/3/2022

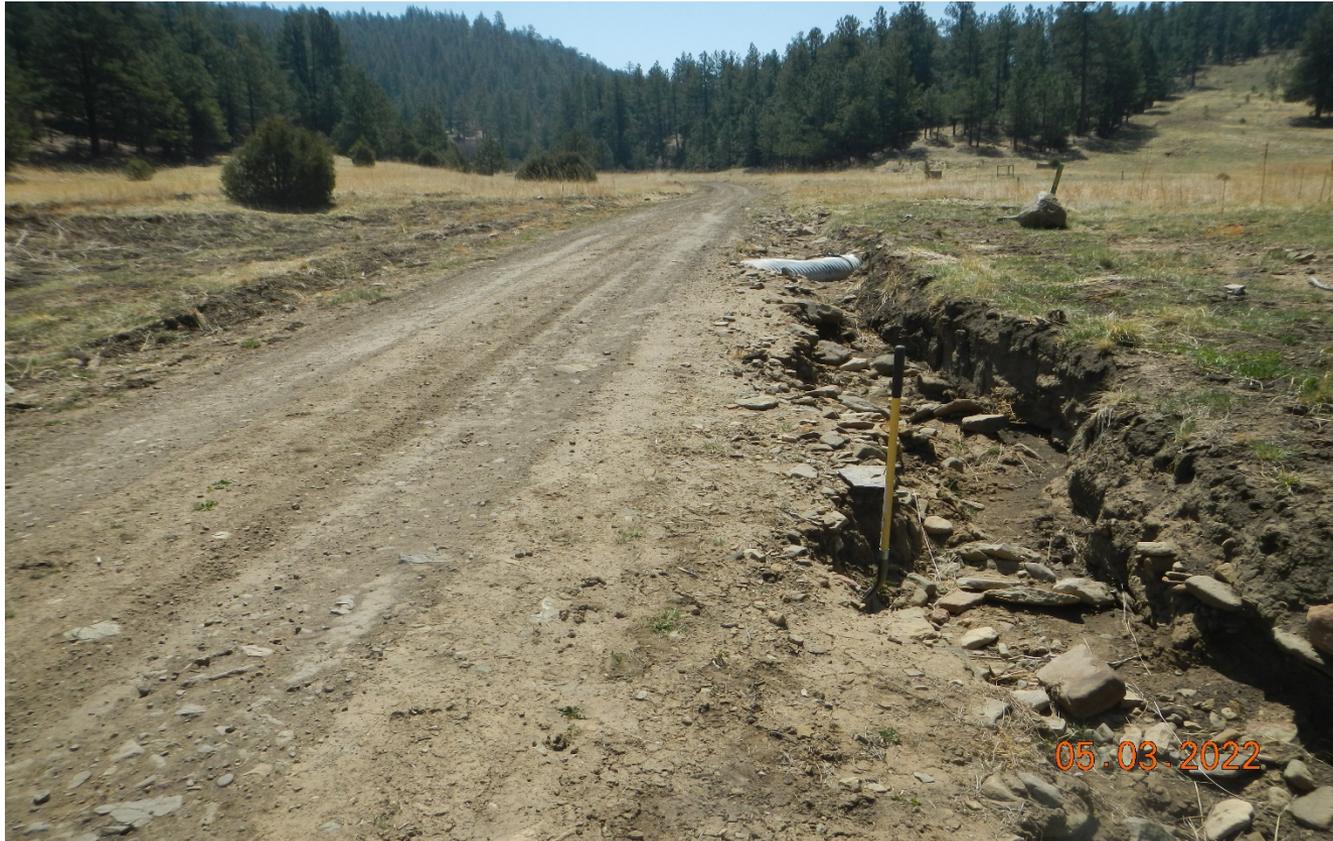
**Photo 1.** Facing southeast along the main road at the upper part of Lorencito Canyon. There is erosion along the road from recent storm event. Stormwater is bypassing the culvert. Previous corrective action was not completed.

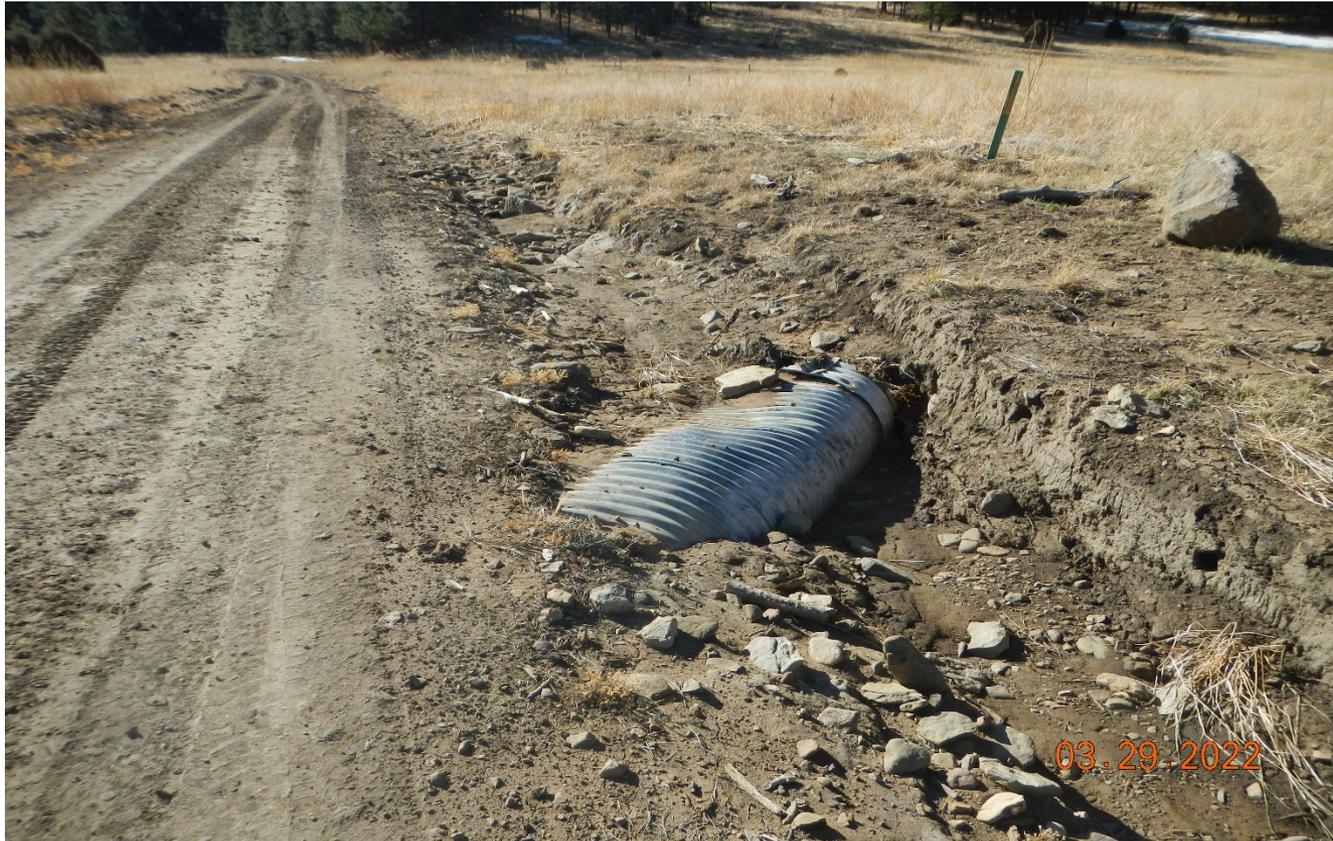
**Photo 2.** The culvert along the road is filled in with sediment causing stormwater to flow down the side of the road. Lat/Long:37.00581,-104.83861. Previous corrective action was not completed.

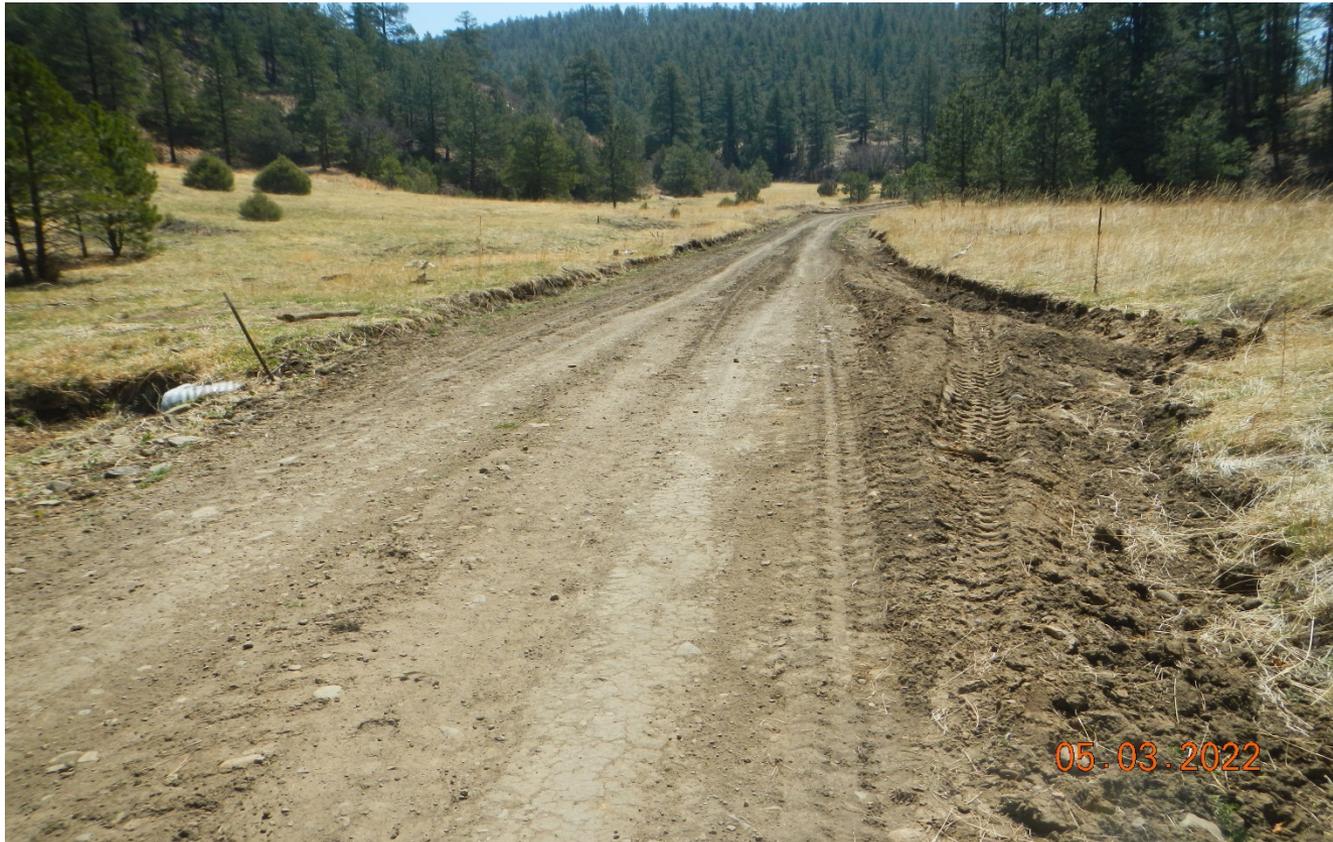
**Photo 3.** The culvert along the road is filled in with sediment causing stormwater to flow down the side of the road. Lat/Long:37.00499,-104.83742. Previous corrective action was not completed.

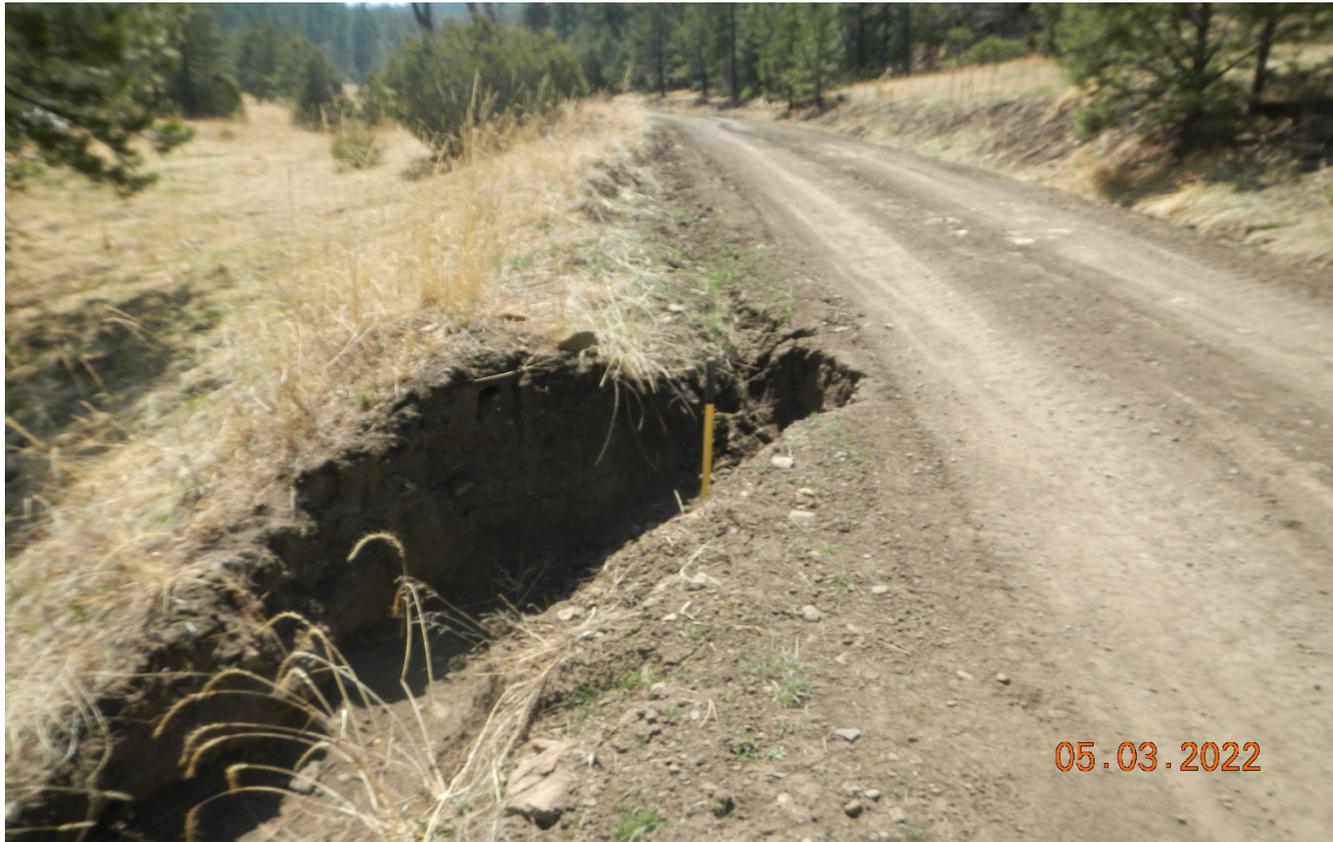
**Photo 4.** There is an erosion gully along the road that needs to be repaired and stabilized.

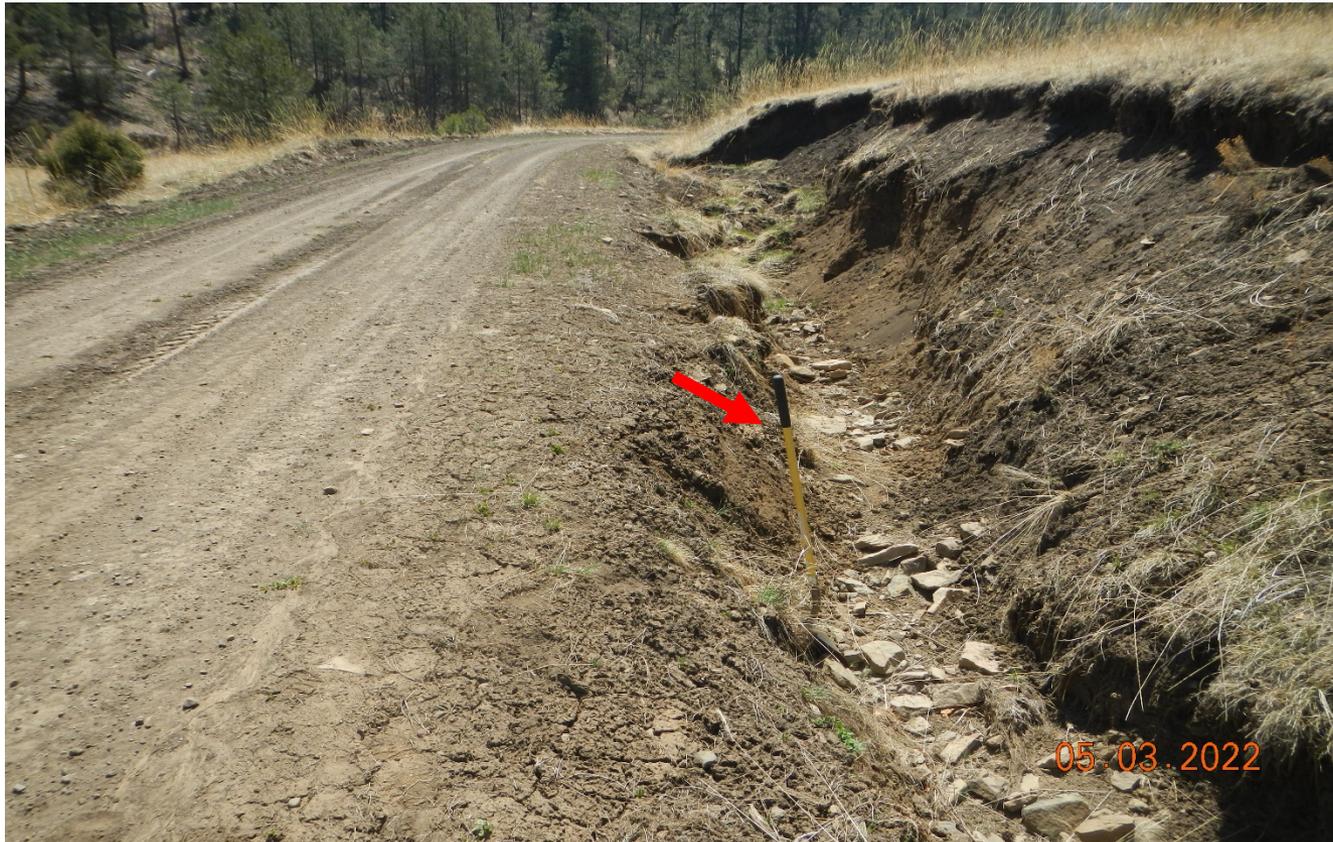
**Photo 5.** The side of the road is eroded and is not stabilized at Lat/Long:36.99952,-104.83425. This area or erosion needs to be repaired and stabilized. Previous corrective action not completed. Red arrow points to 4.5 ft. shovel.

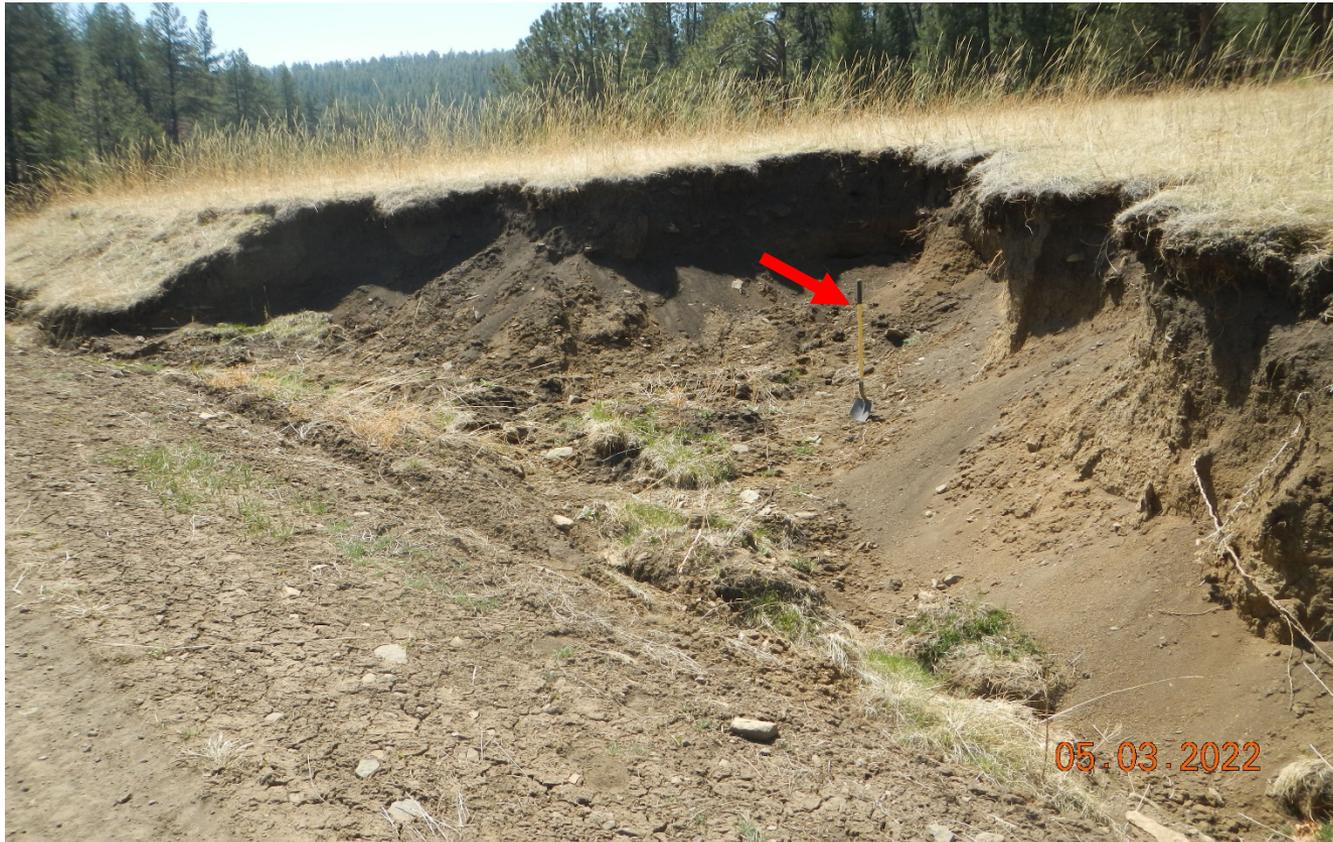
**Photo 6.** The side of the road is eroded and not stabilized at Lat/Long:36.99952,-104.83425. Erosion head cutting is continuing to occur further back. This area needs to be repaired and stabilized. Previous corrective action not completed. Red arrow points to 4.5 ft. shovel.

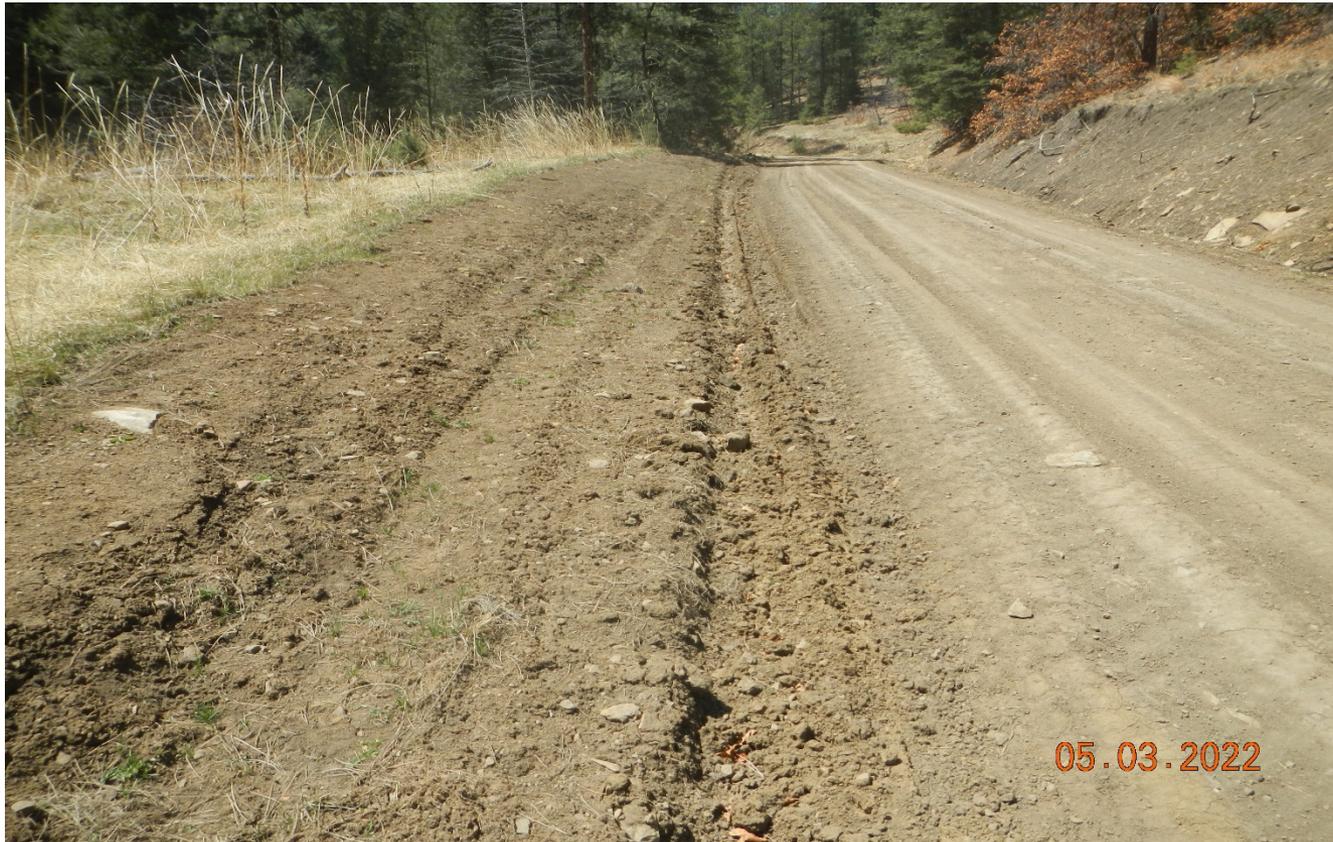
**Photo 7.** There was grading performed along the road. The disturbance along the side of the road needs to be seeded and reclaimed. Previous corrective action not completed.

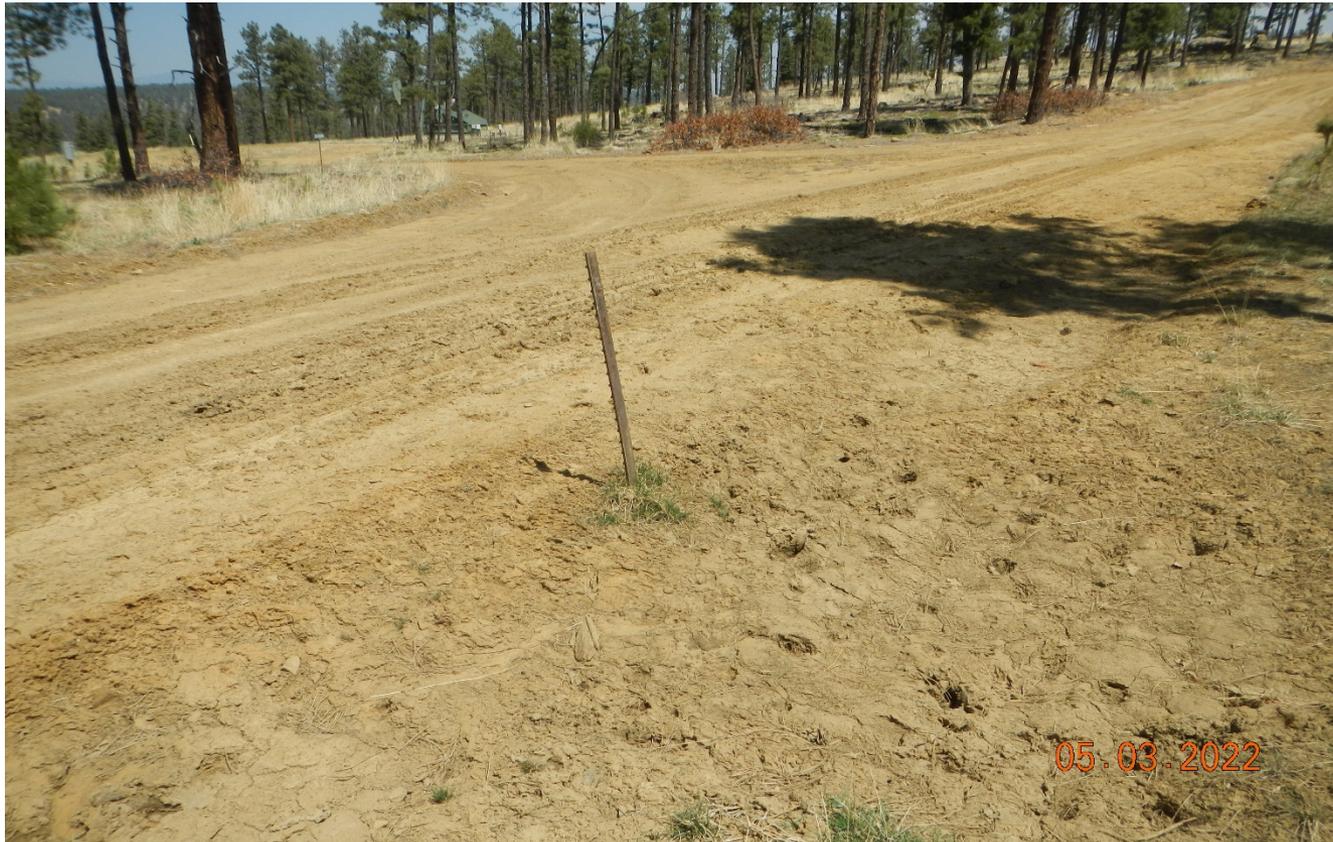
**Photo 8.** The culvert along the road is filled in with sediment at Lat/Long:36.99405,-104.84710. Previous corrective action not completed.

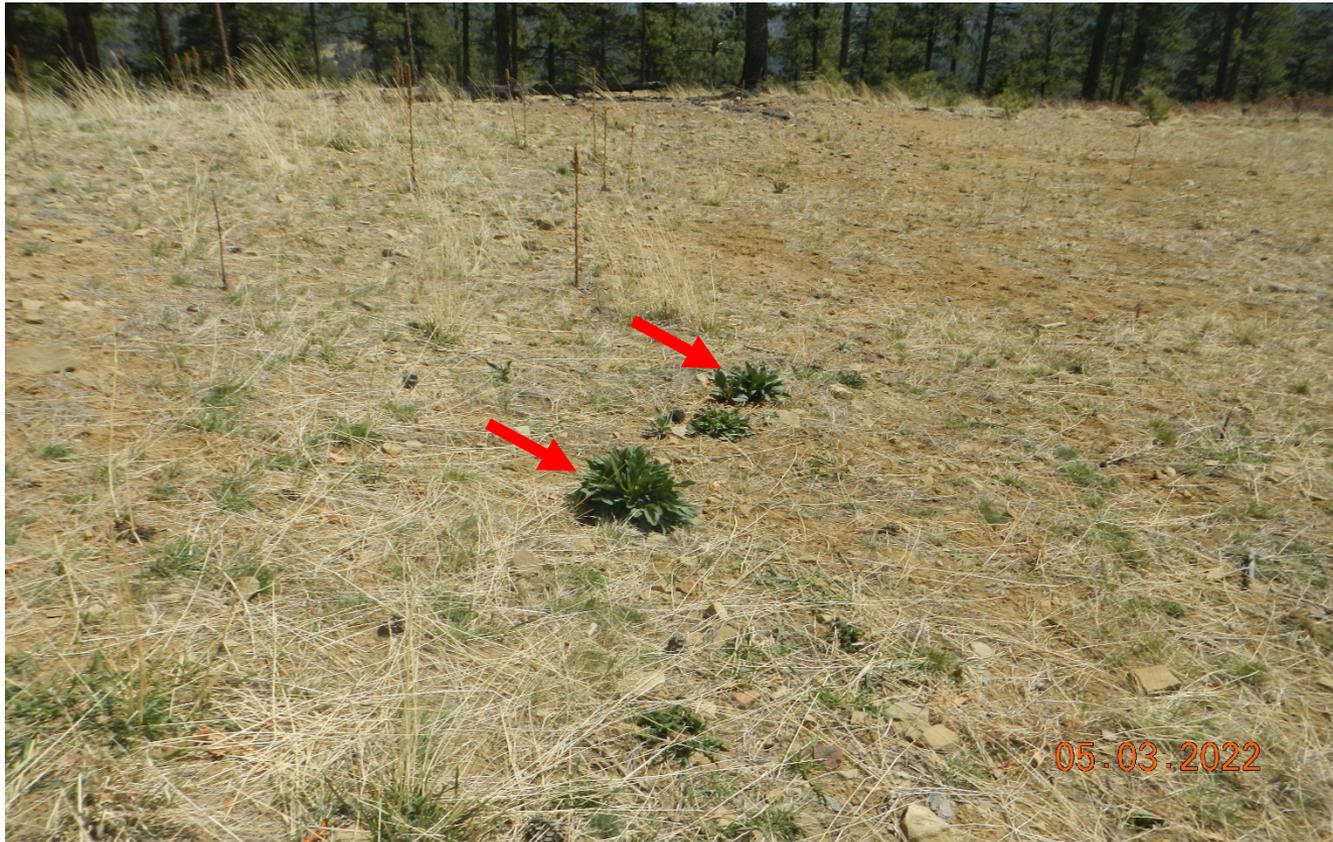
**Photo 10.** There are noxious weeds sprouting up at the location which will need to be controlled. (Hounds tongue, Mullein).
