Inspection Photos

API: 071-06867

Operator: WAPITI OPERATING LLC

Inspection Date: 5/3/2022

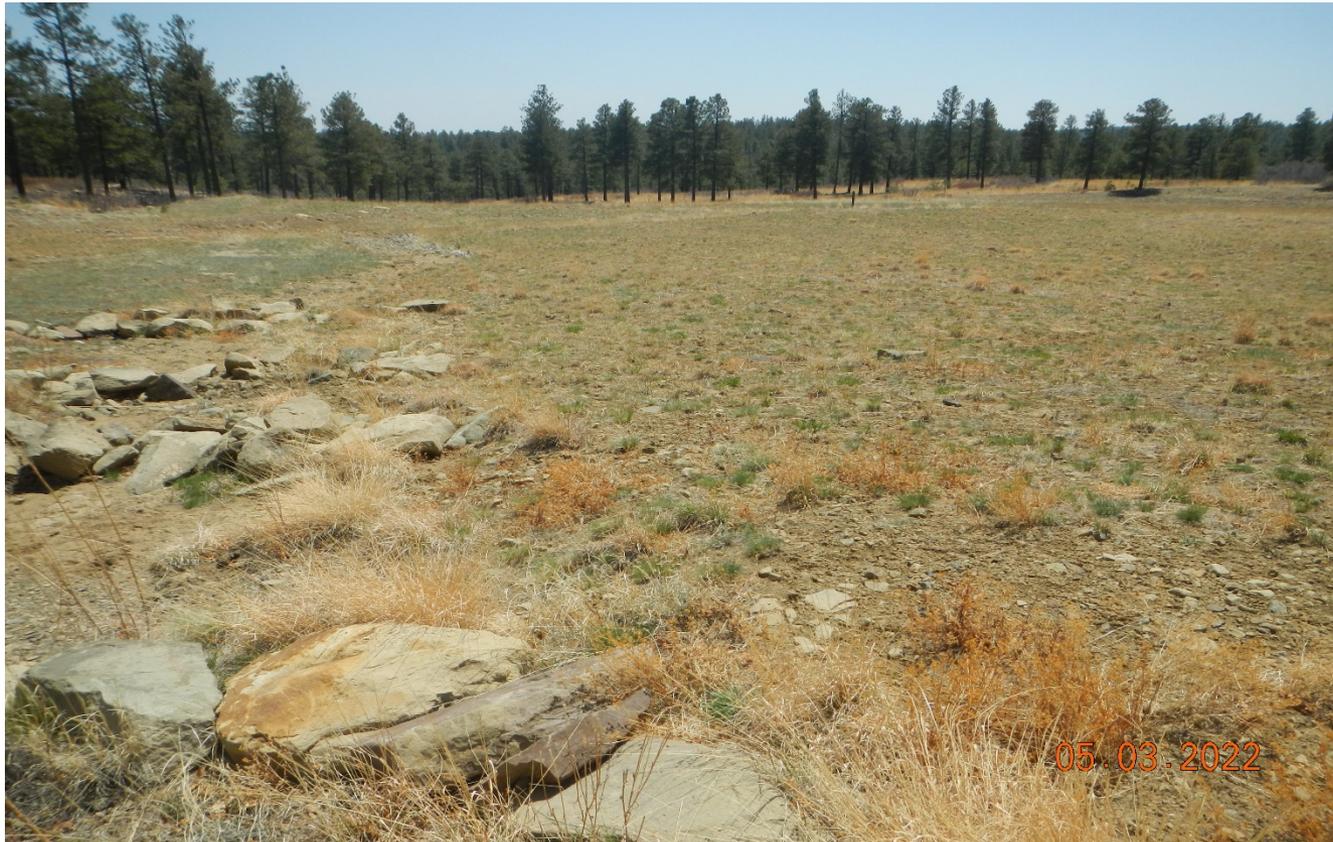
Photo 1. Facing southeast toward the reclaimed location.

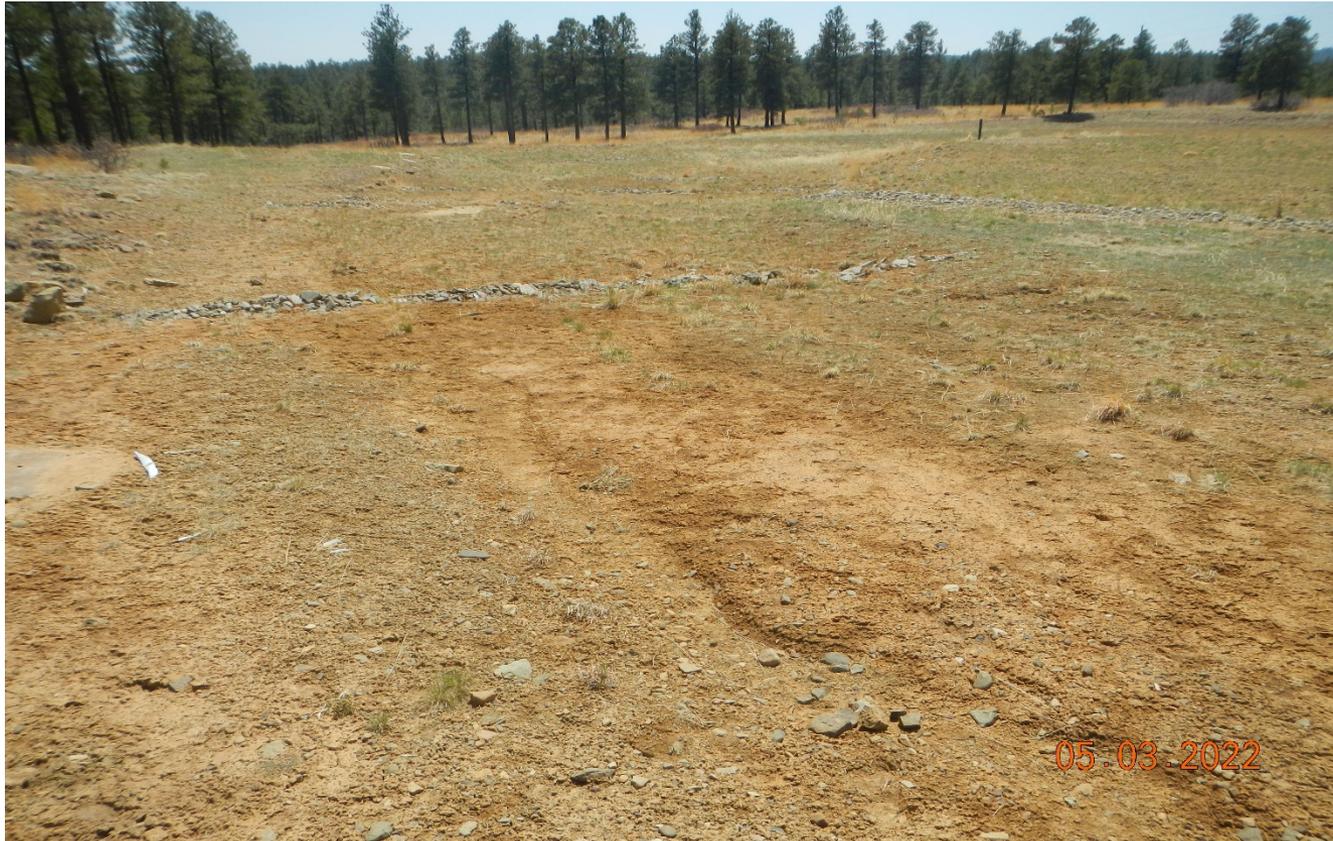
Photo 2. There are areas along the east side that could use additional hand seeding to establish vegetation.

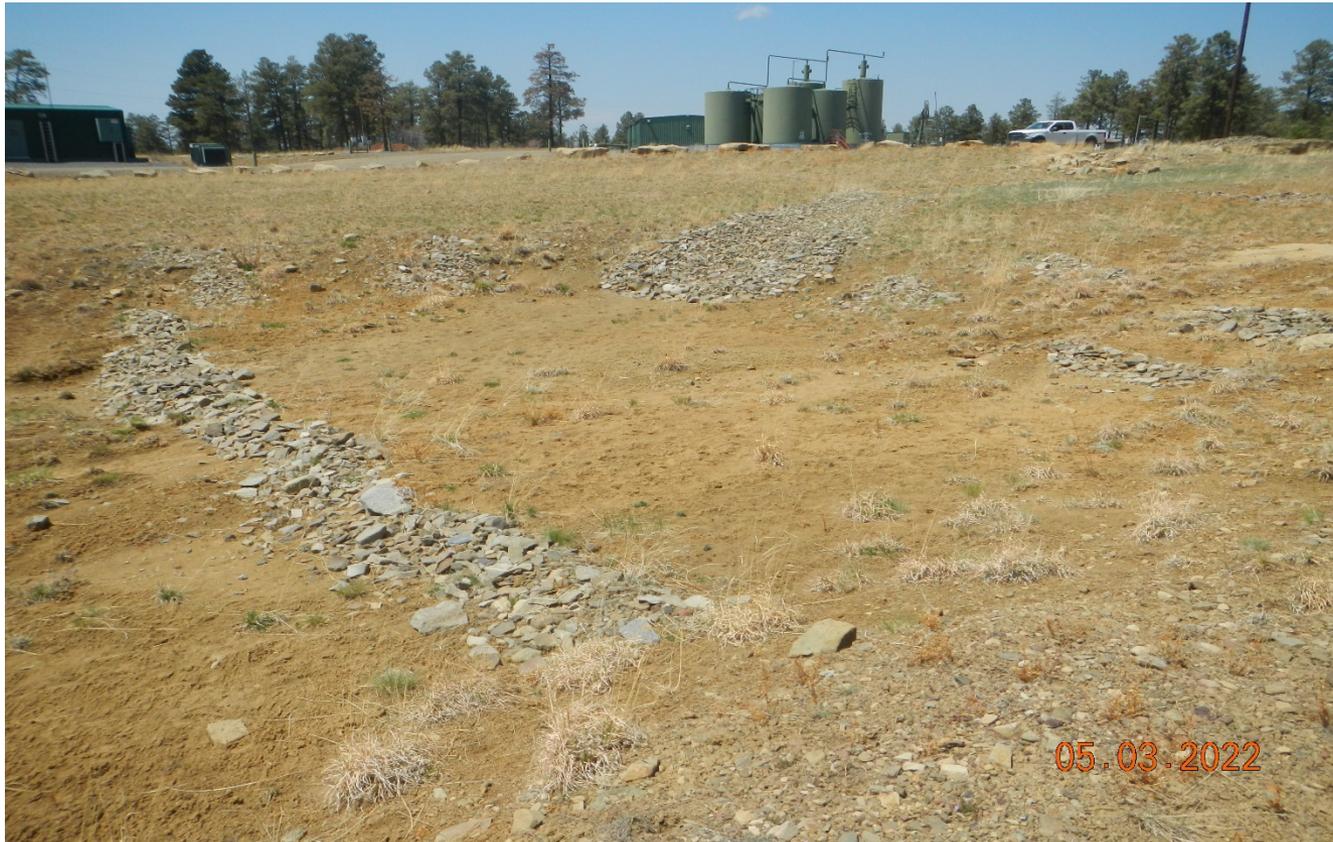
Photo 3. Facing west at the location. There are rock check dams installed where erosion was occurring. This area could use additional hand seeding to establish vegetation.

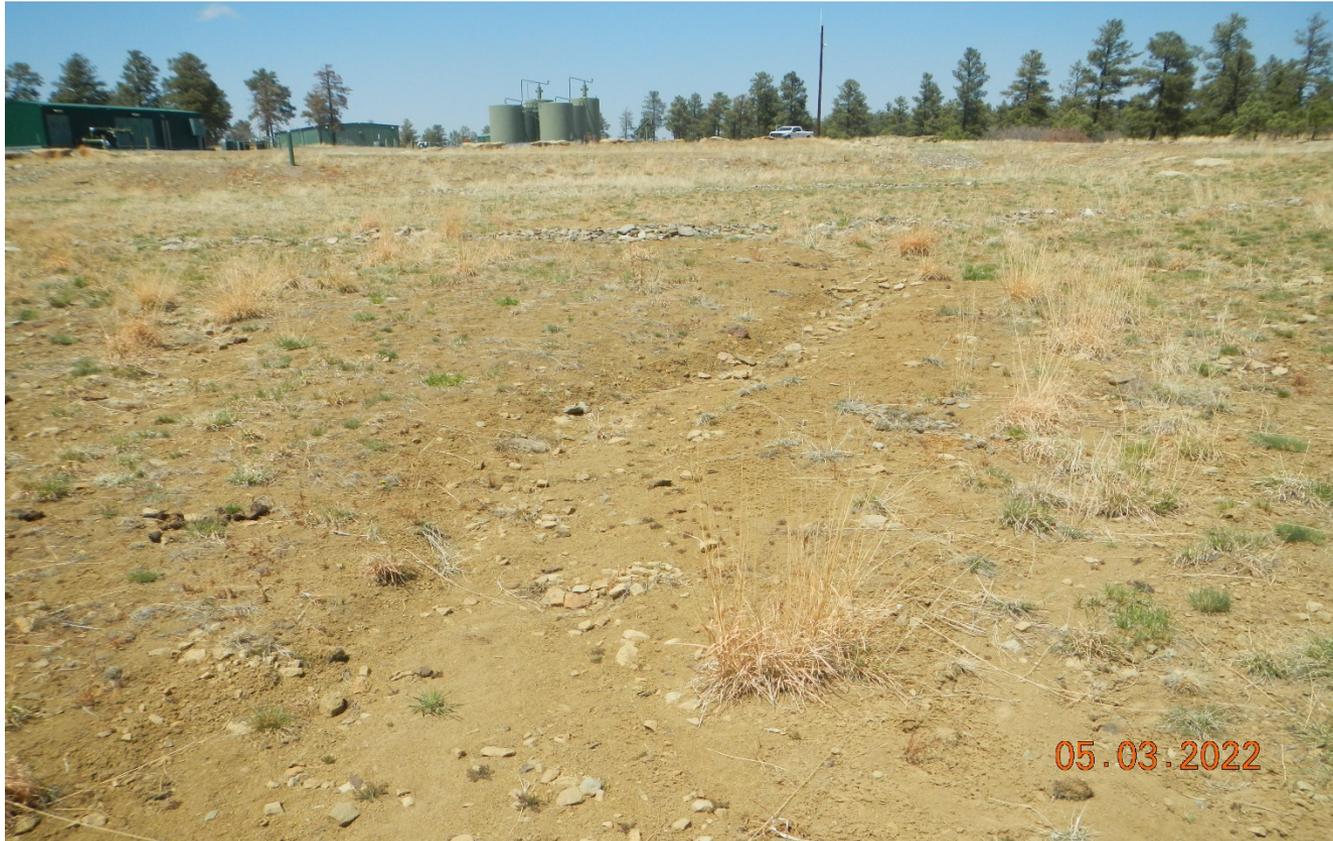
Photo 4. Facing northeast at the location. This area could use additional hand seeding to establish vegetation.

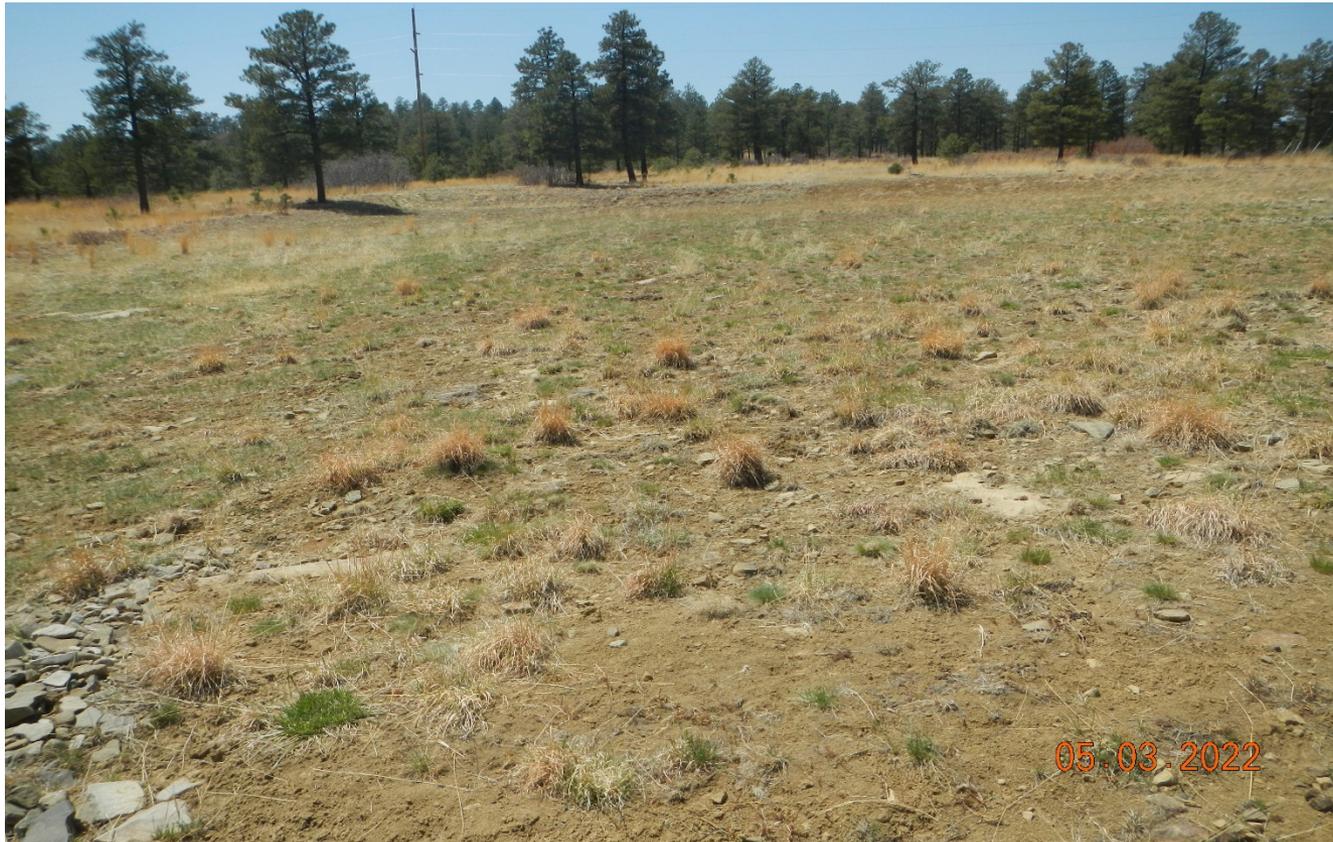
Photo 5. Facing southwest at the location.
