Inspection Photos
Operator: Enduring
API: 067-08398
Date: 4/29/2022

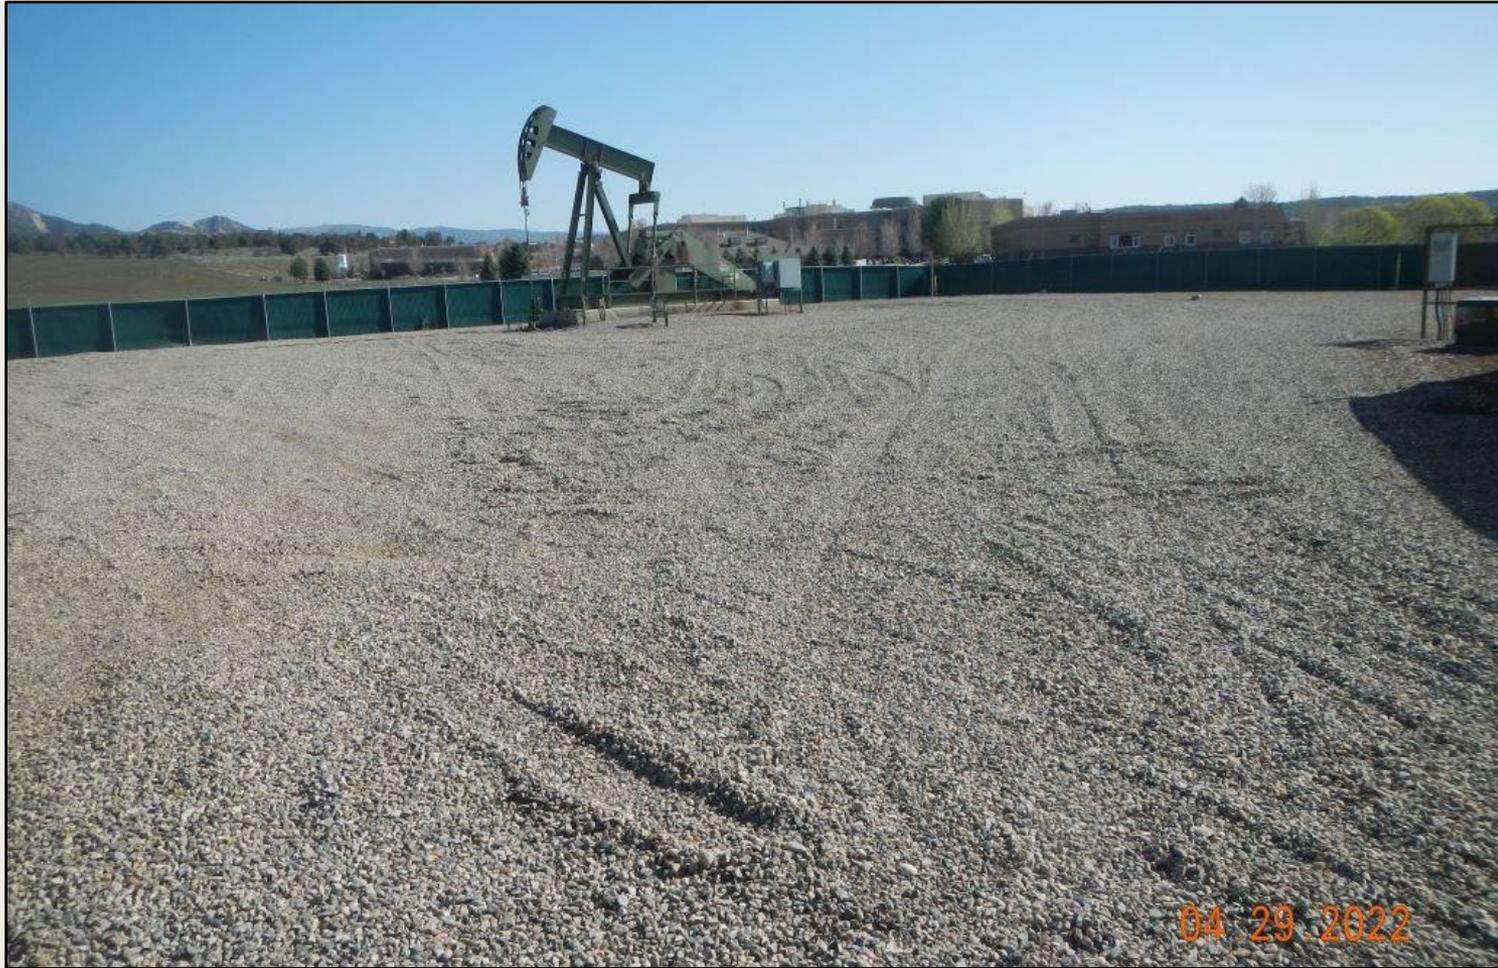
Photo 1. View of the project area from the well pad entrance facing center.

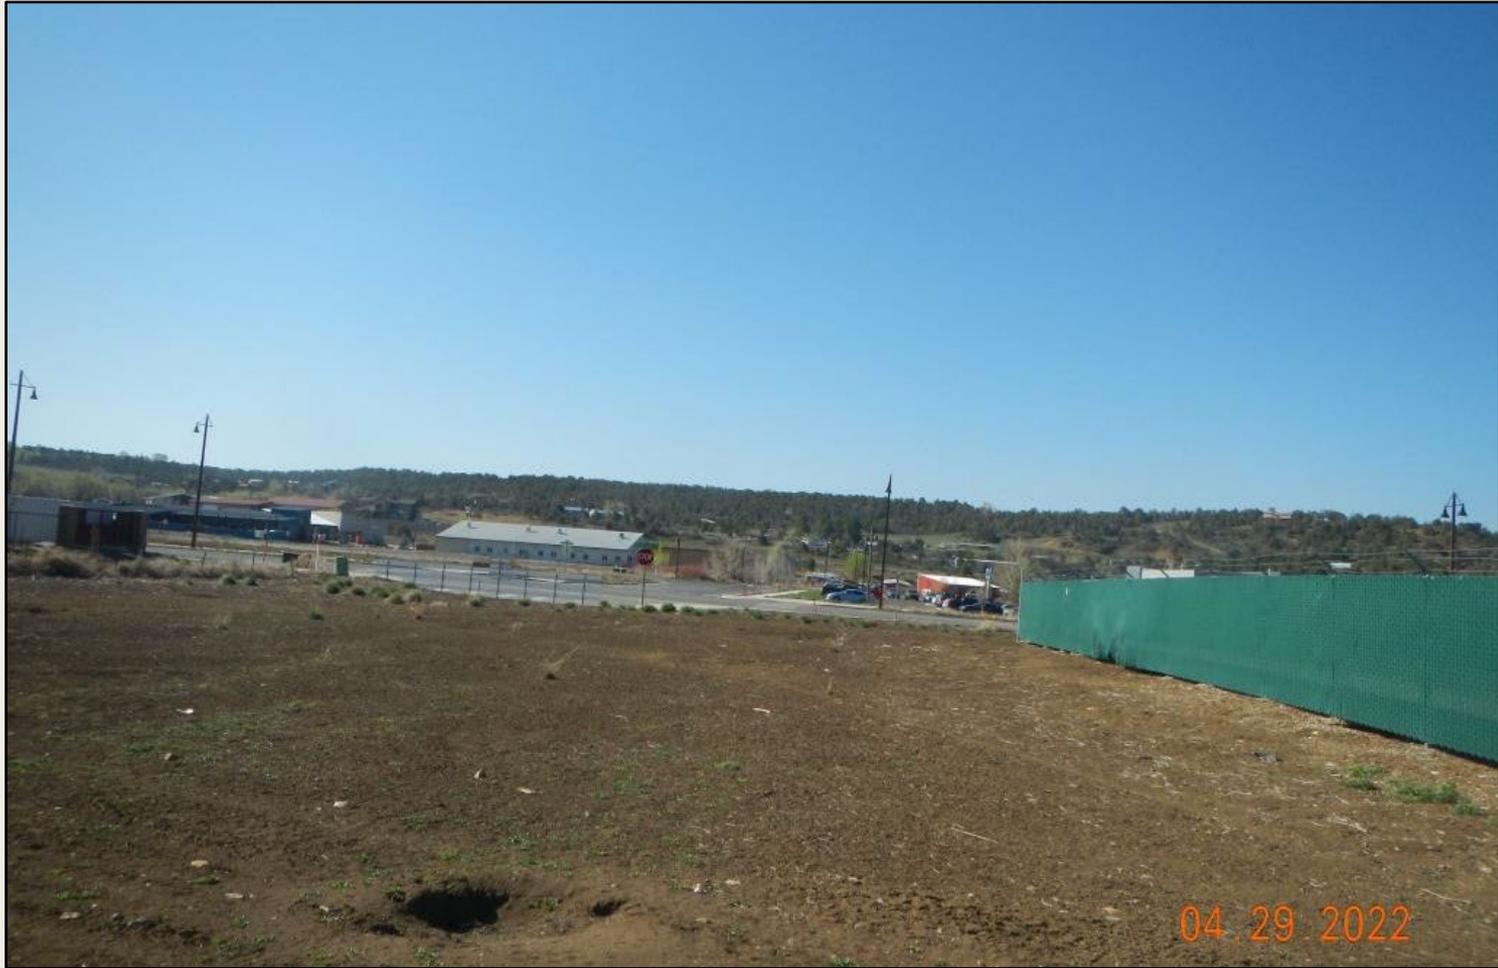
Photo 2. View of the eastern project area from the northeastern corner facing southward. Vegetation remains sparse, similar to reference area. Continue monitoring and managing to ensure site stabilization and that weeds are controlled.

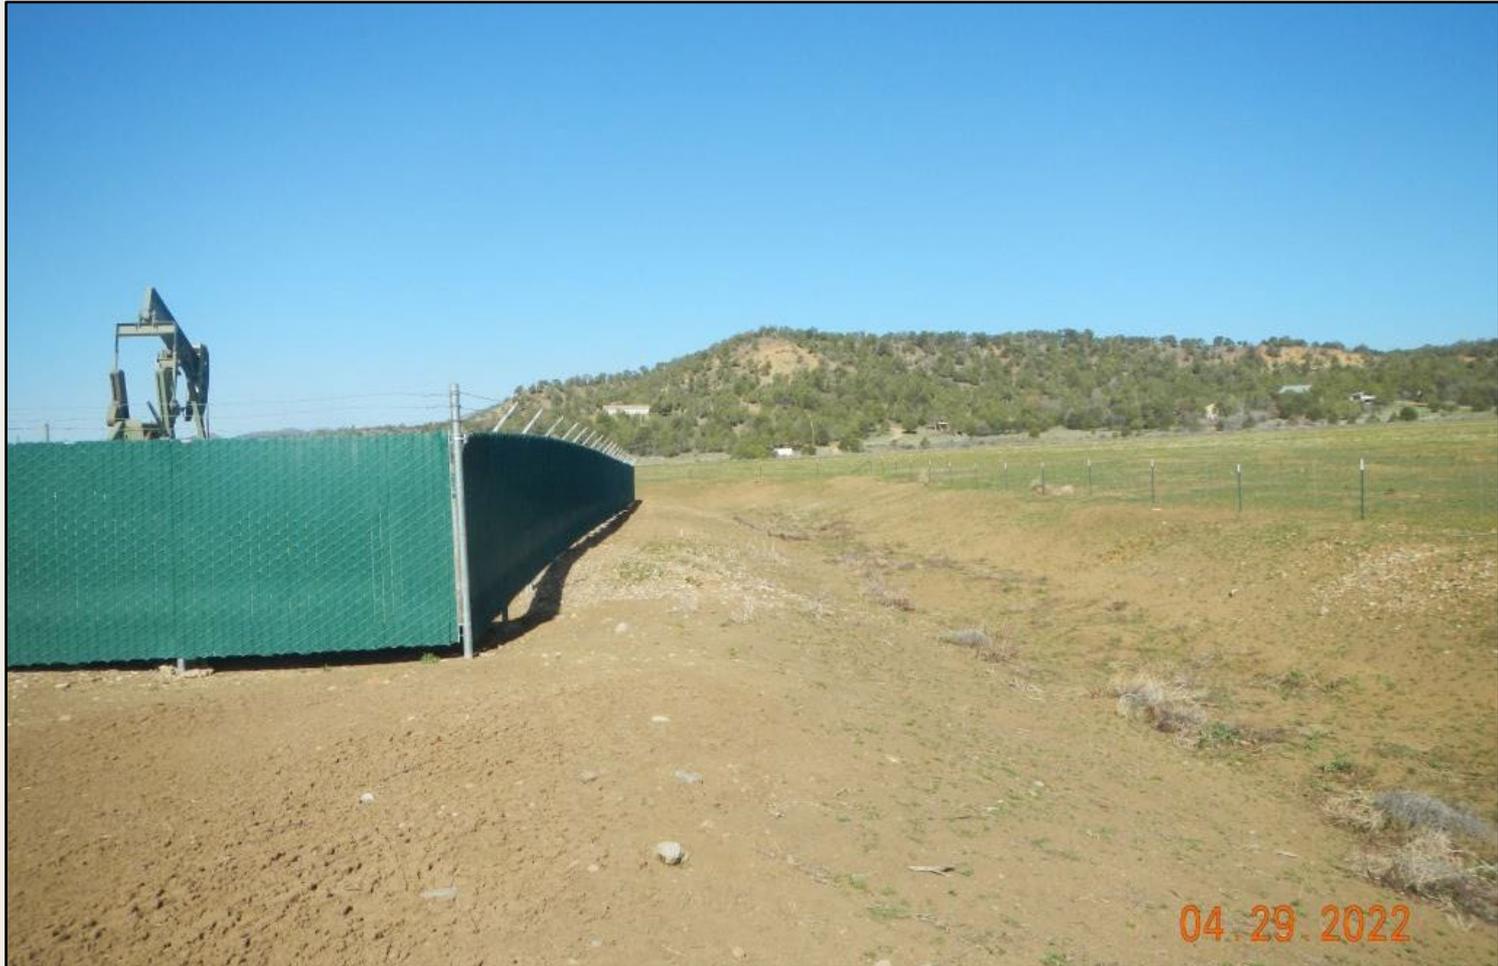
Photo 3. View of the northern project area from the northeastern corner facing westward.

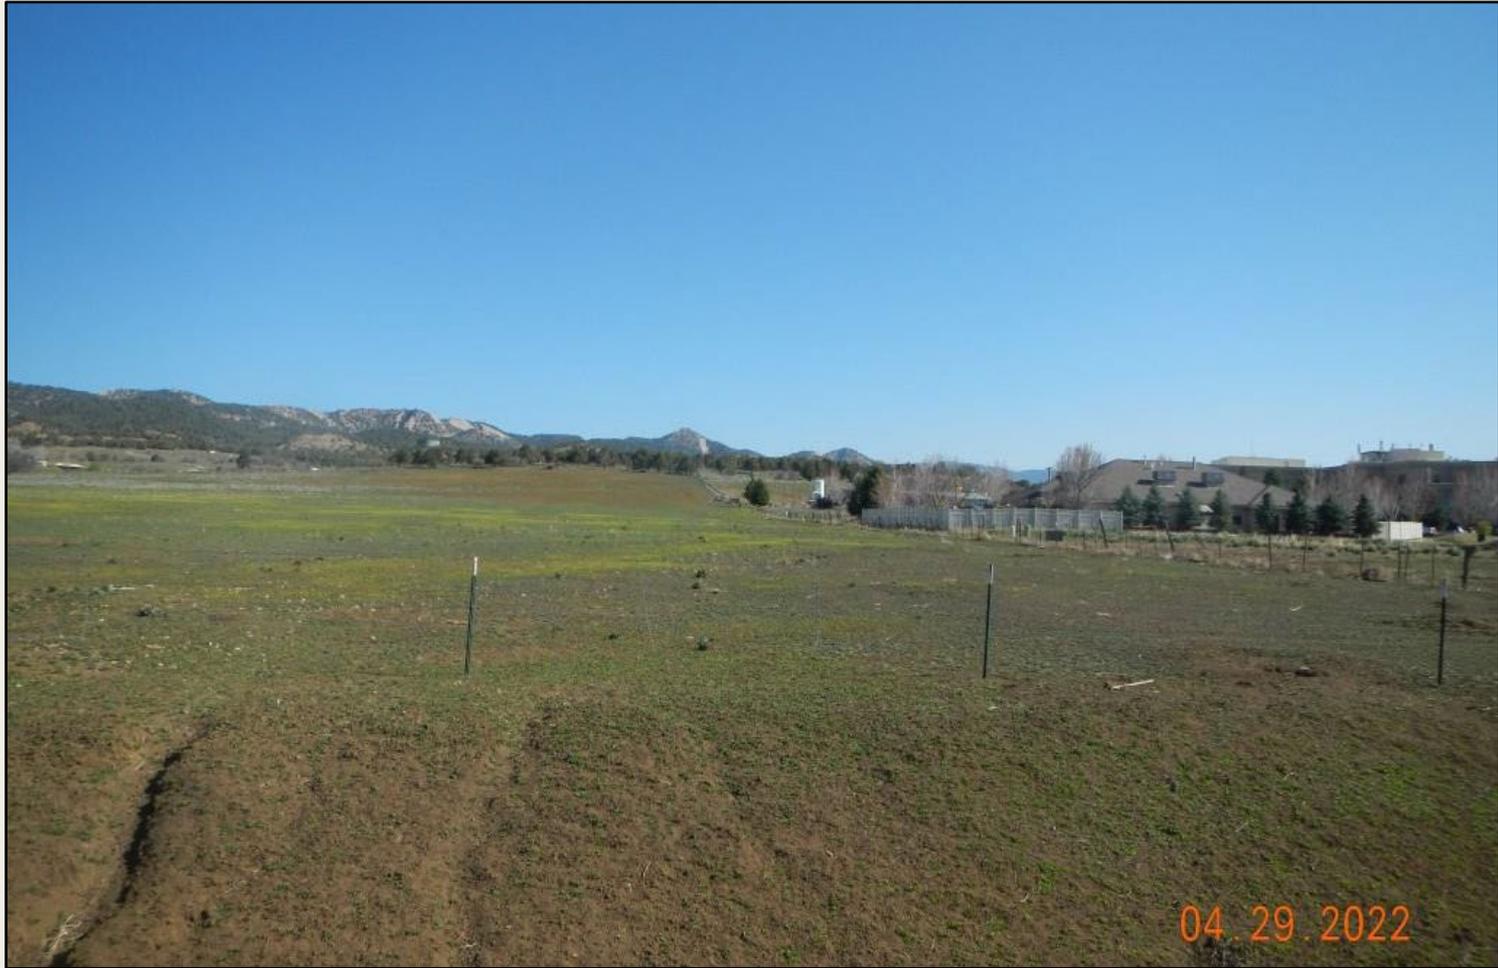
Photo 4. View of the reference area comprised of open grass field.
