Inspection Photos
Operator: Enduring
API: 067-07759
Date: 4/29/2022

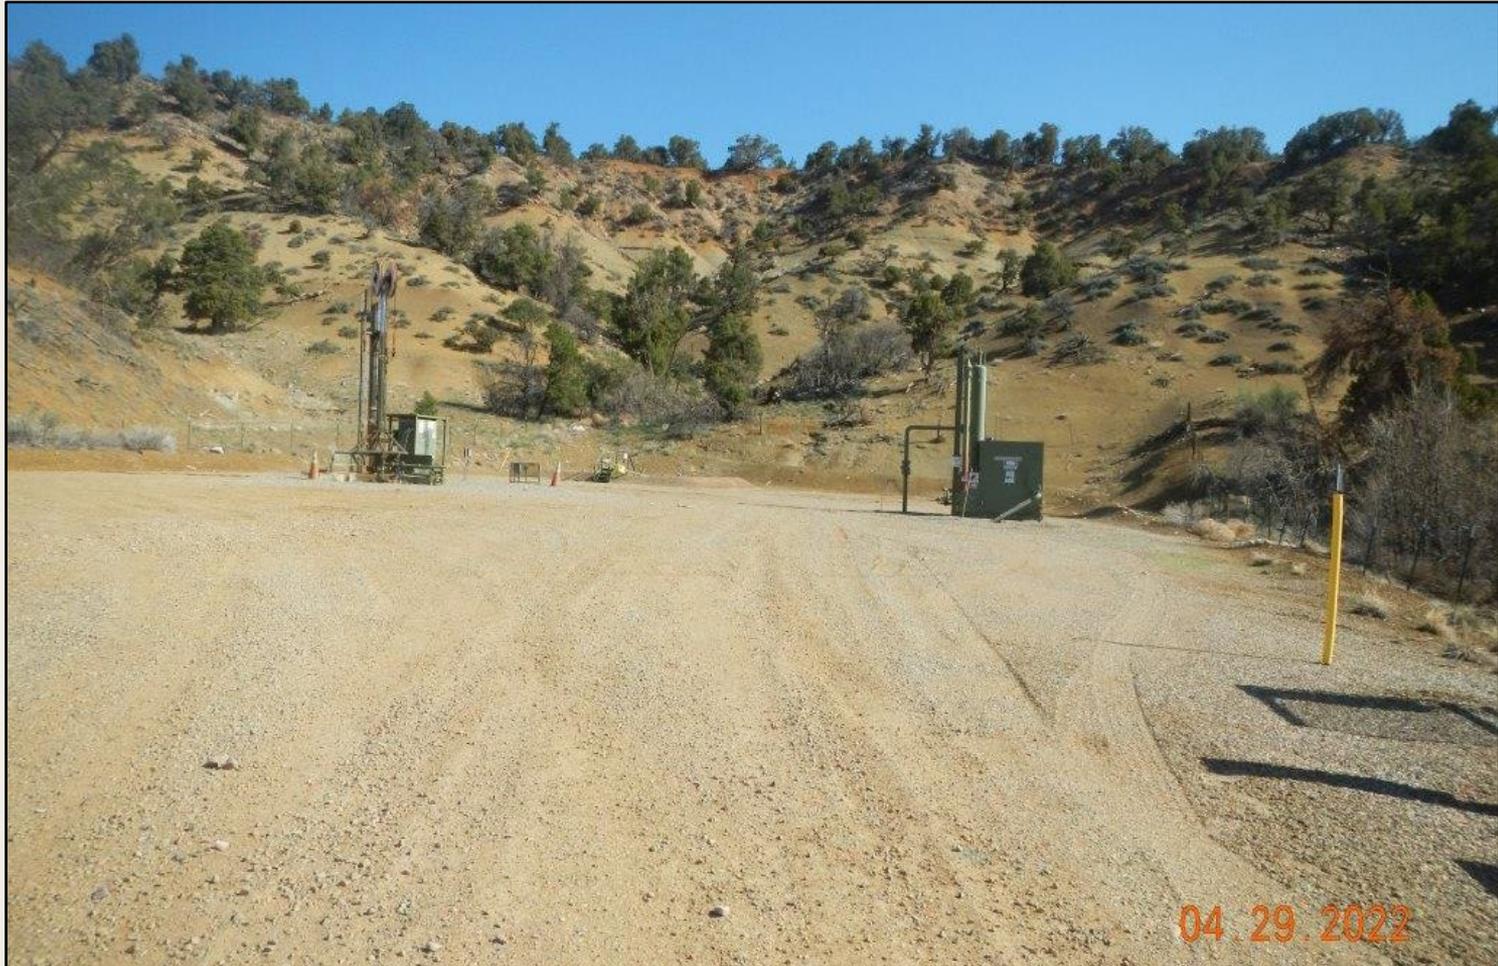
Photo 1. View of the project area from the well pad entrance facing center.

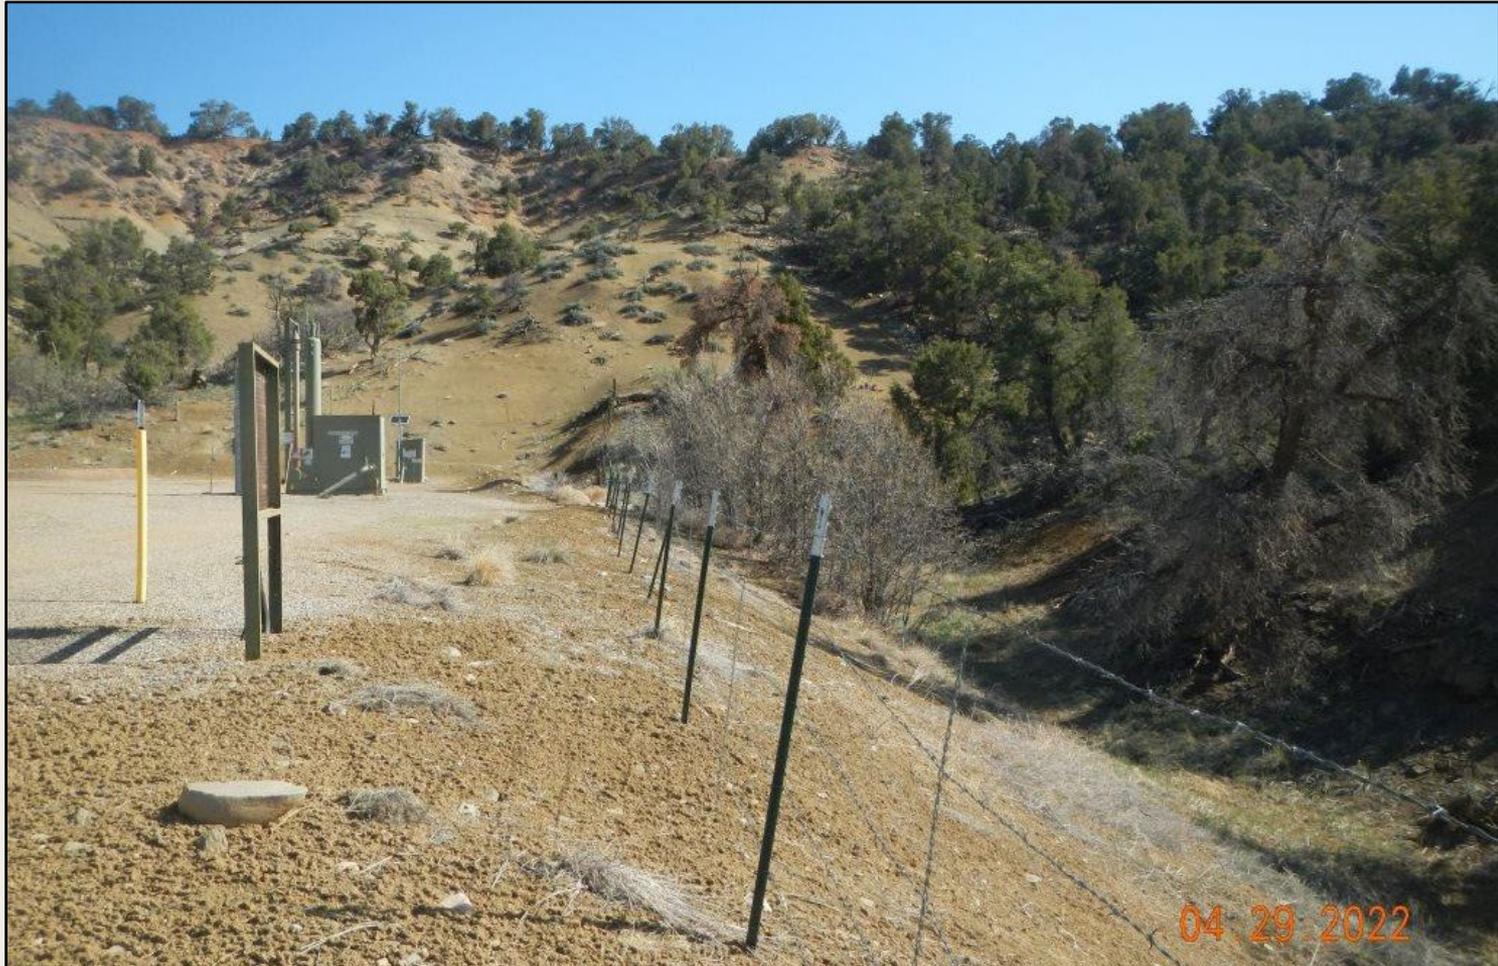
Photo 2. View of the eastern project area from the southeastern corner facing northward. Vegetation remains sparse. Continue monitoring and managing to ensure site stabilization and that weeds are controlled.

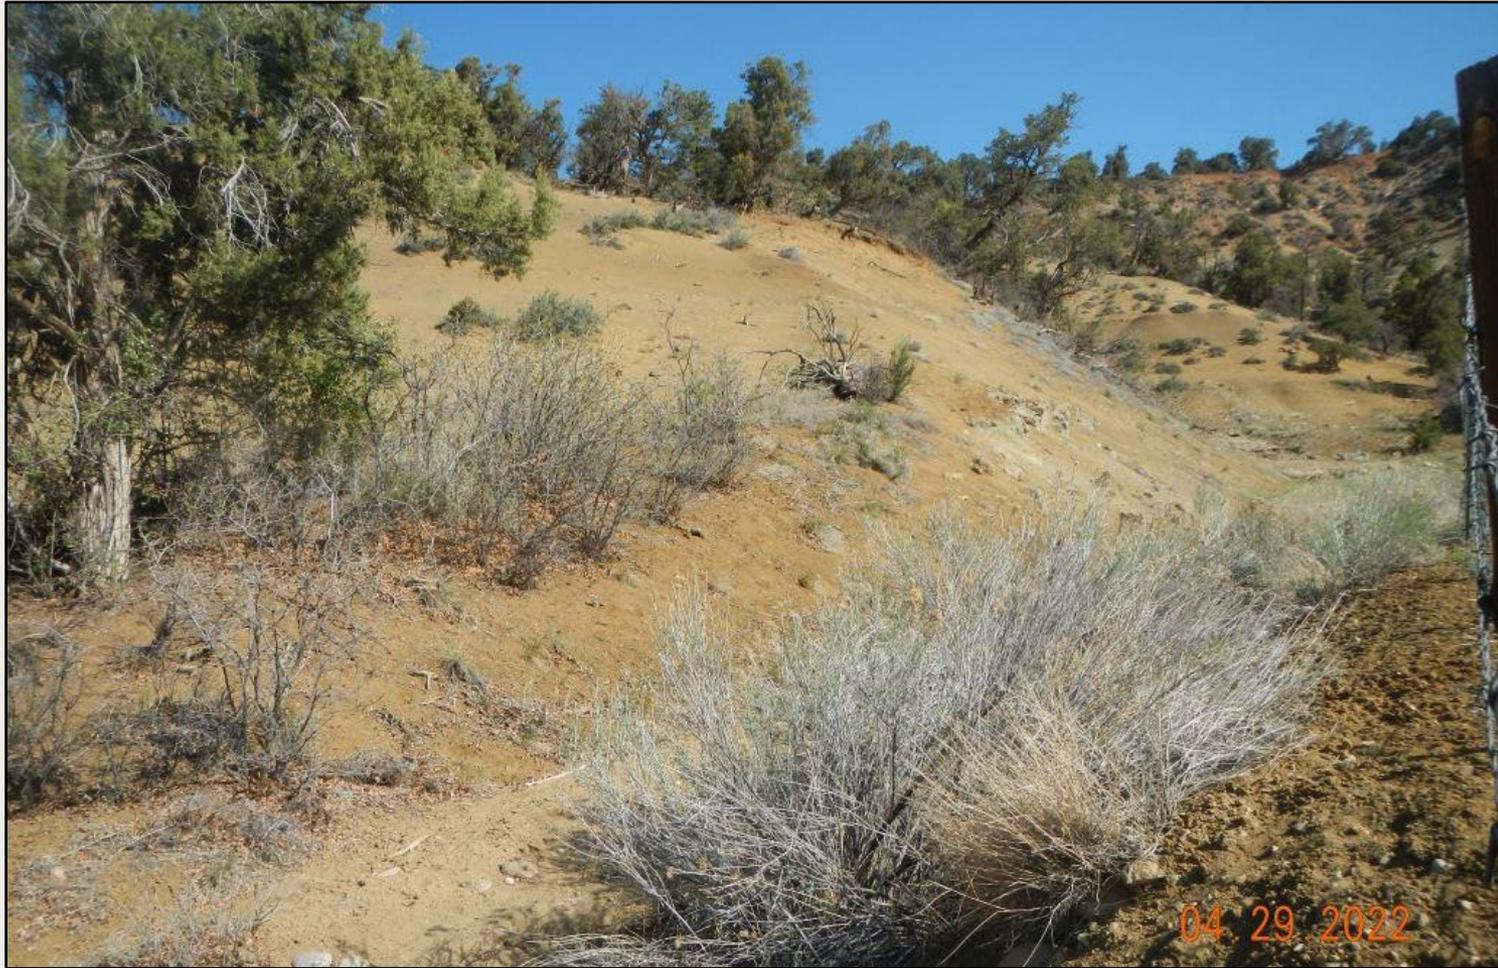
Photo 3. View of the western project area from the northwestern corner facing southward.

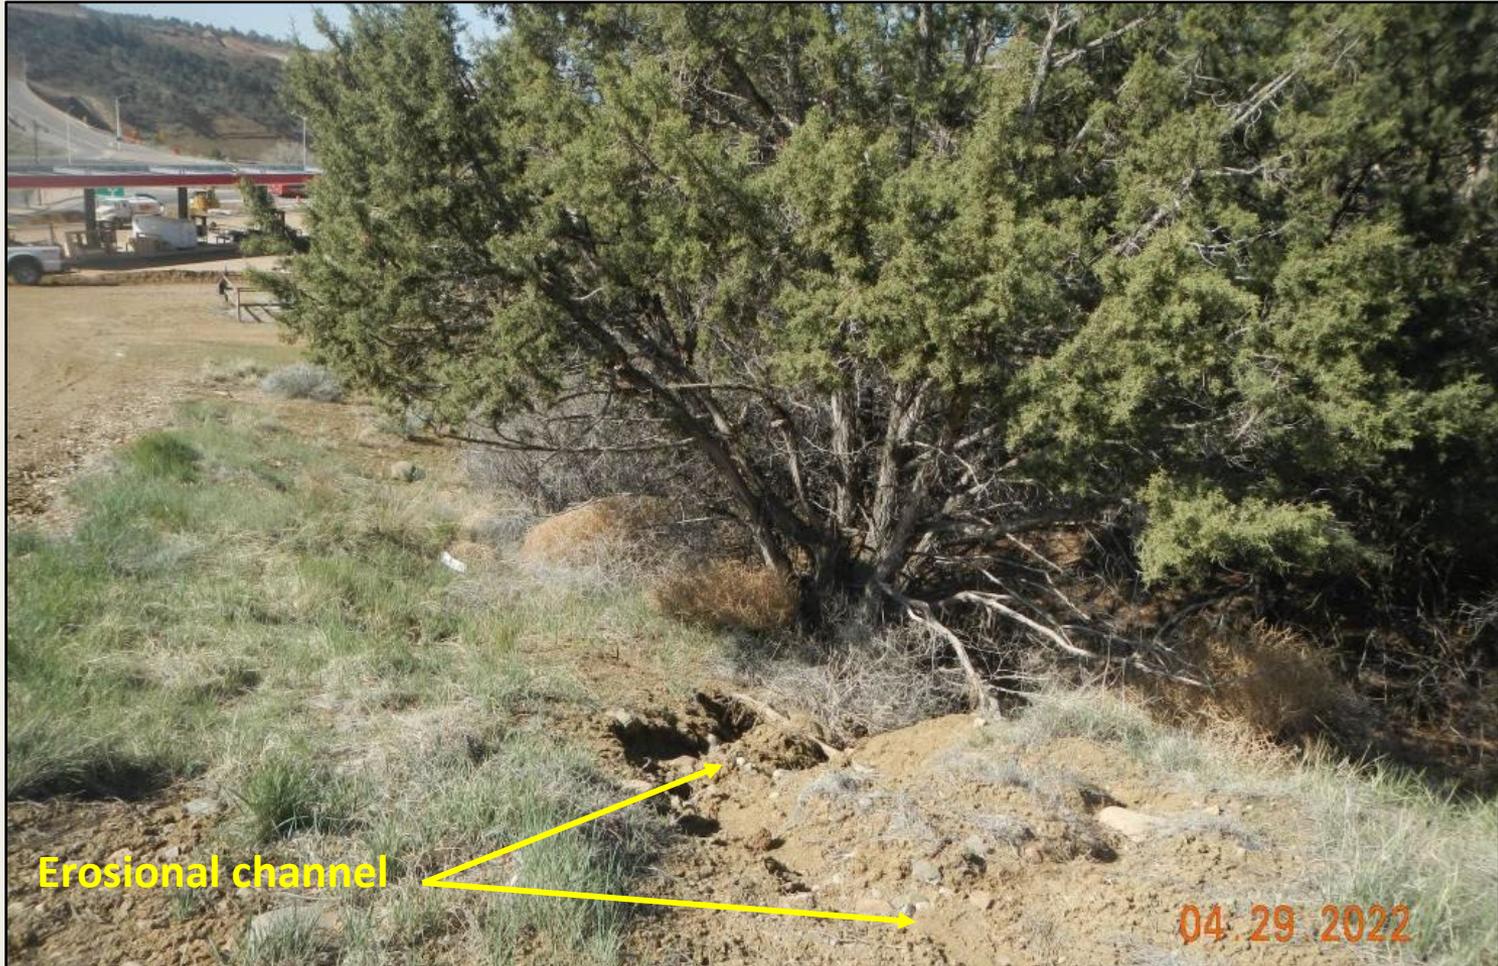
Photo 4. View of erosional channel approximately 12 inches wide and deep near the well pad entrance.

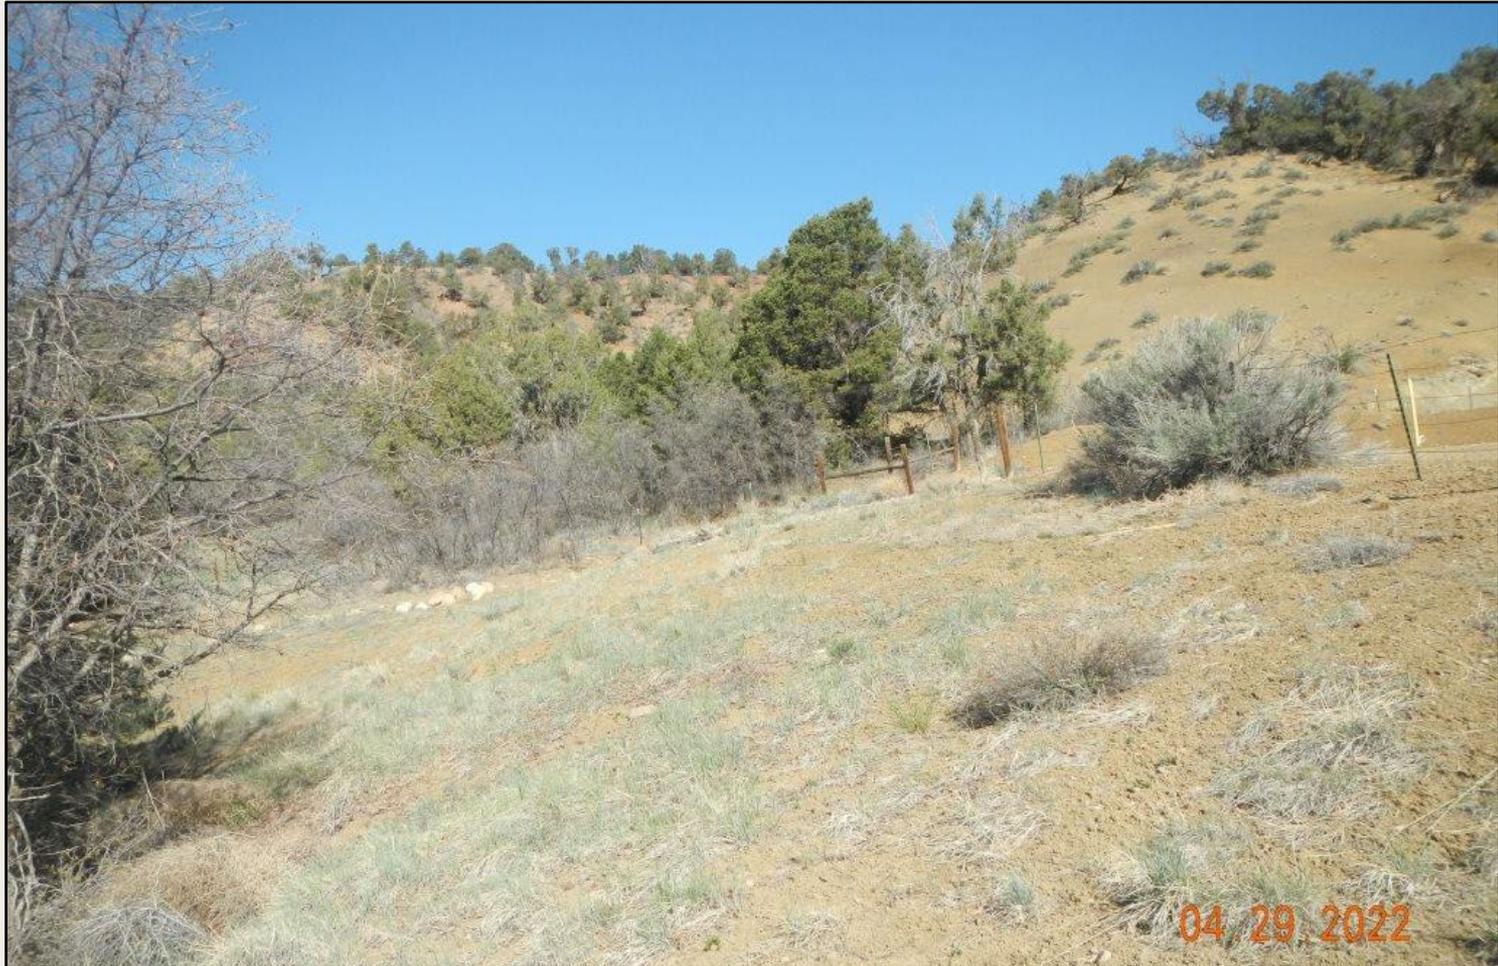
Photo 5. View of the southern project area from the southeastern corner facing westward.

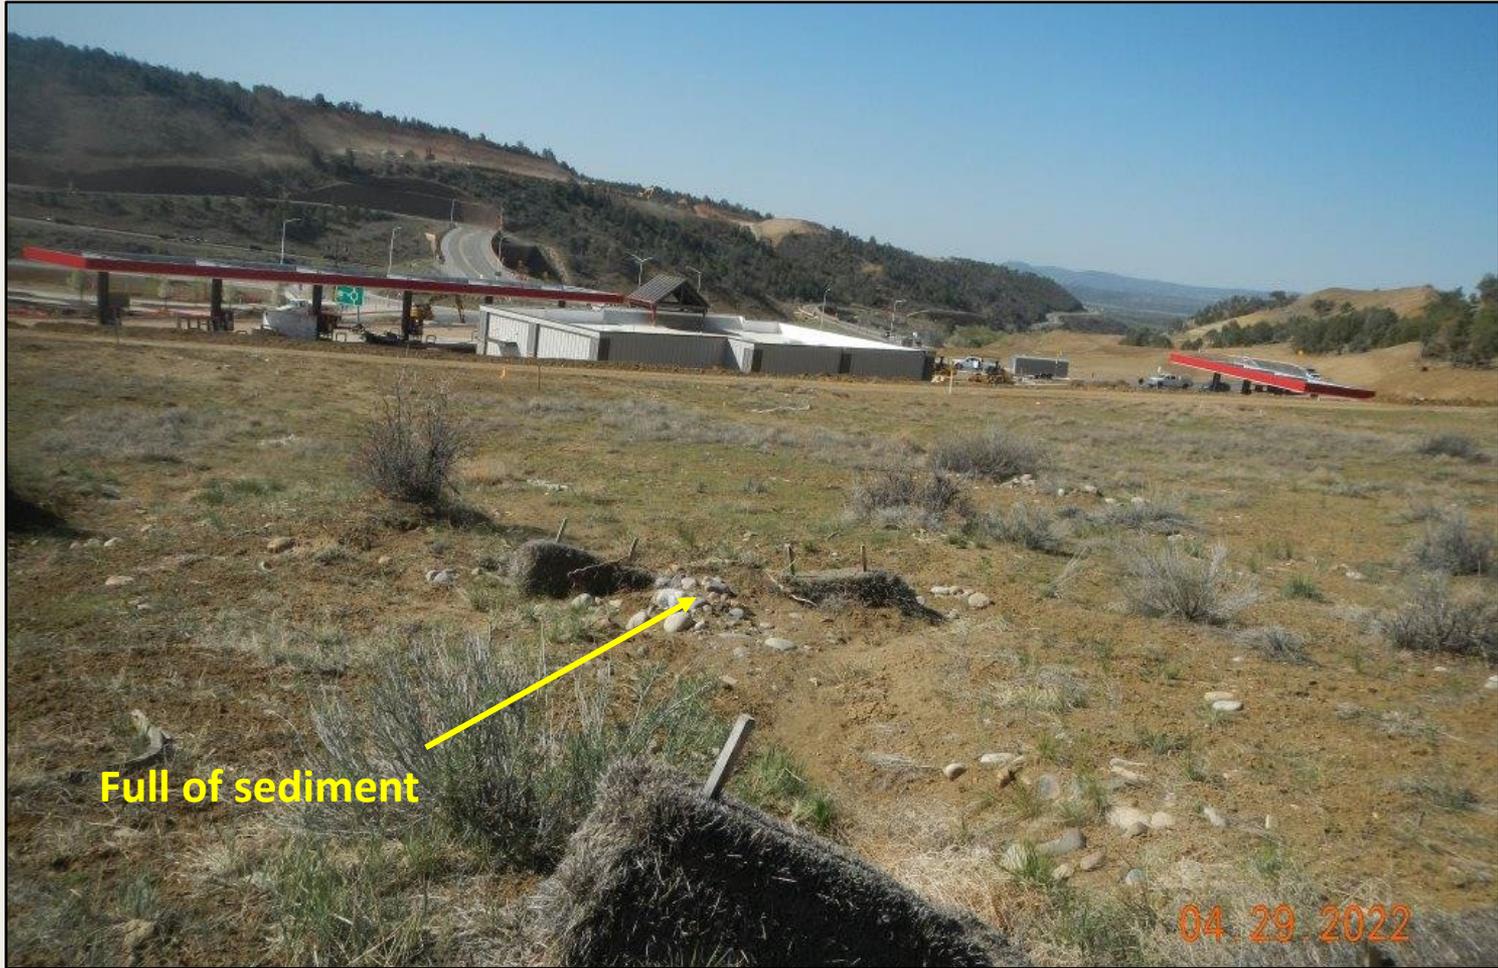
Photo 6. View of BMPs no longer functioning, where stormwater diversion is forming an erosional channel south of the project area.

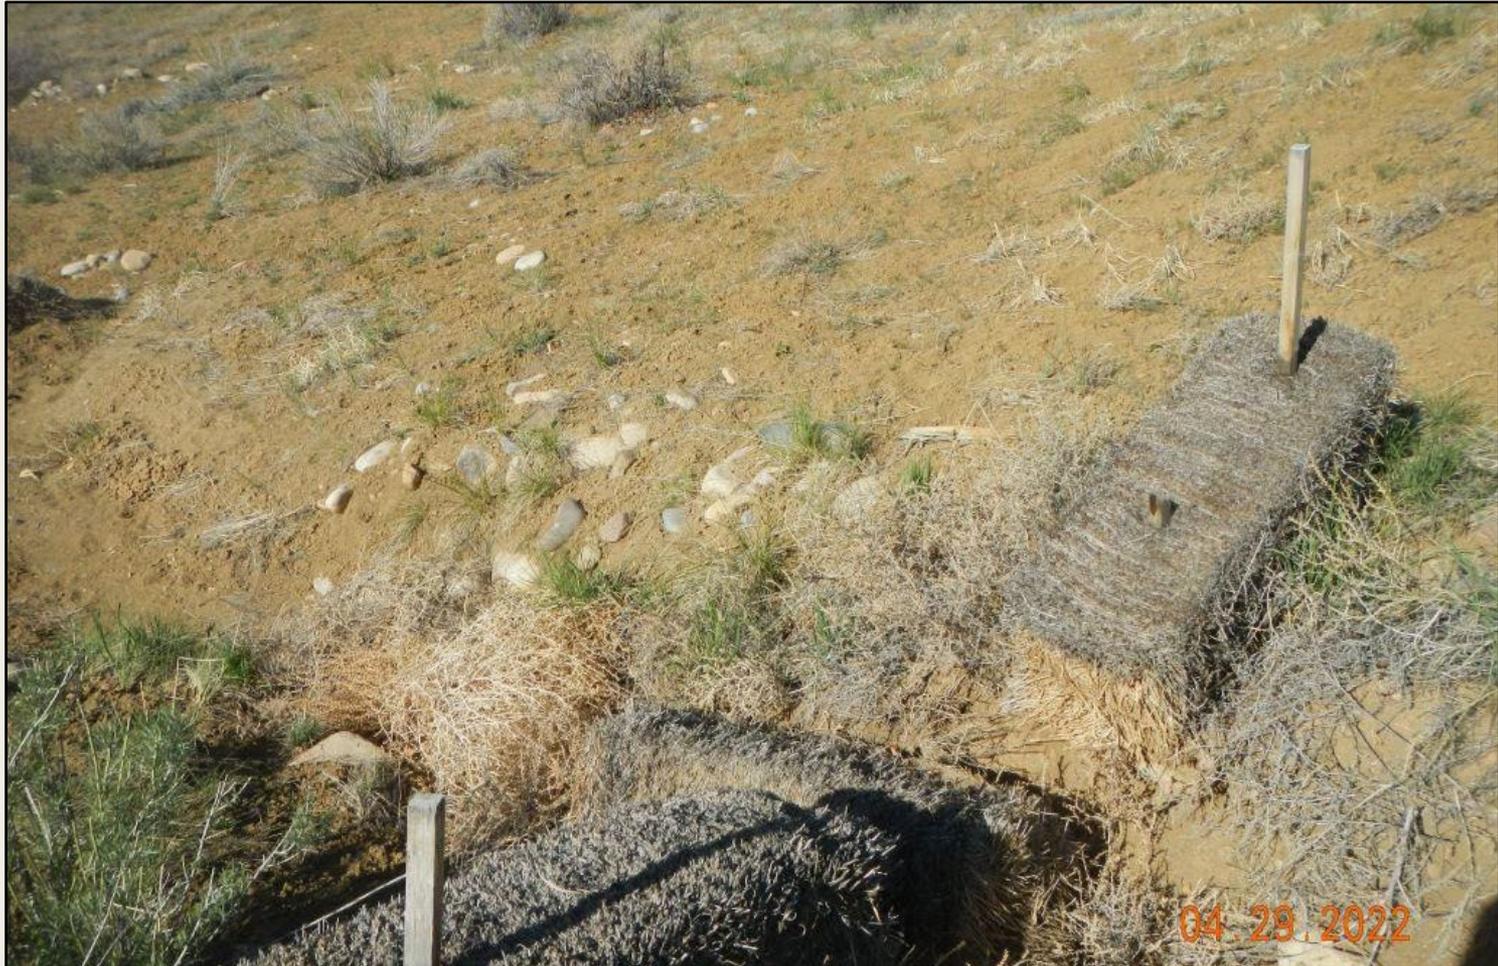
Photo 7. View of another BMP no longer functioning and not adequate in the southern project area.

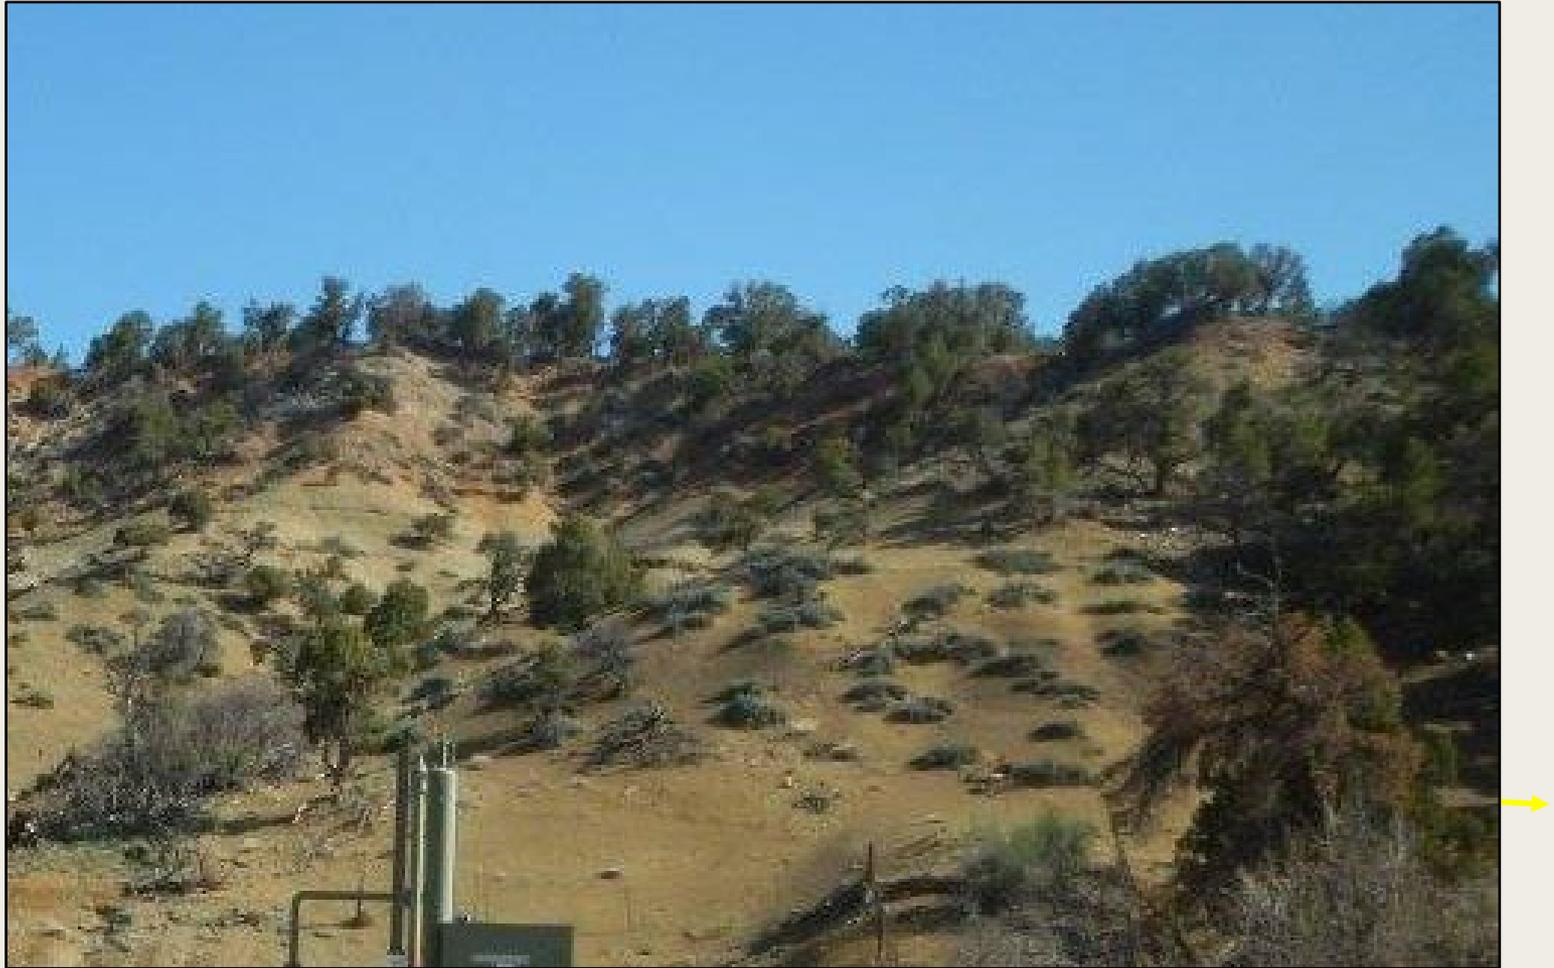
Photo 8. View of the reference area comprised of pinyon and juniper woodland with antelope bitterbrush, gambel oak, Indian ricegrass, and sharpleaf twinpod.
