Inspection Photos  
Operator: Enduring  
API: 067-07514  
Date: 4/29/2022

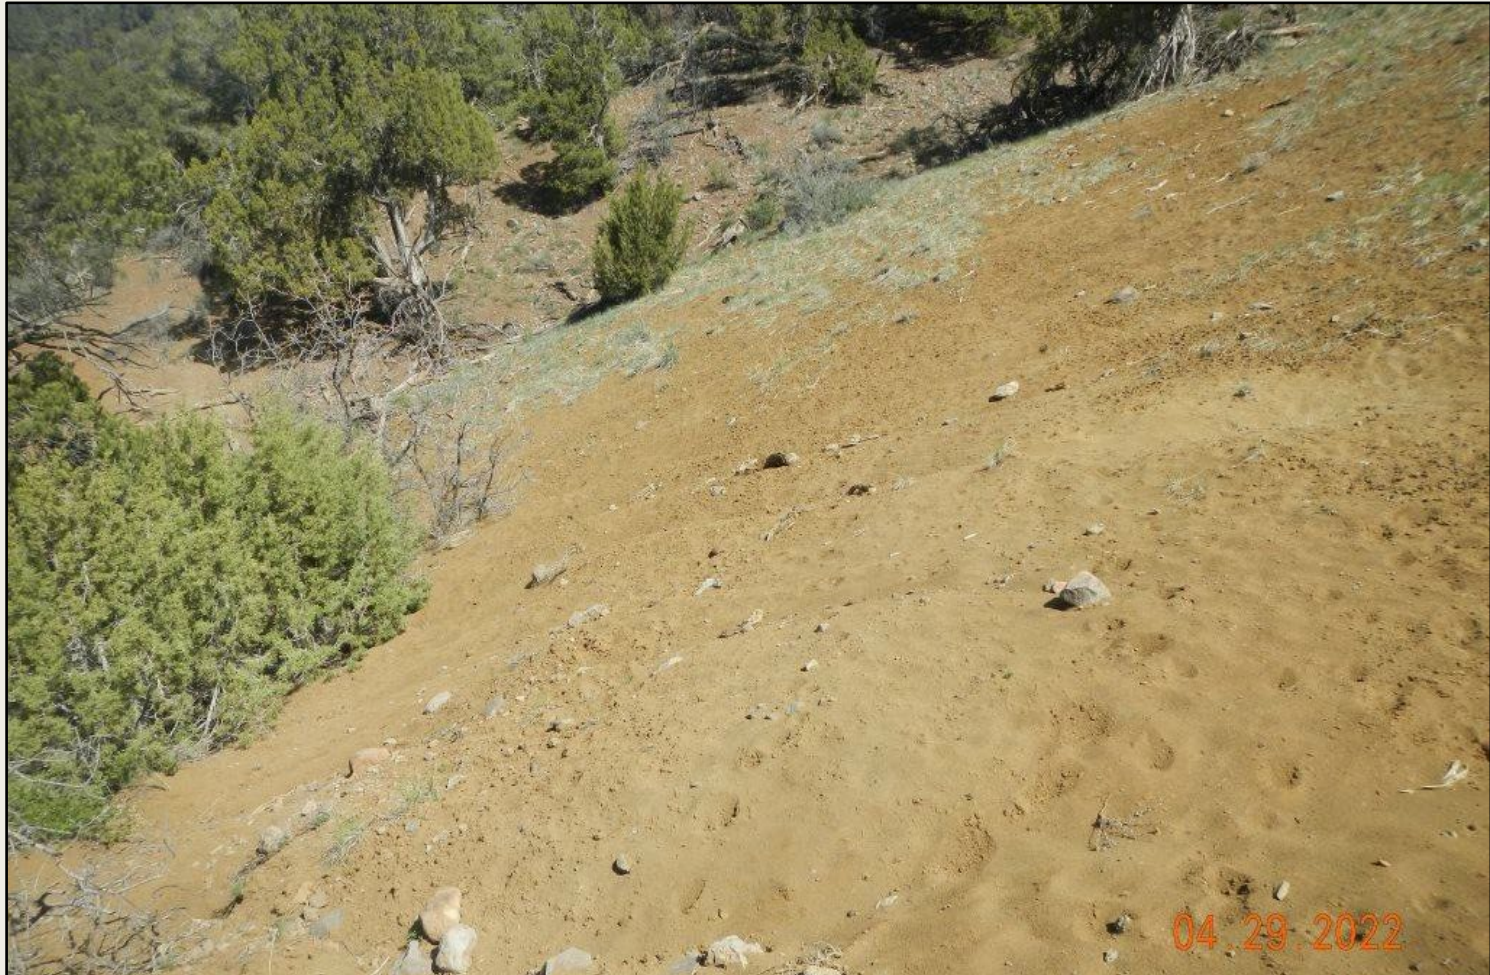
Photo 2. View of the northern project area from the northwestern corner facing eastward. Revegetation is sparse, progressing in portions with western wheatgrass, other portions remain bare. Stabilization is needed here.

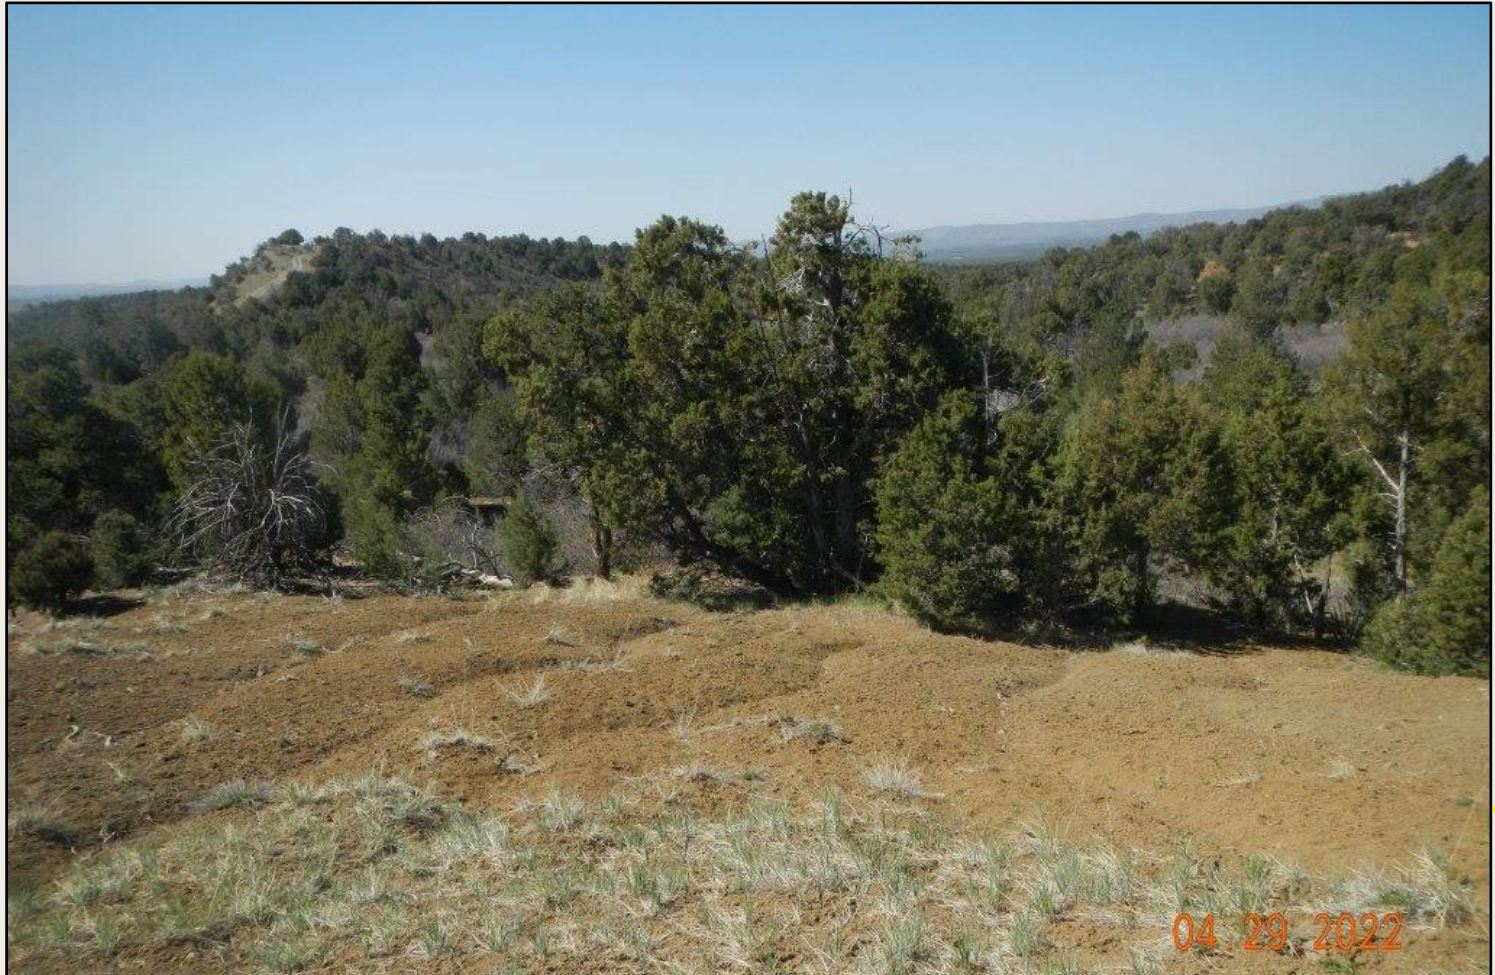
Photo 3. View of erosional rilling within the western project area. Stabilization is needed here.

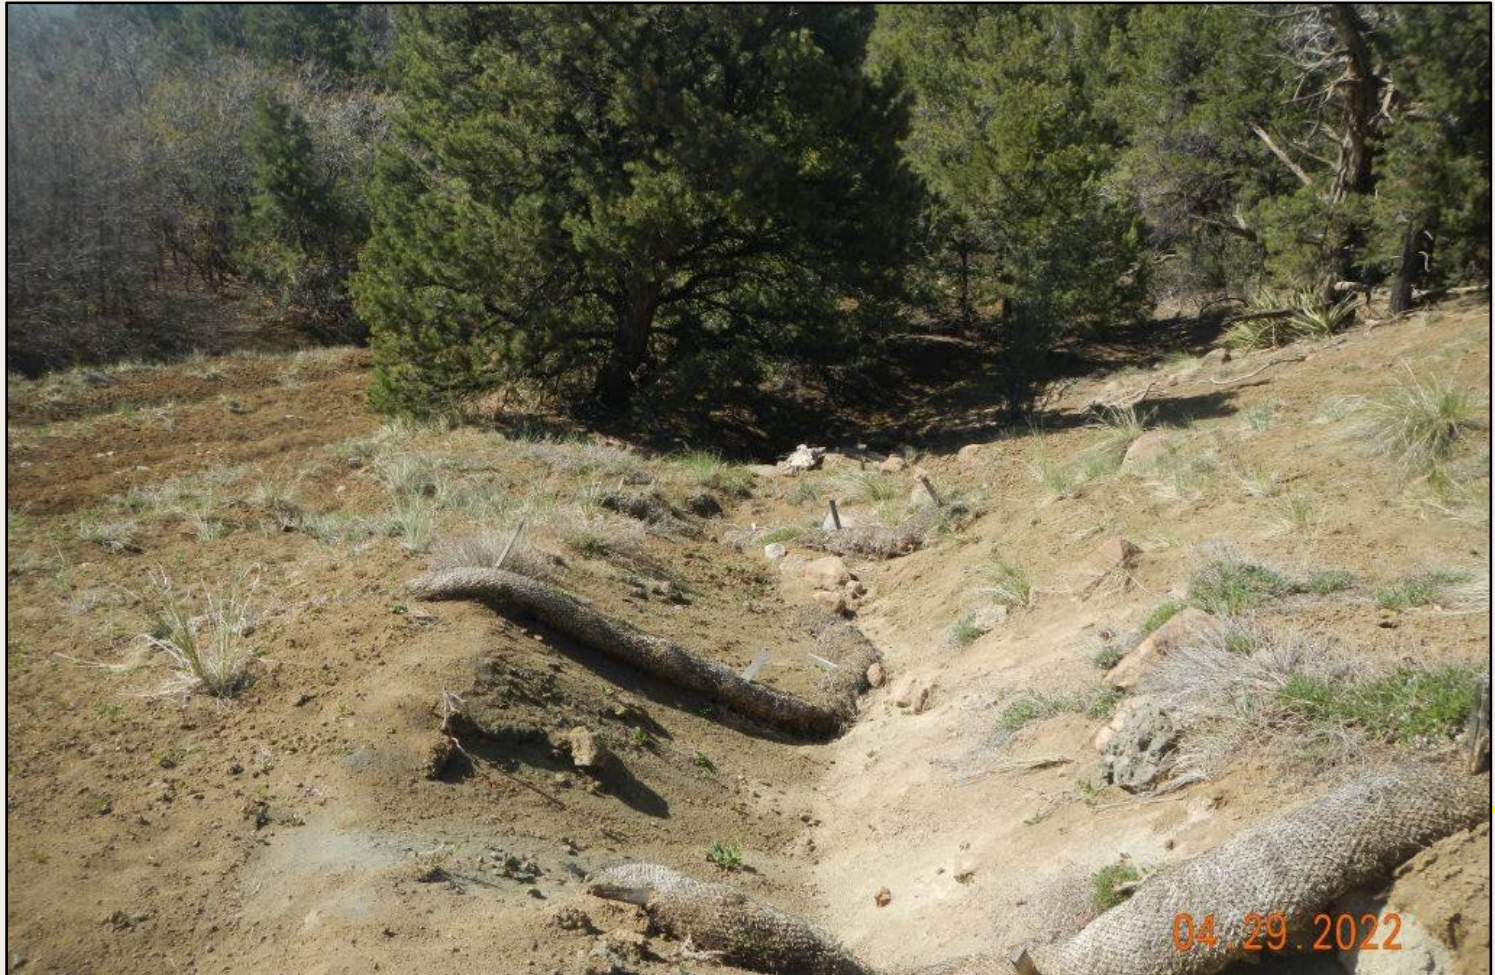
Photo 4. View of erosional channel forming within the southwestern project area. Wattles are not functioning and are not adequate BMPs for this area.

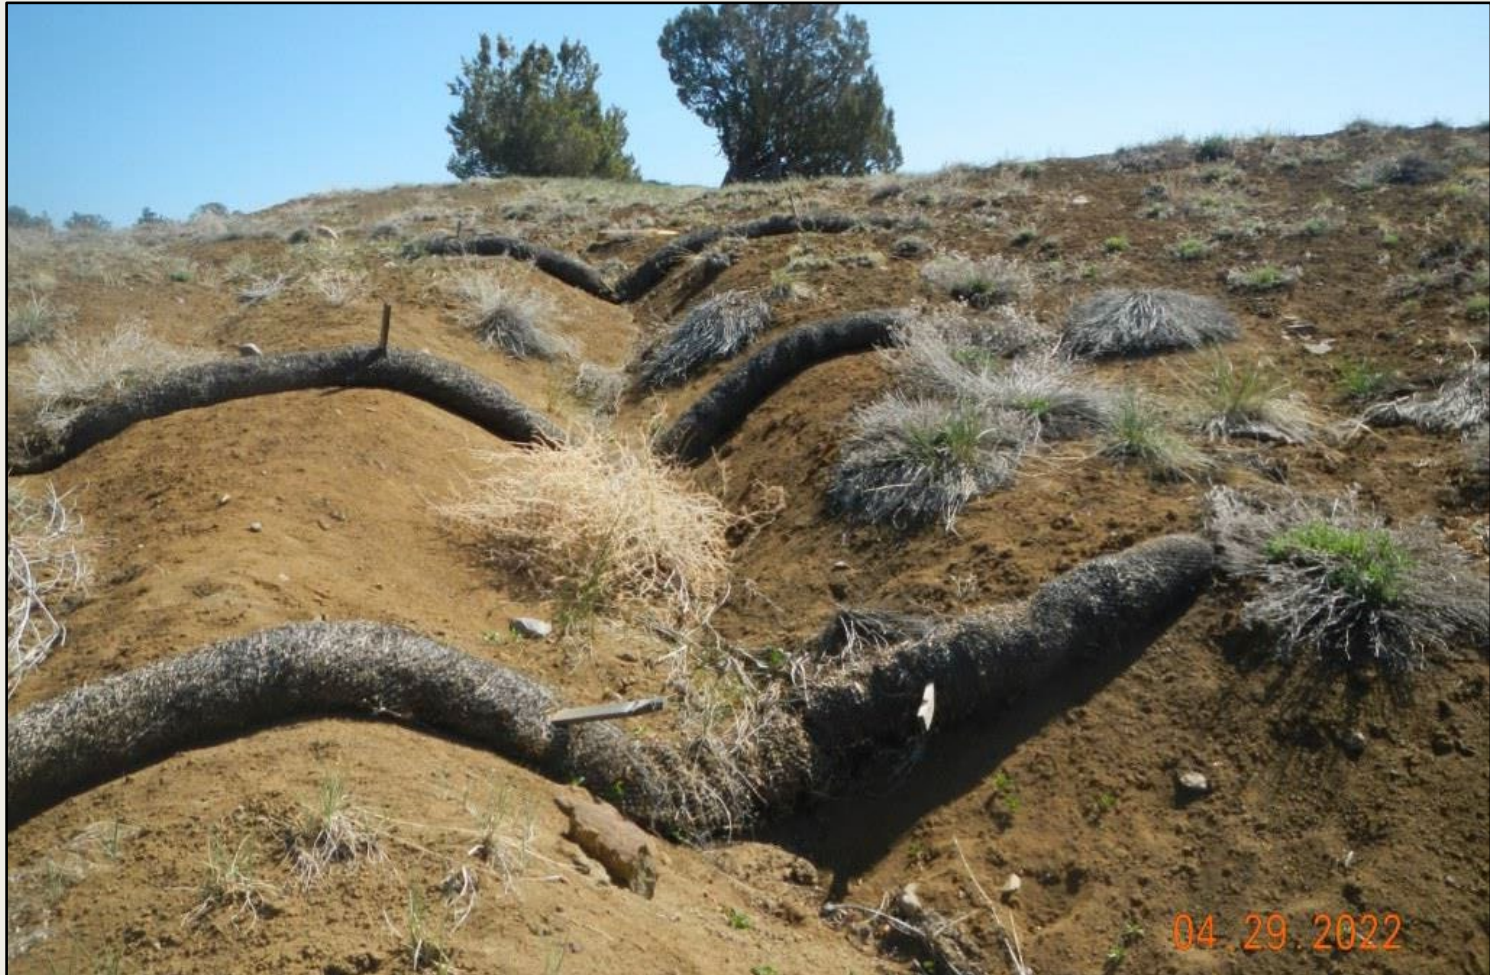
Photo 5. View of more erosional channeling forming within the southwestern project area. Wattles are not functioning and are not adequate BMPs for this area.
