Inspection Photos  
Operator: Enduring  
API: 067-08667  
Date: 4/29/2022

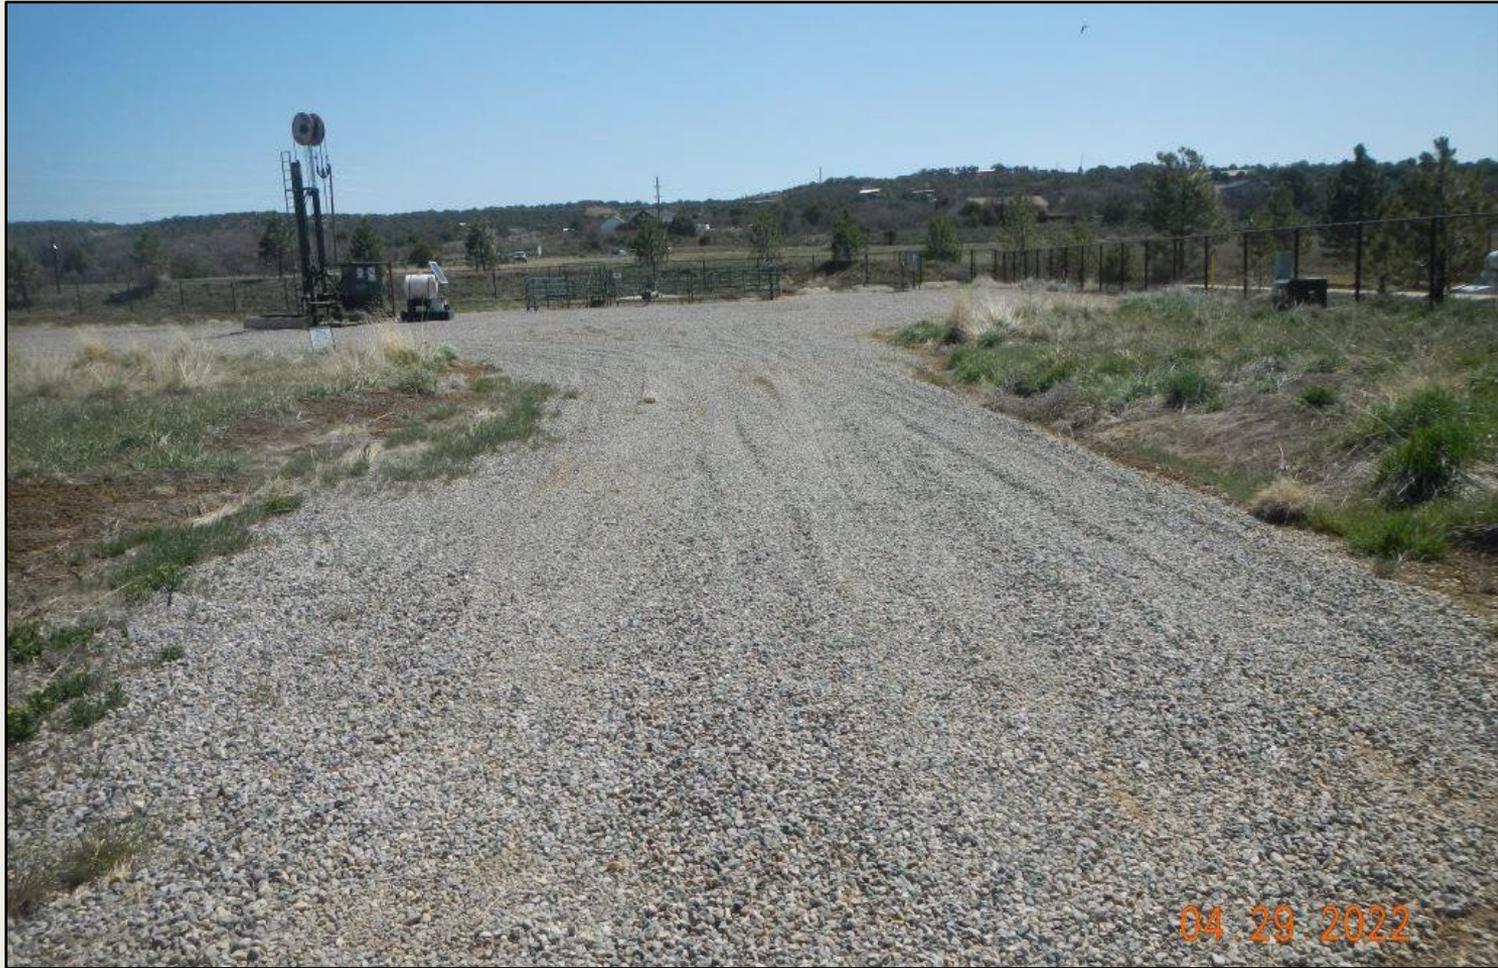
Photo 1. View of the project area from the well pad entrance facing center.

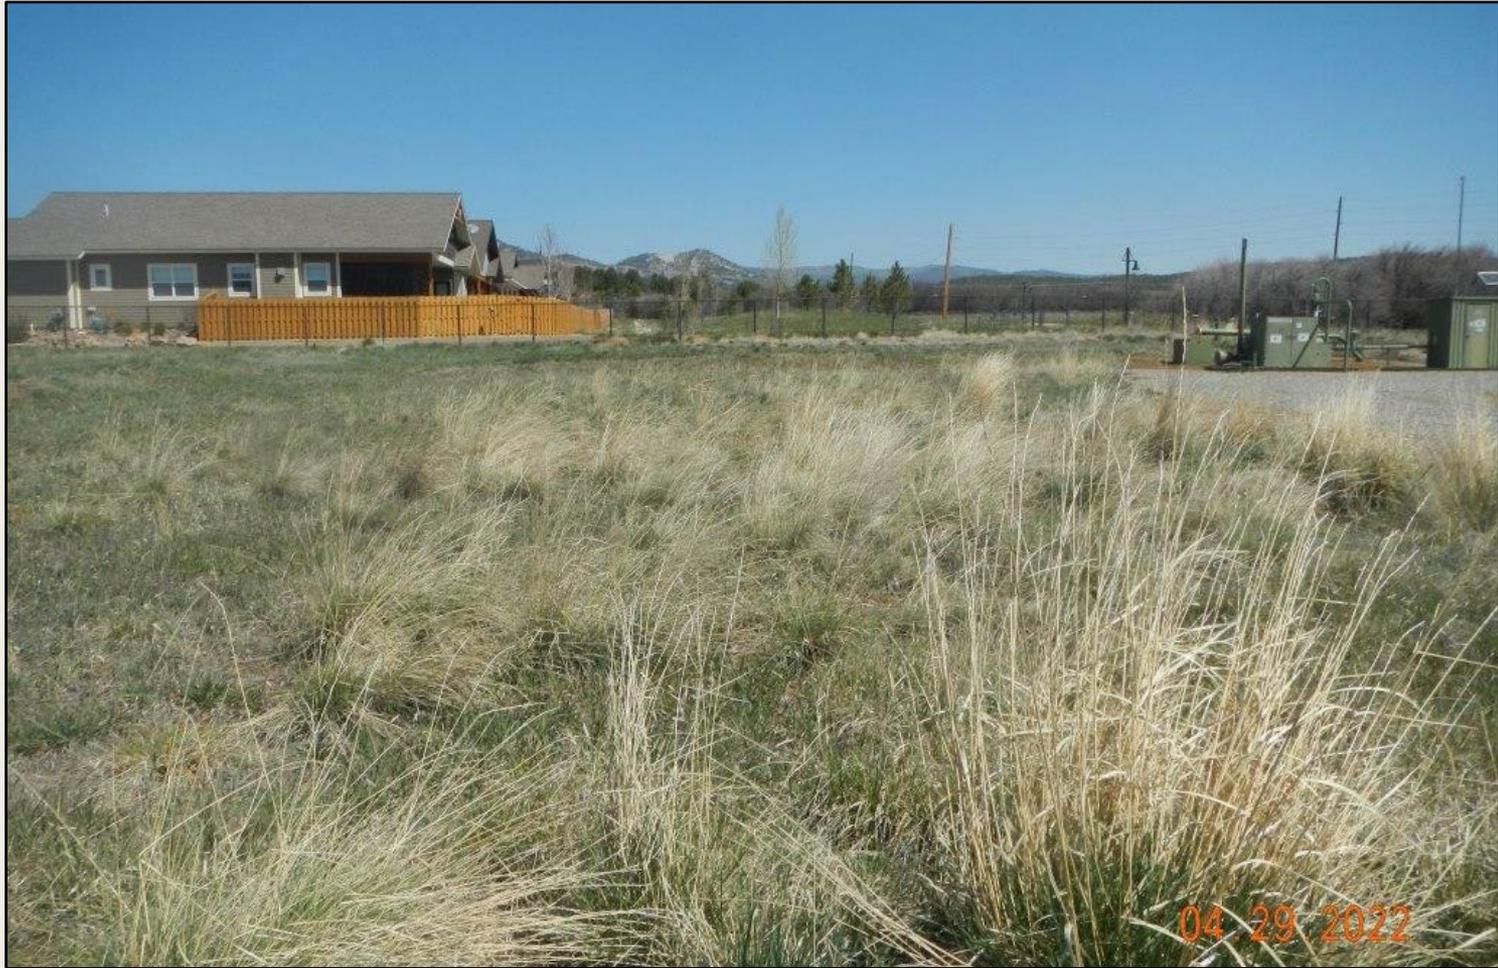
Photo 2. View of the western project area from the well pad entrance facing northward. Revegetation is progressing with smooth brome, intermediate wheatgrass, and western wheatgrass.

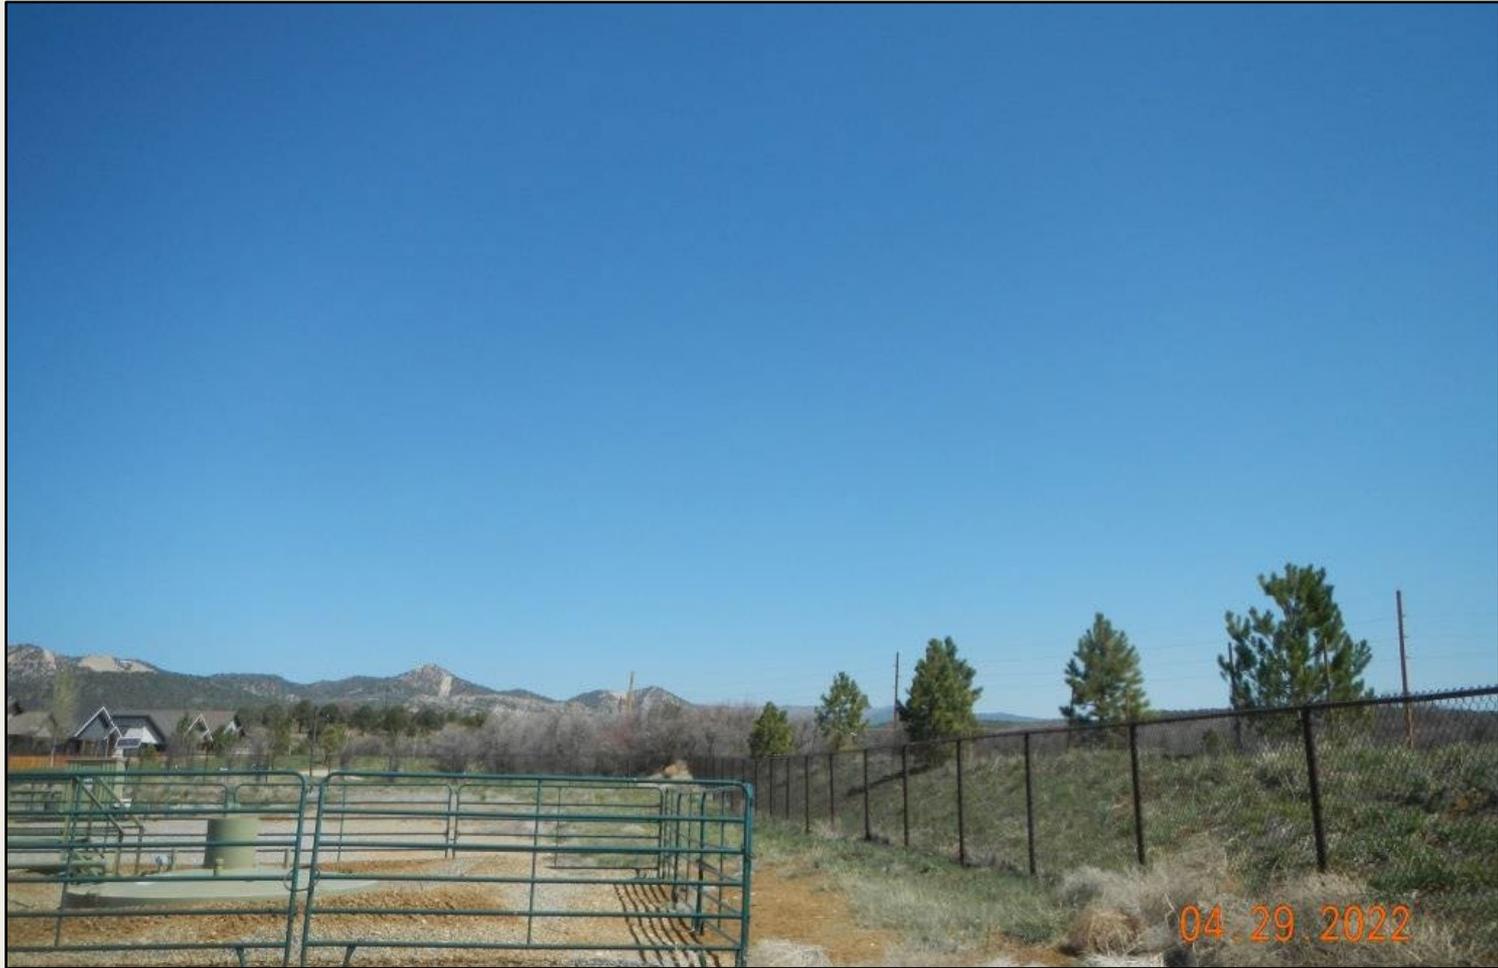
Photo 3. View of the eastern project area from the southeastern corner facing northward.

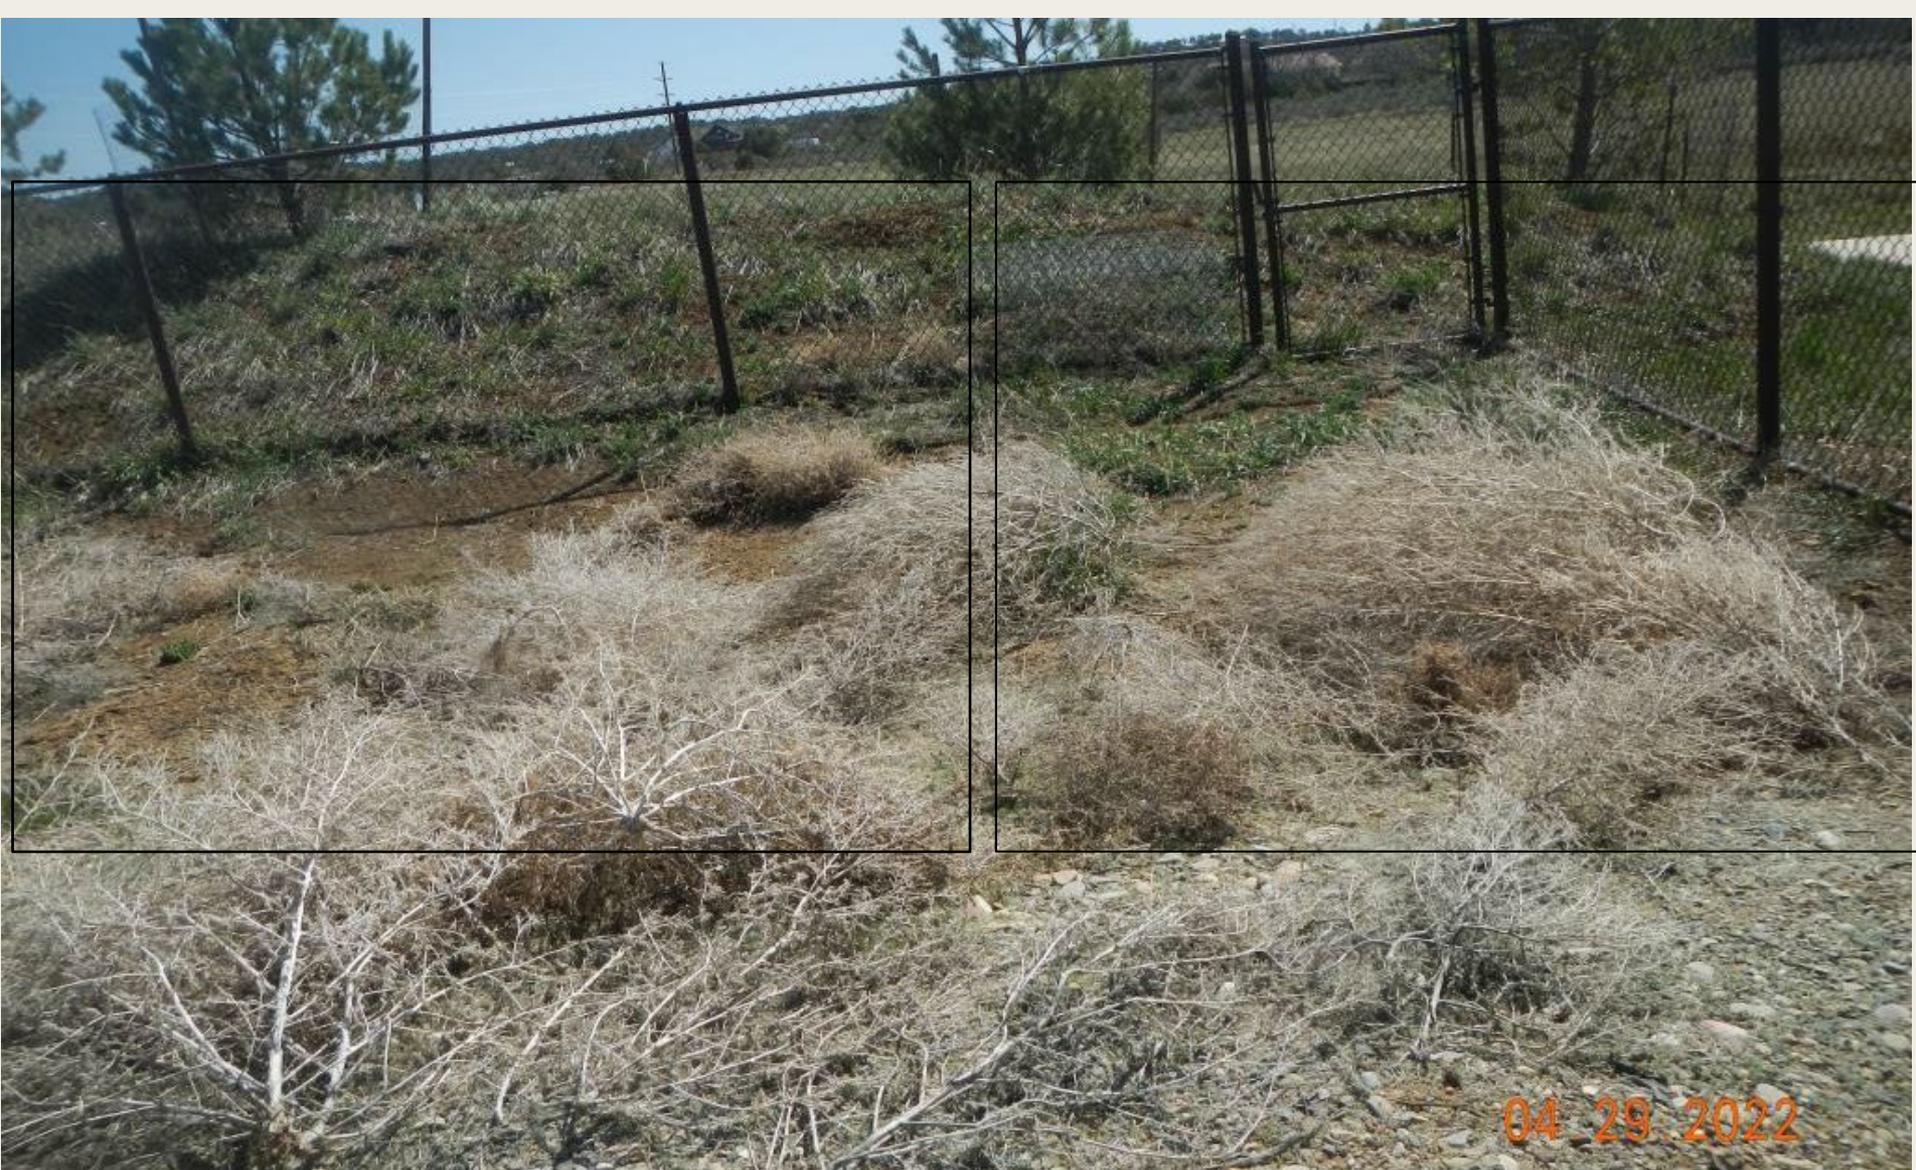
Photo 3. View of weed debris observed within the project area.
