Inspection Photos

081-07349

Inspection Date: 5/5/2022

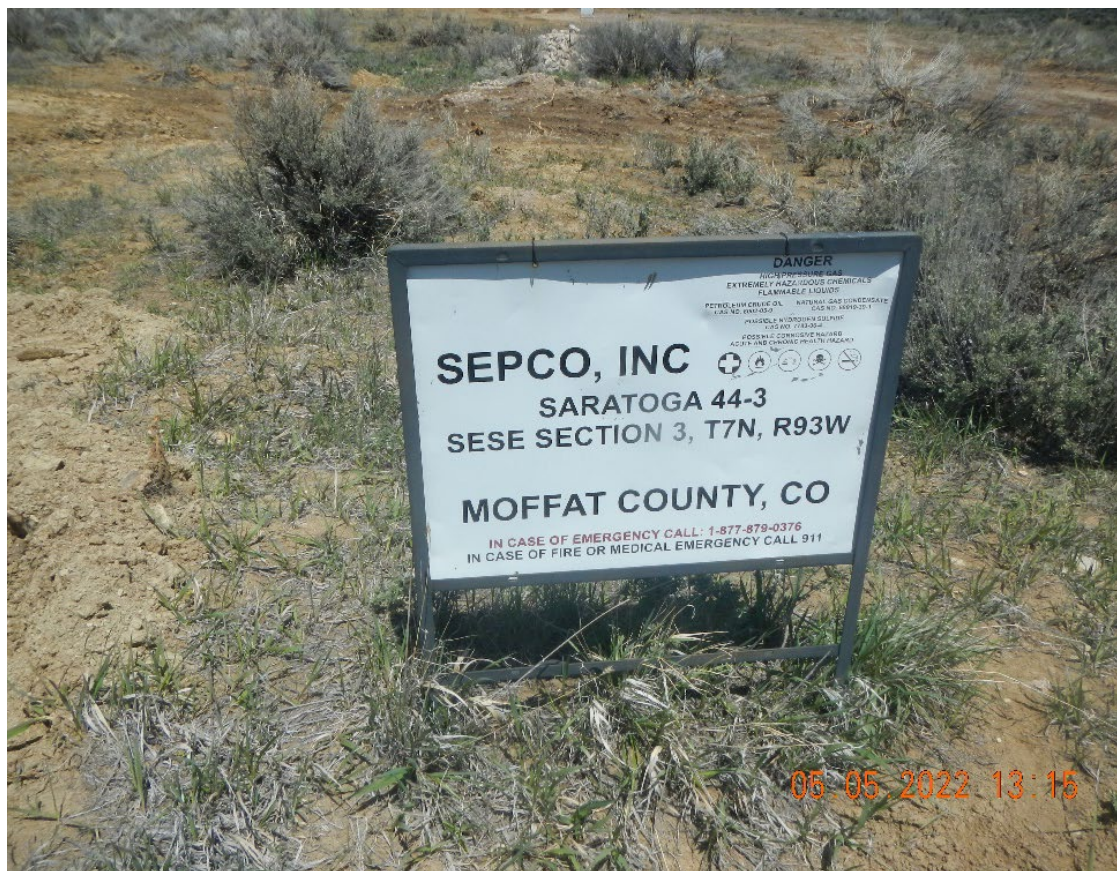
Photo #1 sign at location. Well was PA wellhead was cut off. Surface of ground appeared to be backfilled.

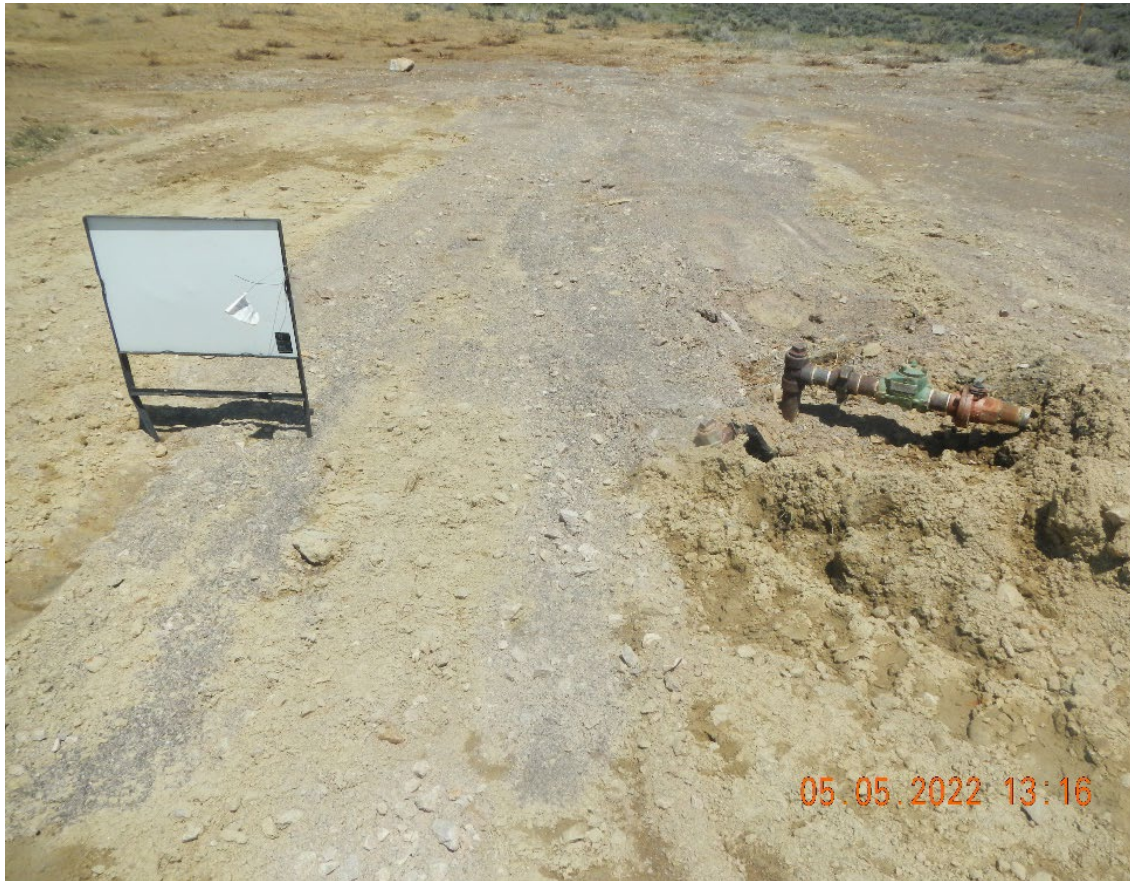
**Photo #2 area near wellhead, flowlines sill present**

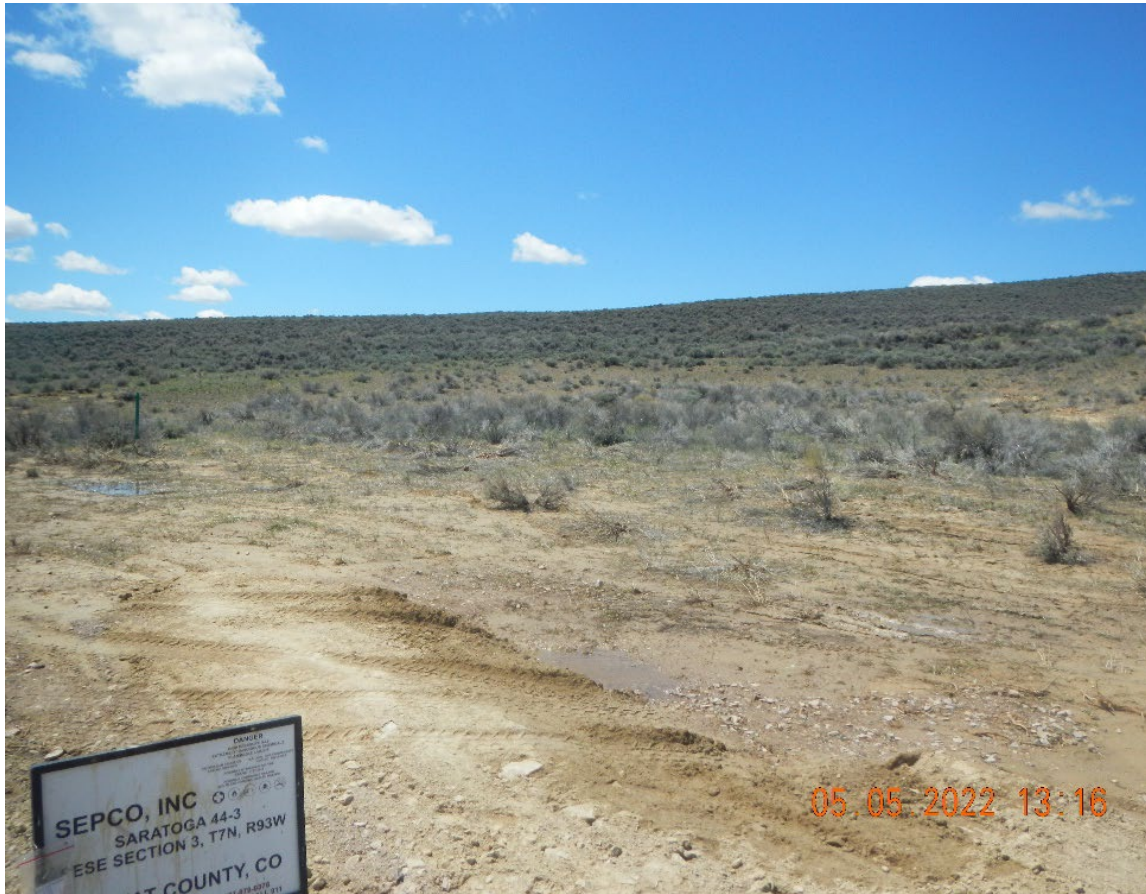
Photo #3 sign at lower left was area of wellhead, note flowline marker in background.

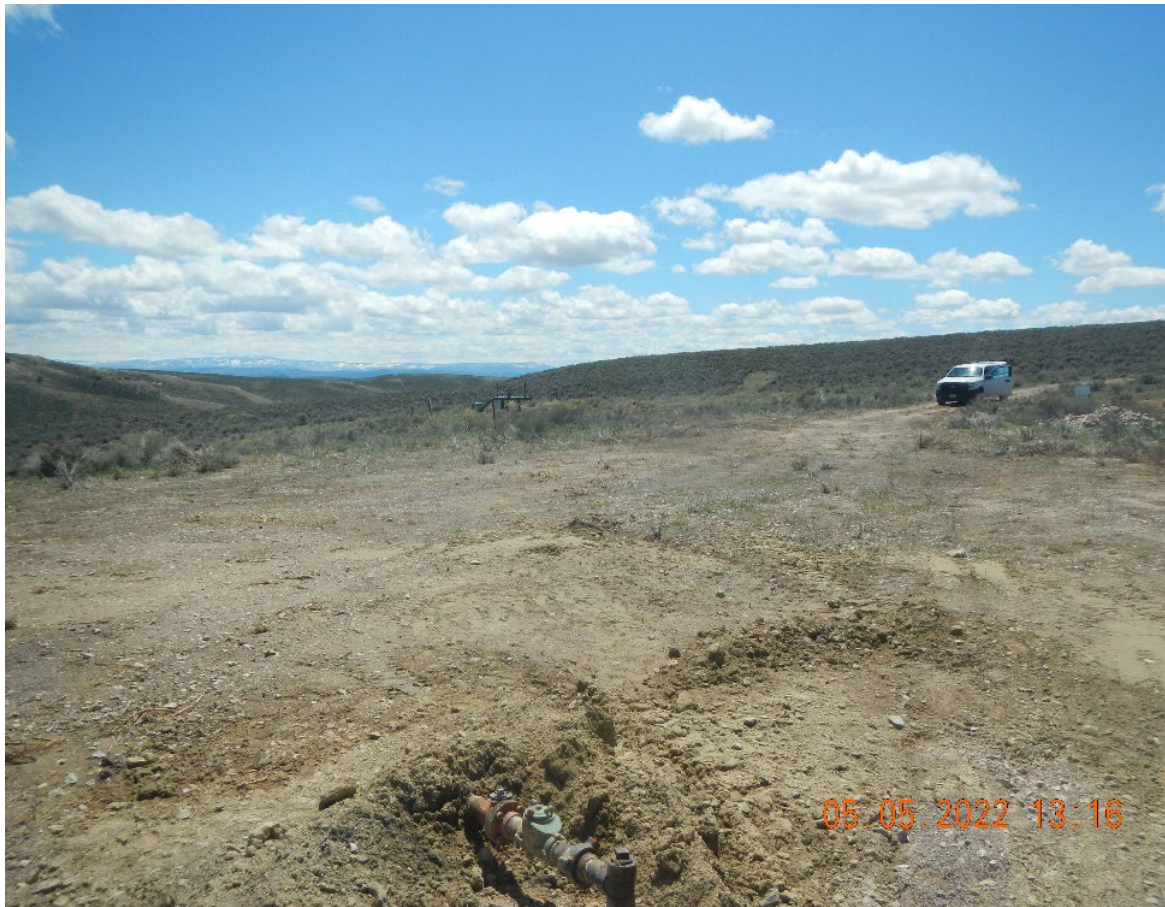
**Photo #4 photo taken from near wellhead, in center of photo, off location gathering lines.**

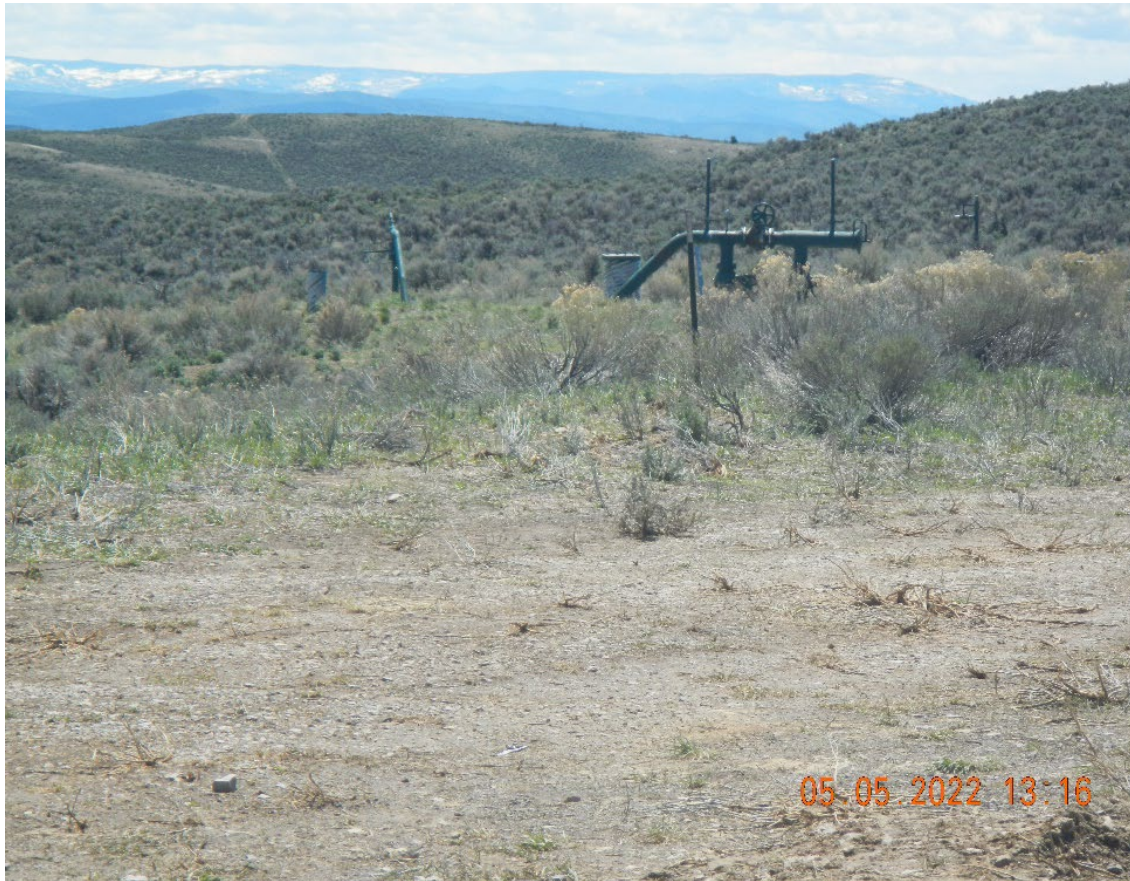
**Photo #5 close up of Photo #4; gathering line and valve can. This area should be identified and investigated on the Form 27**

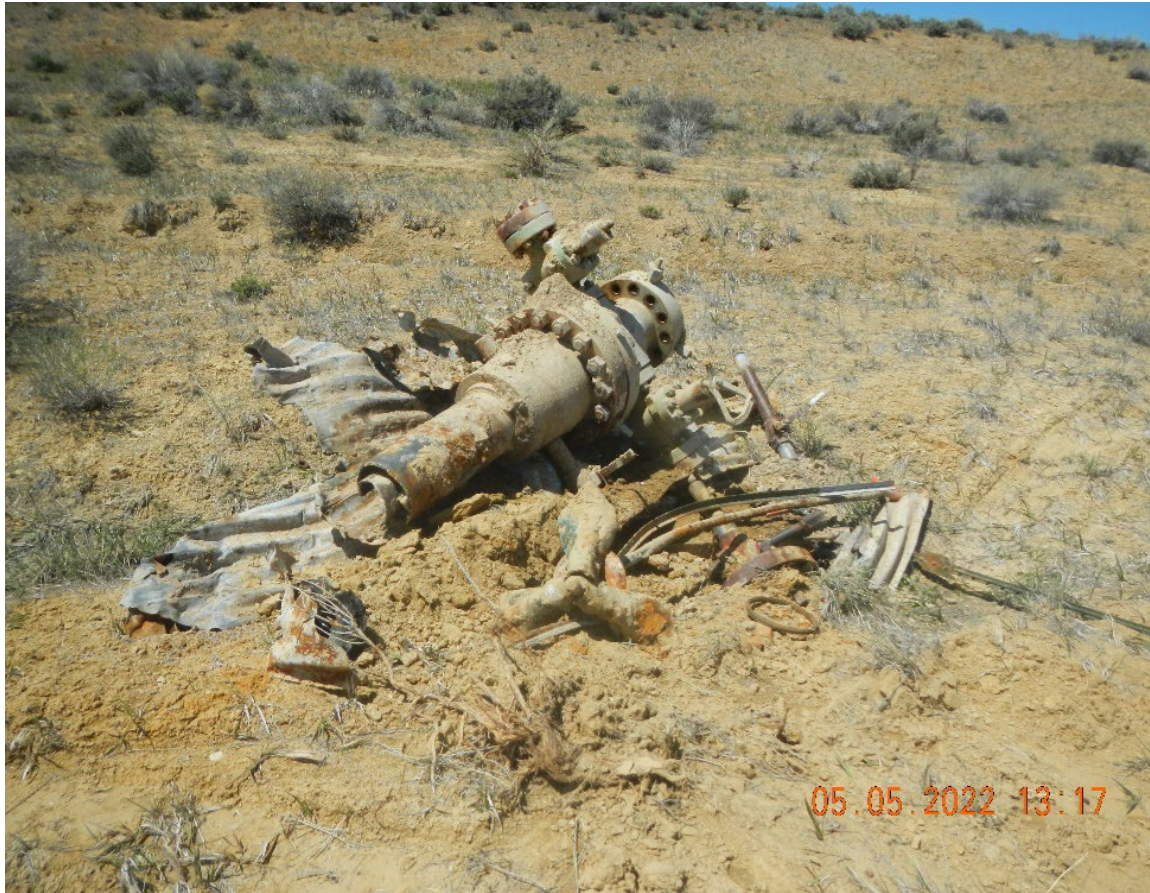
**Photo #6 debris from PA and cut cap. All debris should be removed.**

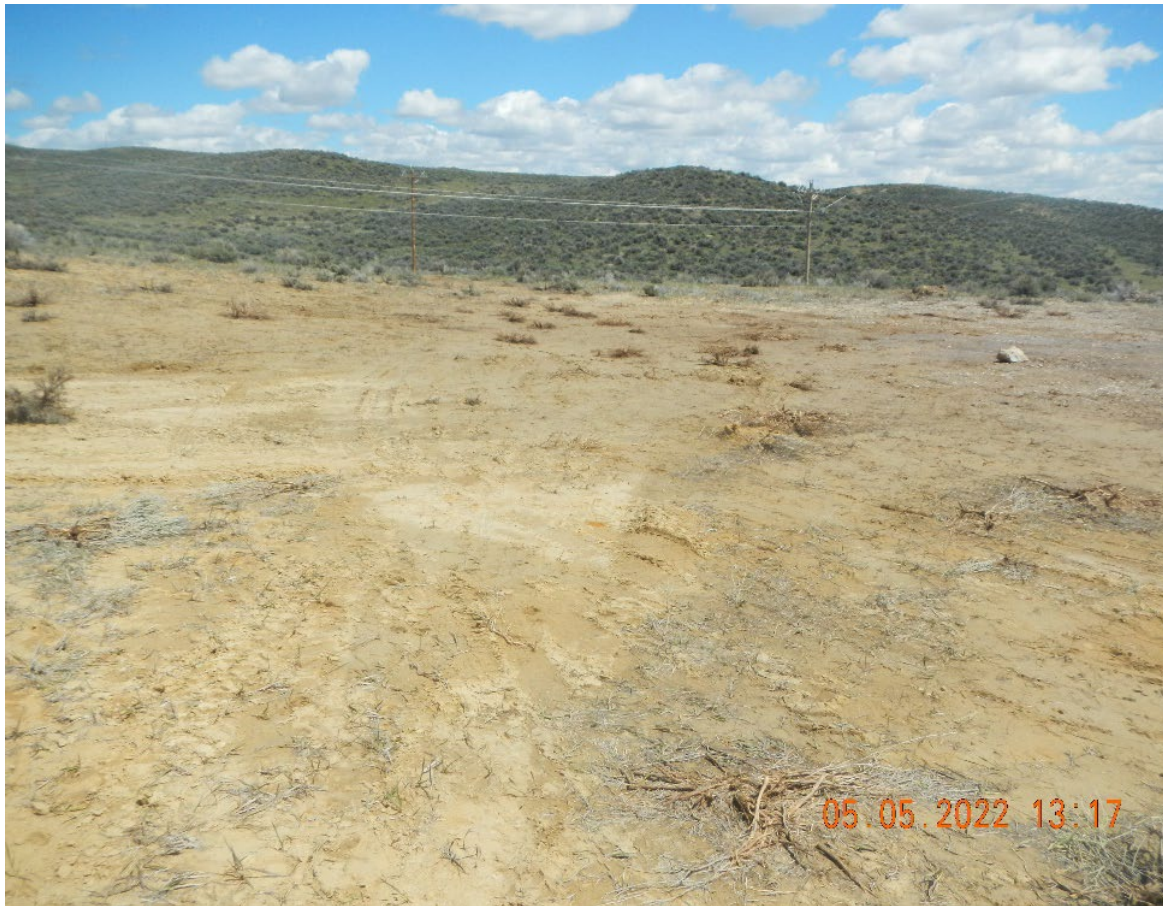
**Photo #7 photo of pad, showing bare ground.**

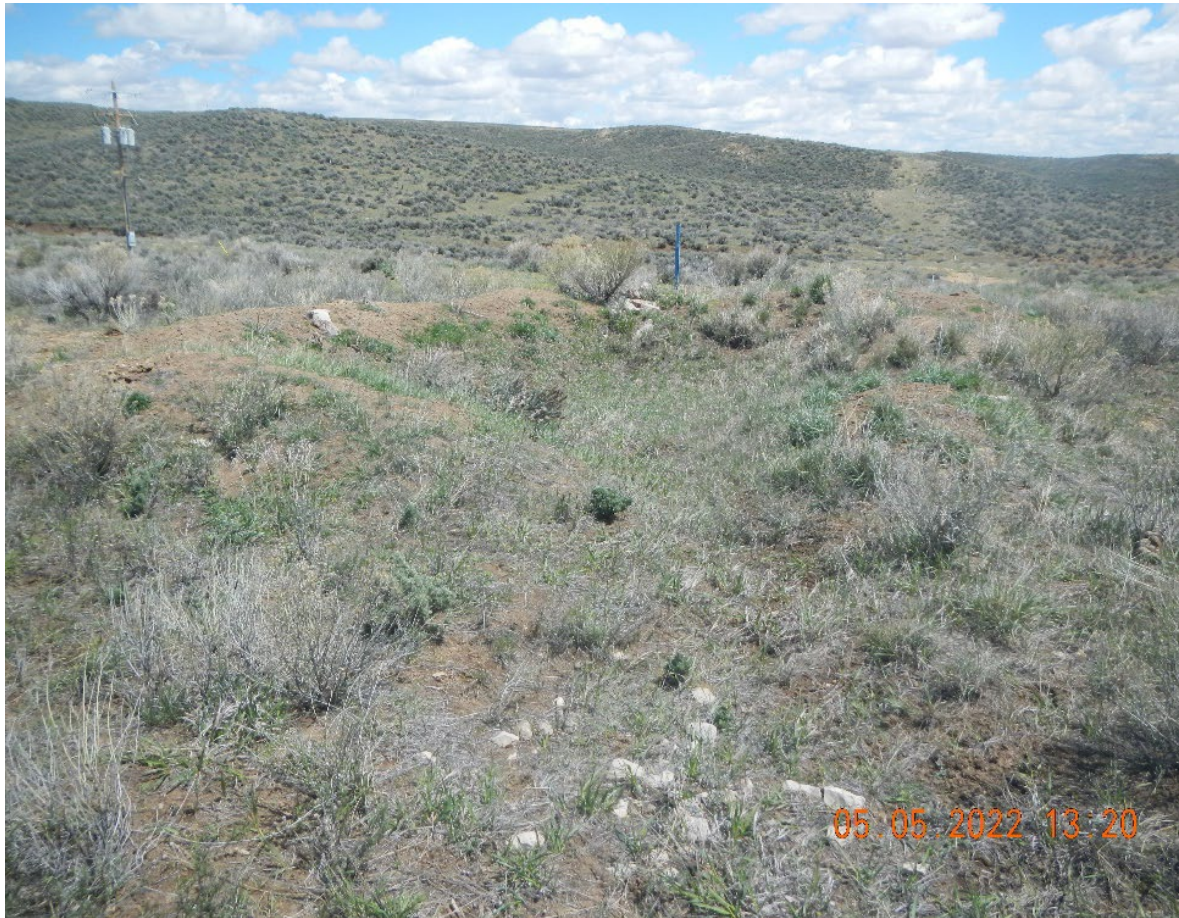
**Photo #8 adjacent possibly surface water diversions?**

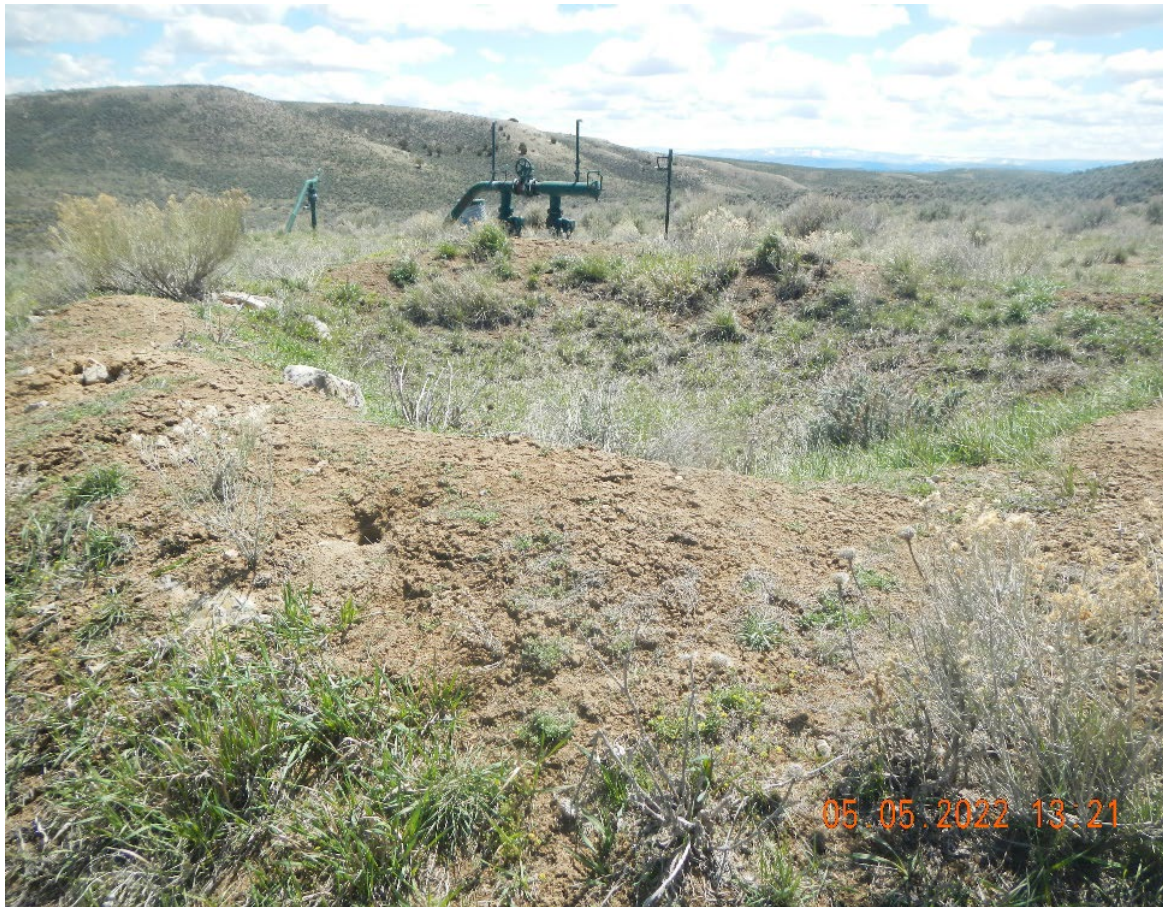
**Photo #9 Pipeline infrastructure from Photo #4. there was a impoundment of some sort, looks similar to a pit but was open on the up grade side. This area should be addressed on the form 27.**

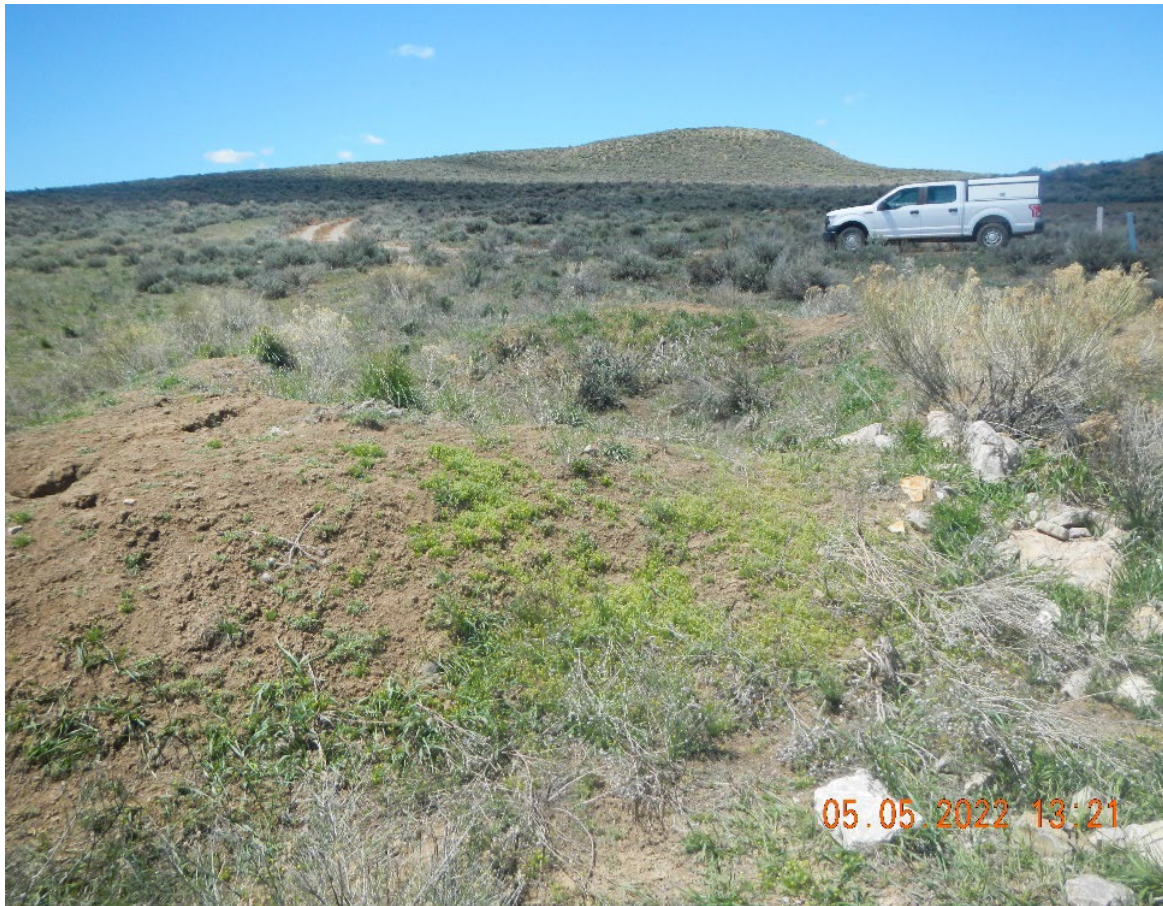
Photo #10 another angle of photo #9
