Inspection Photos
Operator: Simcoe
API: 067-08358
Date: 5/9/2022

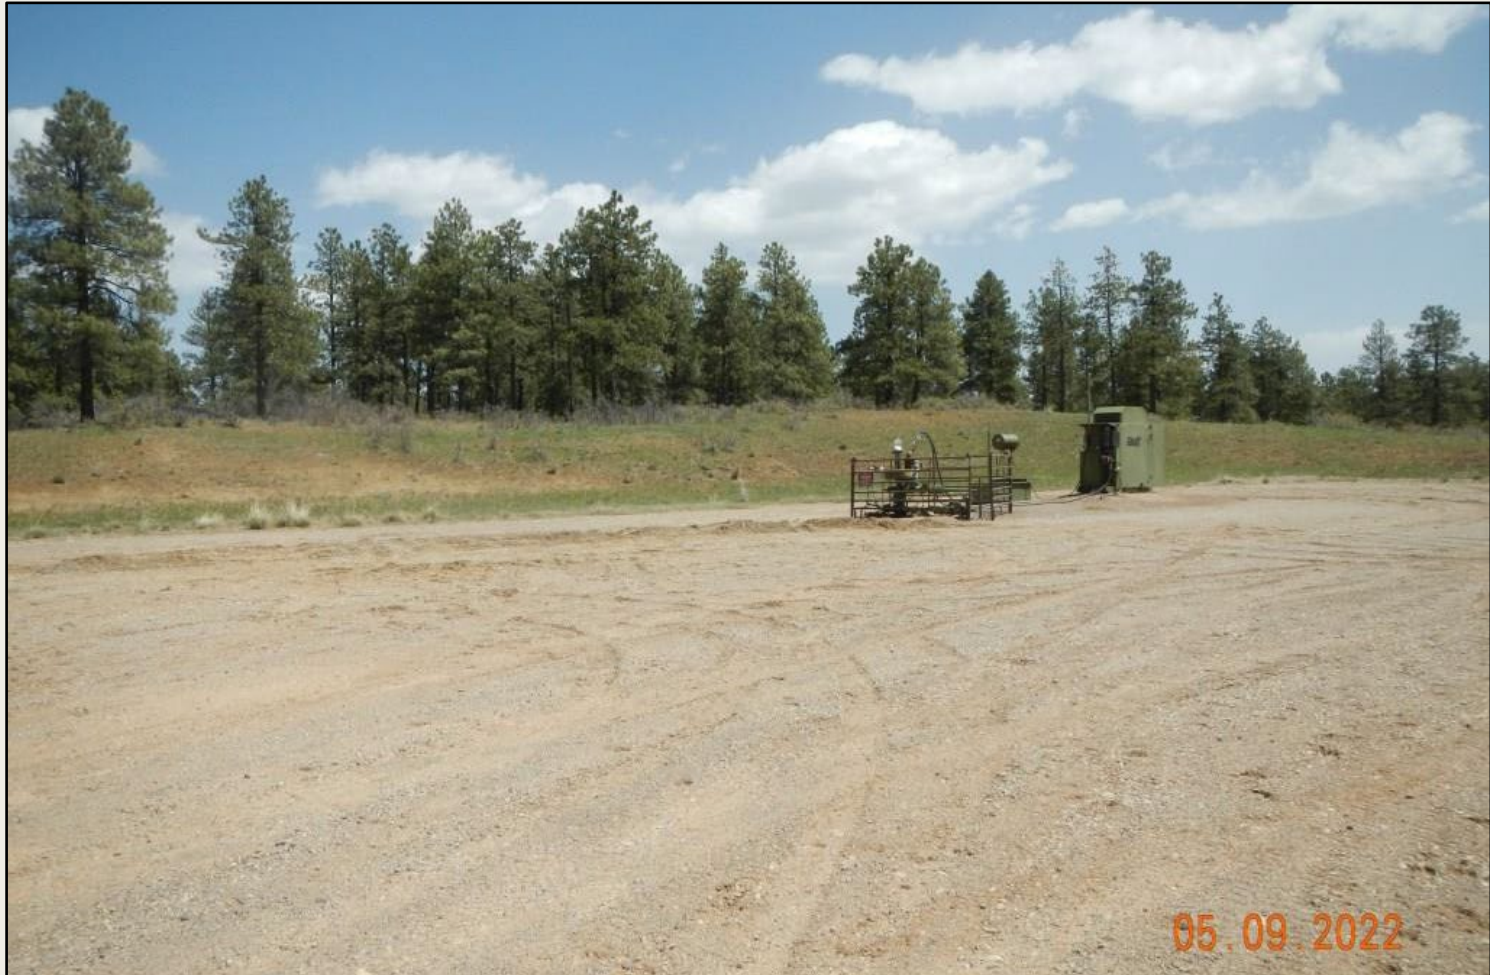
Photo 1. View of the project area from the well pad entrance facing center.

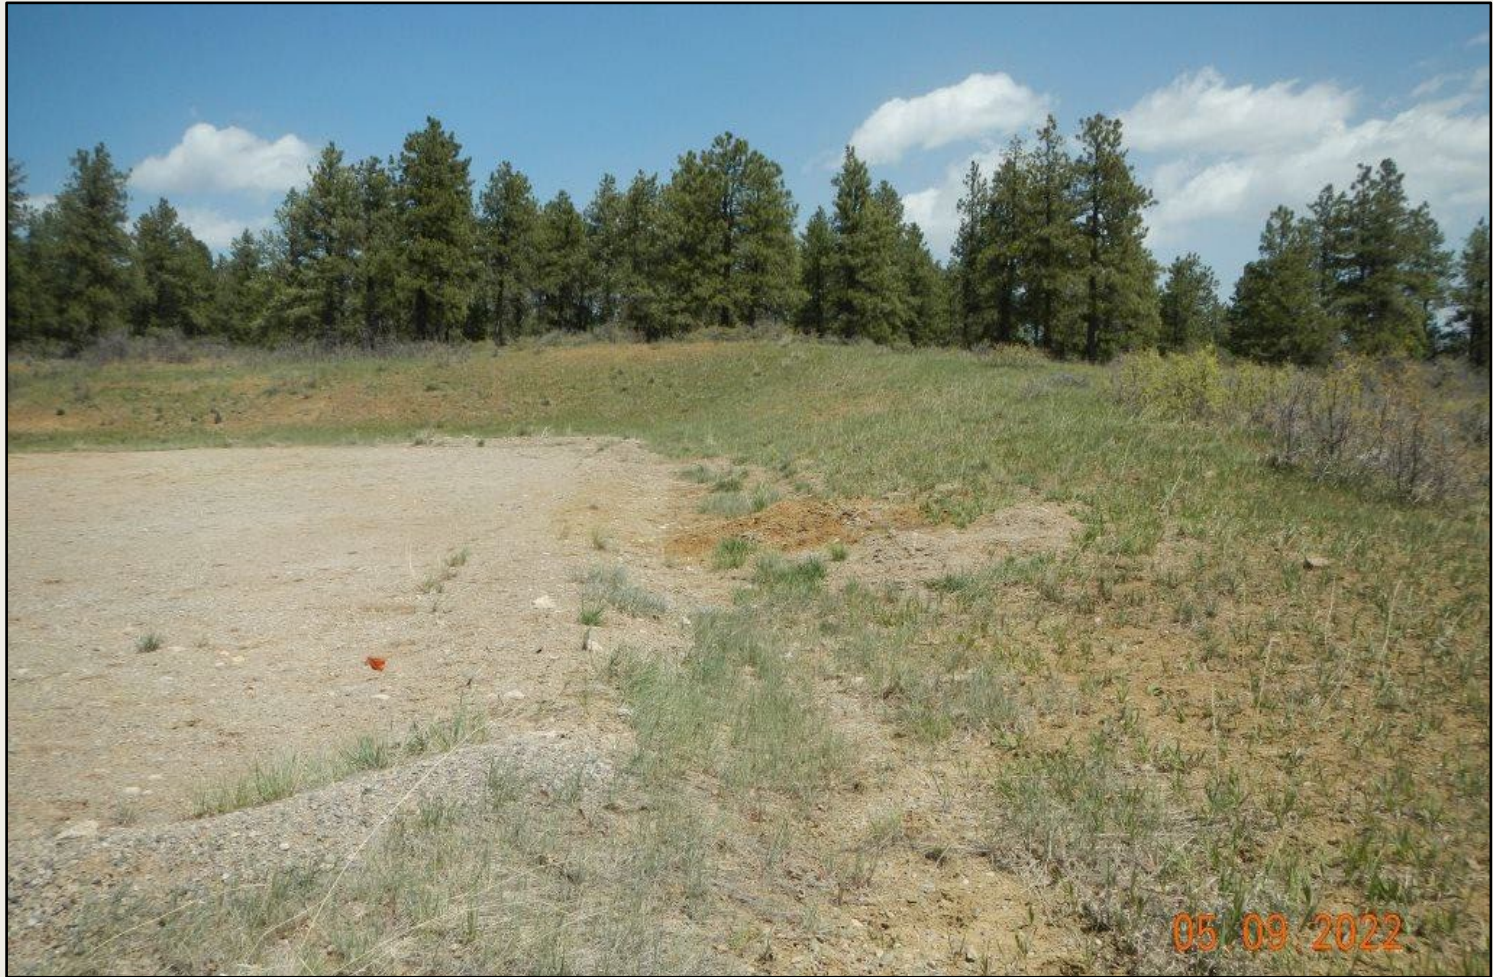
Photo 2. View of the eastern project area from the southeastern corner facing northward. Revegetation is progressing with smooth brome, sand dropseed, crested wheatgrass, and western wheatgrass.

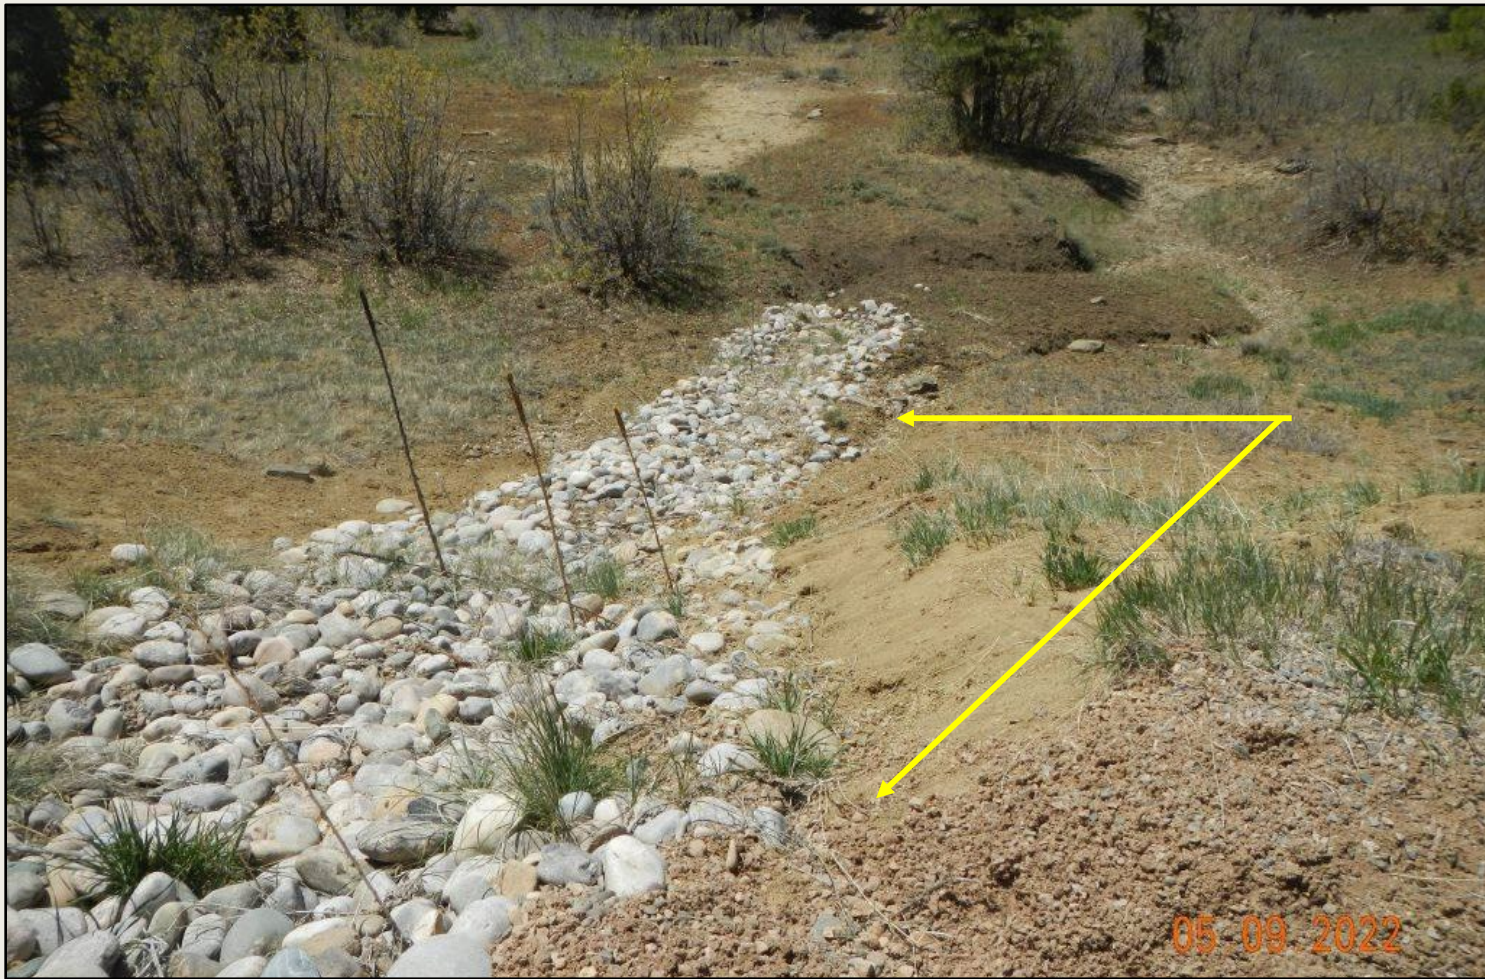
Photo 3. View of cobble BMP within the southern project area, needing maintenance. Concentrated stormwater flows are eroding along the edge of the BMP (yellow arrows) resulting in continued erosion downstream and sediment discharge.

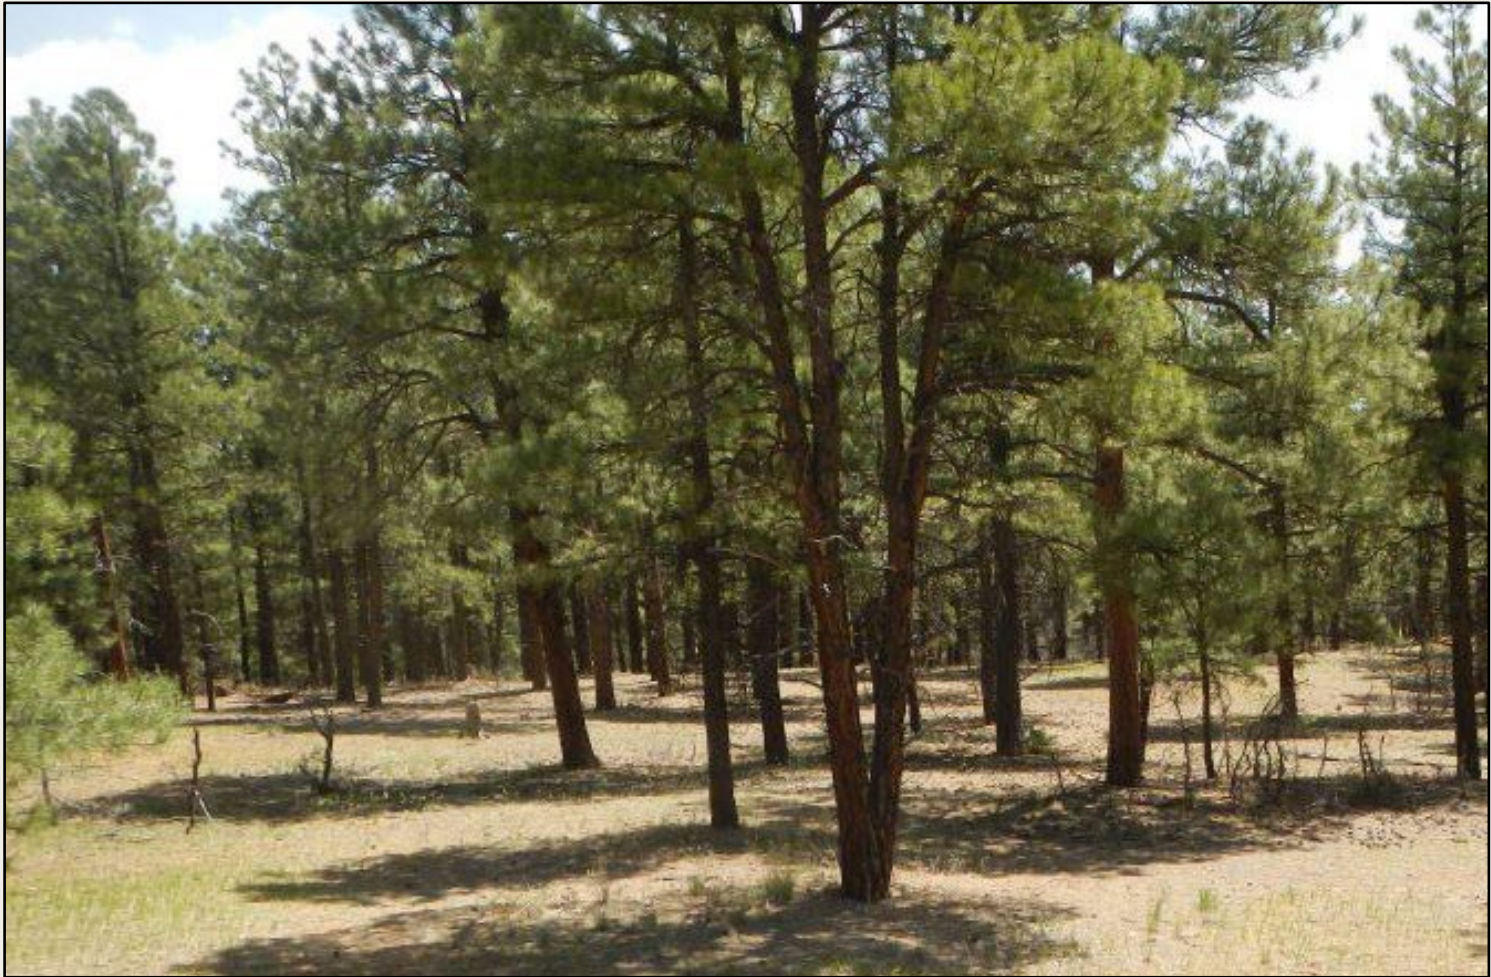
Photo 4. View of reference area comprised of ponderosa pine forest with gambel oak, Oregon grape, balsamroot, and muttongrass.
