Inspection Photos  
Operator: Simcoe  
API: 067-07195  
Date: 5/9/2022

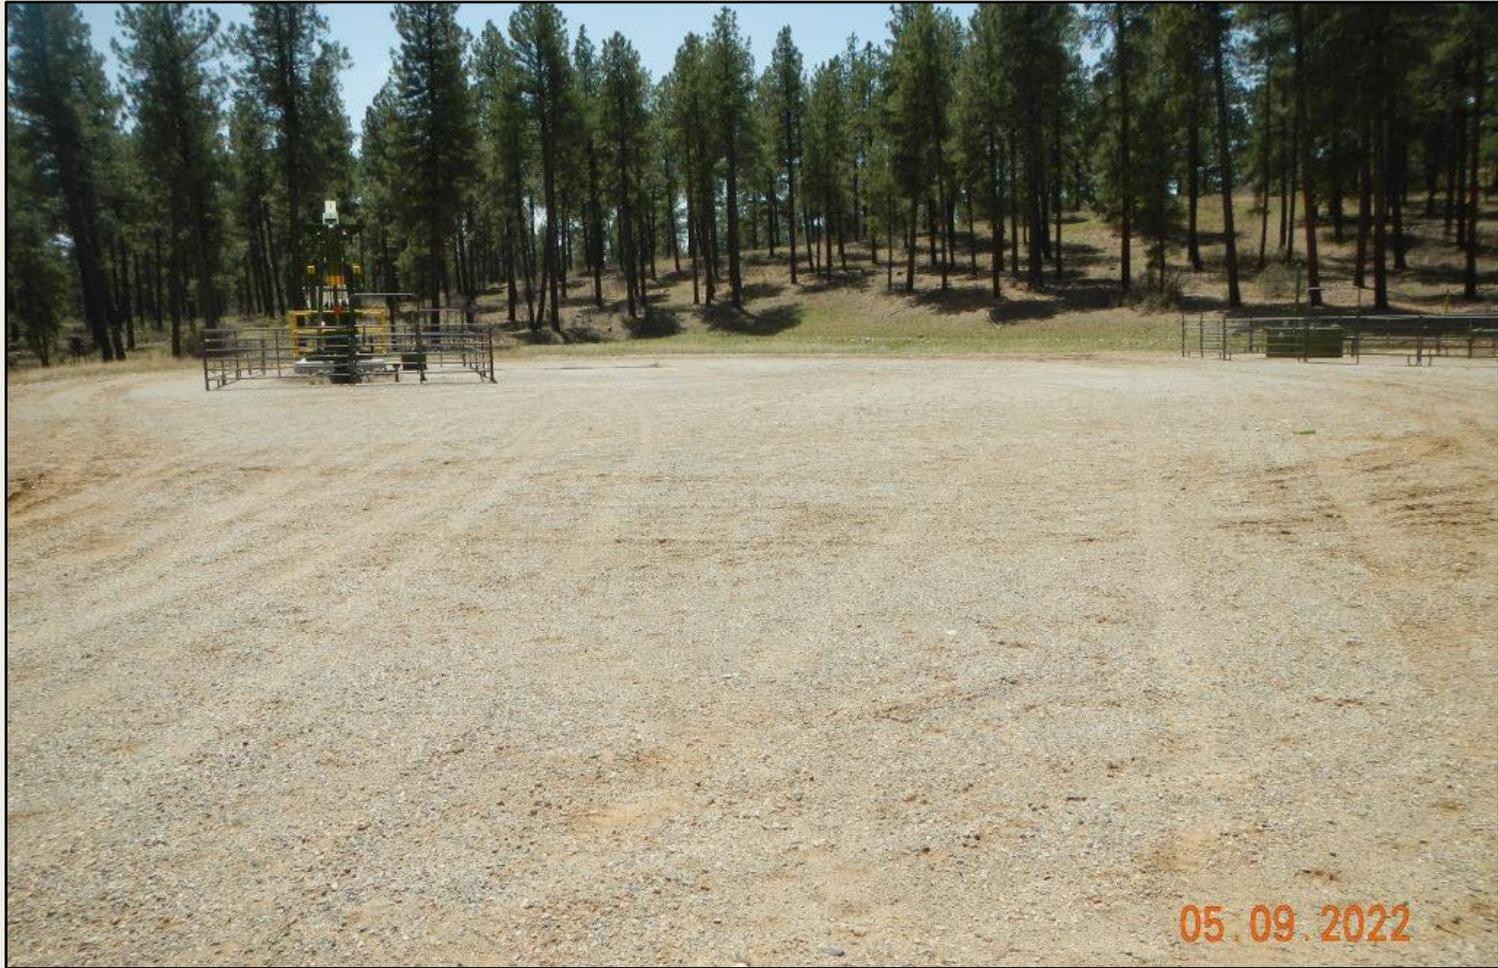
Photo 1. View of the project area from the well pad entrance facing center.

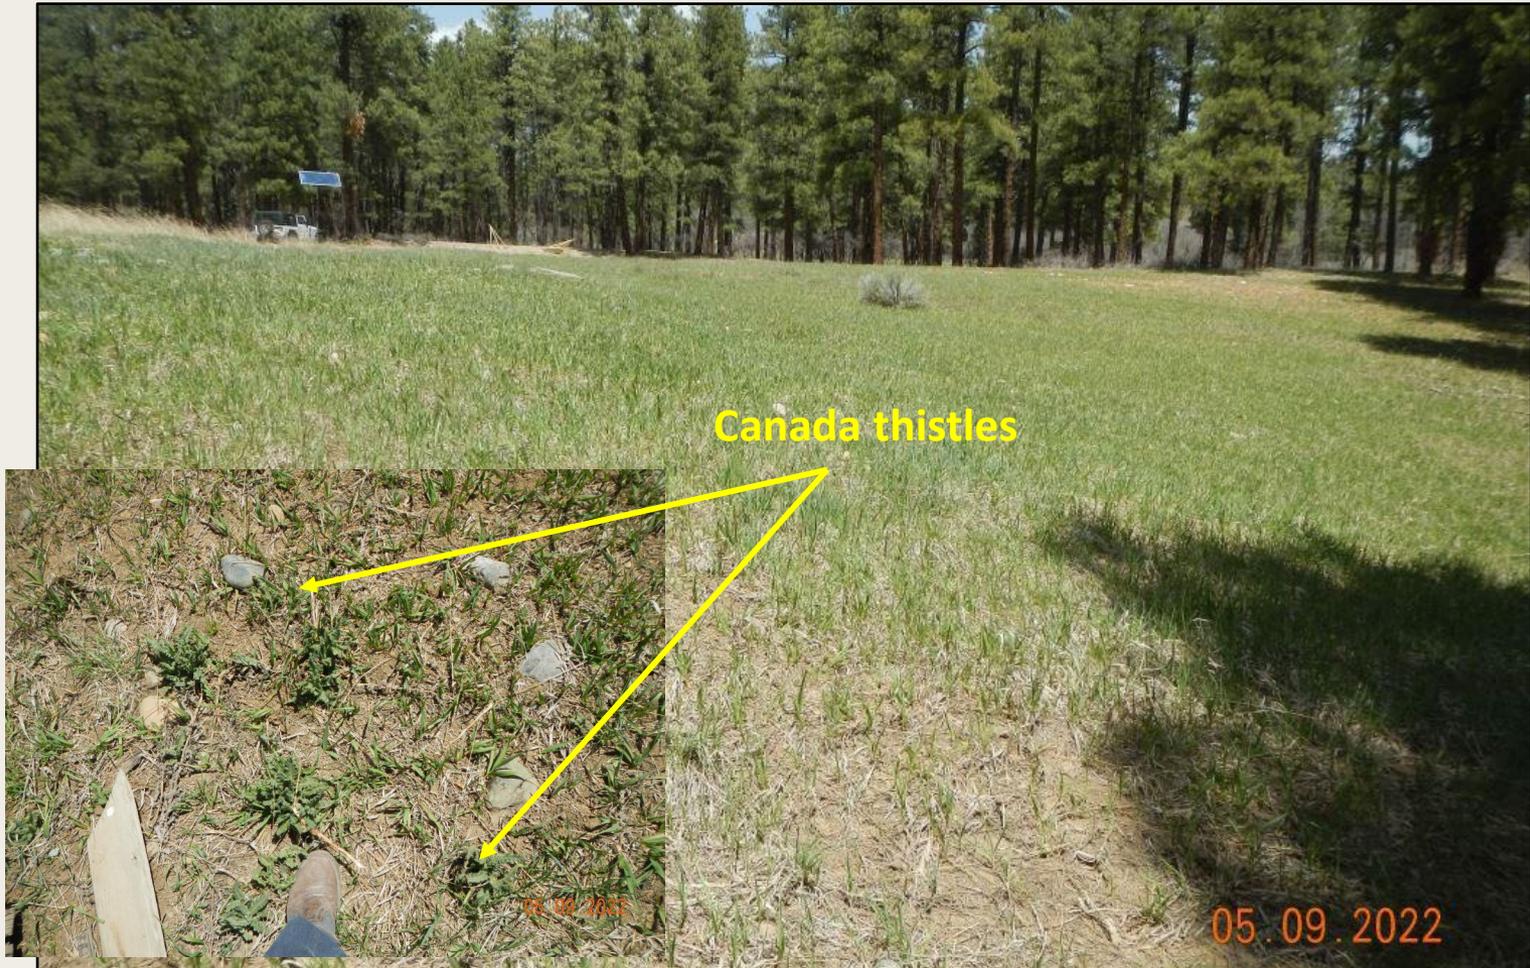
Photo 2. View of the eastern fill slope from the southeastern corner facing northward. Revegetation is progressing largely with smooth brome. Scattered Canada thistles (~25) observed.

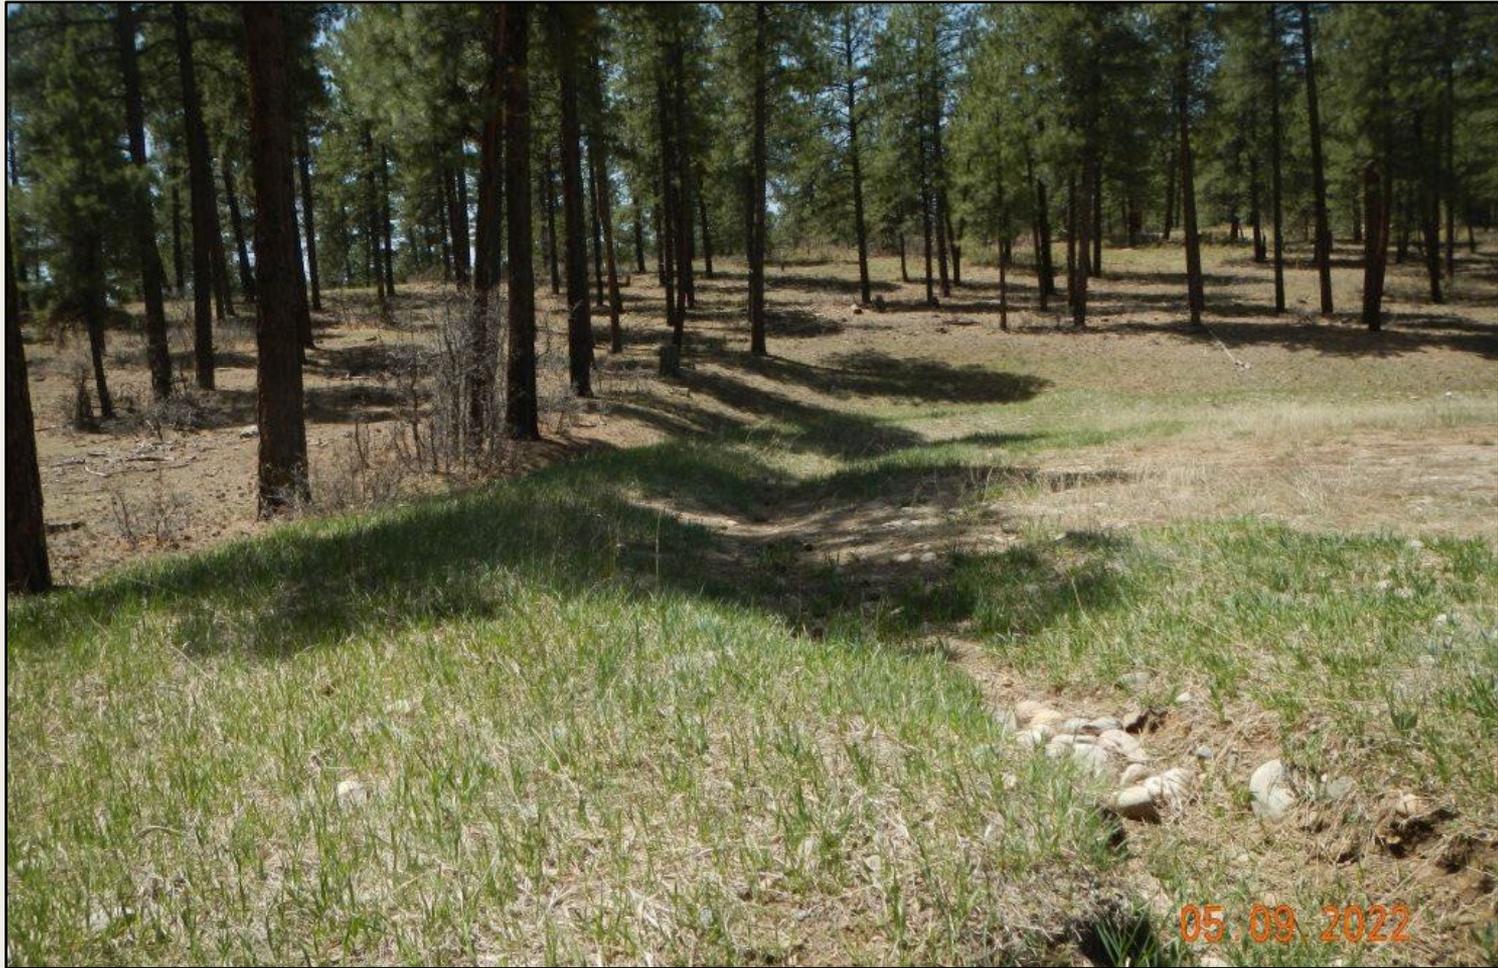
Photo 3. View of the southern project area from the southeastern corner facing westward. Stormwater diversion needs stabilization (Photo 4).

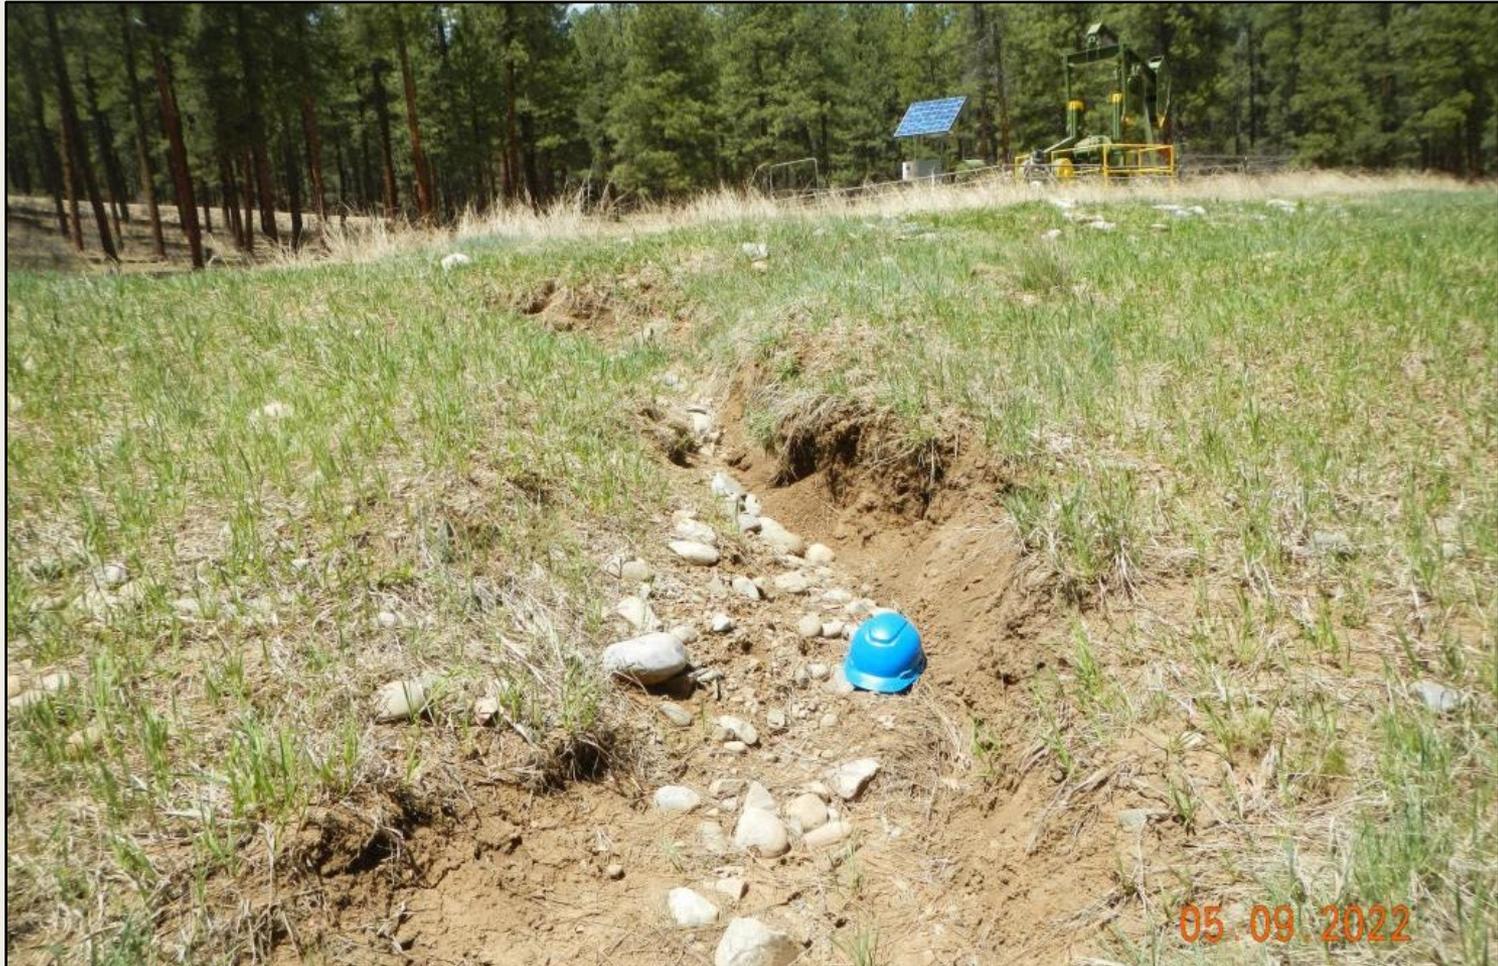
Photo 4. View erosional channeling approximately 2ft wide and deep within the southeastern project area, downslope from diversion in Photo 3.

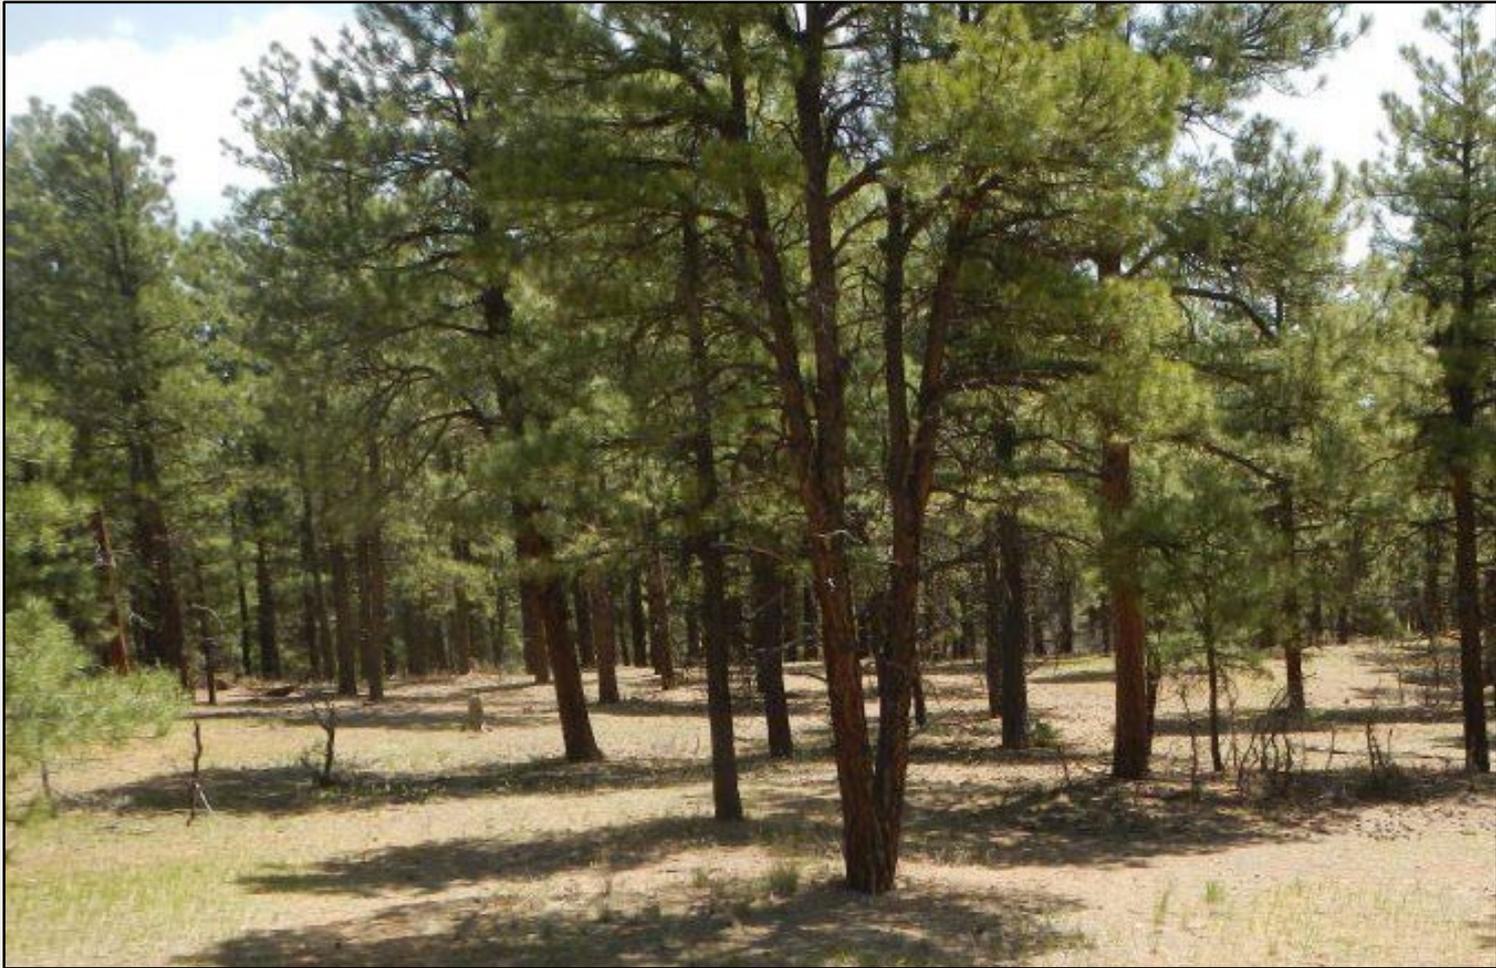
Photo 5. View of reference area comprised of ponderosa pine forest with gambel oak, Oregon grape, balsamroot, and muttongrass.
