Inspection Photos  
Operator: Simcoe  
API: 067-08357  
Date: 5/9/2022

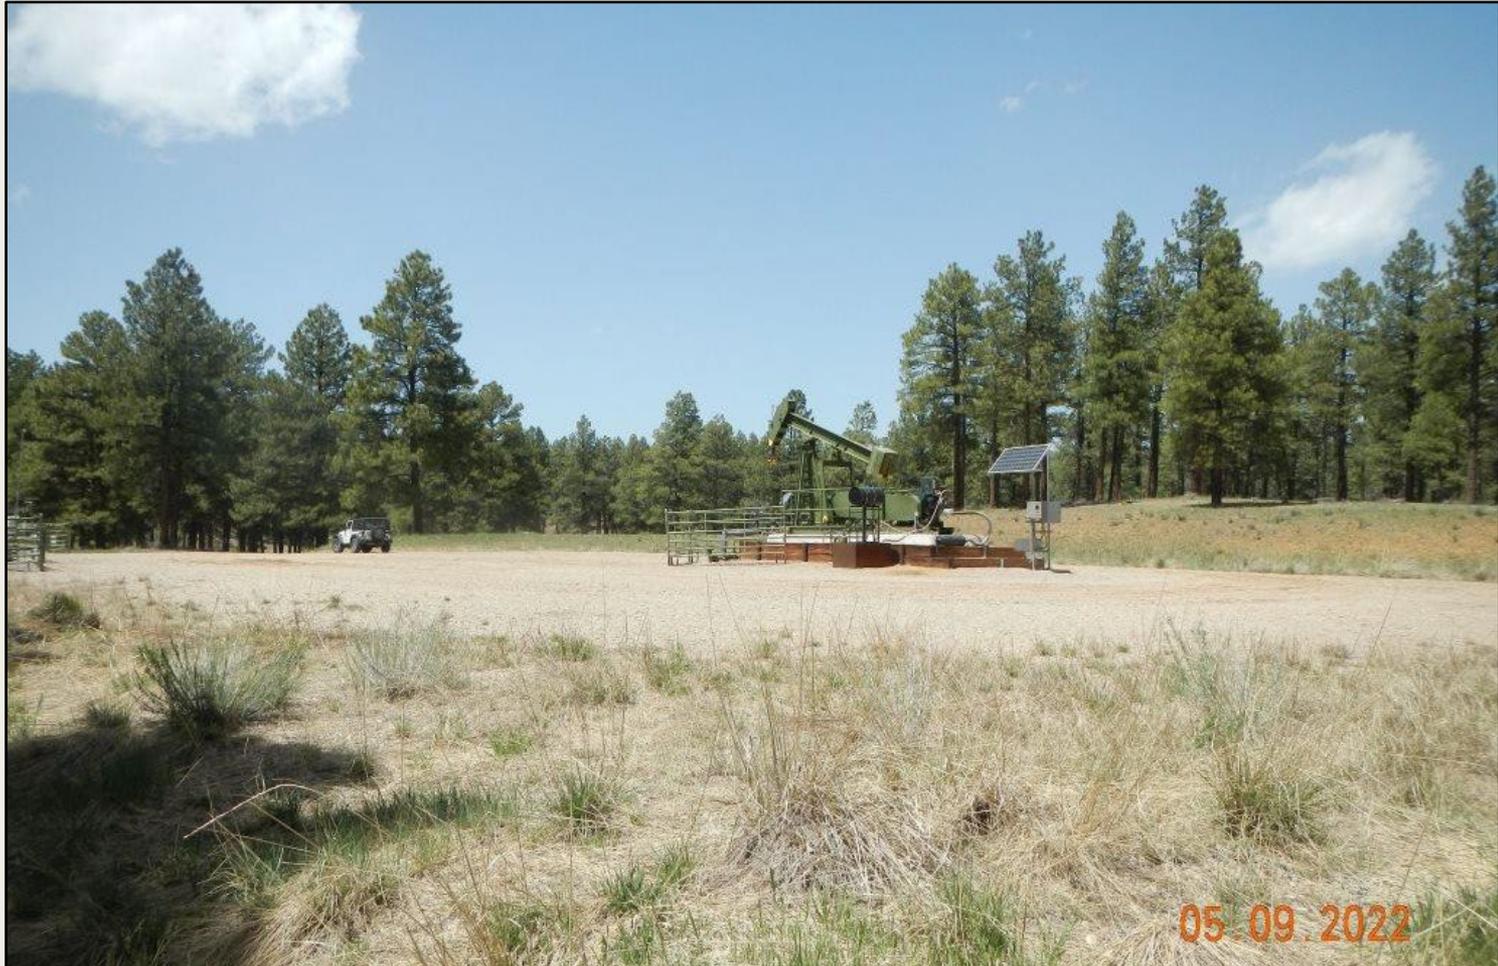
Photo 1. View of the project area from the southeastern corner facing center.

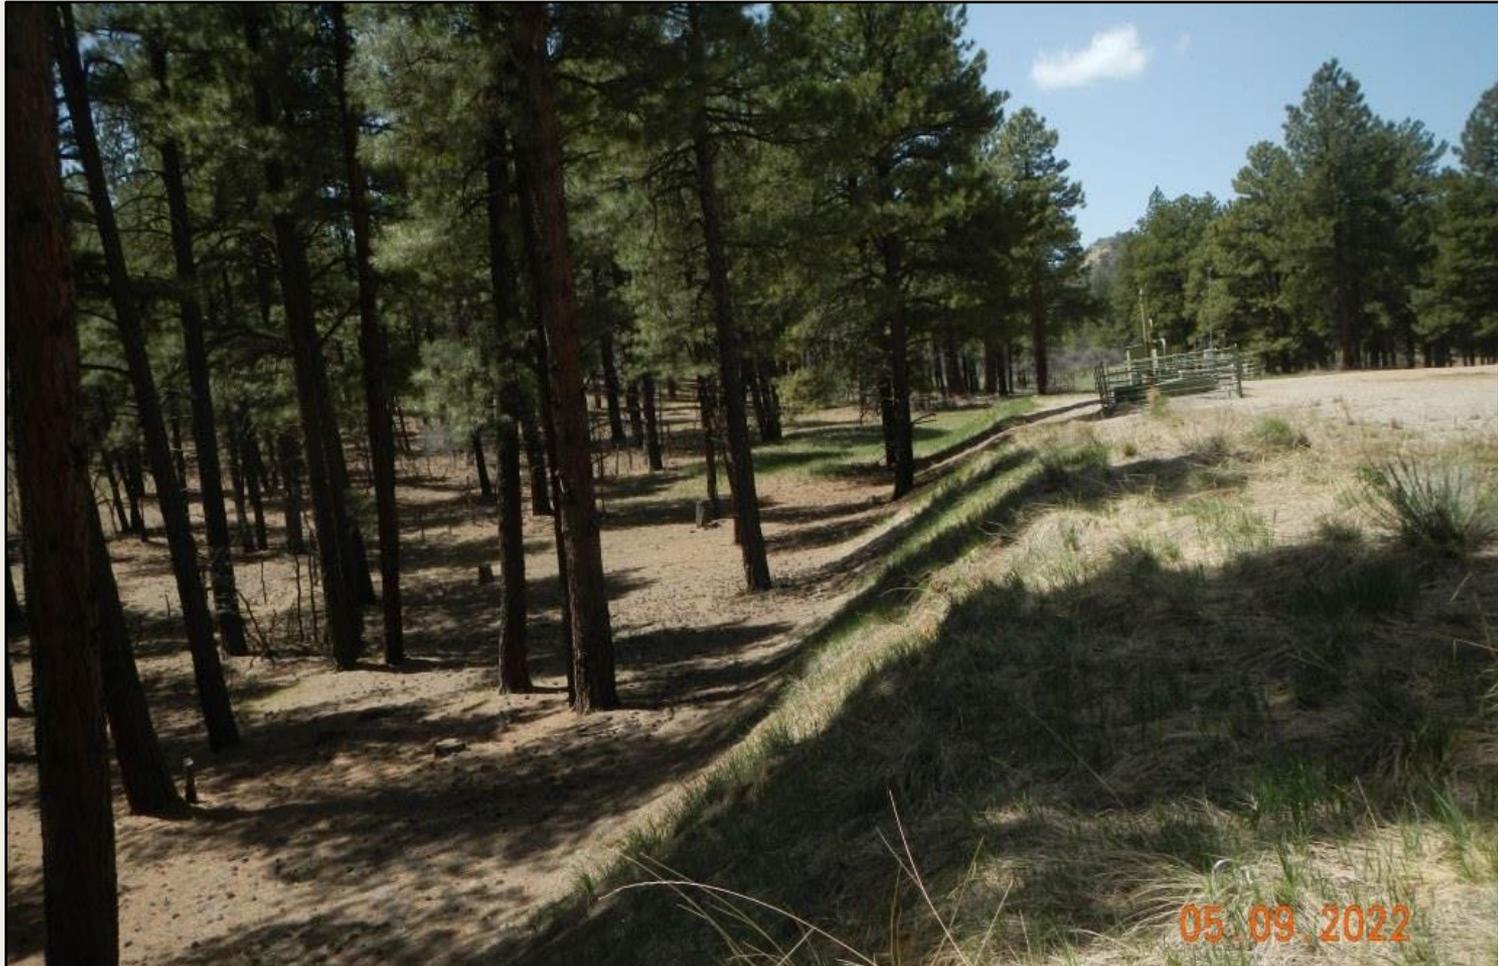
Photo 2. View of the southern fill slope from the southeastern corner facing westward. Revegetation is progressing largely with smooth brome, western wheatgrass, intermediate wheatgrass, and sand dropseed.

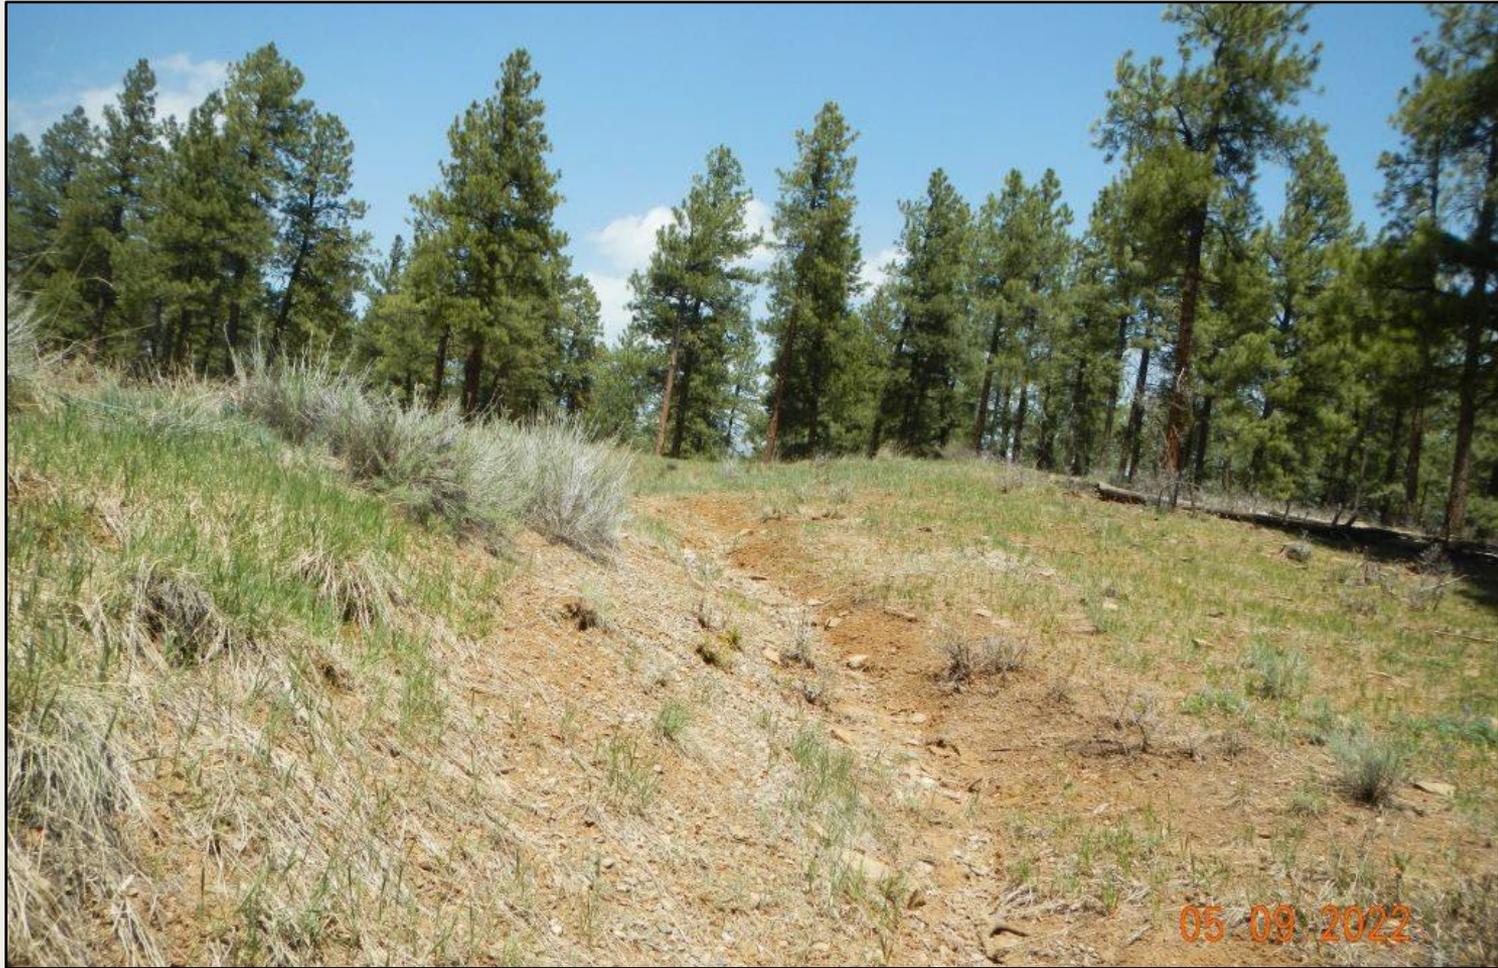
Photo 3. View of the eastern project area from the southeastern corner facing northward. Stormwater diversion needs stabilization (see Photo 4).

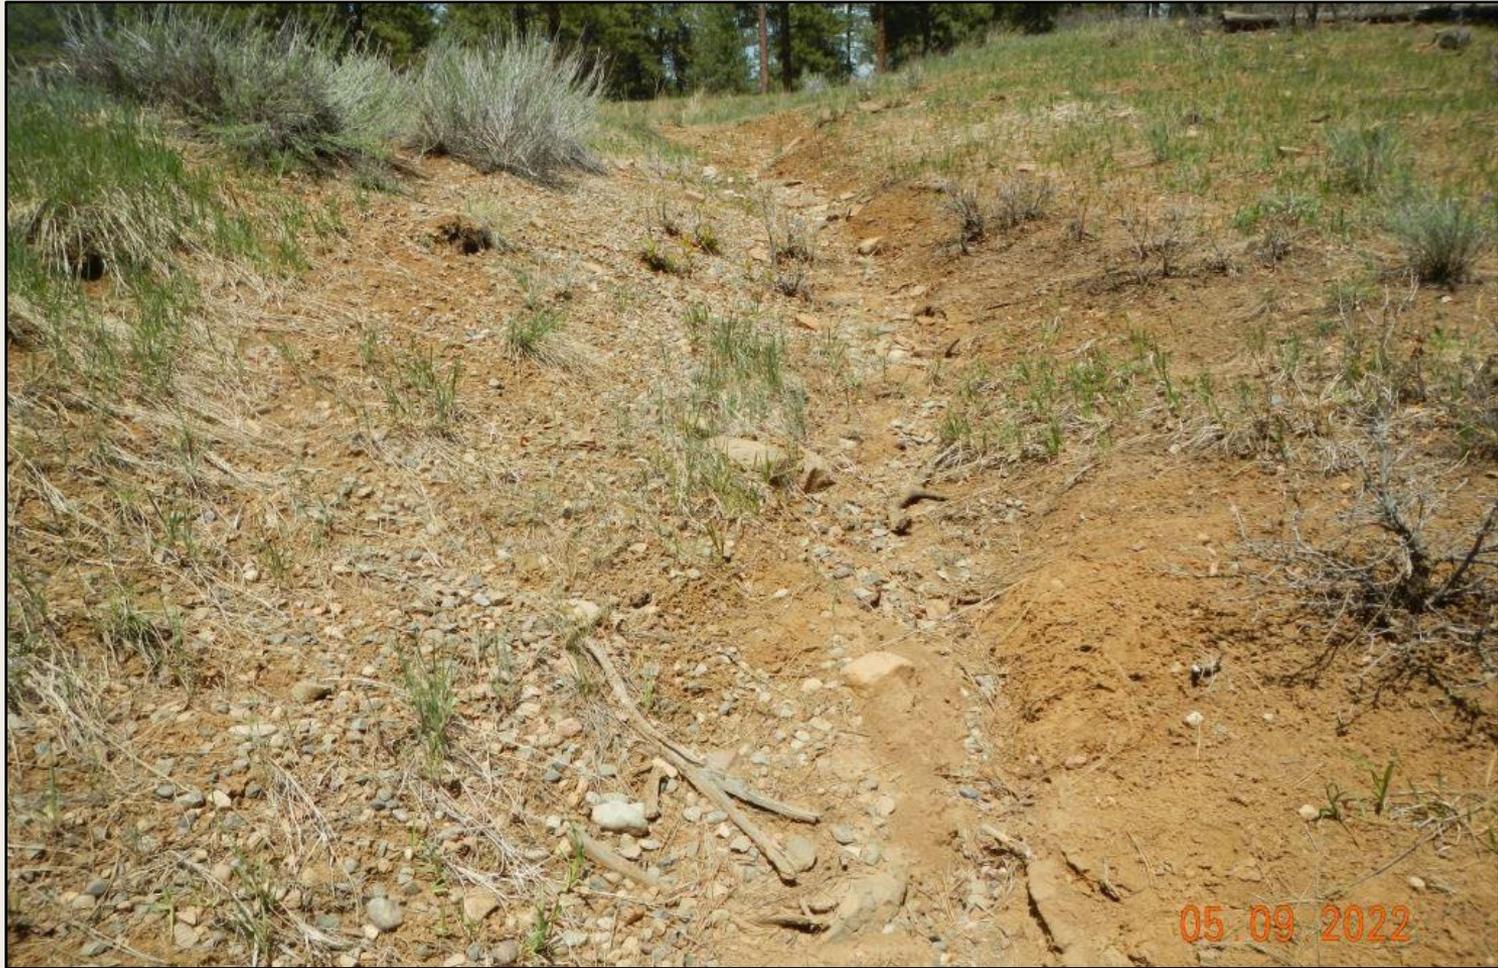
Photo 4. View erosional channeling approximately 2ft wide and deep within the eastern project area.
