Inspection Photos
Location Name: Andrews (Lanyard Water Flood) 23-18
Location ID: 317994

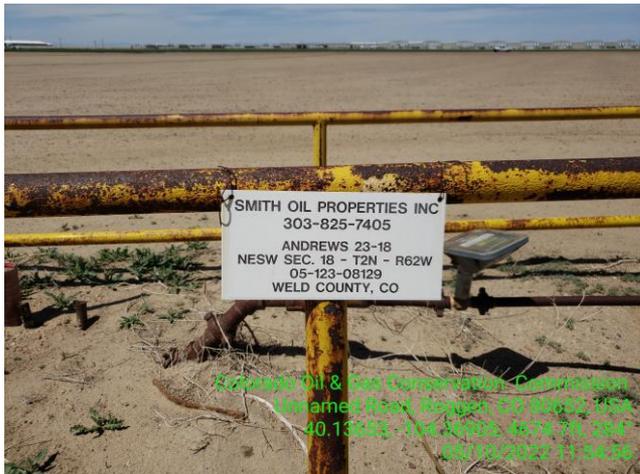
Photo 1 Wellsite.

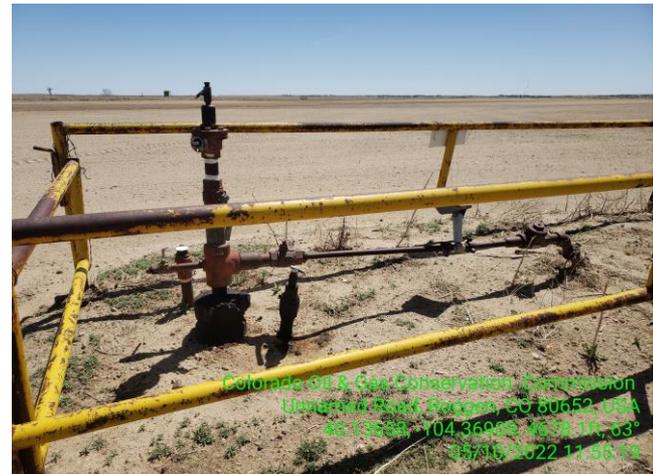
Photo 2 WH sign

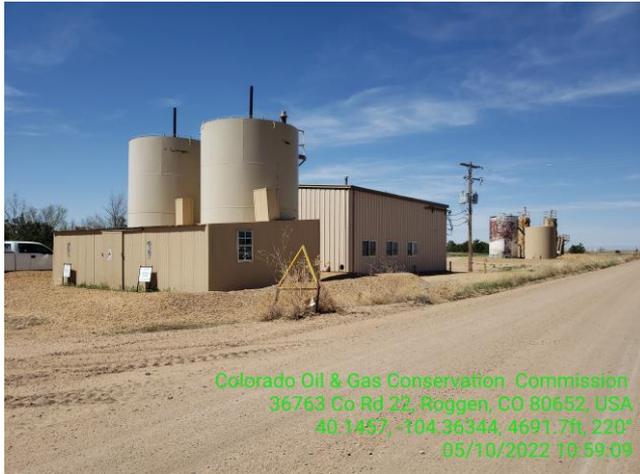
Photo 3 TB location.

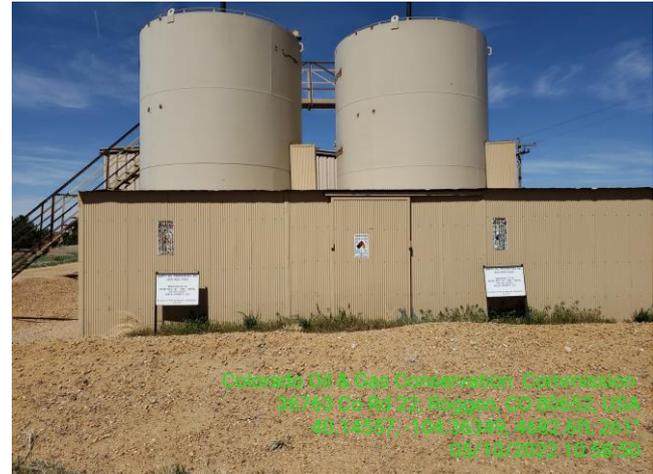
Photo 4 TB signs PW tanks

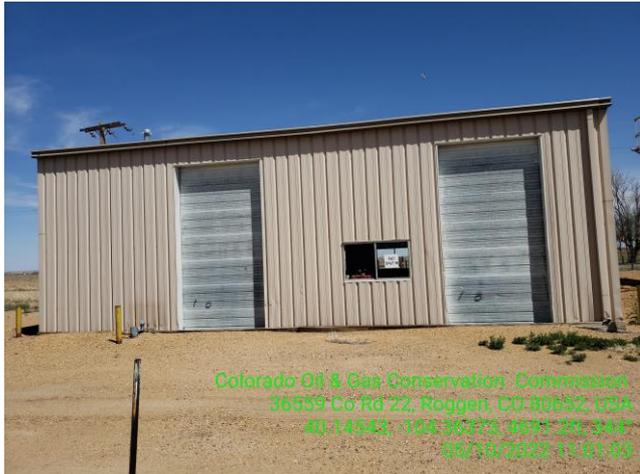
Photo 5 locked office/shop building.

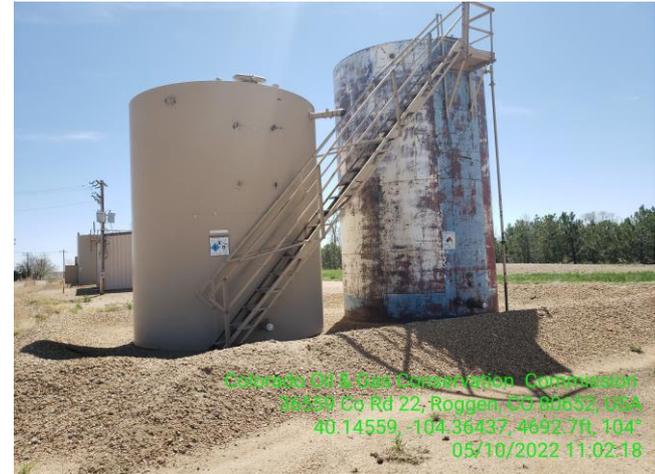
Photo 6 PW tanks

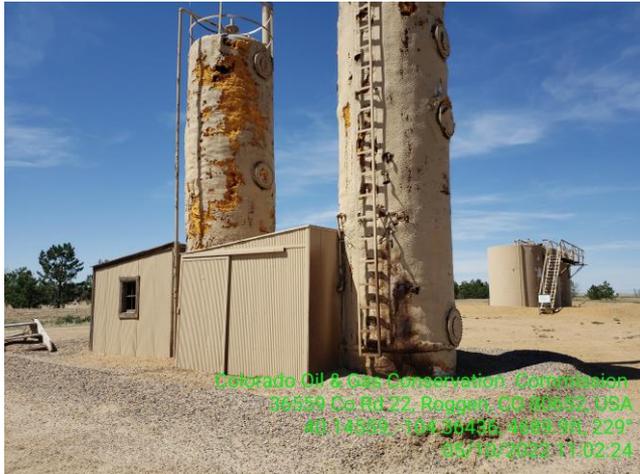
Photo 7 Vertical Separators.

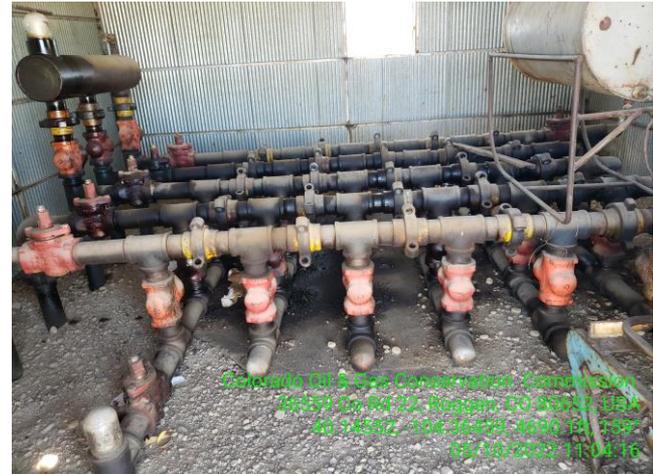
Photo 8 Flow line manifold

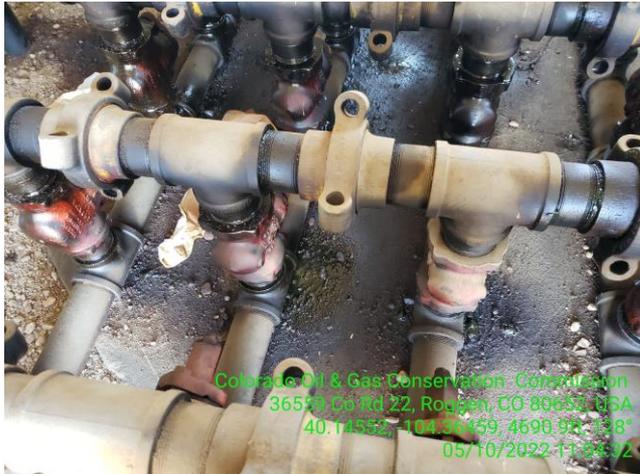
Photo 9 stained ground inside flow line manifold house.

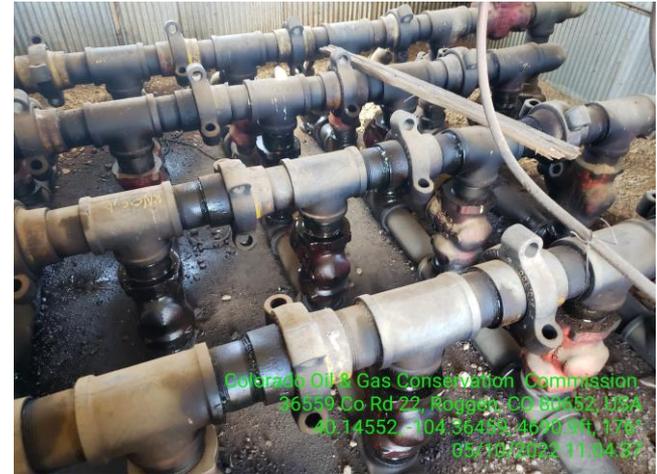
Photo 10 Leaking threads on the Flow line manifold

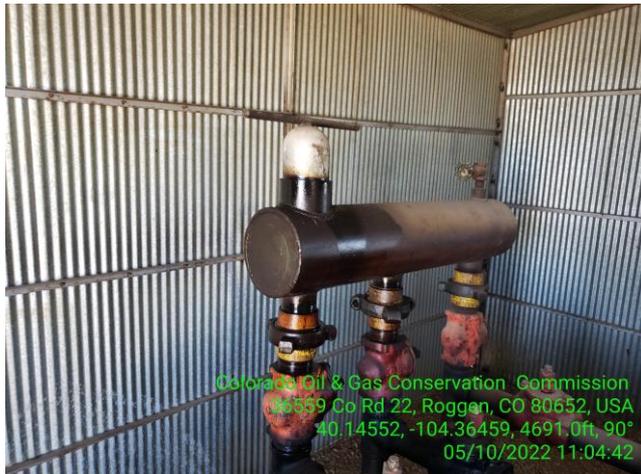
Photo 11 Leaking threads on the flow line manifold.

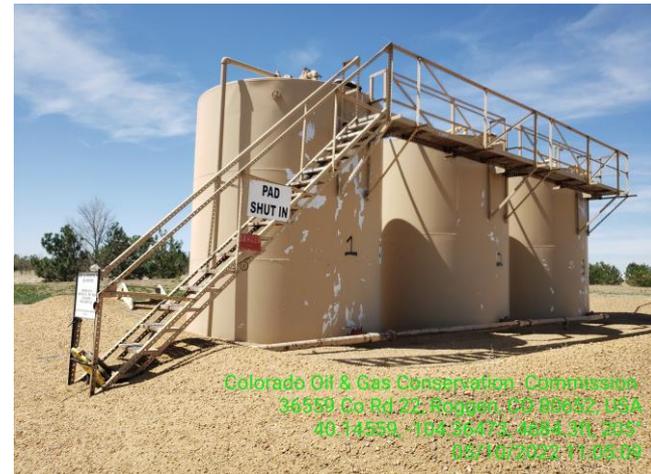
Photo 12 Crude oil tanks

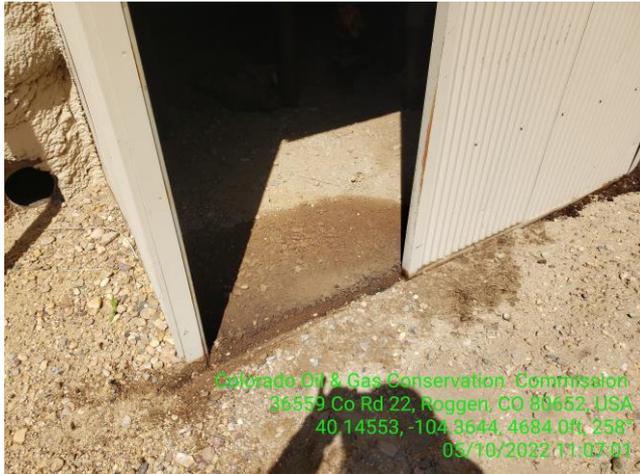
Photo 13 Stained soil at Vert. Sep. house

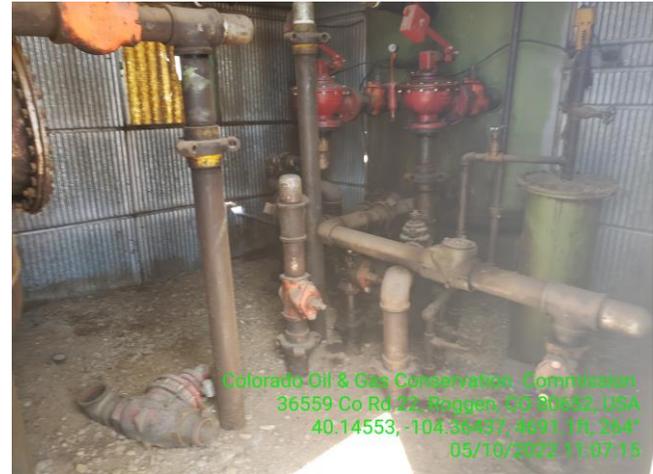
Photo 14 inside of Vert. Sep. house

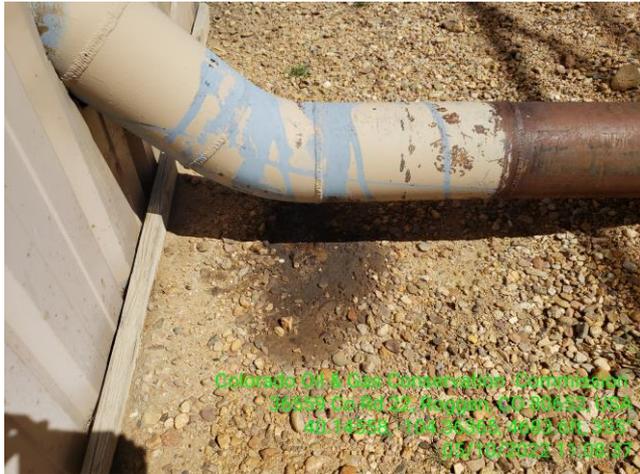
Photo 15 Stained soil under PW flow line at the east shop wall

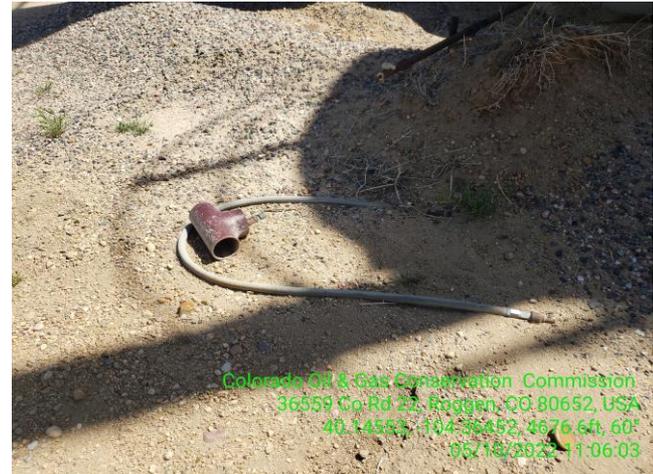
Photo 16 trash

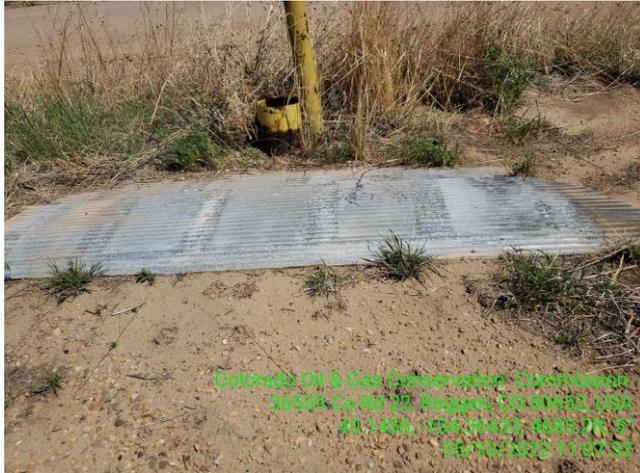
Photo 17 trash

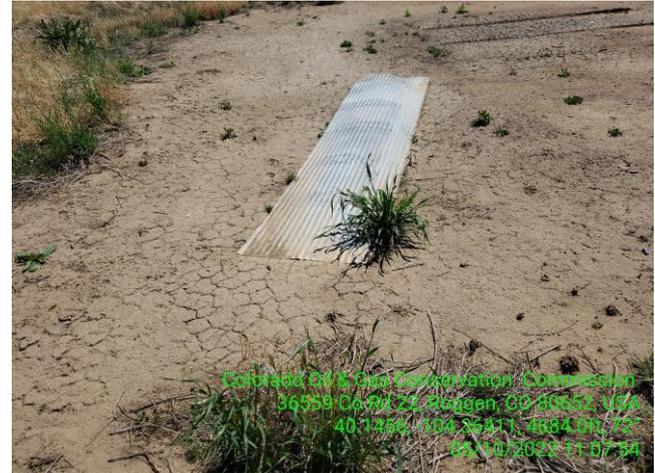
Photo 18 trash
