Inspection Photos

API: 055-06219

Operator: PETROGLYPH OPERATING CO

Inspection Date: 5/11/2022

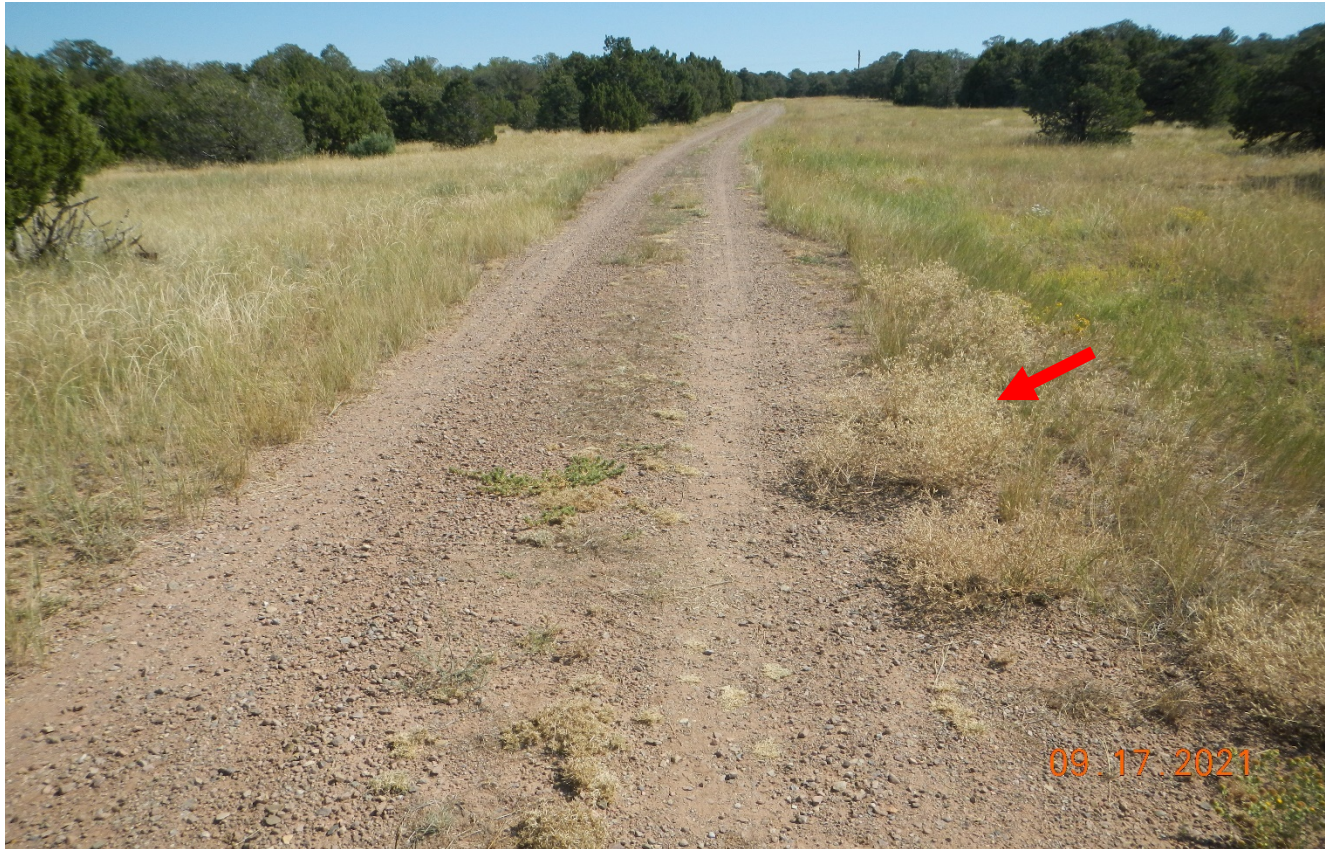
Photo 1. Facing southeast along the access road. There are noxious weeds along the road (Diffuse knapweed).

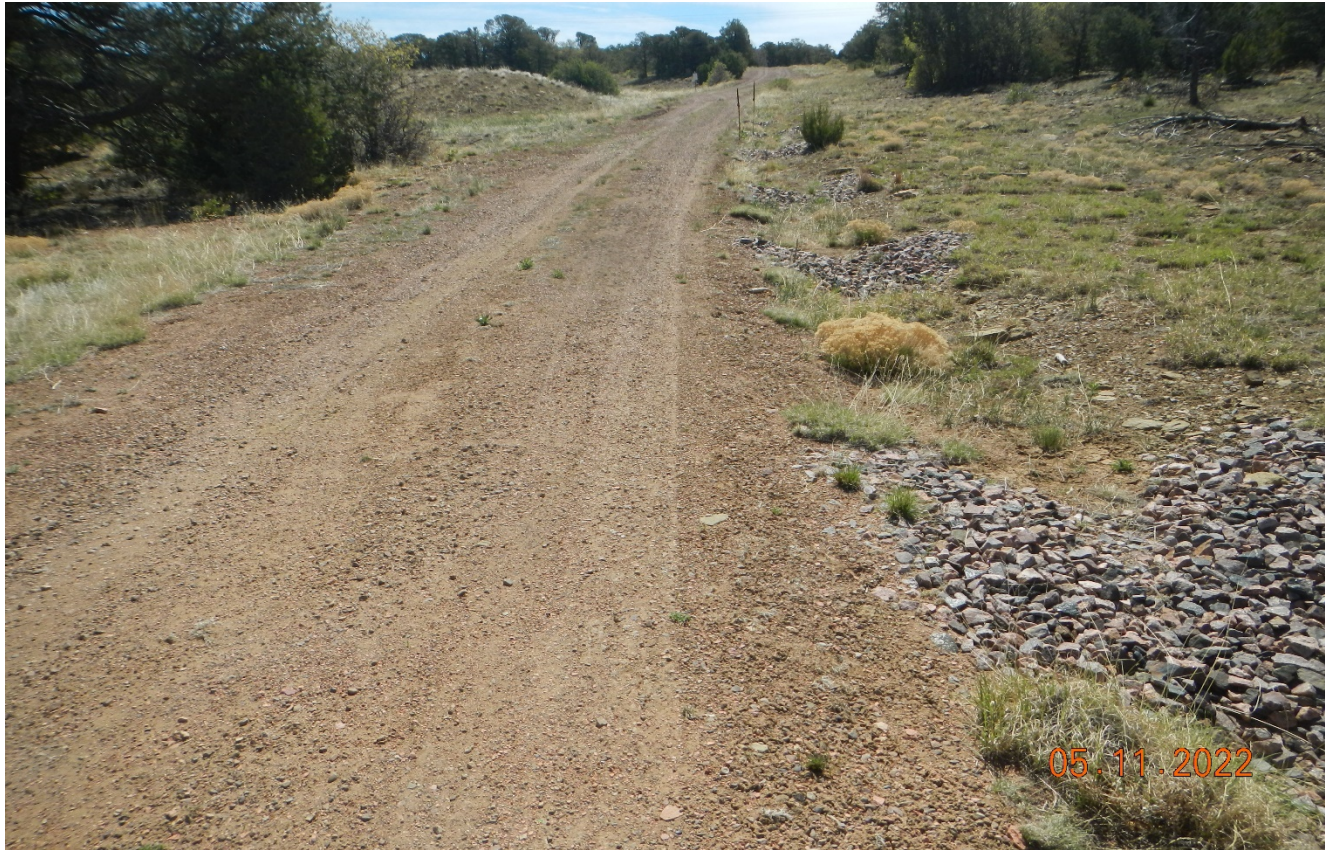
Photo 2. Facing southeast along the access road. The rock check dams along the road side appear to be controlling erosion.

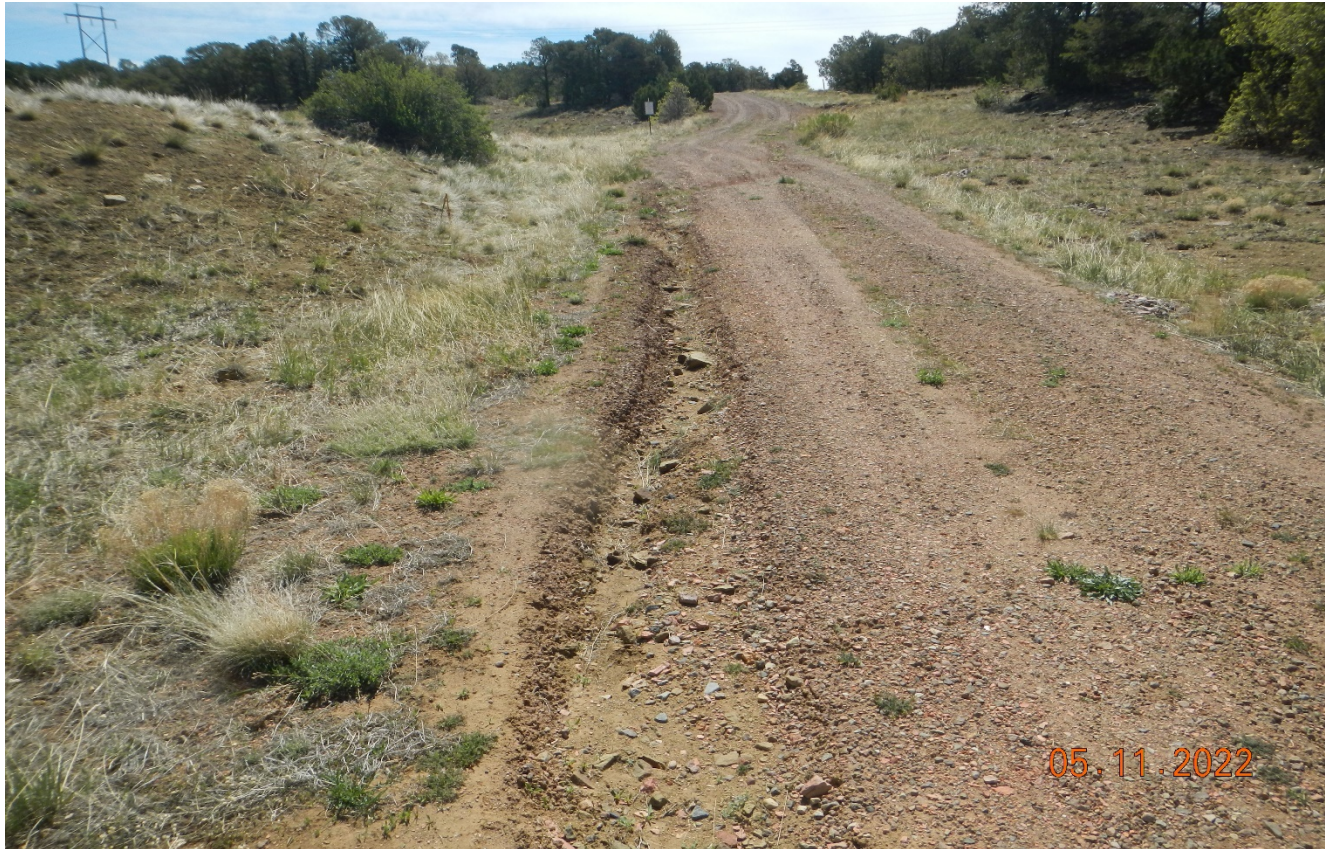
Photo 3. Facing southeast further along the access road. There is erosion occurring along the road that has not been repaired. Previous corrective action not completed.

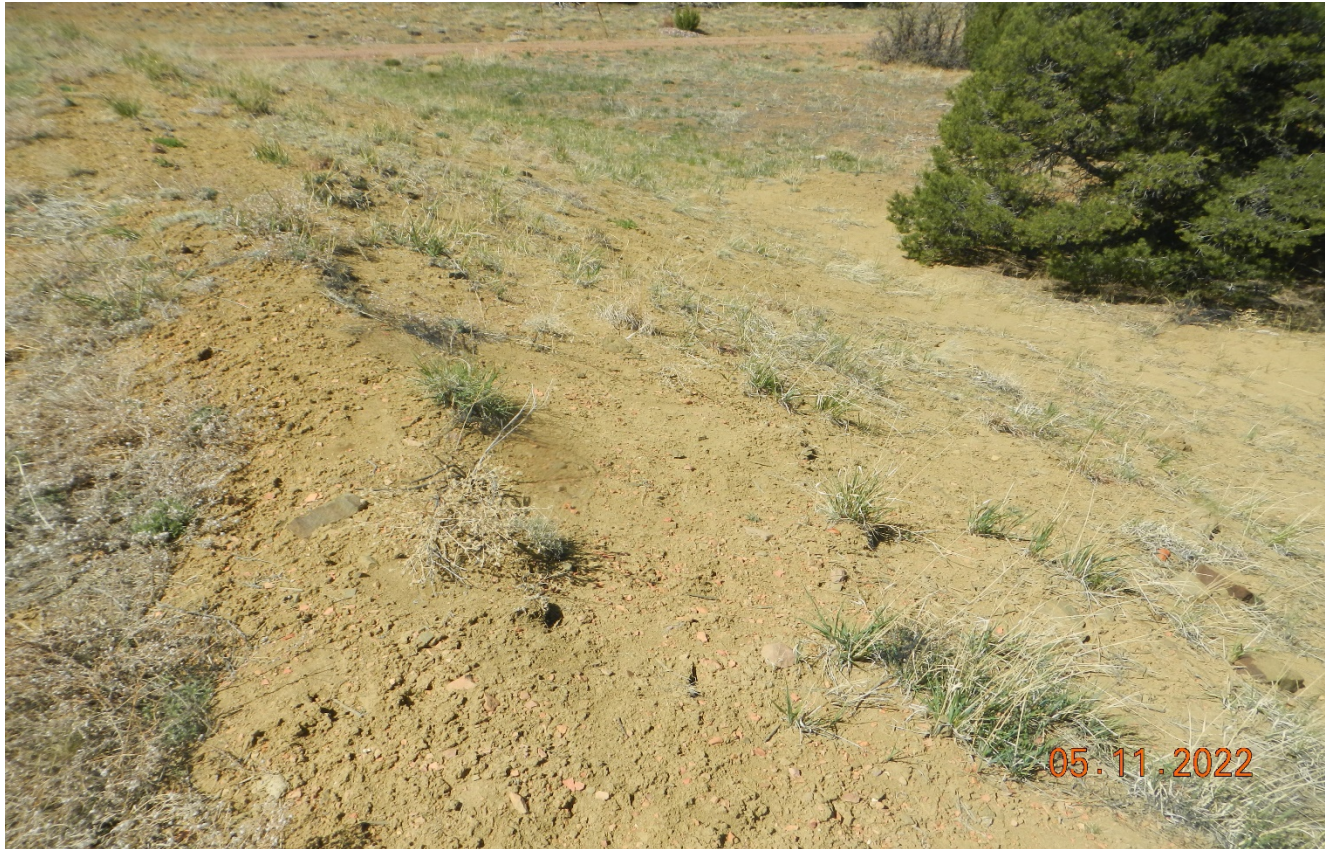
Photo 5. Facing toward the fill slope. There is sparse vegetation along the fill slope and the plastic netting still remains.

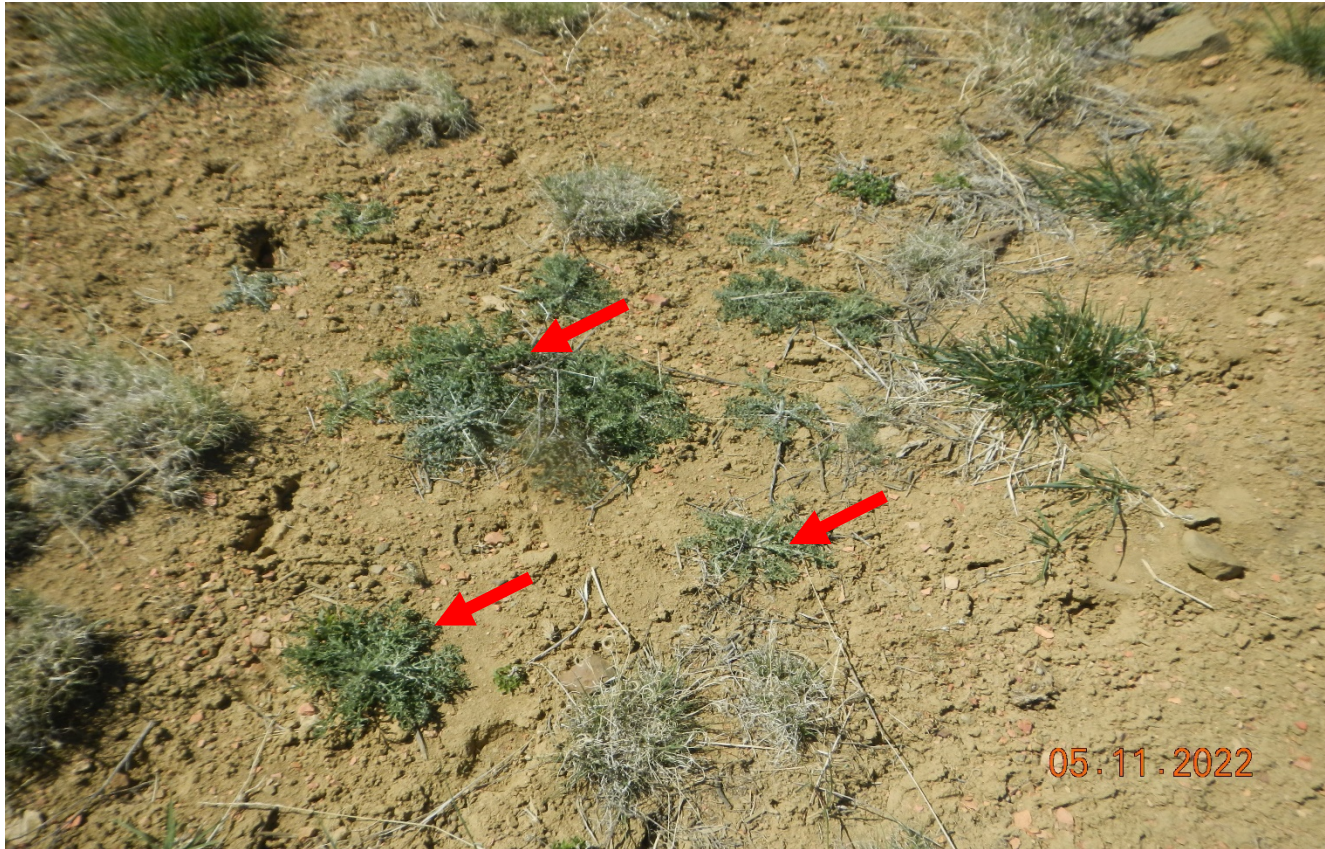
Photo 6. There are noxious weeds (Diffuse knapweed) sprouting up near the fill slope.

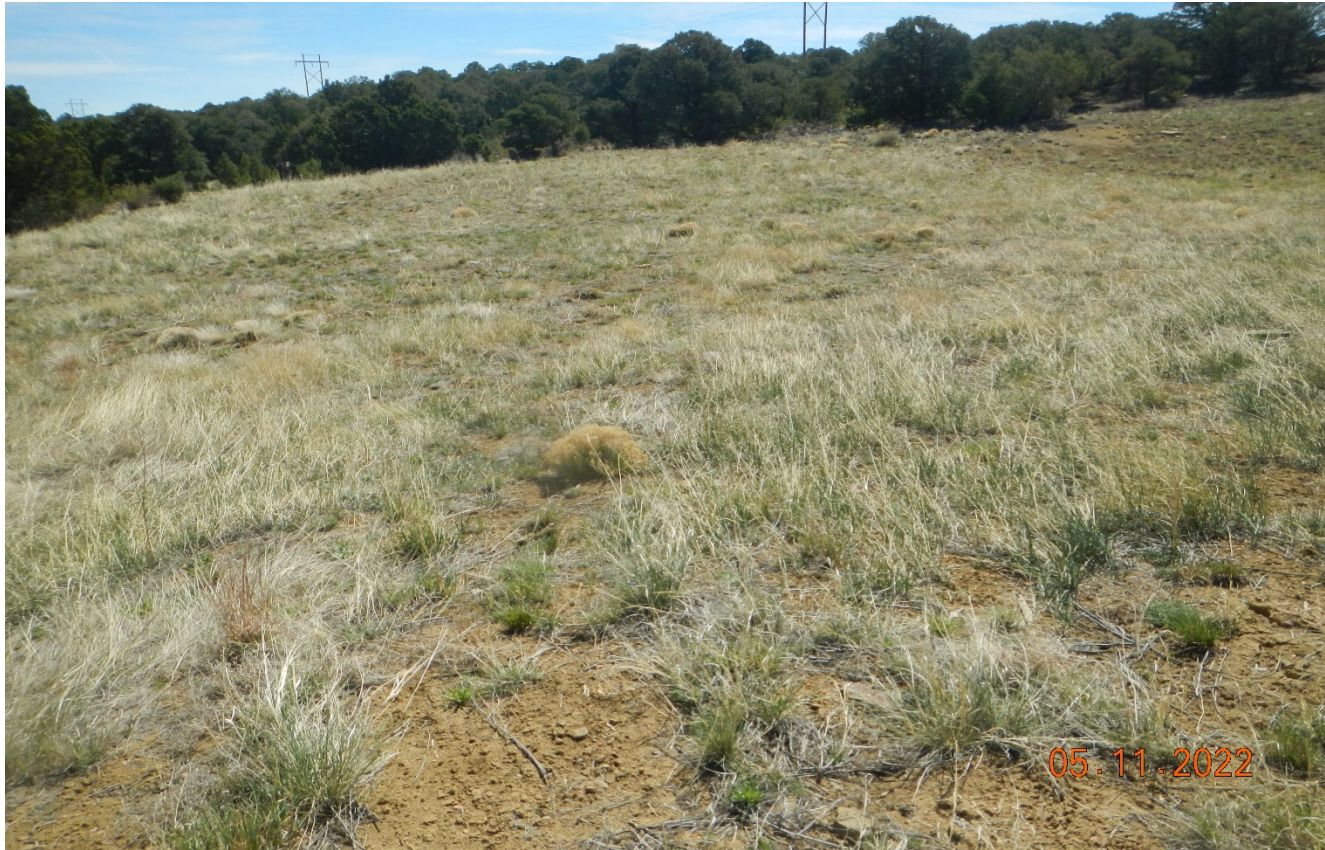
Photo 7. Facing toward the east side of the location. The vegetation is well established at the eastern portion of the location.
