Inspection Photos

5/10/2022

Operator: GORDON ENGINEERING INC -
34720

Location ID: 334074
Mesa County, CO

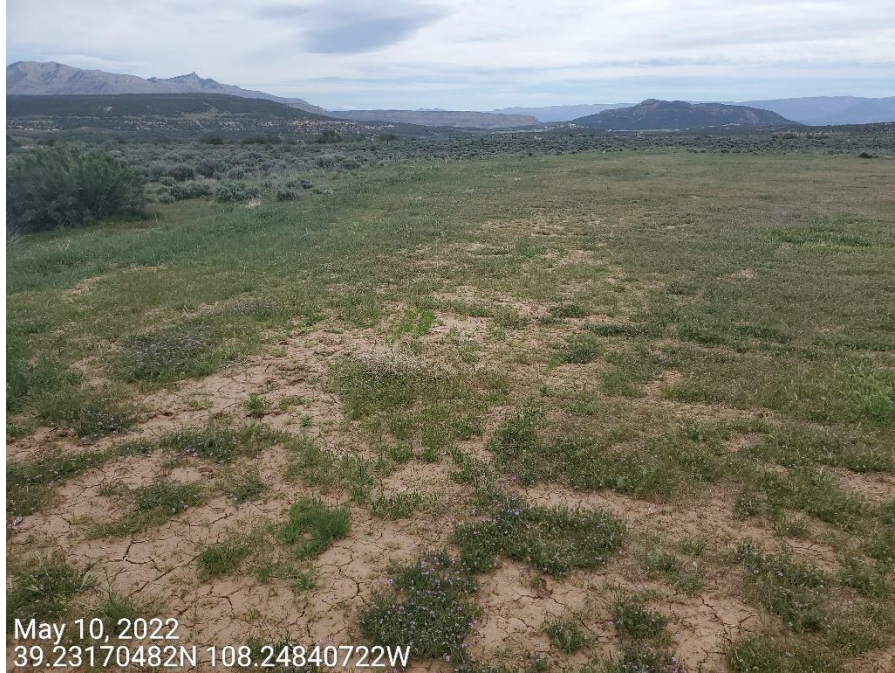
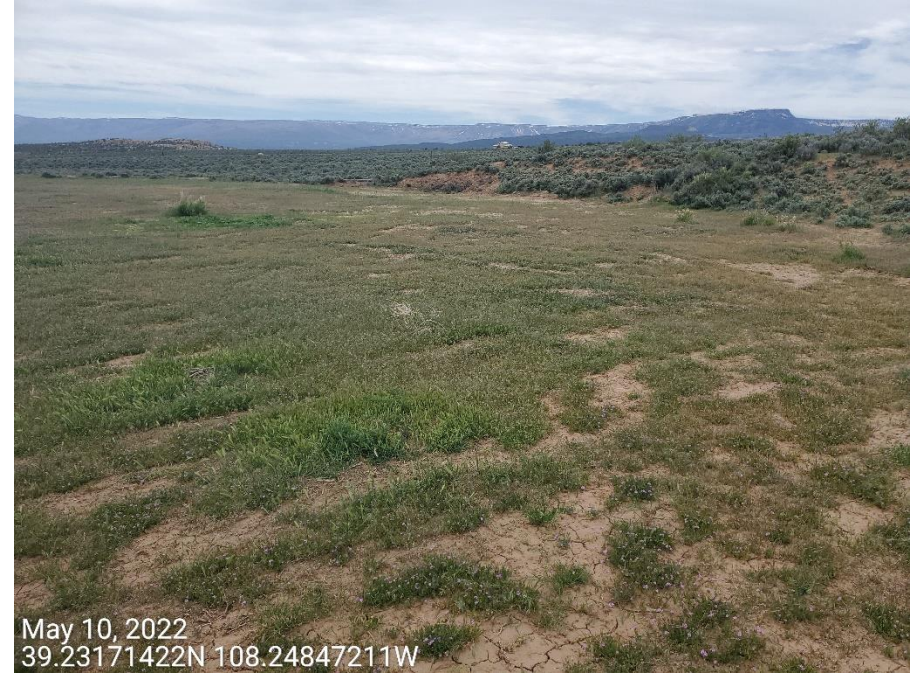
Photo 1: Photos taken from the west end of the Location, facing northeast and east. Photo provides overview of the Location. Operator appears to have conducted revegetation activities; however work including, but not limited to, compaction alleviation (cross ripping to a minimum depth of 18 inches), recontouring and regrading of the Location/access road has not been performed in accordance with 1004 reclamation requirements. Vegetation observed in photo is predominantly undesirable and noxious plant species monoculture, such as cheat grass.

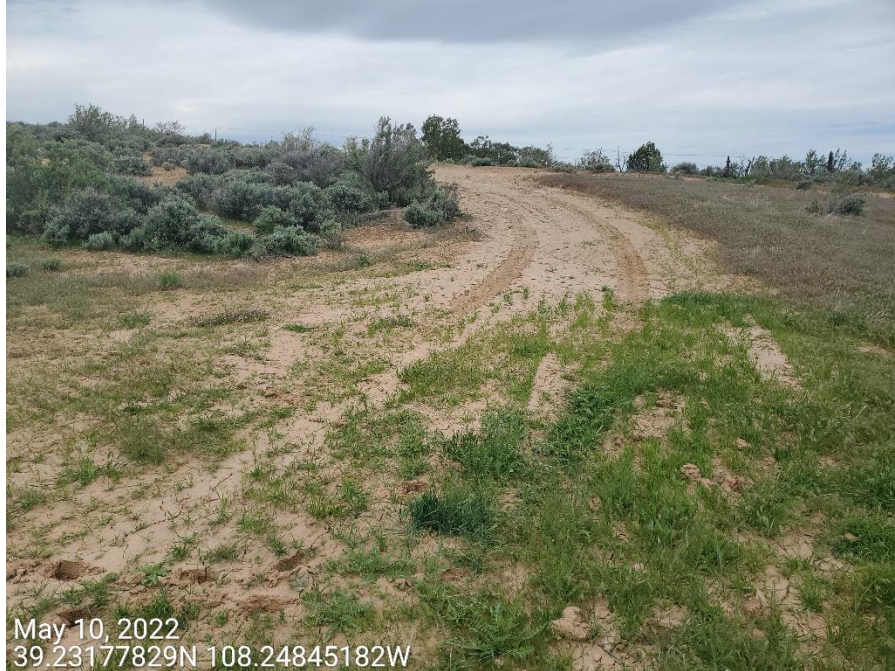
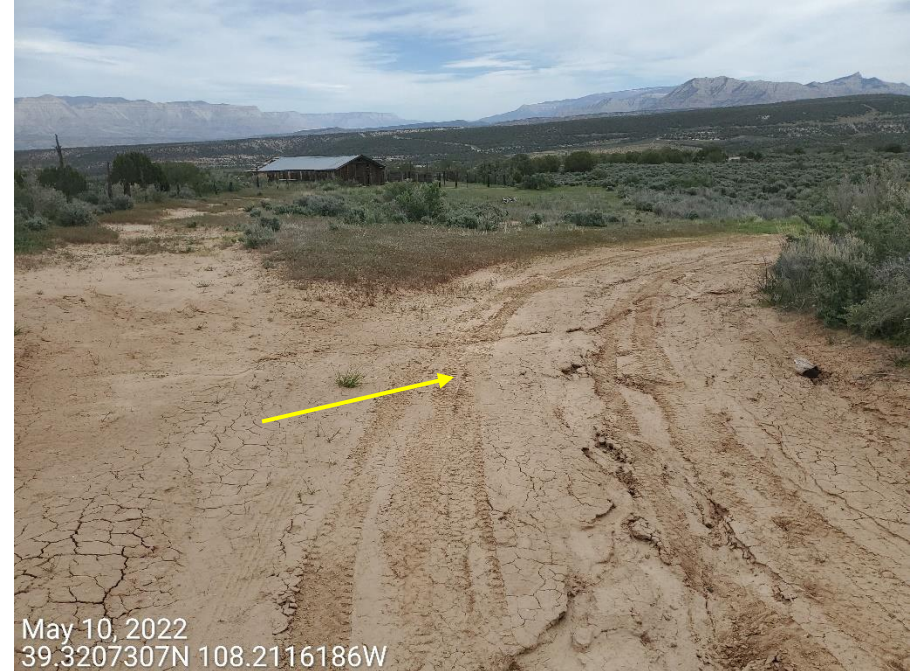
Photo 2: Photo show access road leading to location has not been reclaimed.

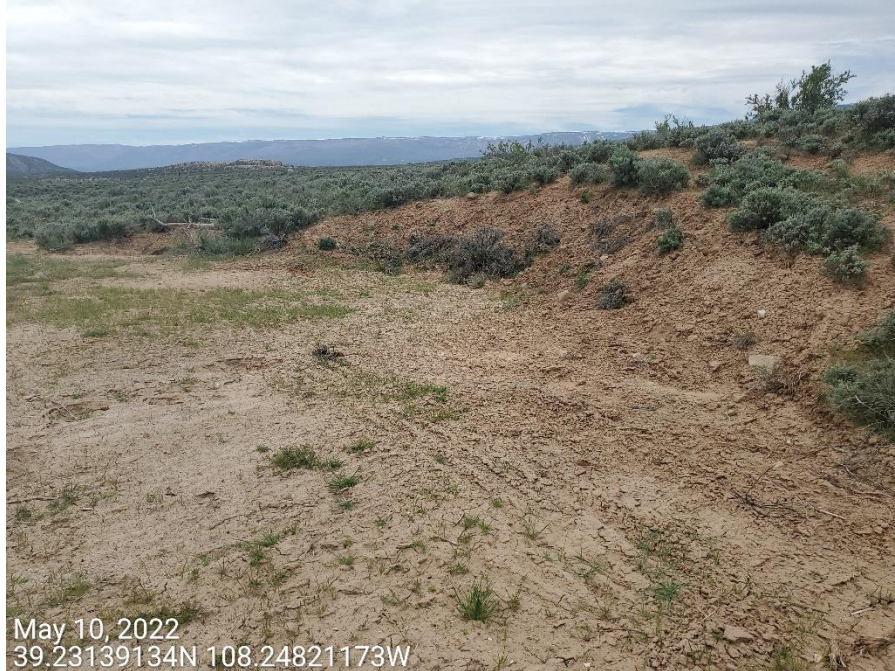
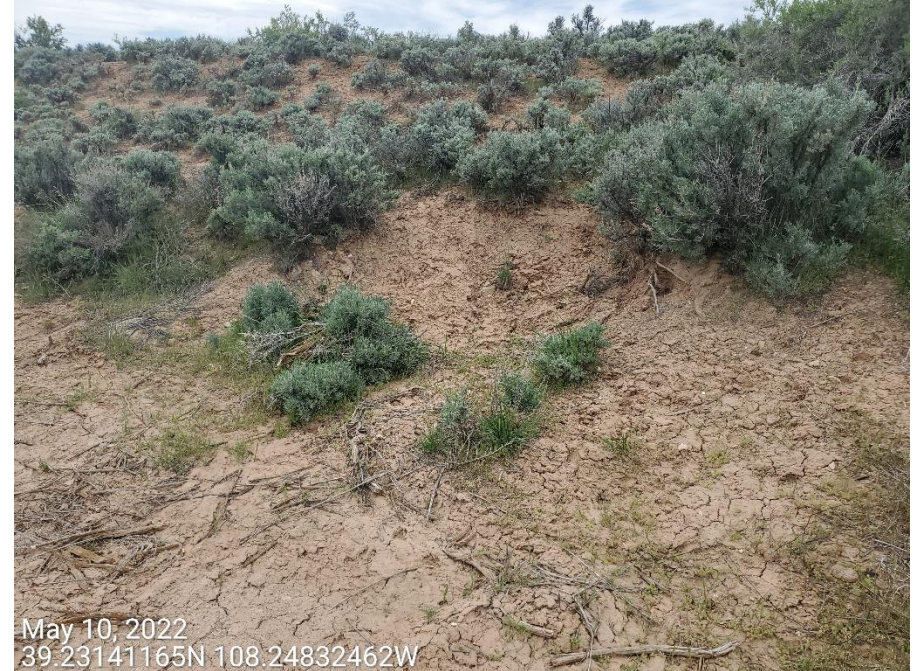
Photo 3: Photo example showing areas of the cut slope that remain evident; area appears to have been used as a “borrow area” in the past.

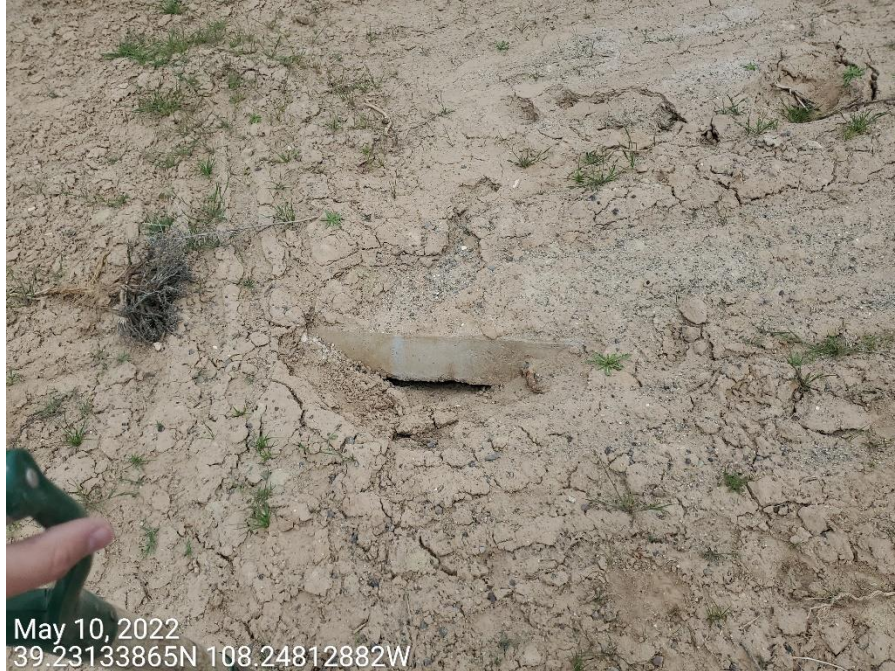
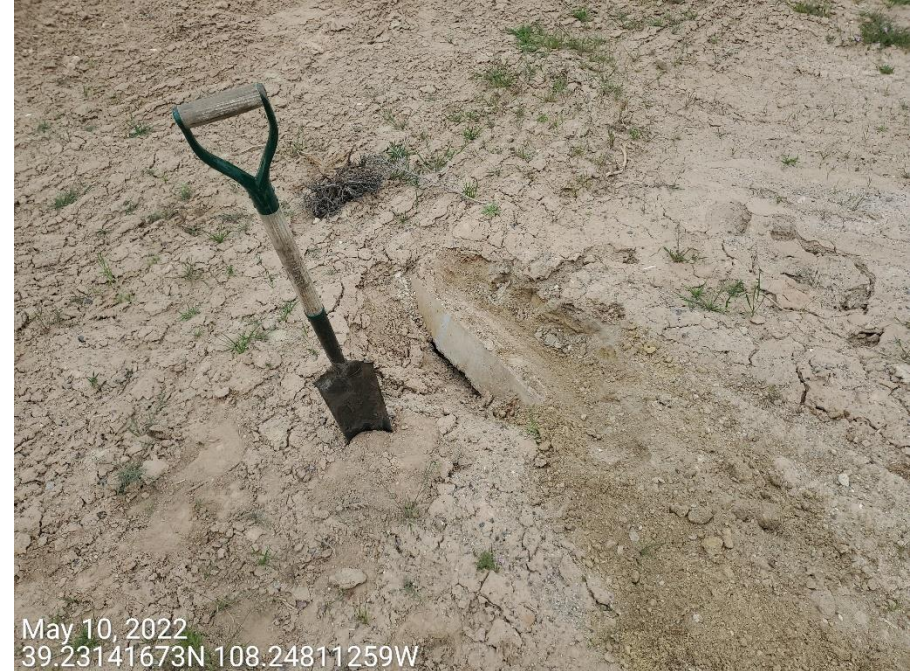
Photo 4: Photos taken from the south end of the Location. Photo shows Operator has buried concrete blocks on Location; this improper disposal of non-E&P waste, and is prohibited pursuant to Rule 906.d.

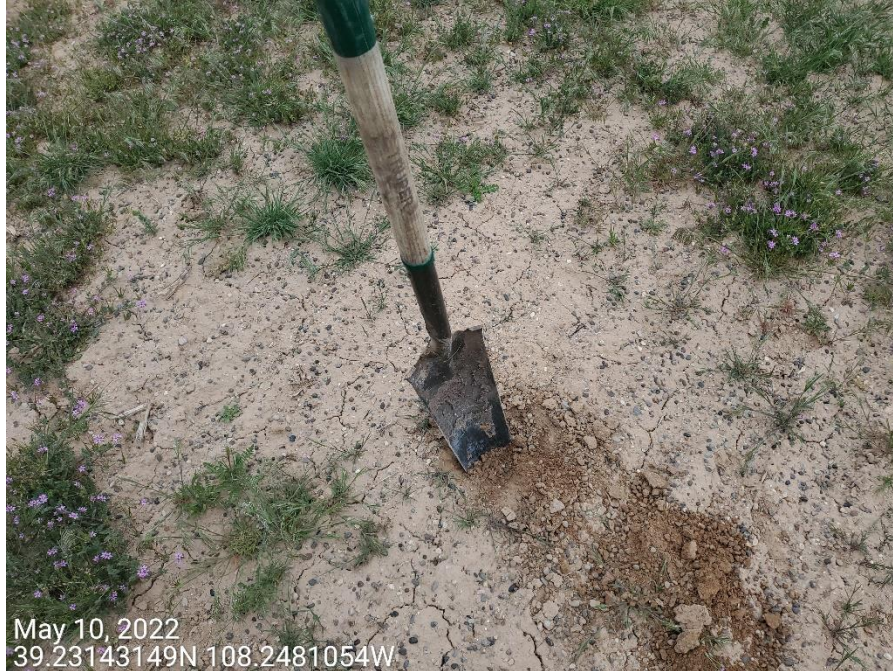
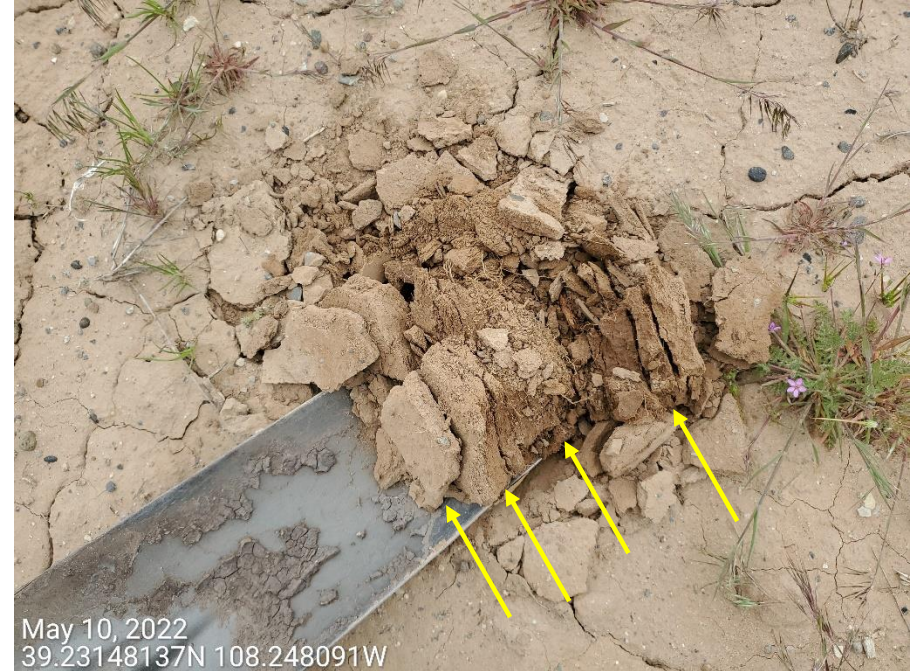
Photo 5: Photo shows compaction issues evident on Location; reclamation specialist attempted to conduct a test-pit, and was only able to easily penetrate the first few inches of soil.

Photo right shows “platy” soil structures. These structures are thin, flat plates of soil that lie horizontally and are usually found in compacted soils.

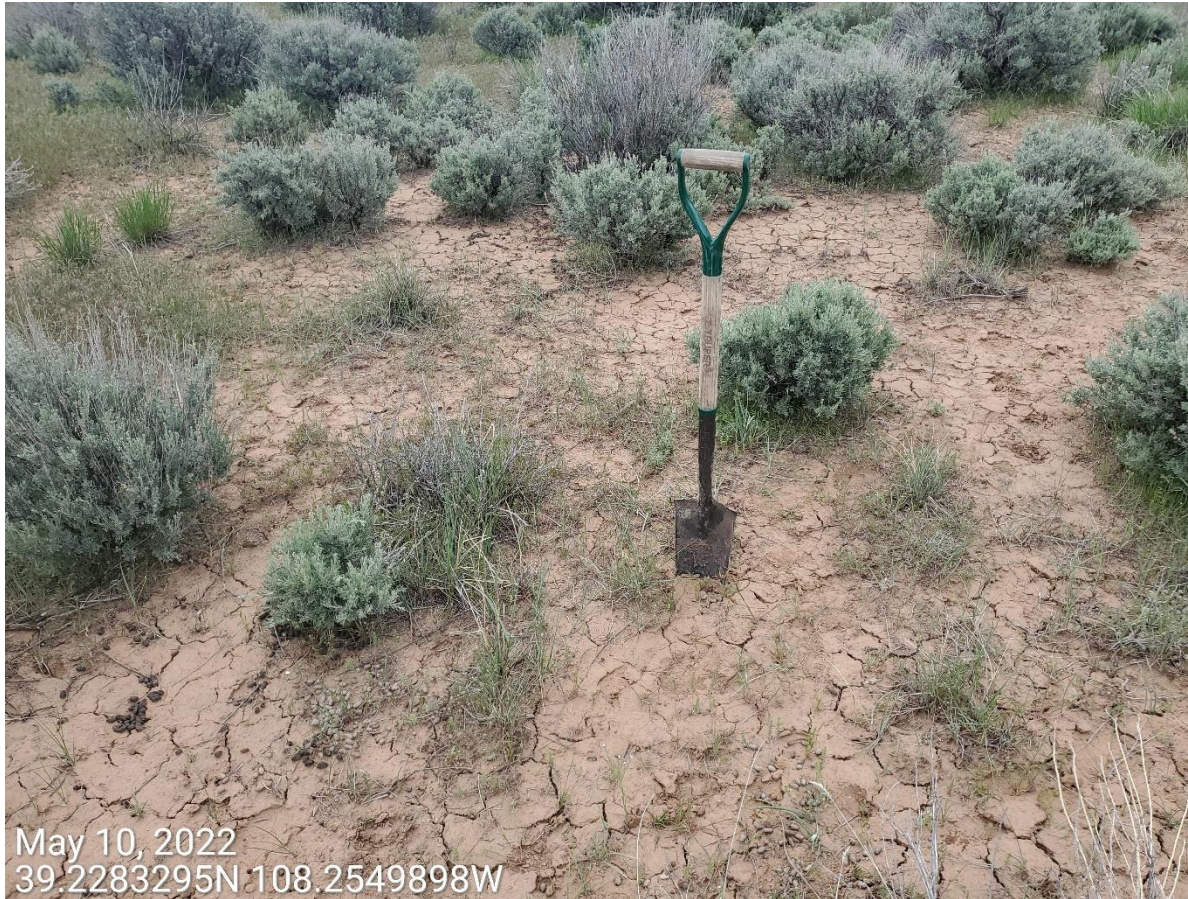
Photo 6: Photo taken from the adjacent reference area, to compare to the observed compaction concerns on Location. Photo shows reclamation specialist was able to easily penetrate approximately 10 inches of soil on the reference.
