Final Reclamation Inspection

Operator: KERR MCGEE OIL & GAS ONSHORE LP #47120

Location ID: 149021

Inspection Document #: 697503939

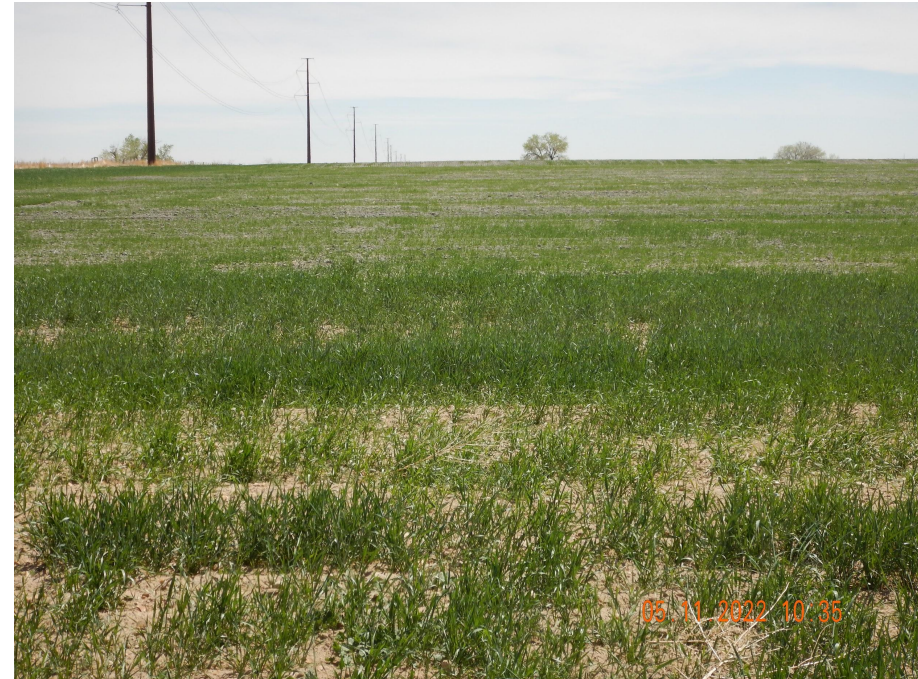
Photo 2. Photo taken from the northwestern DFMF #1 (Pod 1A), facing East. Photo illustrates the establishment of winter wheat. There appears to be better establishment along the perimeter where there was a berm BMP.

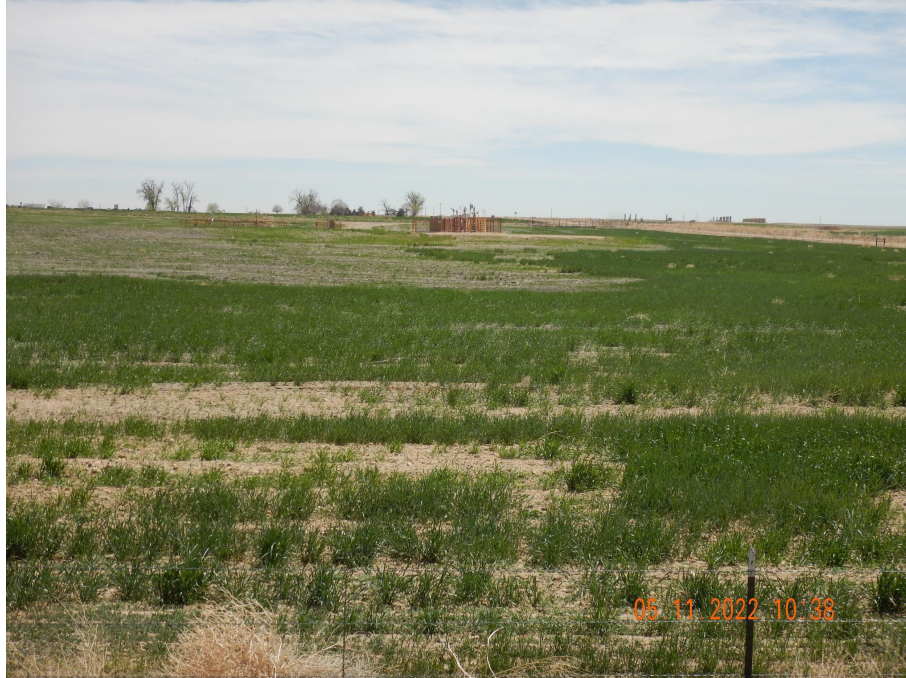
Photo 3. Photo taken from the southwestern DFMF #1 (Pod 1D), facing East. See comments under Photo 2.

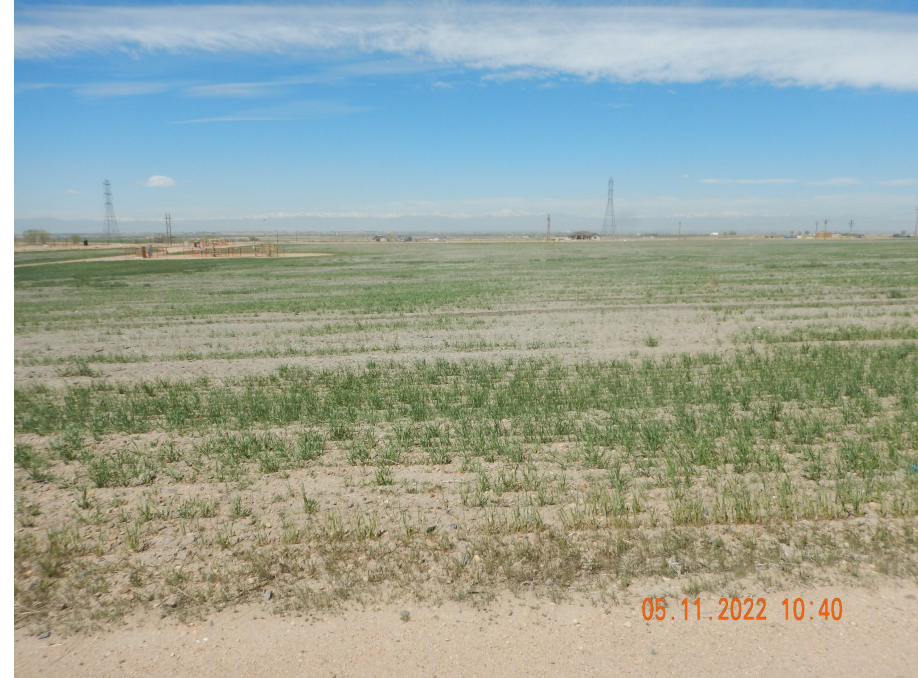
Photo 4. Photo taken from the southwestern DFMF #1 (Pod2D), facing West. See comments under Photo 2.

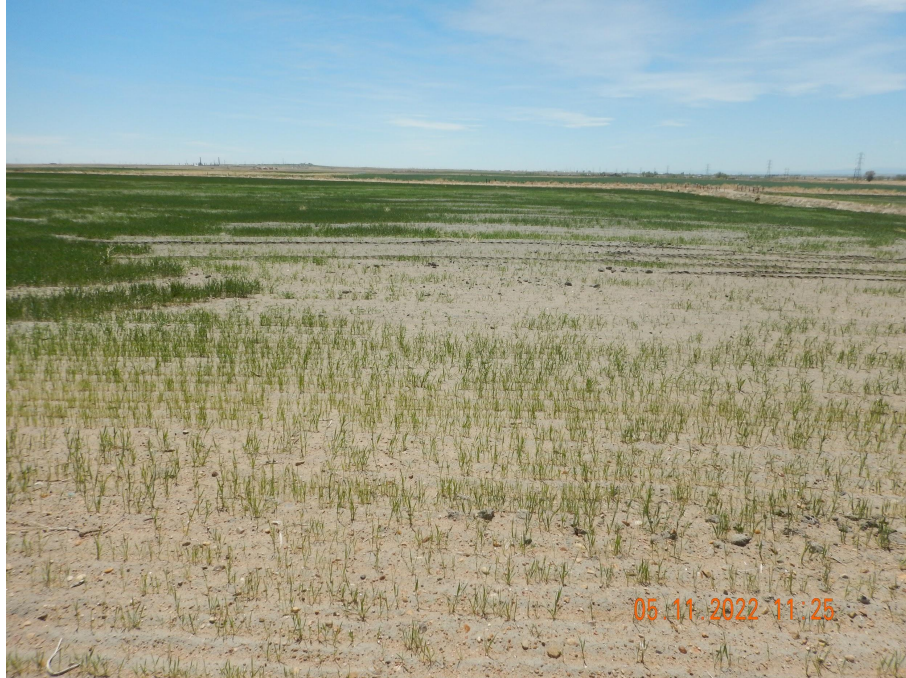
Photo 5. Photo taken from the southern DFMF #1 (Pod3D), facing South. See comments under Photo 2.

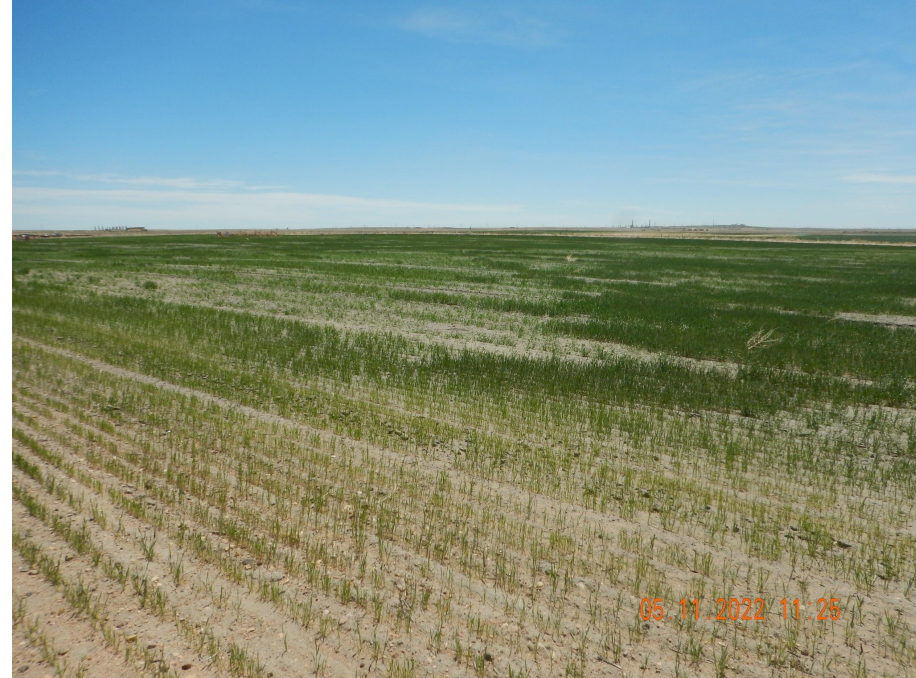
Photo 6. Photo taken from the southern DFMF #1 (Pod 3D), facing Southeast. See comments under Photo 2.

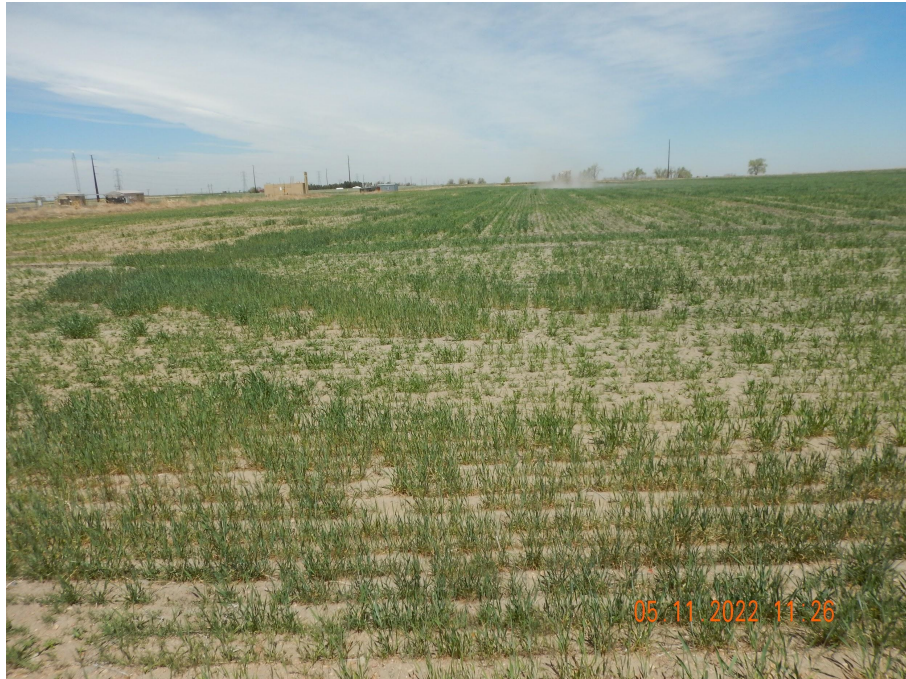
Photo 7. Photo taken from the southern DFMF #1 (Pod3C), facing North. See comments under Photo 2.

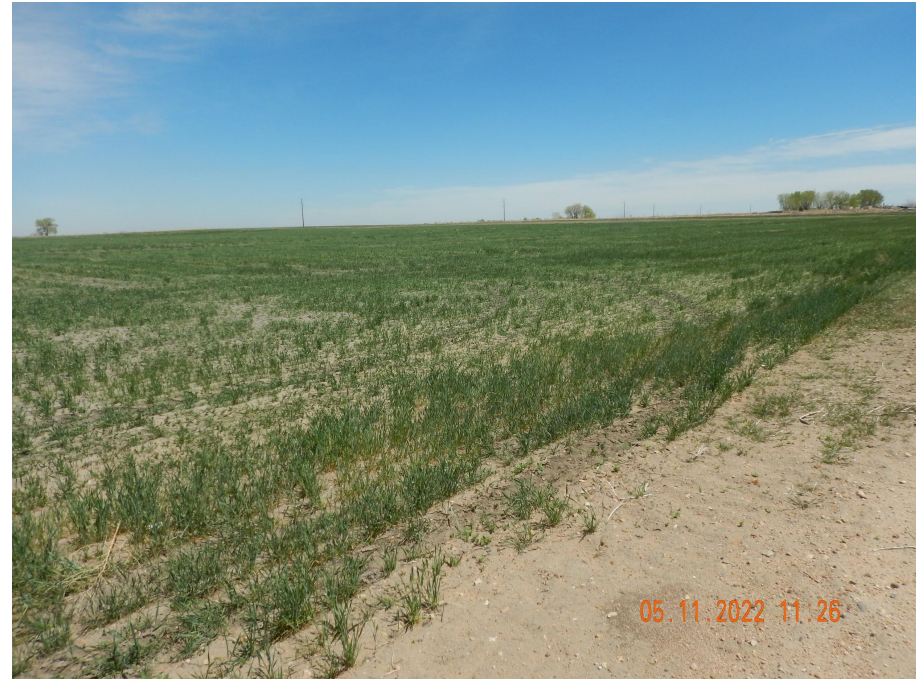
Photo 8. Photo taken from the southern DFMF #1 (Pod3C), facing Northeast. See comments under Photo 2.

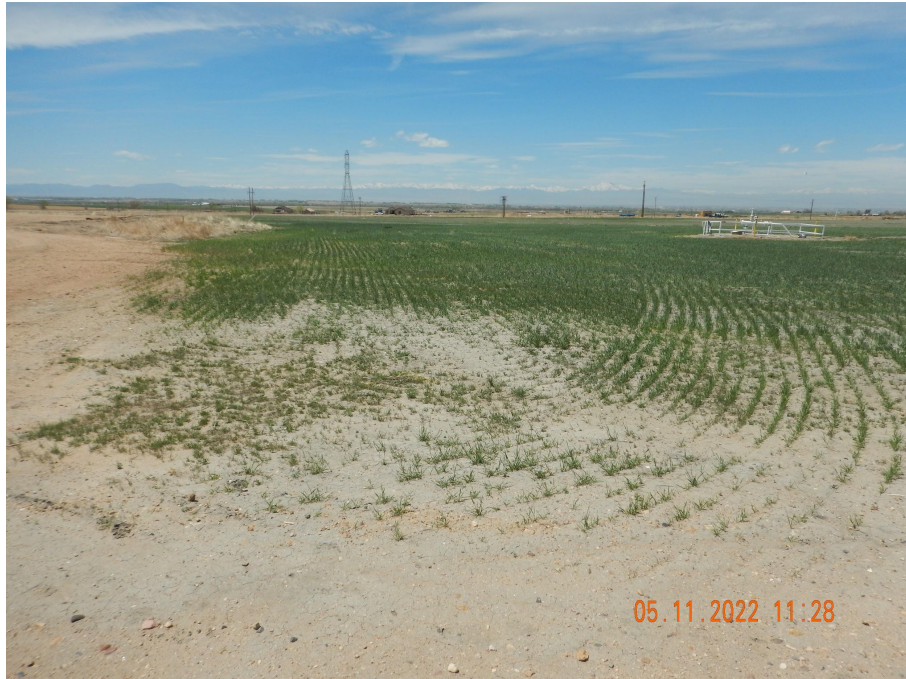
Photo 9. Photo taken from the central DFMF #1 (Pod2C), facing West. See comments under Photo 2.

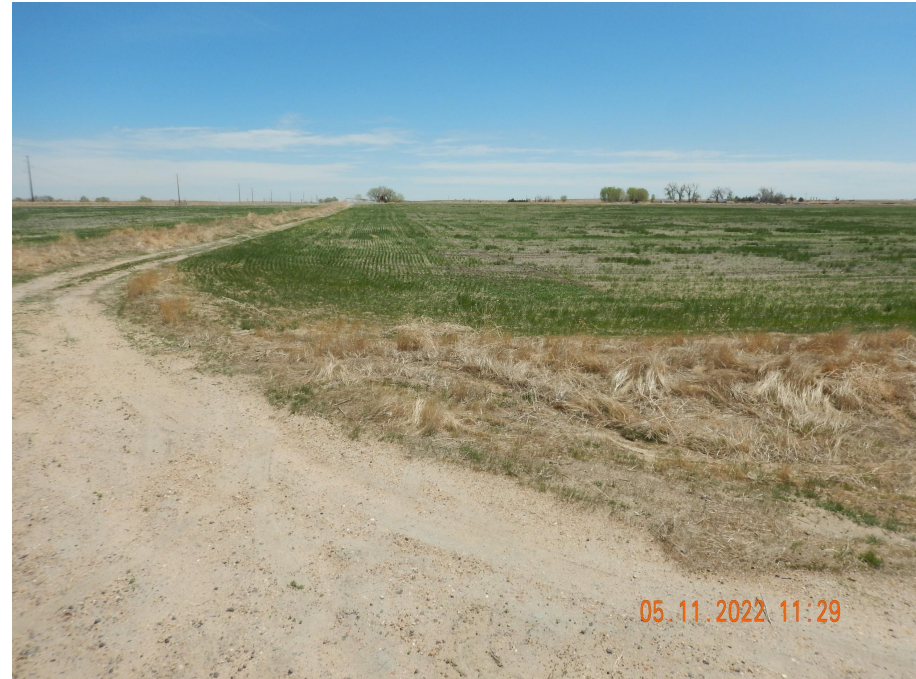
Photo 10. Photo taken from the central DFMF #1 (Pod3B), facing East. See comments under Photo 2.

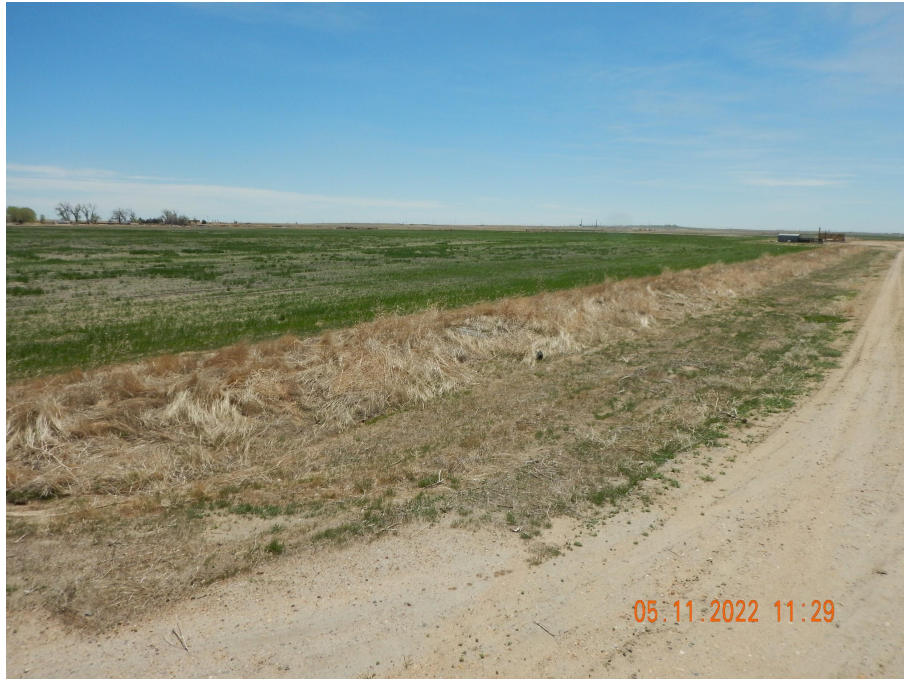
Photo 11. Photo taken from the northcentral DFMF #1 (Pod3A), facing Northeast. See comments under Photo 2.

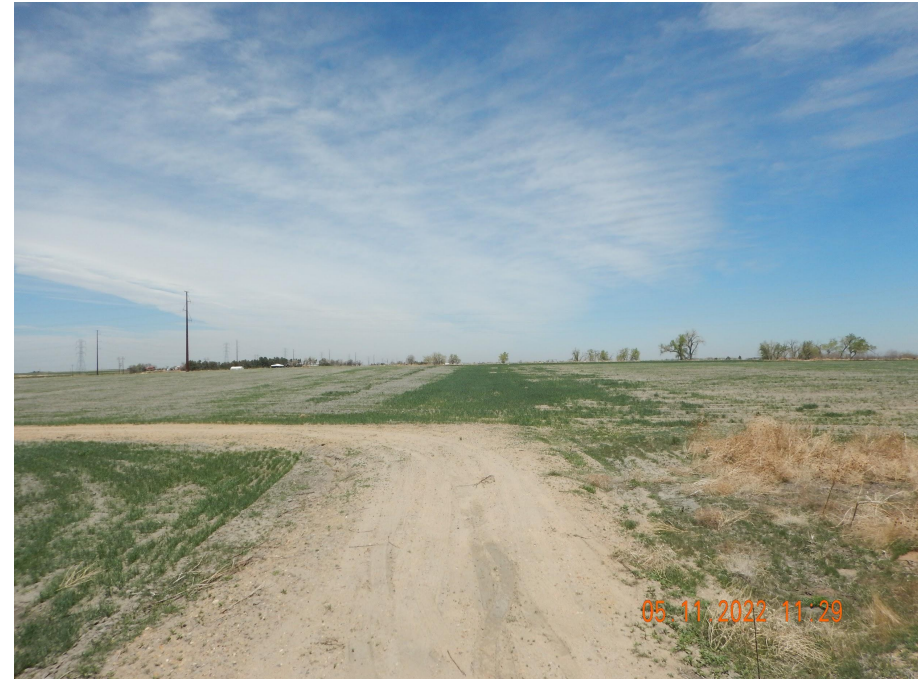
Photo 12. Photo taken from the northcentral DFMF #1 (Pod2A), facing North. See comments under Photo 2.

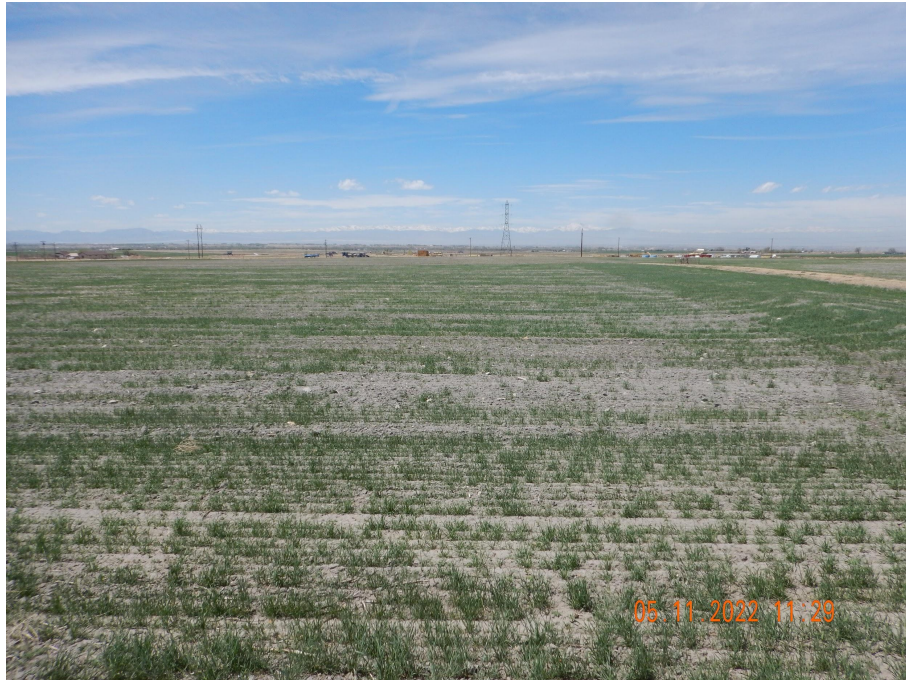
Photo 13. Photo taken from the northcentral DFMF #1 (Pod2B), facing West. See comments under Photo 2.

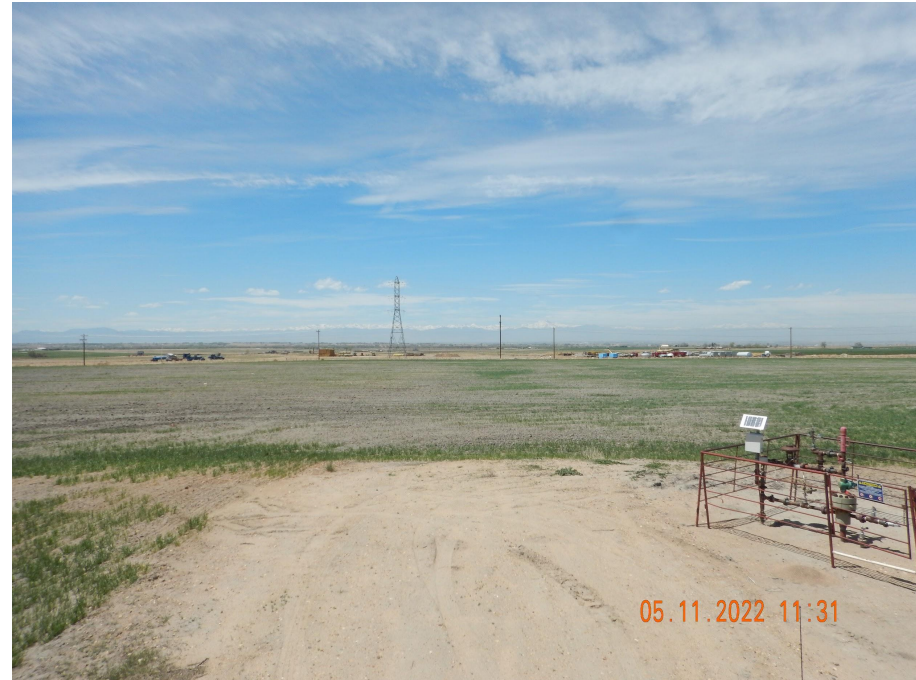
Photo 14. Photo taken from the northwestern DFMF #1 (Pod1B and Pod1A), facing West. See comments under Photo 2.

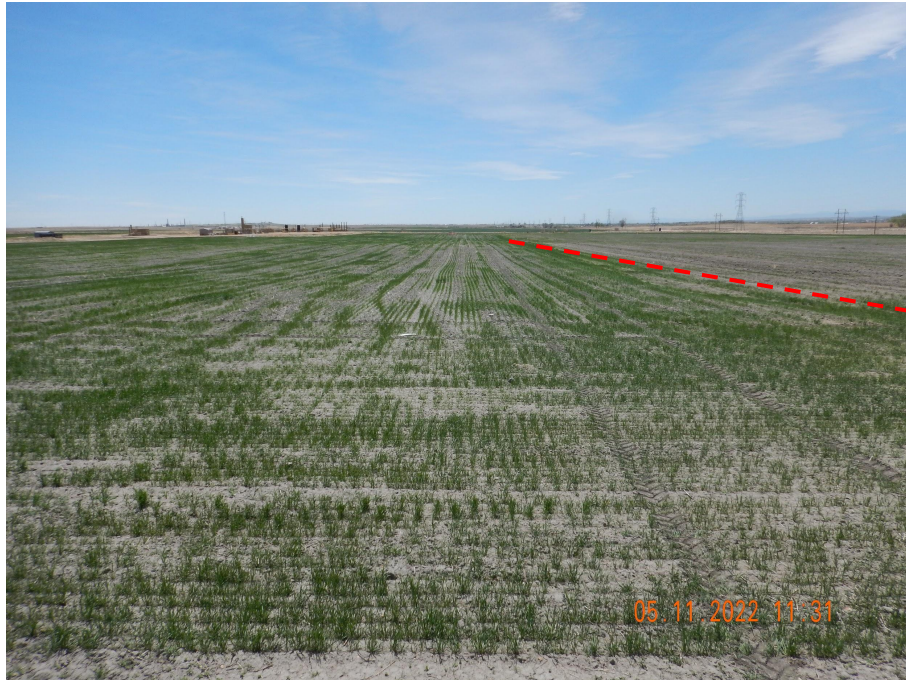
Photo 15. Photo taken from the northwestern DFMF #1 (Pod2B left of red-dashed line and Pod1B right of line), facing South. See comments under Photo 2.

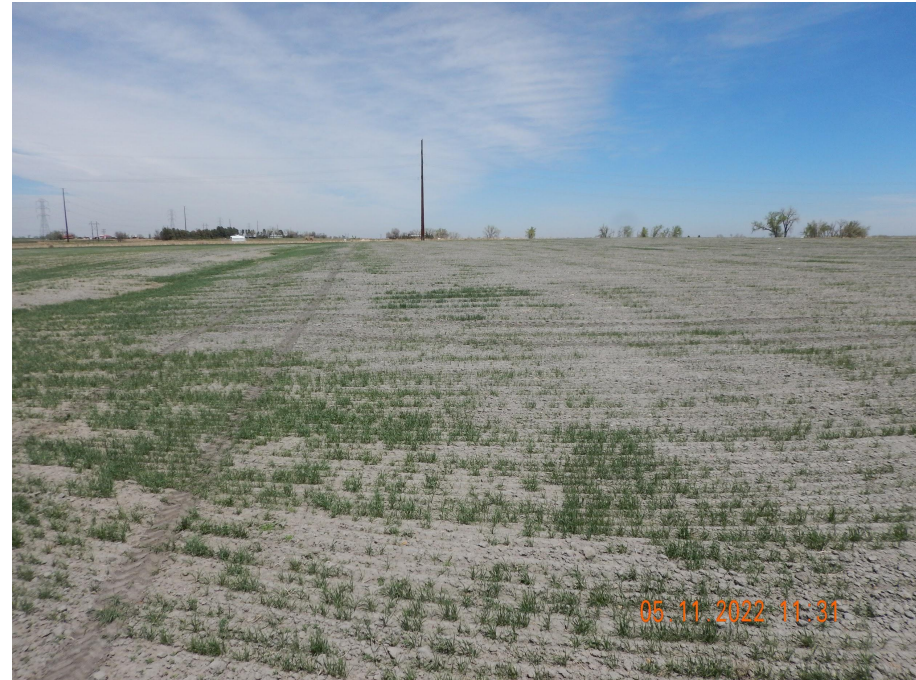
Photo 16. Photo taken from the northwestern DFMF #1 (Pod2A), facing North. See comments under Photo 2.
