Inspection Photos
Operator: Enduring
API: 067-07864
Date: 5/13/2022

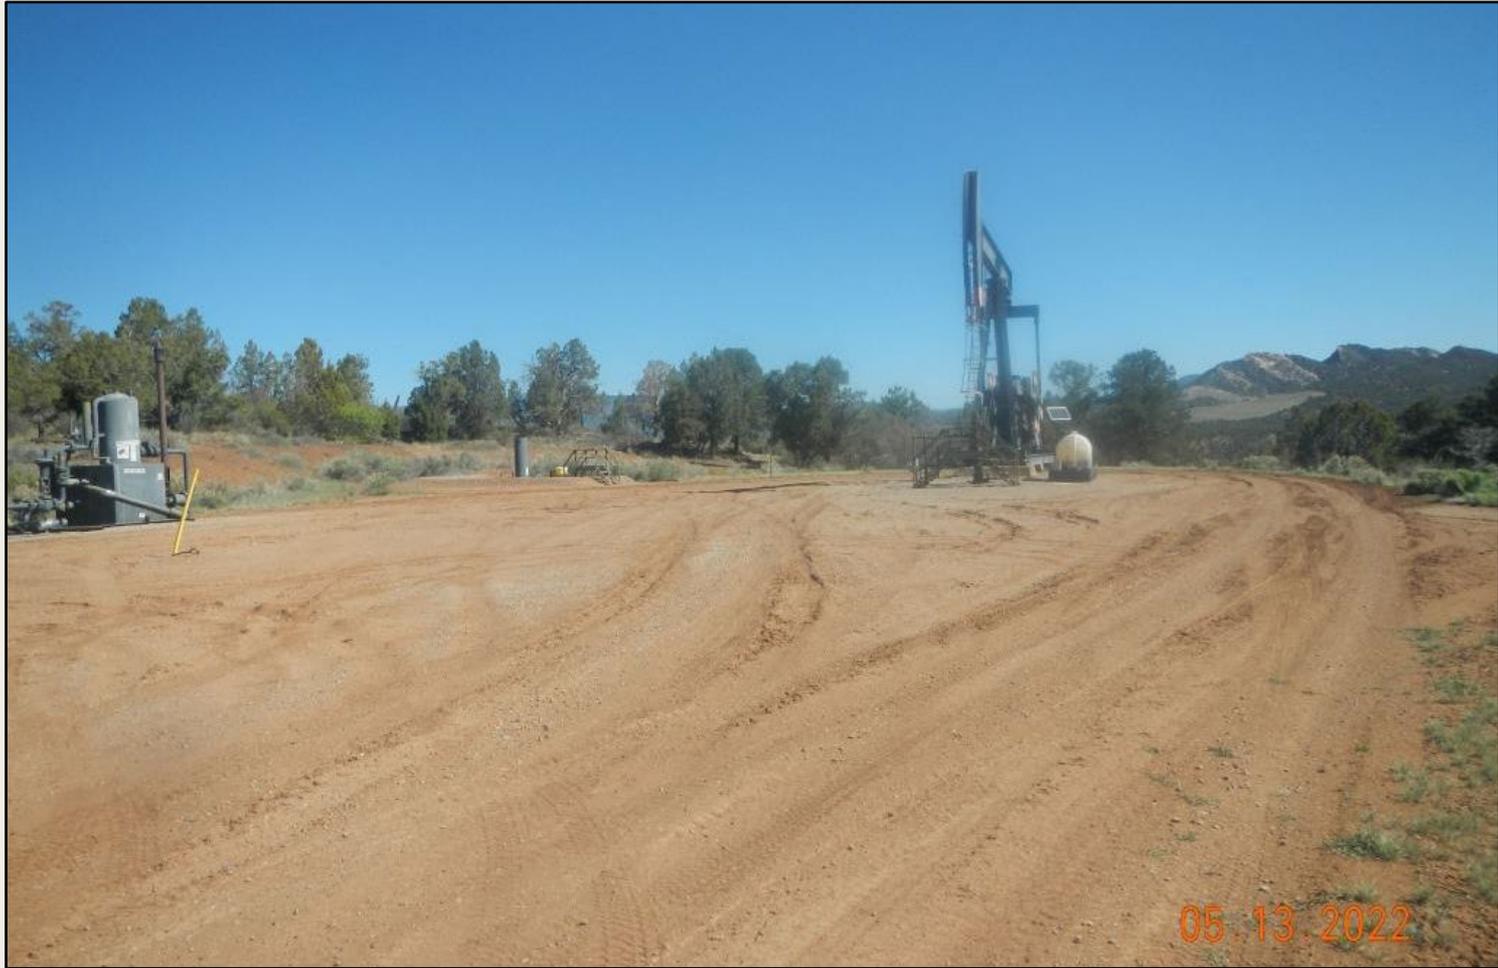
Photo 1. View of the project area from the well pad entrance facing center.

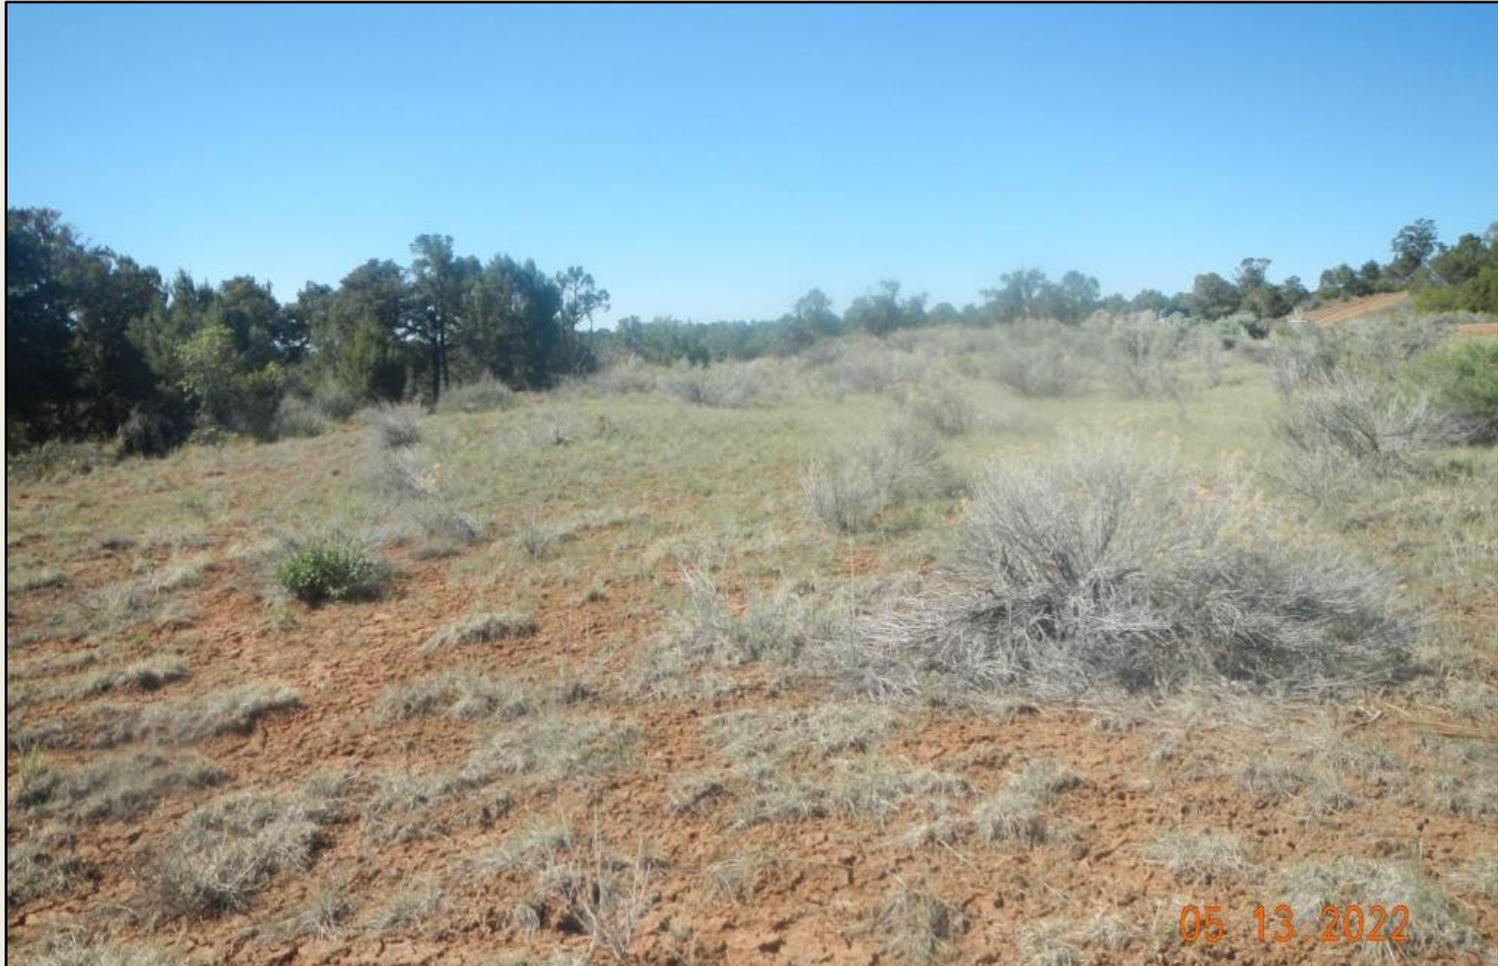
Photo 2. View of the eastern fill slope from the northeastern corner facing southward. Revegetation is progressing with western wheatgrass, rubber rabbitbrush, blue grama, sand dropseed, and Indian ricegrass.

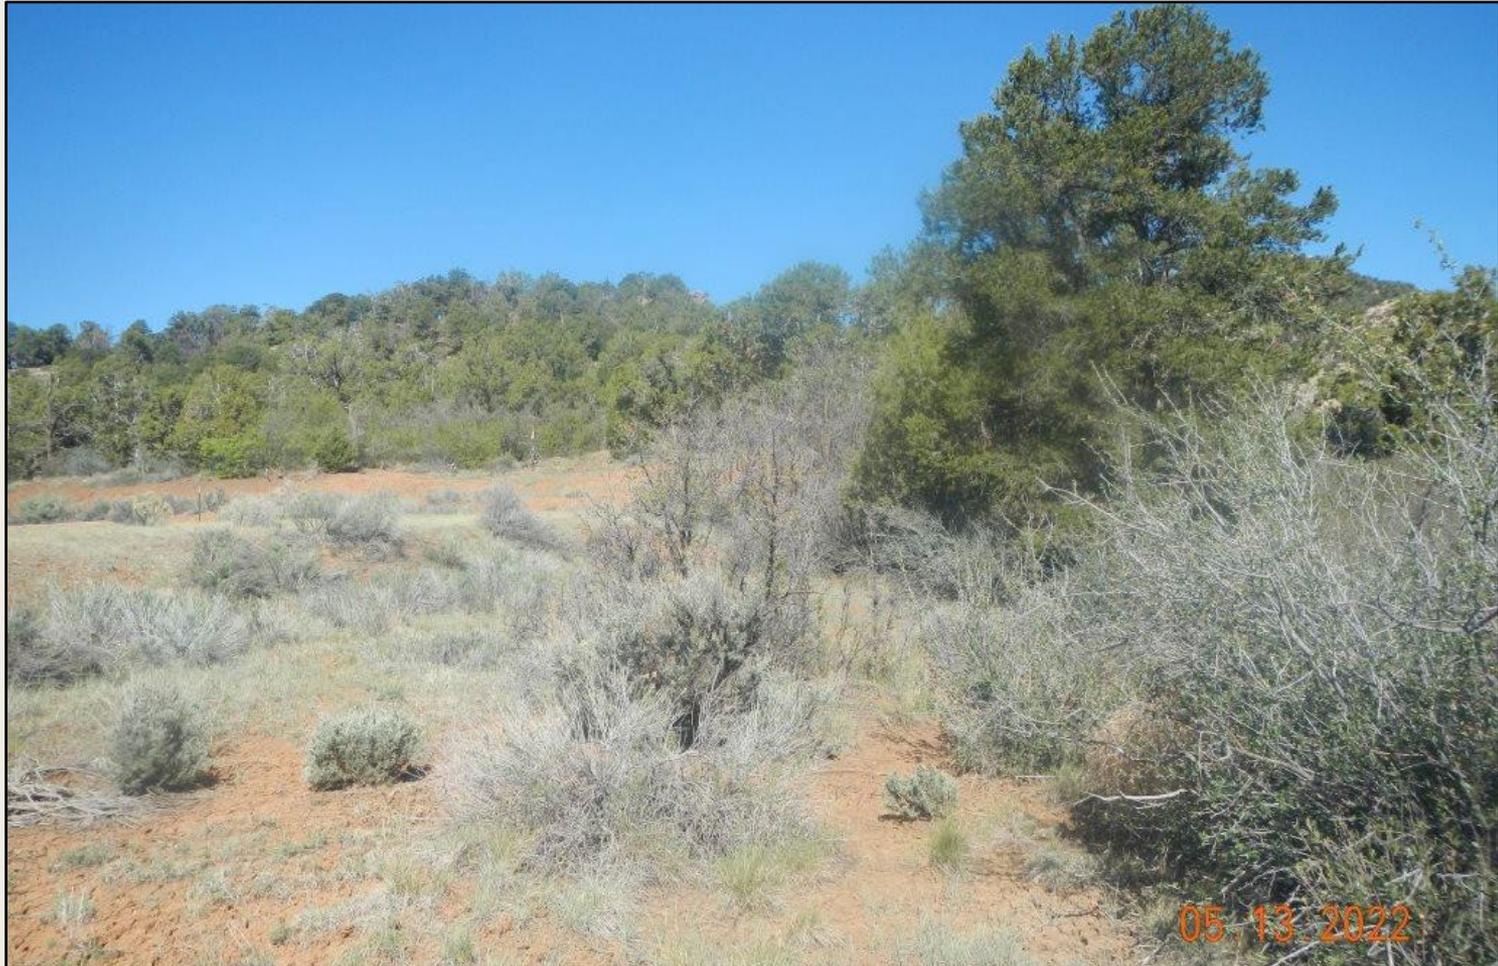
Photo 3. View of the northern project area from the northeastern corner facing westward.

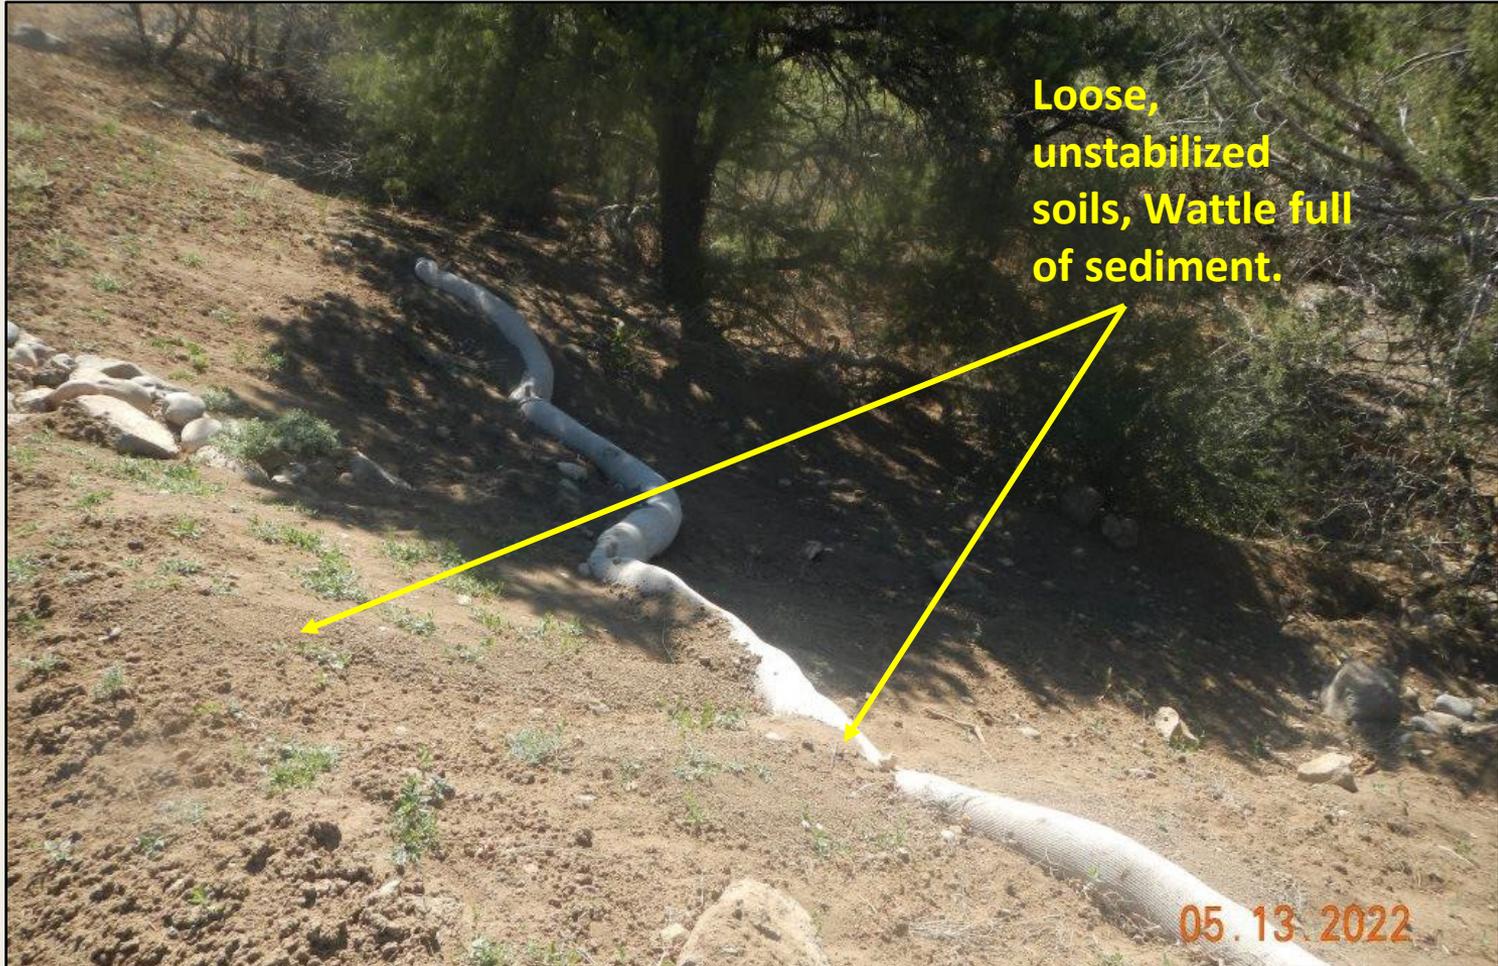
Photo 4. View of wattles down-slope from access road full of sediment and not functioning. Soils on slope are not stabilized.

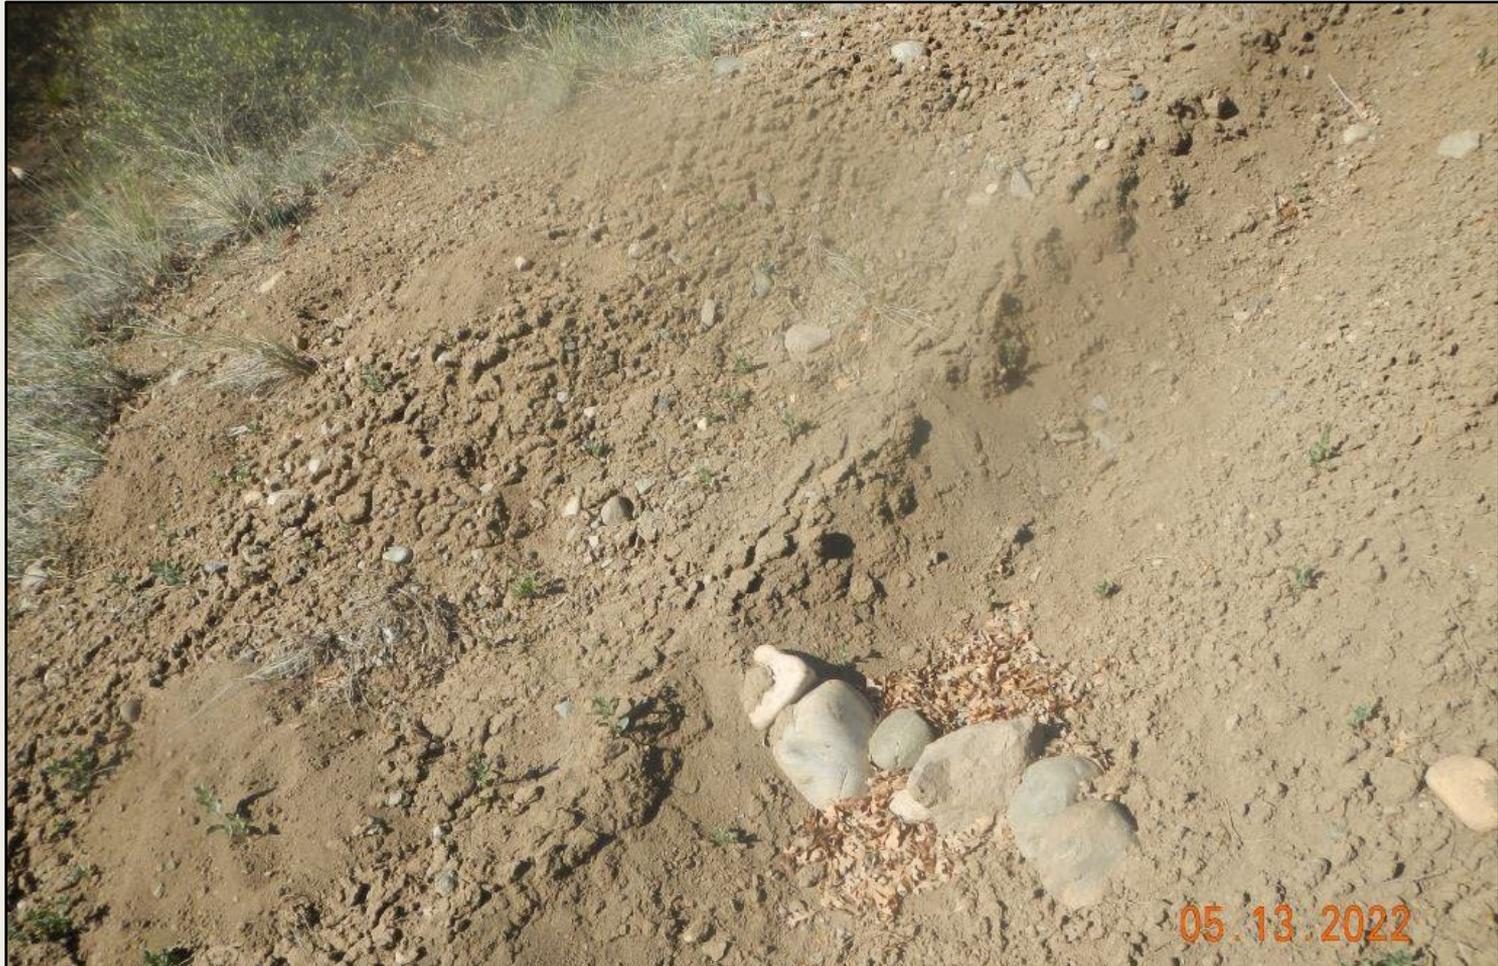
Photo 5. View of cobble installed along roadside surrounded by loose soils. This is not an appropriate nor adequate BMP to reduce stormwater erosion.

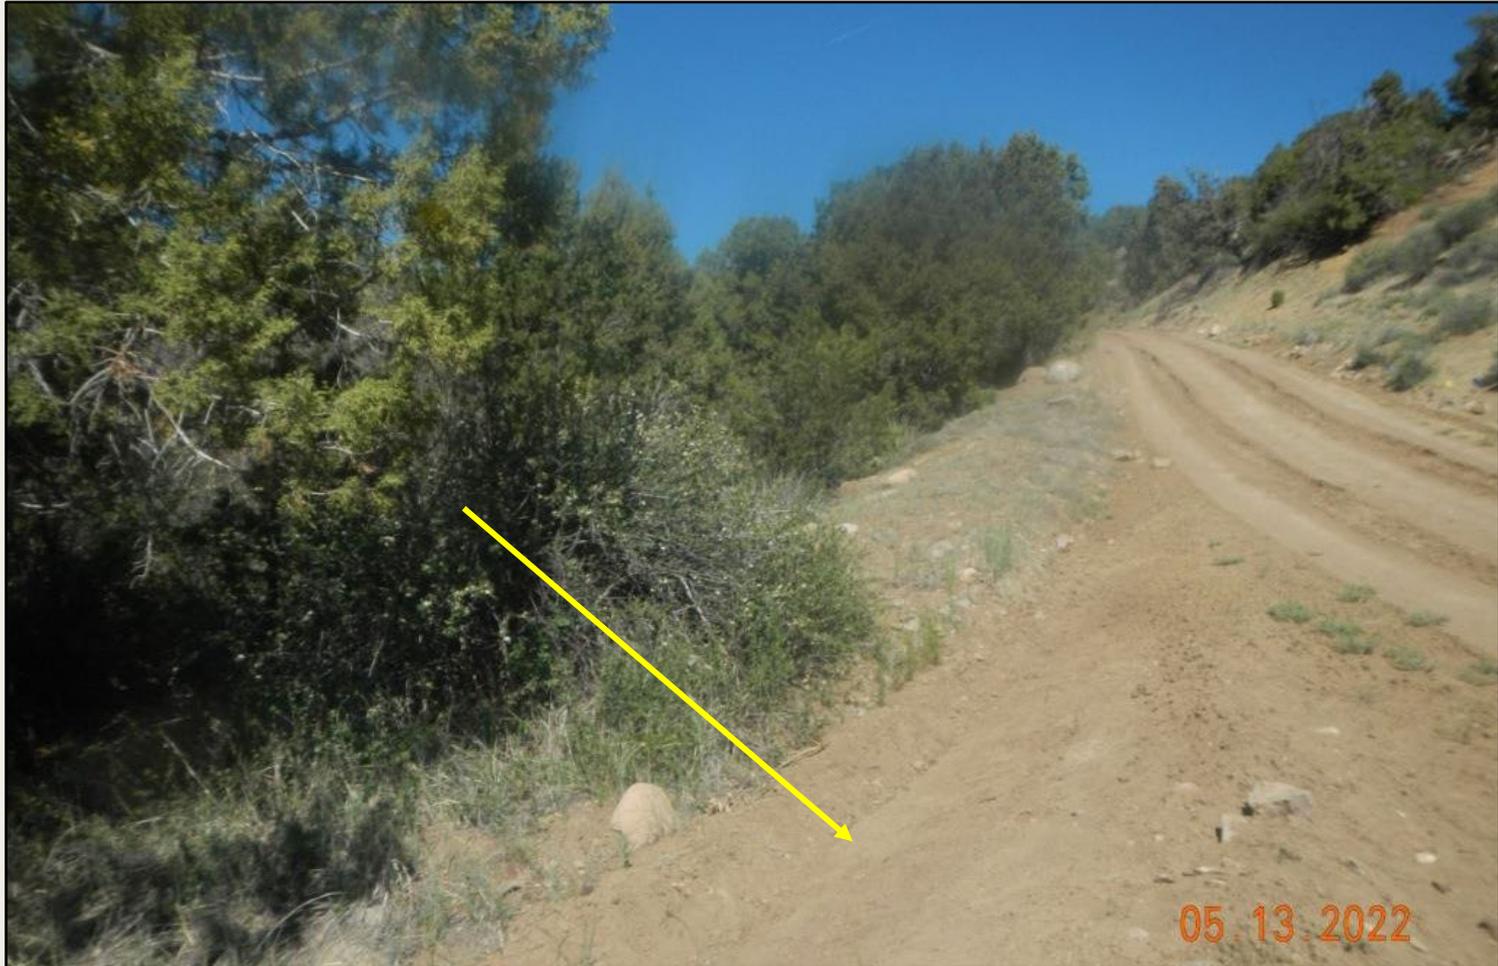
Photo 6. View of unstabilized turnout (yellow arrow) with loose soils and stormwater BMPs not present.

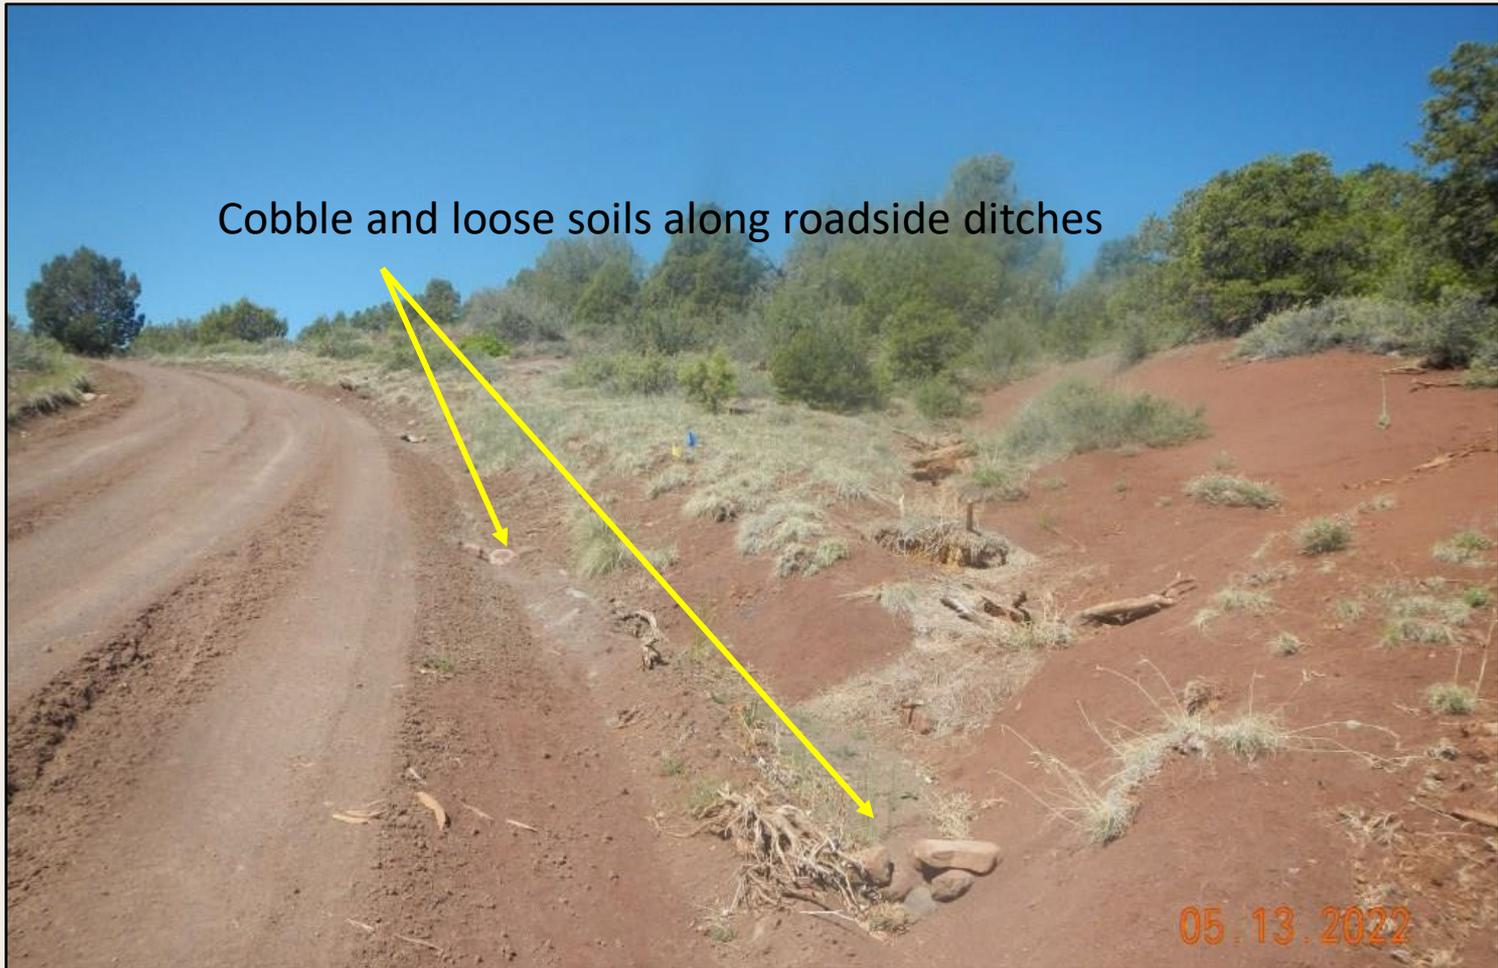
Photo 7. View of another area along the access road where graded ditches are not stabilized. Cobble placed in ditches are not adequate.

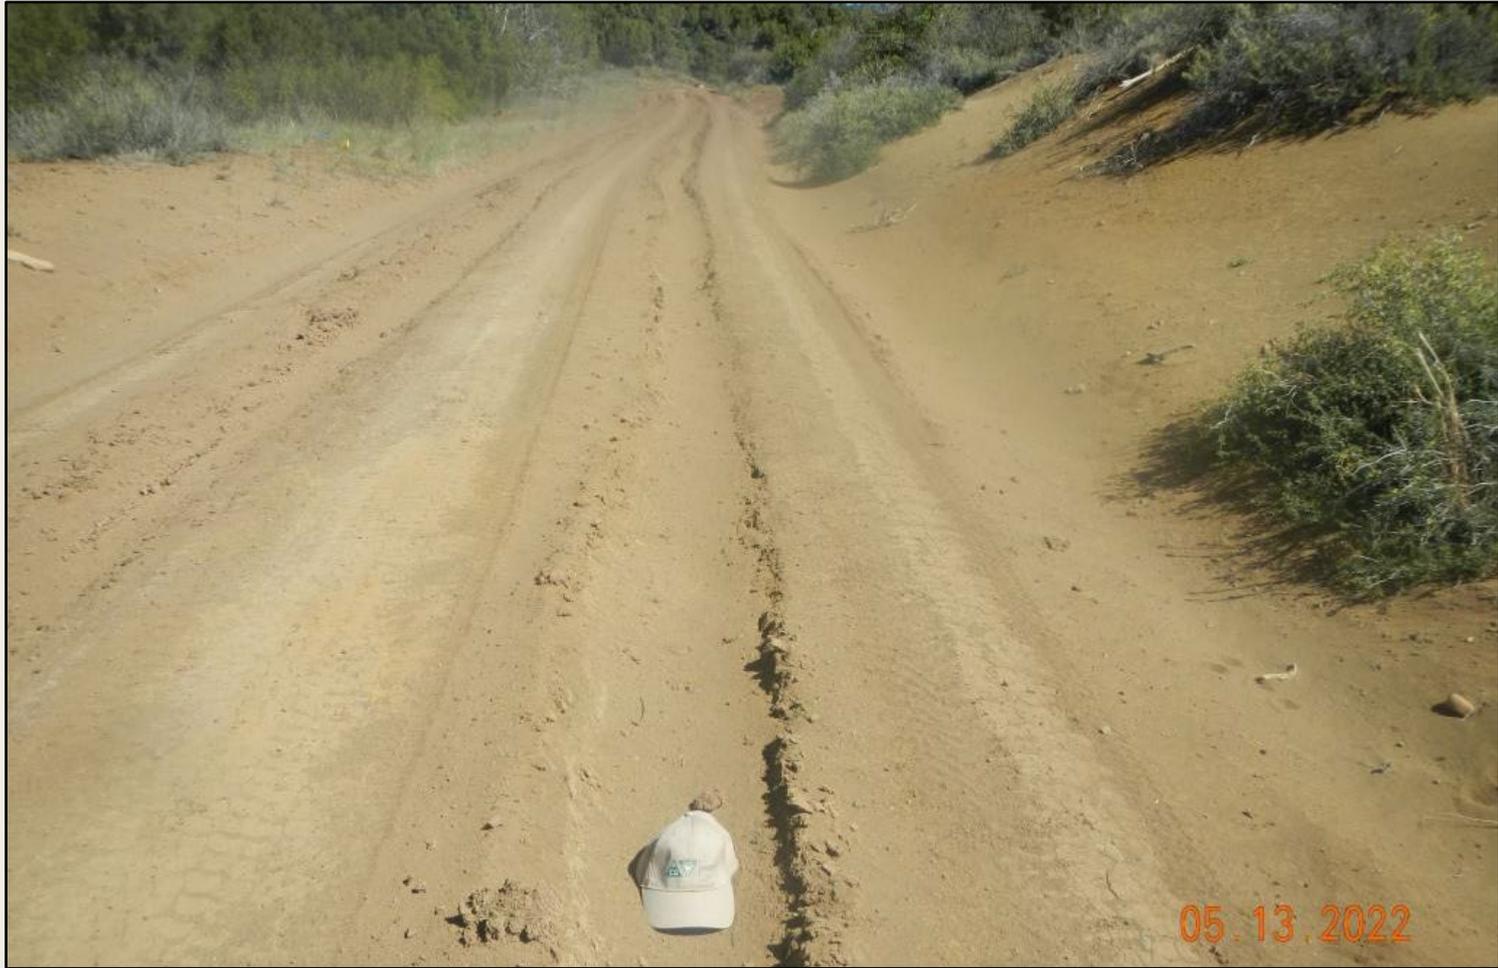
Photo 8. View of erosional channeling on access road surface, approx. 1-1.5ft wide and deep. Road surface is not stabilized.

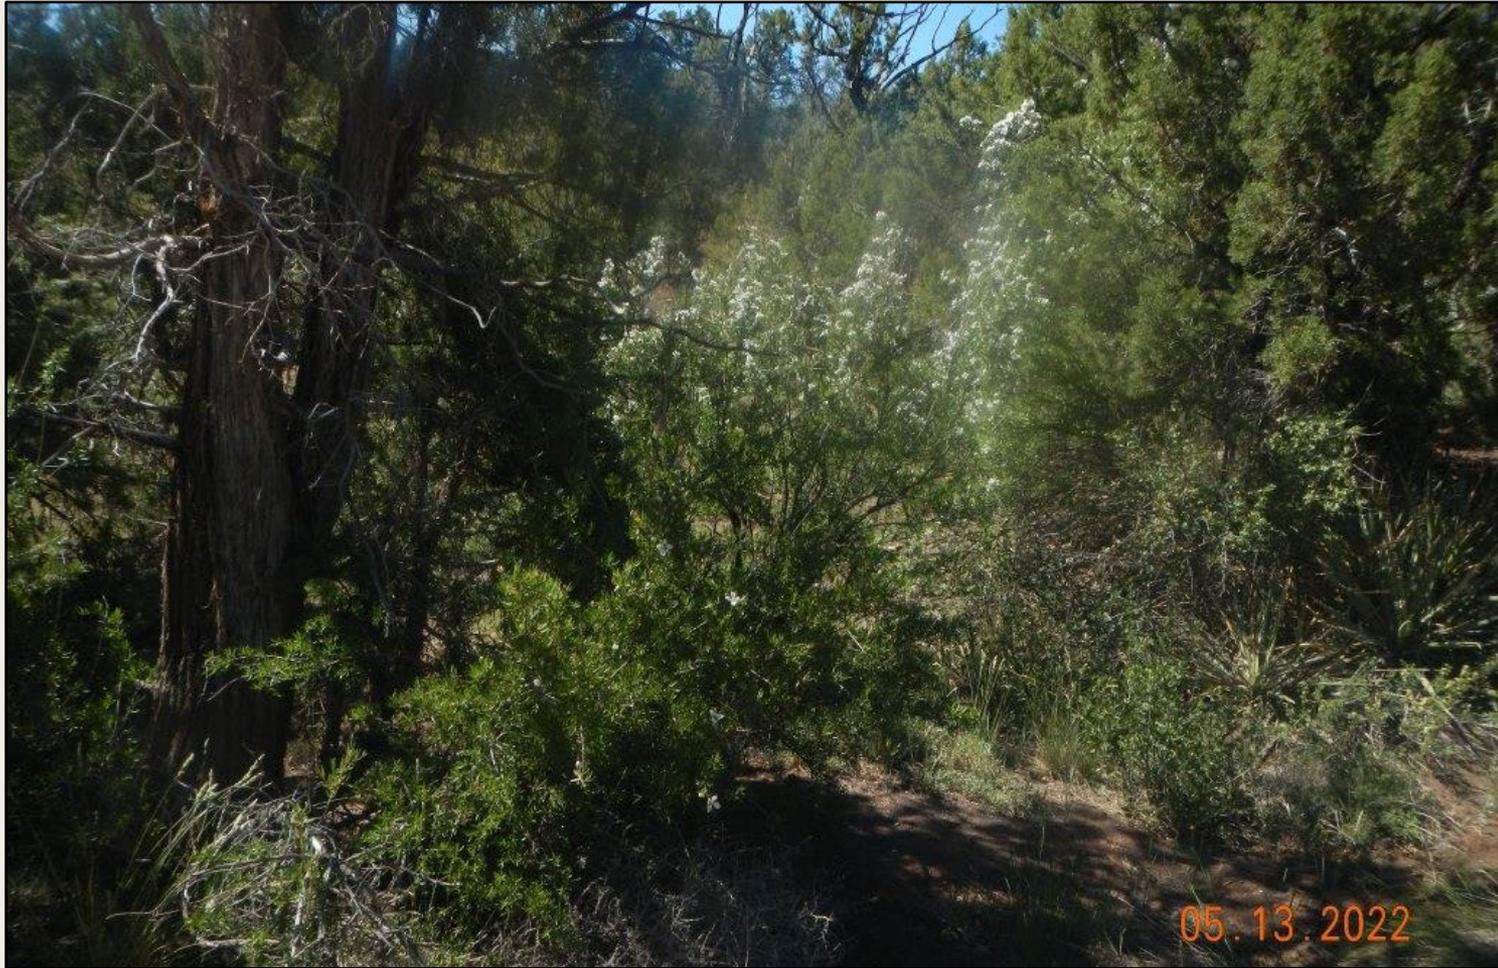
Photo 9. View of reference area pinyon and juniper woodland with understory of shrubs such as antelope bitterbrush, cliff fendlerbush, banana yucca, Indian ricegrass, and claret cup.
