Inspection Photos  
Operator: Enduring  
API: 067-08658  
Date: 5/13/2022

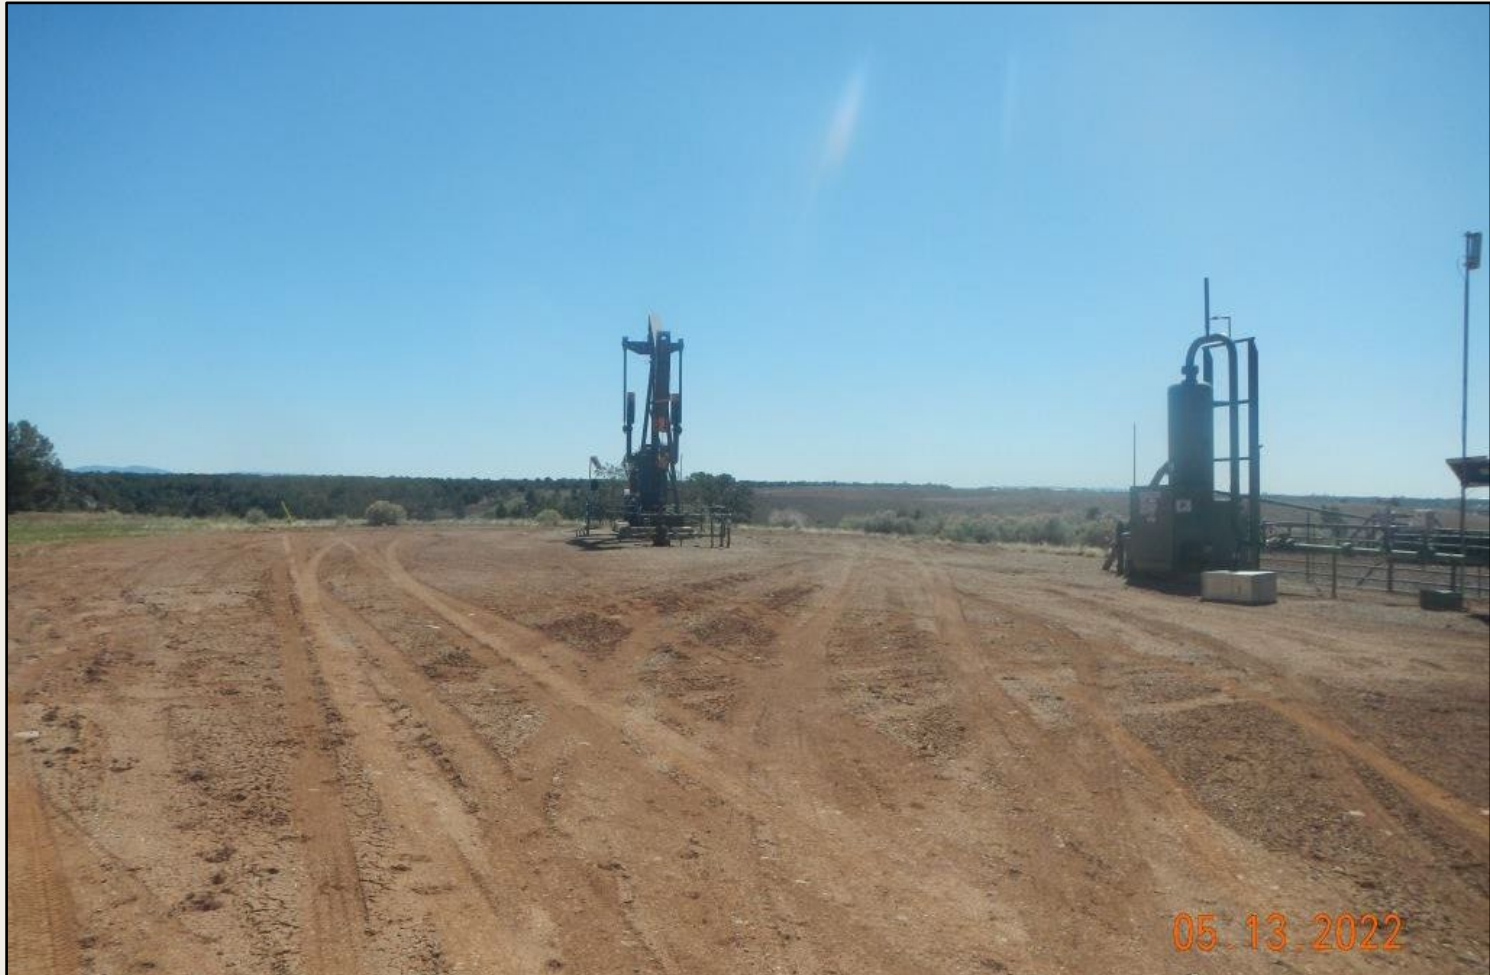
Photo 1. View of the project area from the well pad entrance facing center.

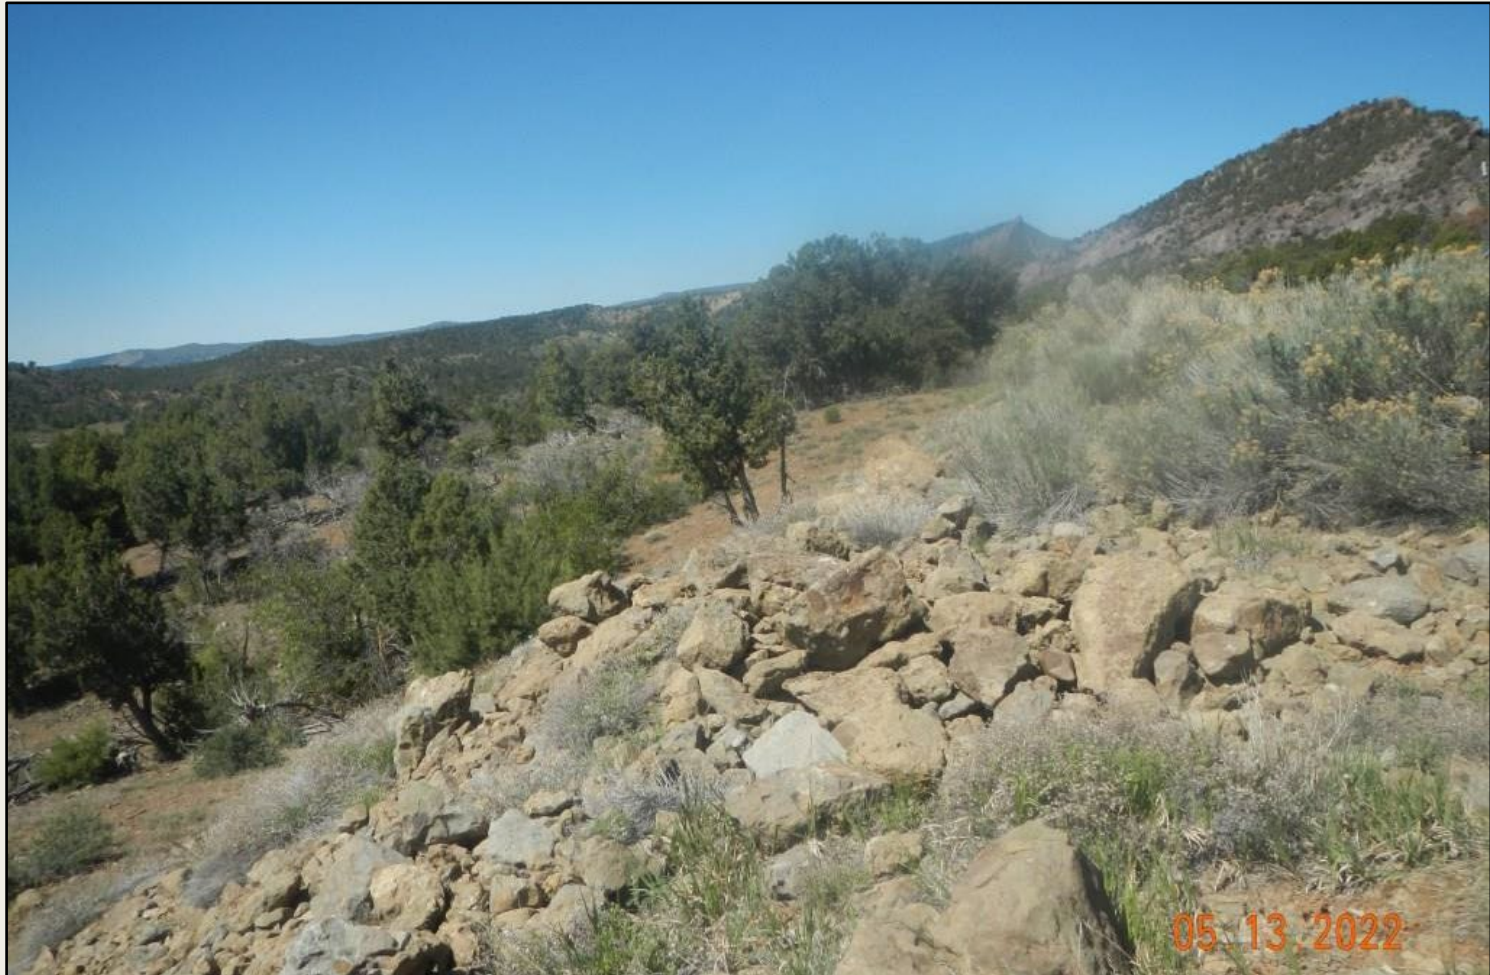
Photo 2. View of the southern fill slope from the southeastern corner facing westward. Slope is largely rock stabilized with western wheatgrass, rubber rabbitbrush, hairy goldenaster, and crested wheatgrass observed.

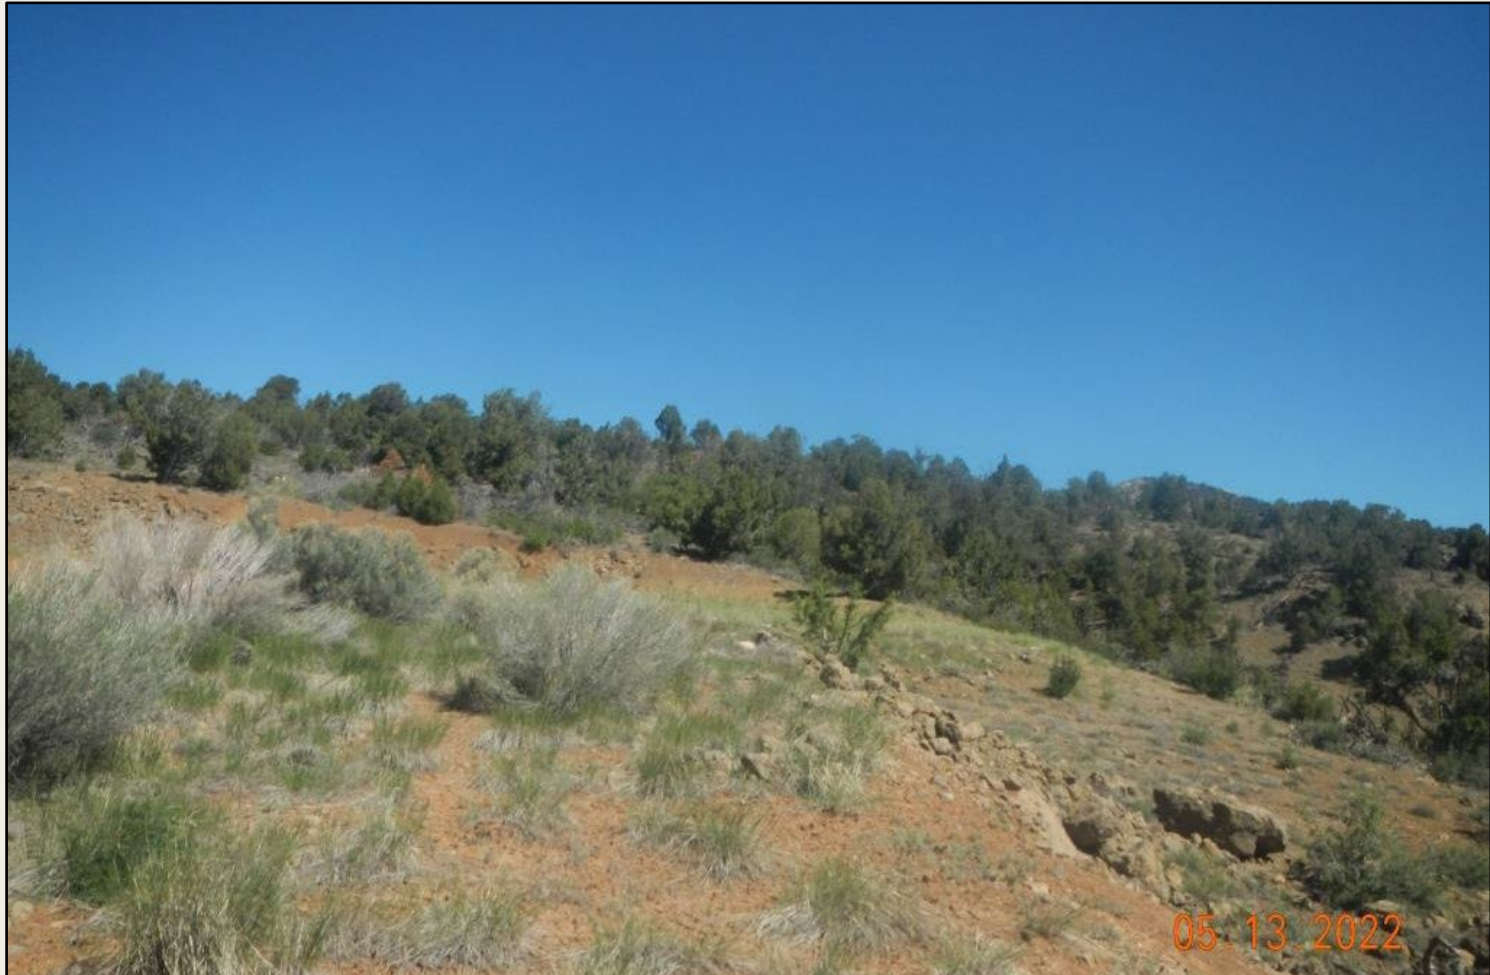
Photo 3. View of the eastern project area from the southeastern corner facing northward.

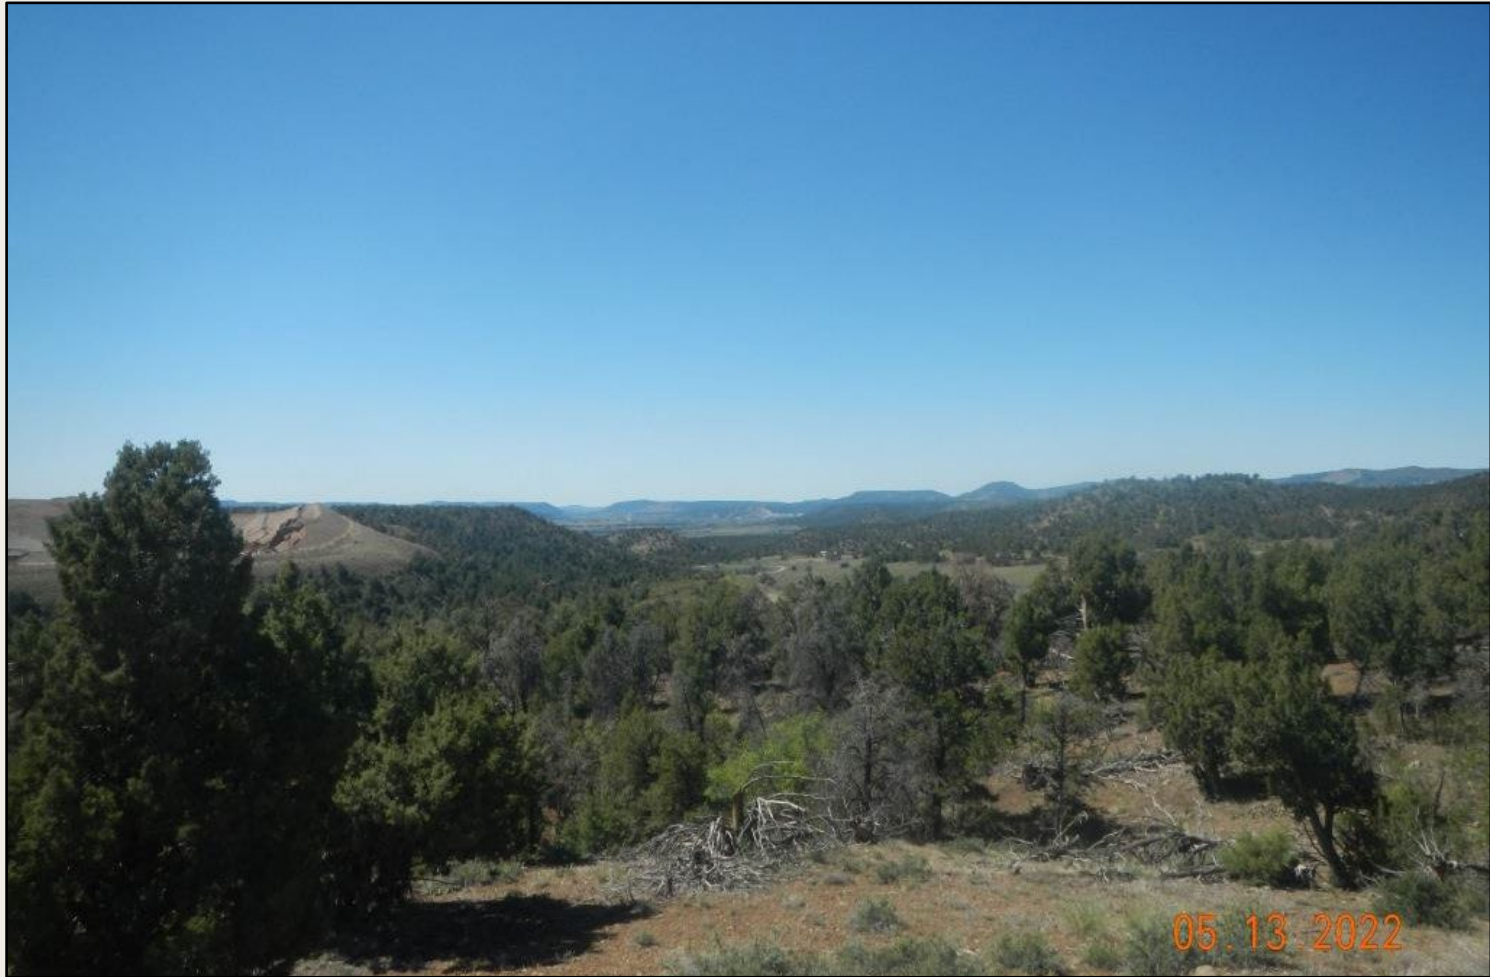
Photo 4. View of reference area pinyon and juniper woodland with understory of shrubs such as antelope bitterbrush, lanceleaf buckwheat, banana yucca, purple threeawn, Indian ricegrass, and claret cup.
