Inspection Photos  
Operator: Enduring  
API: 067-07636  
Date: 5/13/2022

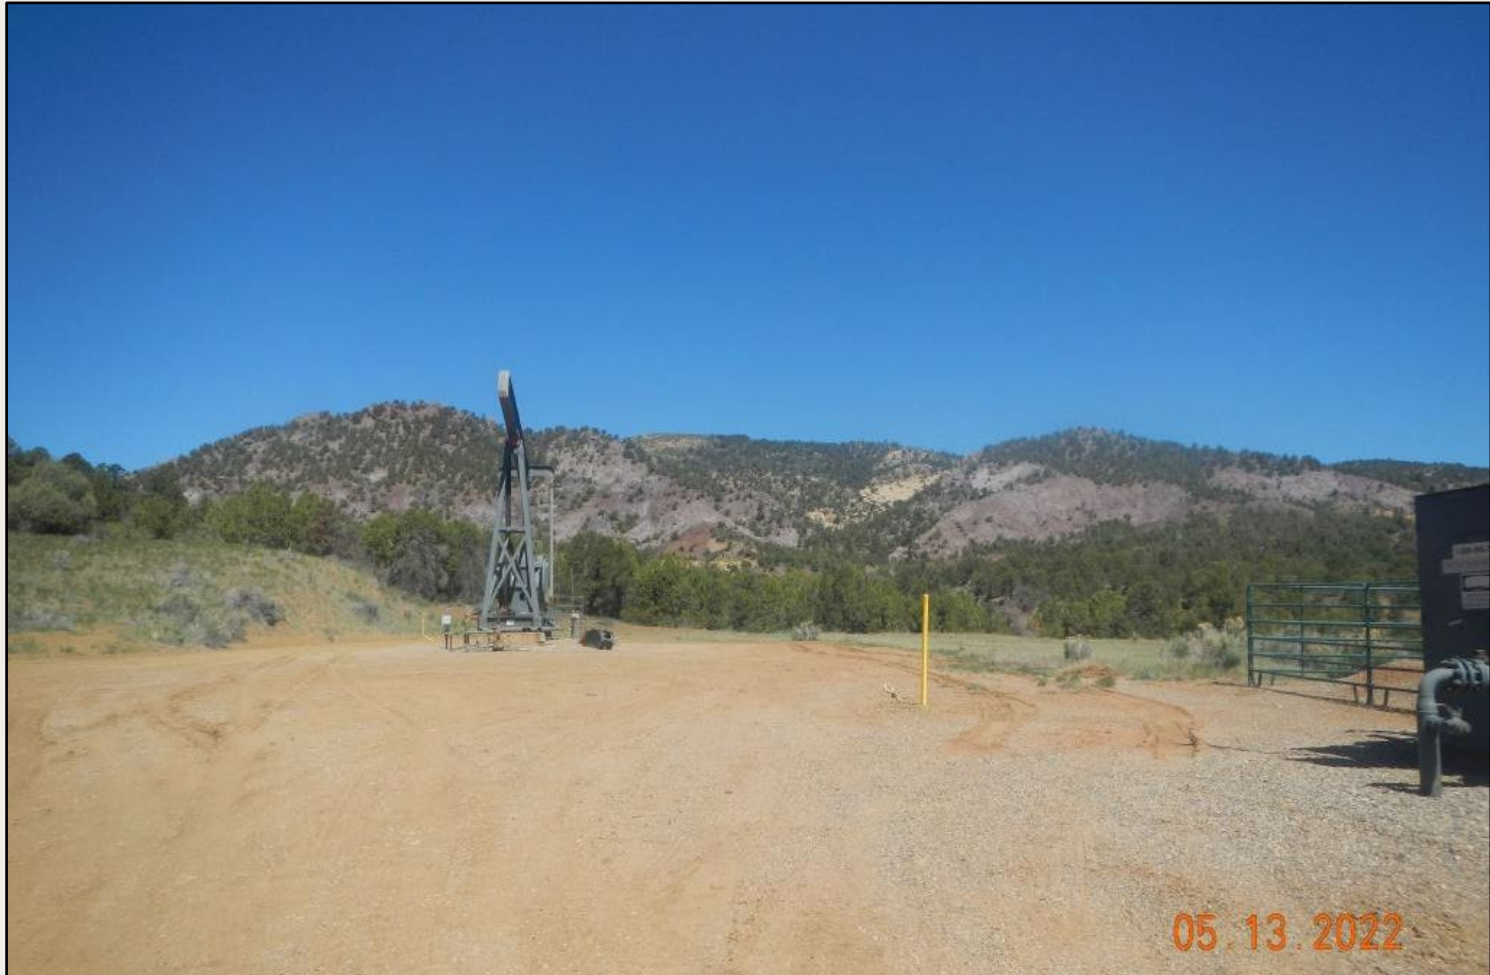
Photo 1. View of the project area from the southeastern corner facing center.

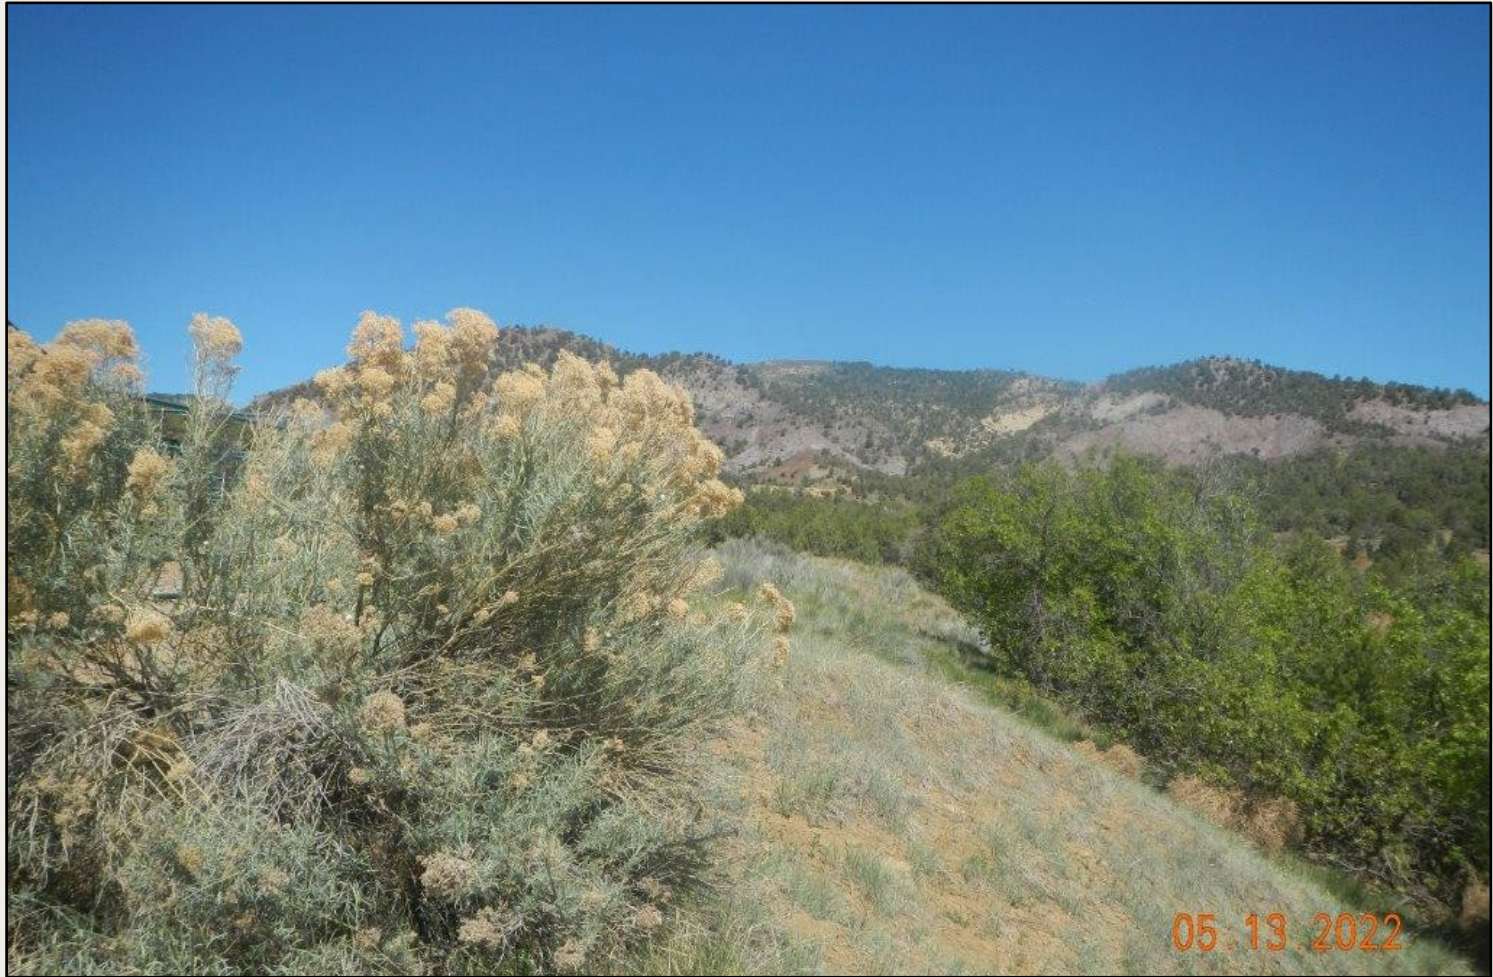
Photo 2. View of the northeastern fill slope from the southeastern corner facing northward. Revegetation is progressing with western wheatgrass, smooth brome, and crested wheatgrass.

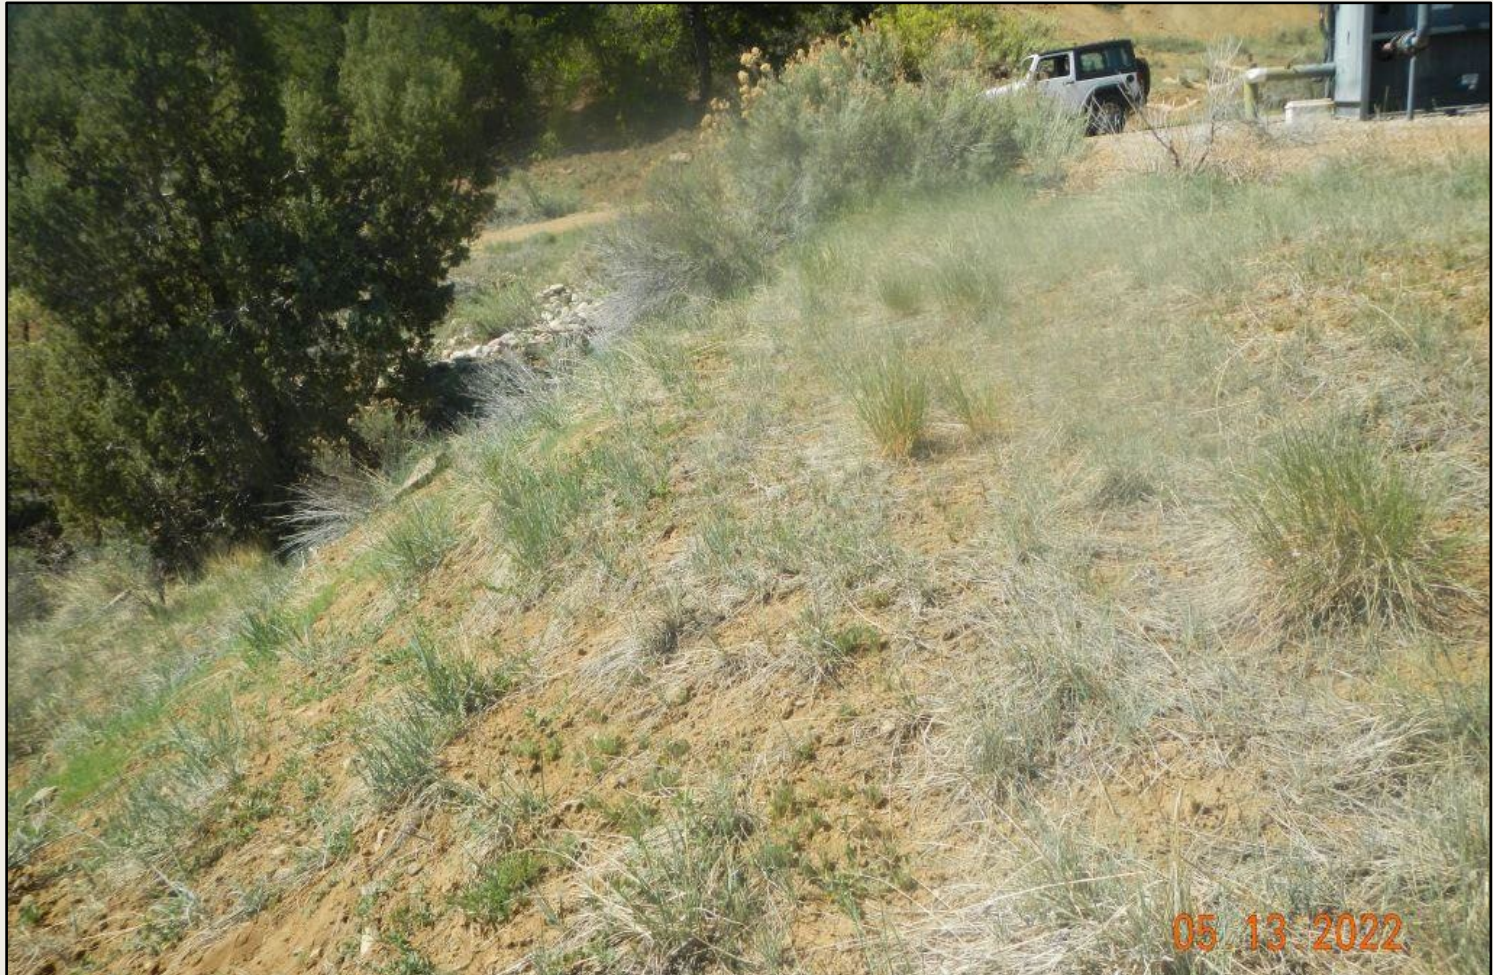
Photo 3. View of the southern project area from the southeastern corner facing westward.
