Inspection Photos  
Operator: Enduring  
API: 067-07650  
Date: 5/13/2022

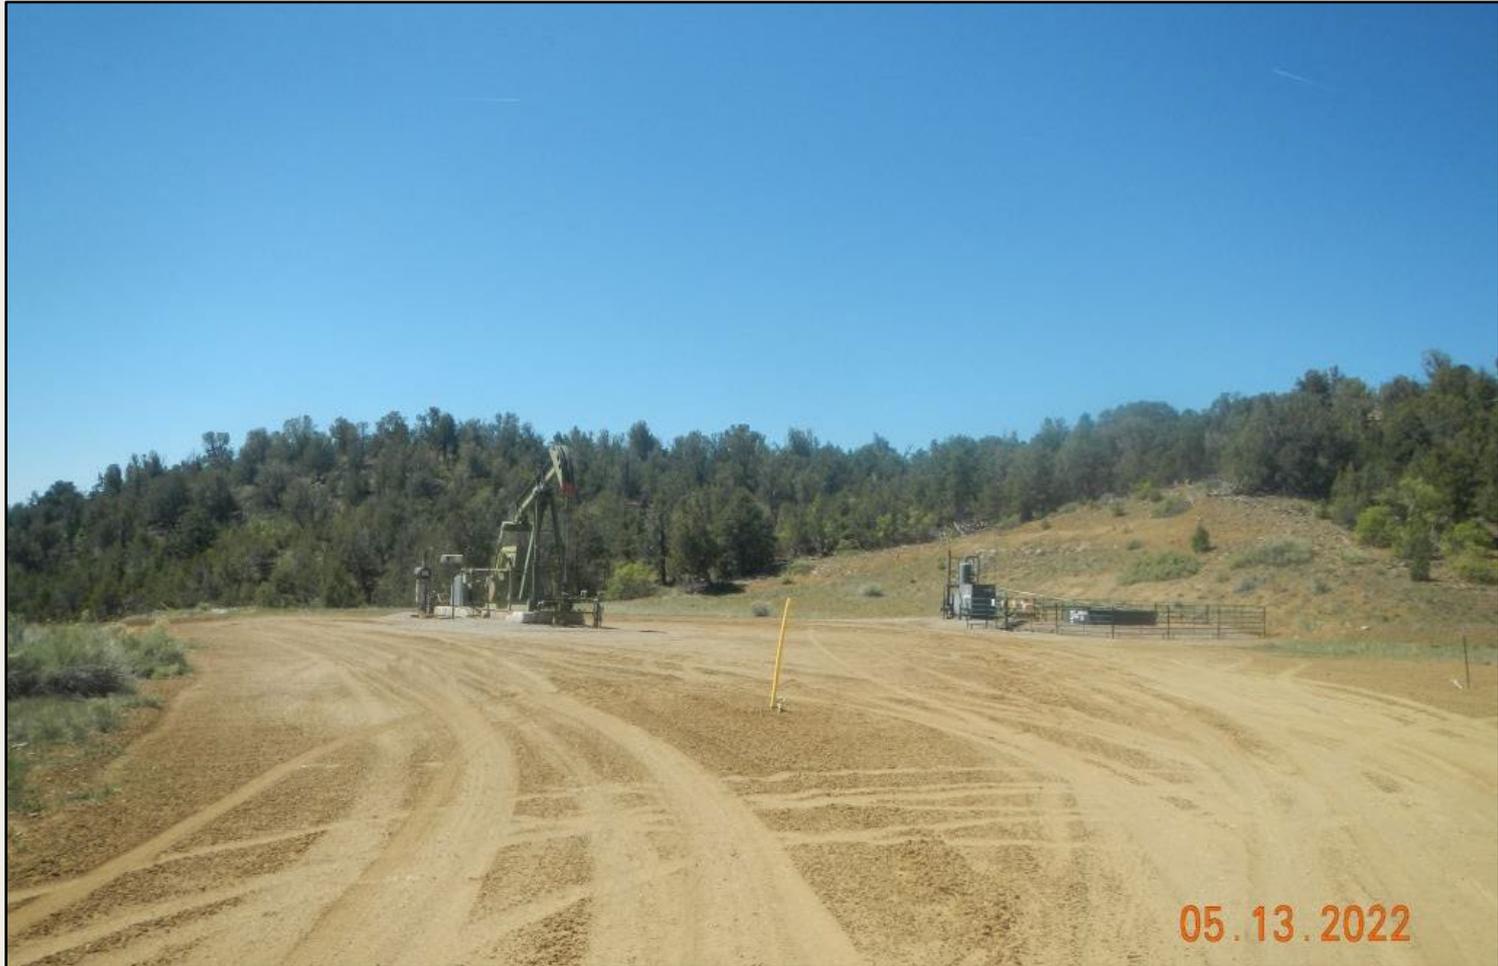
Photo 1. View of the project area from the well pad entrance facing center.

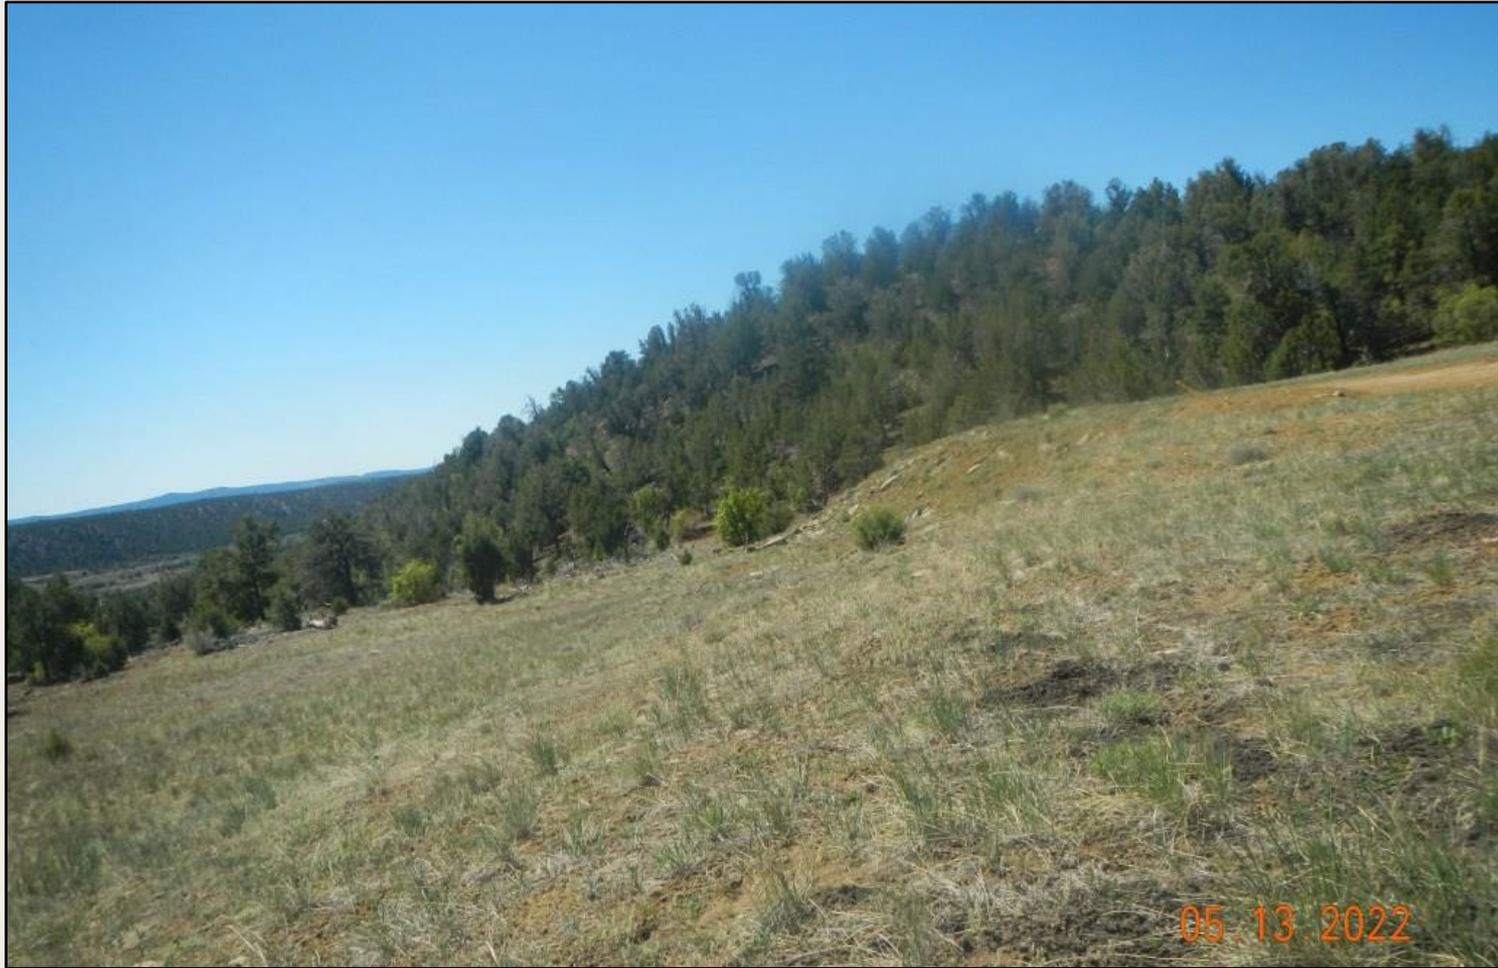
Photo 2. View of the eastern fill slope from the northeastern corner facing southward. Revegetation is progressing with western wheatgrass, Indian ricegrass, crested wheatgrass, and sand dropseed.

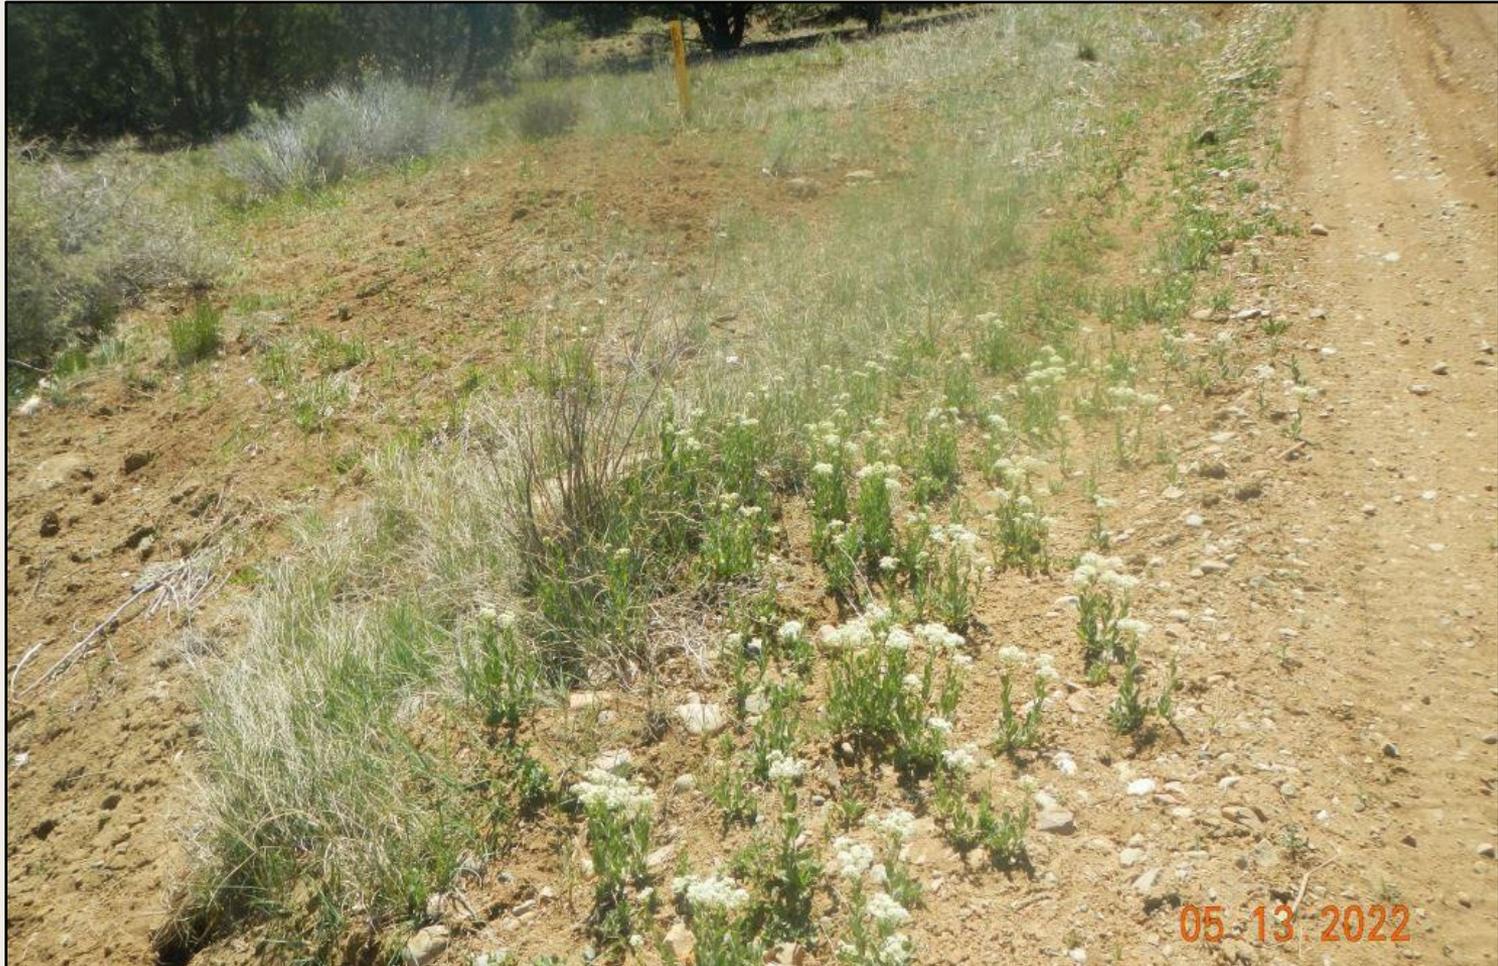
Photo 3. View of hoary cress weeds (approx. 75) along the access road.

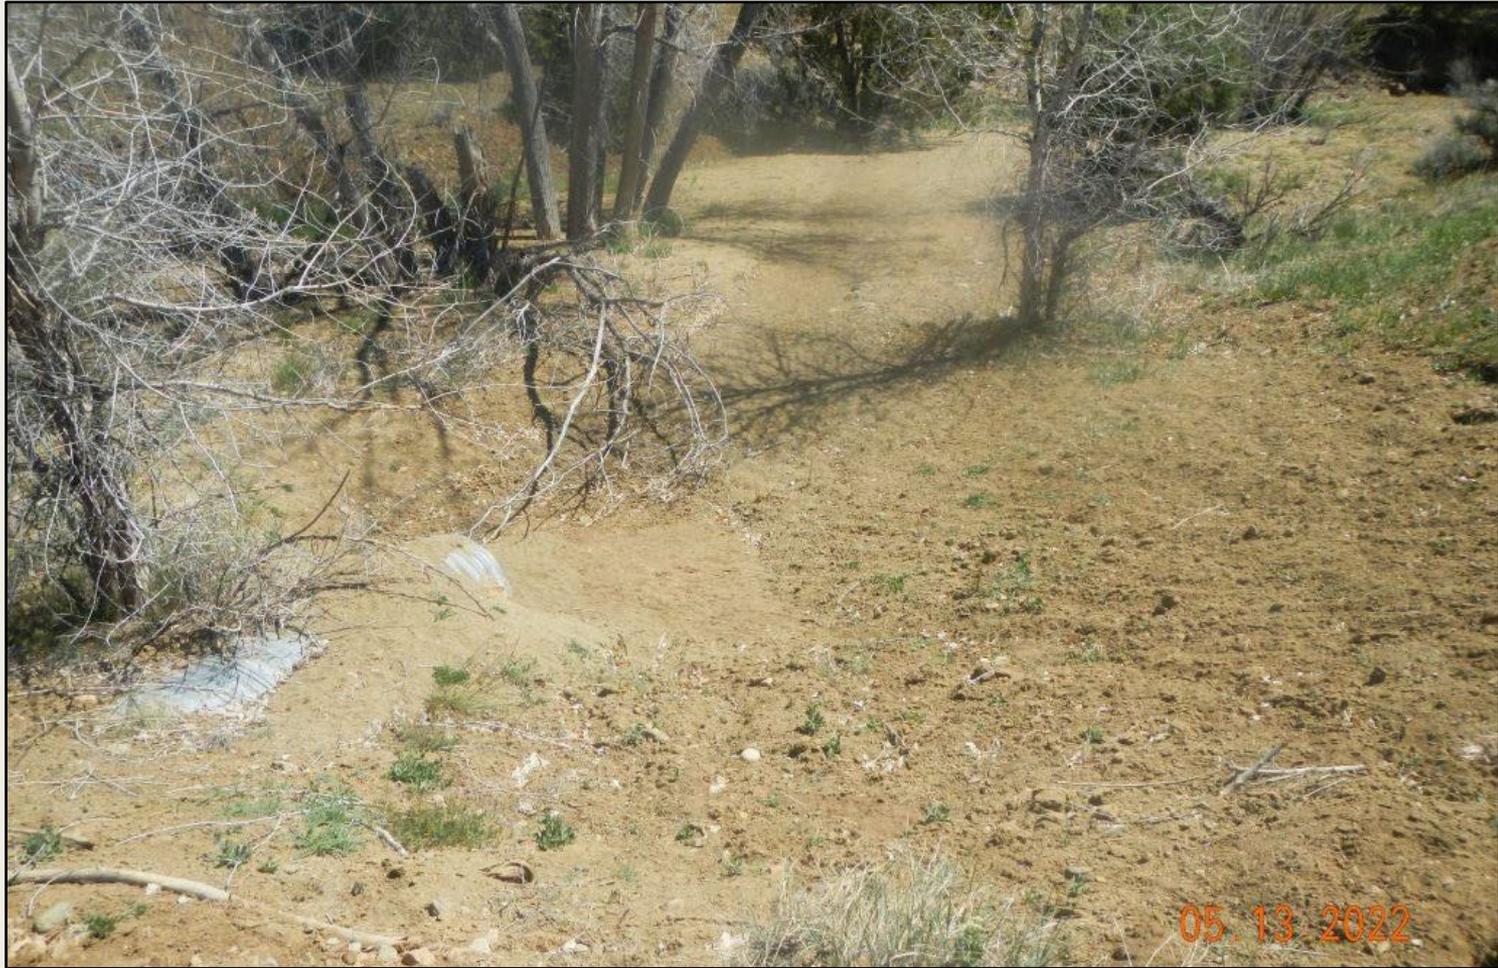
Photo 4. View of culvert outlet at access road crossing. Culvert outlet continues to lack stabilization.

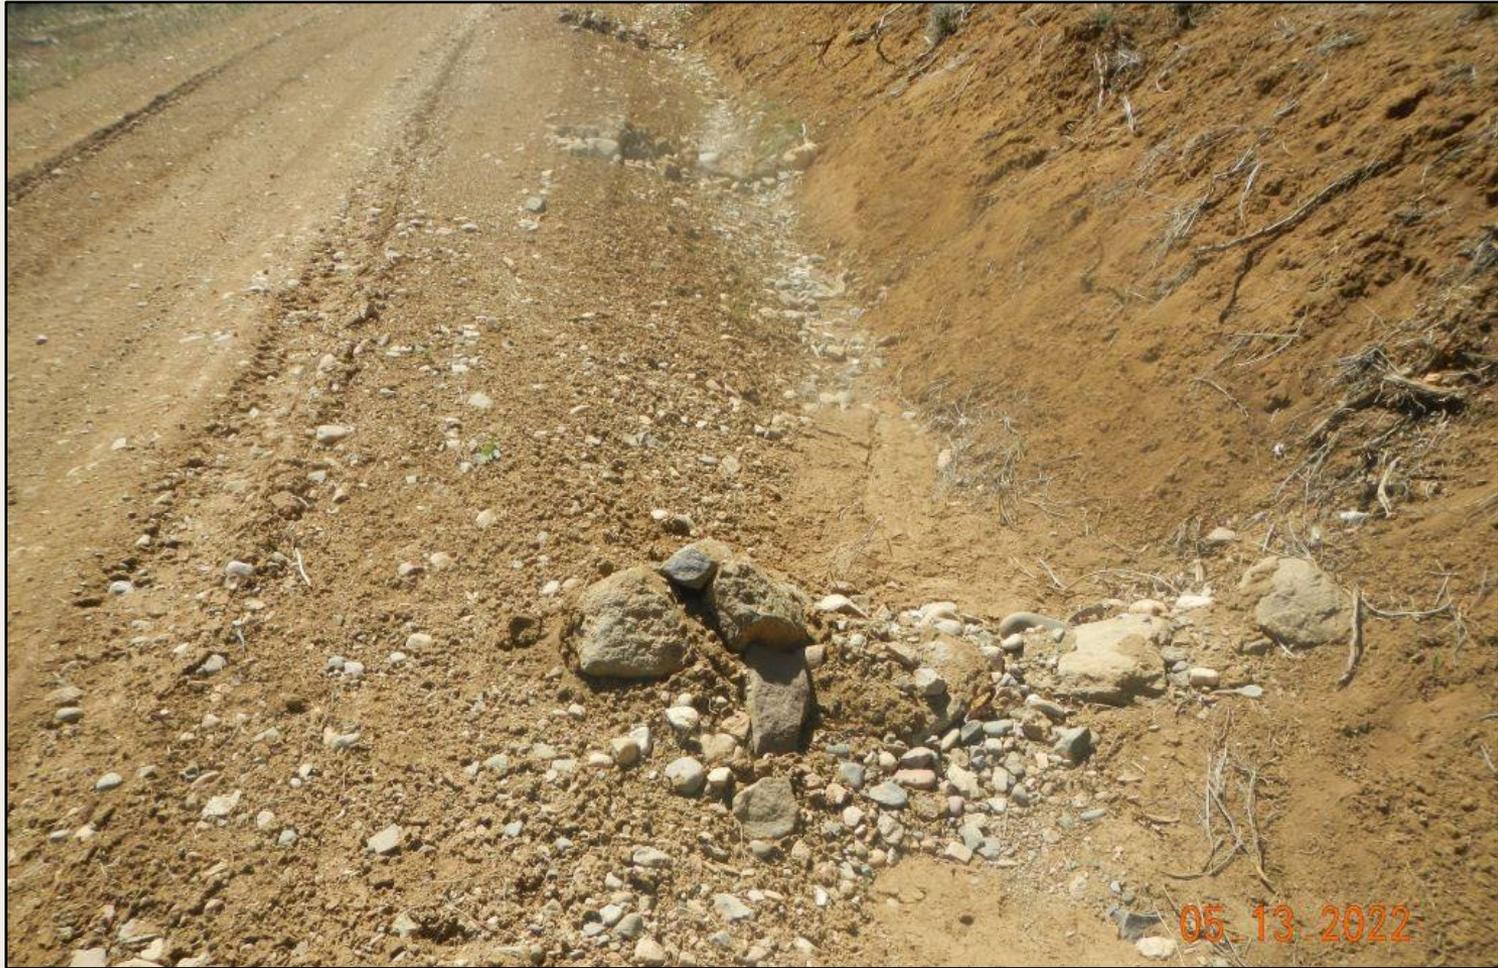
Photo 5. View of roadside ditch with rock placement full of sediment. This is not an adequate BMP for this area.

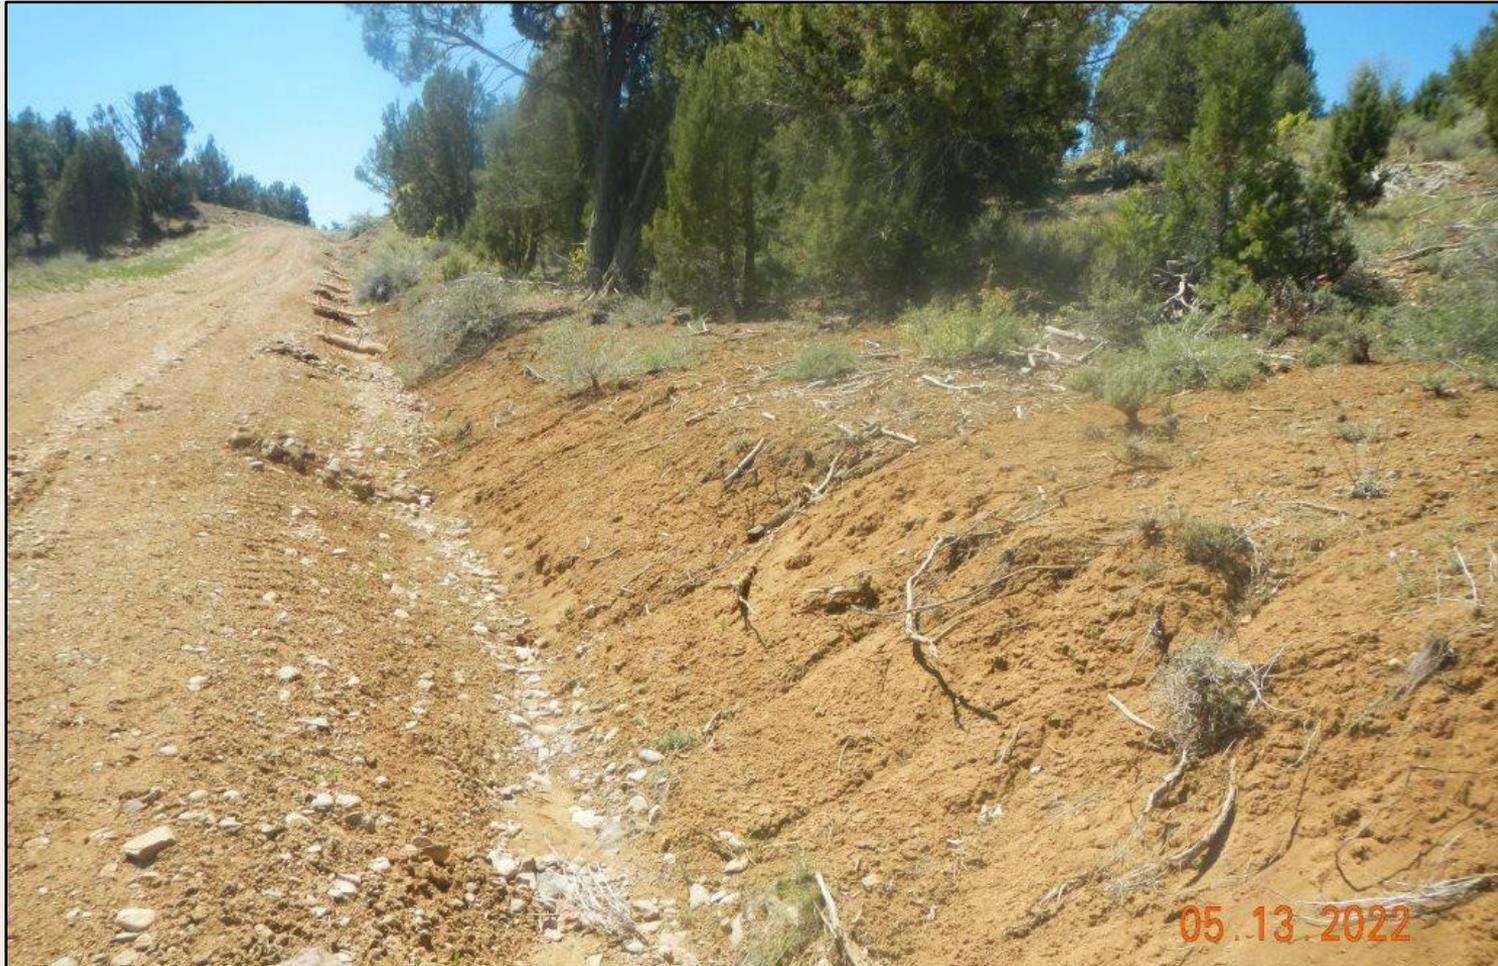
Photo 6. Another view of rocks placed along roadside and continued erosion along roadside.
