Inspection Photos
Operator: Enduring
API: 067-08734
Date: 5/13/2022

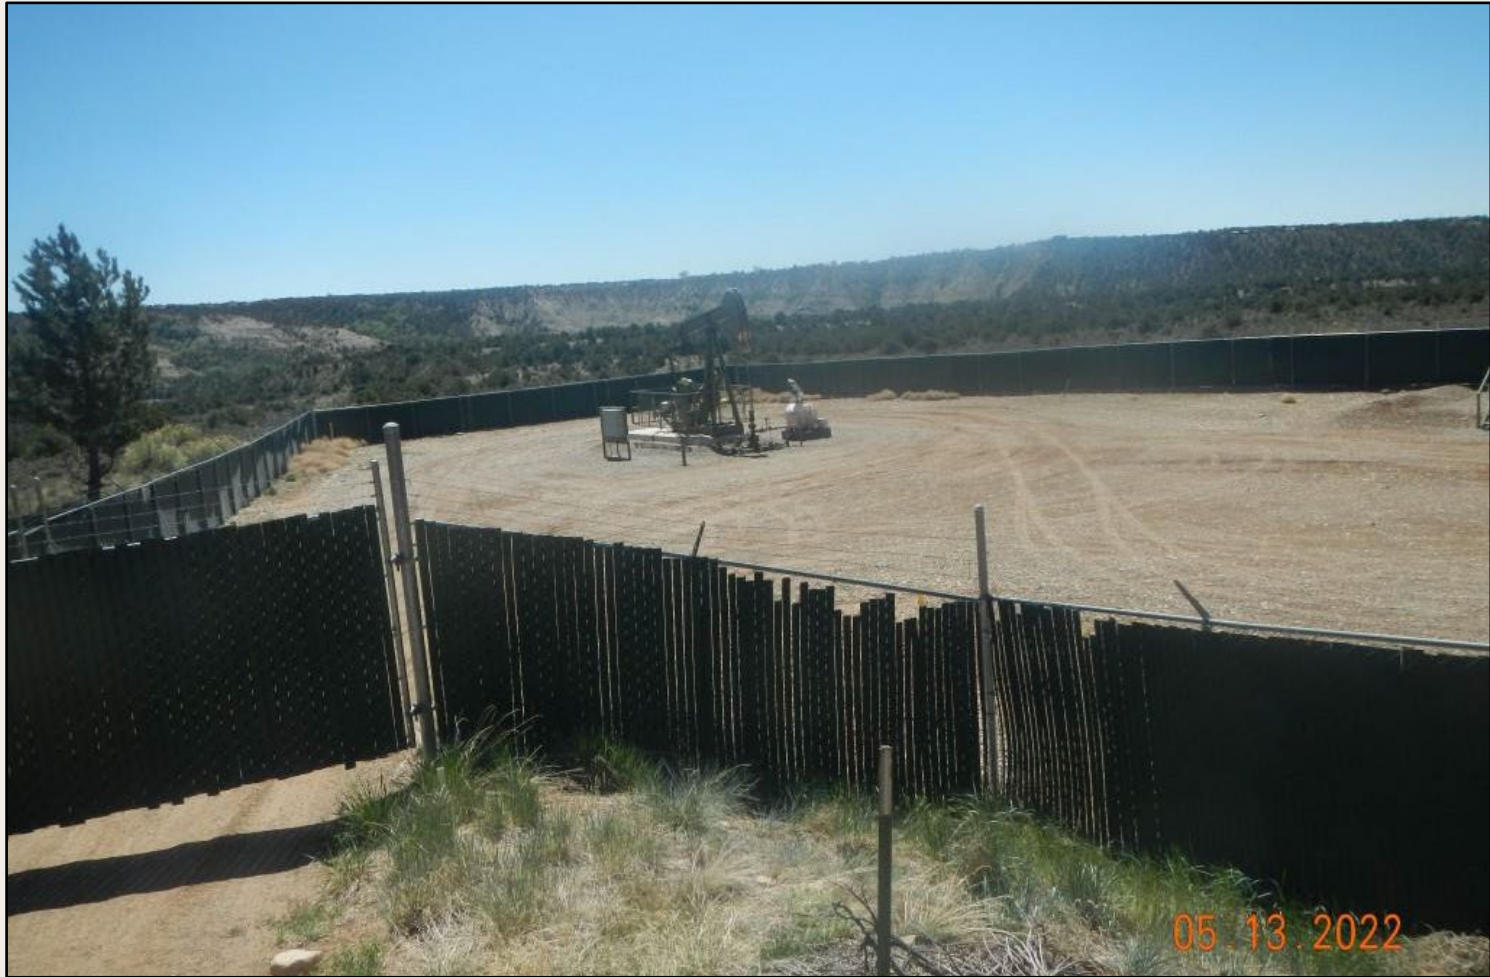
Photo 1. View of the project area from the well pad entrance facing center.

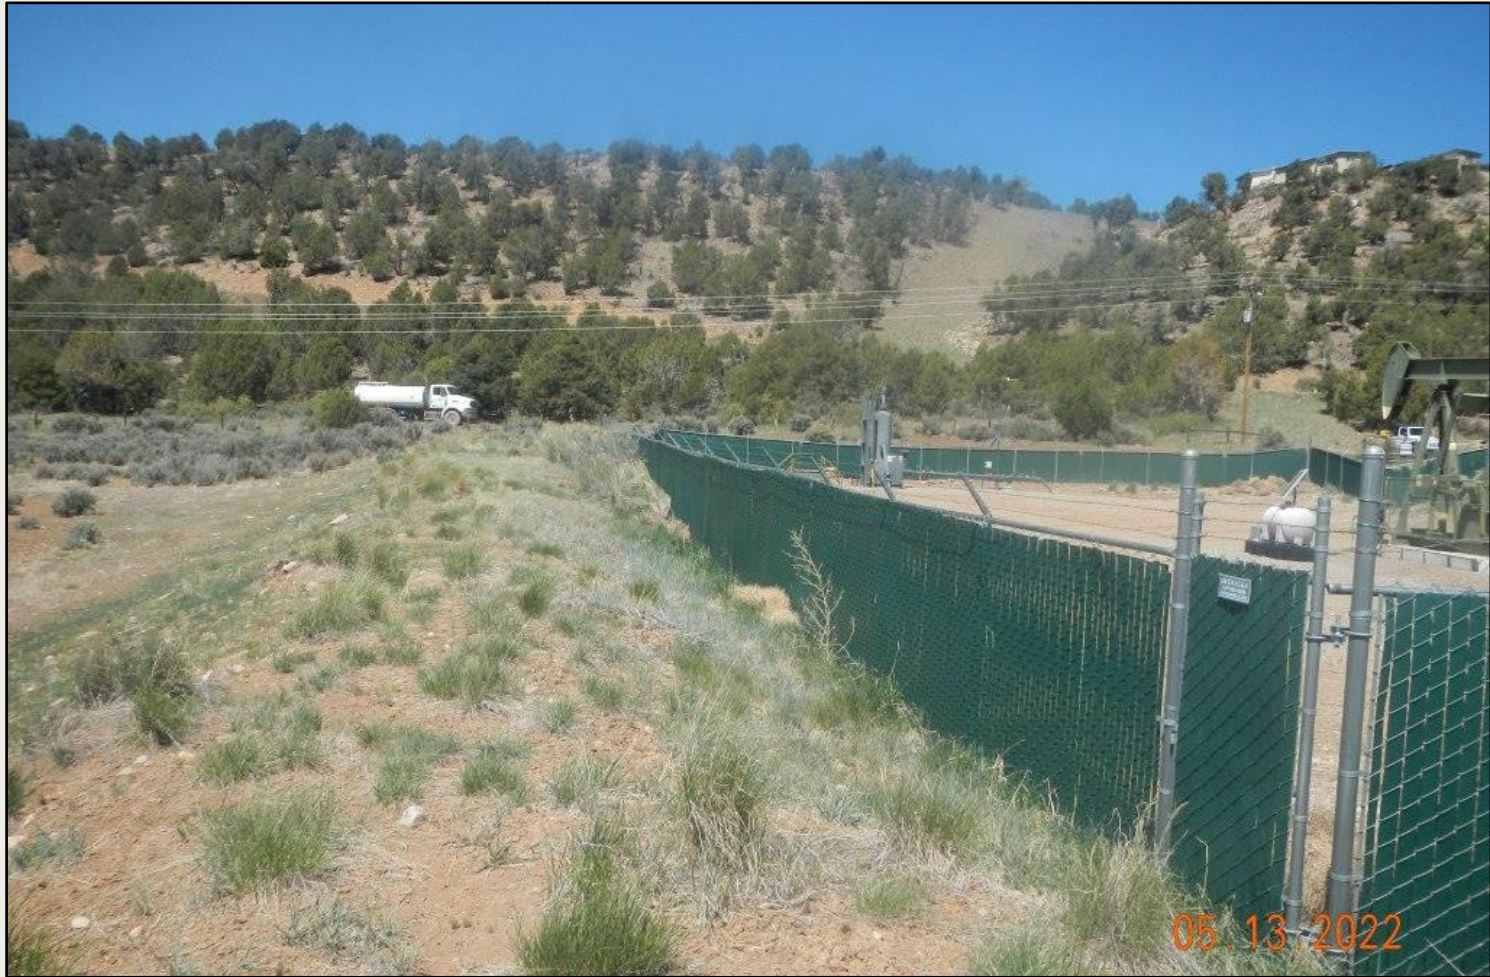
Photo 2. View of the southern project area from the southeastern corner facing westward. Revegetation is progressing with crested wheatgrass and western wheatgrass.

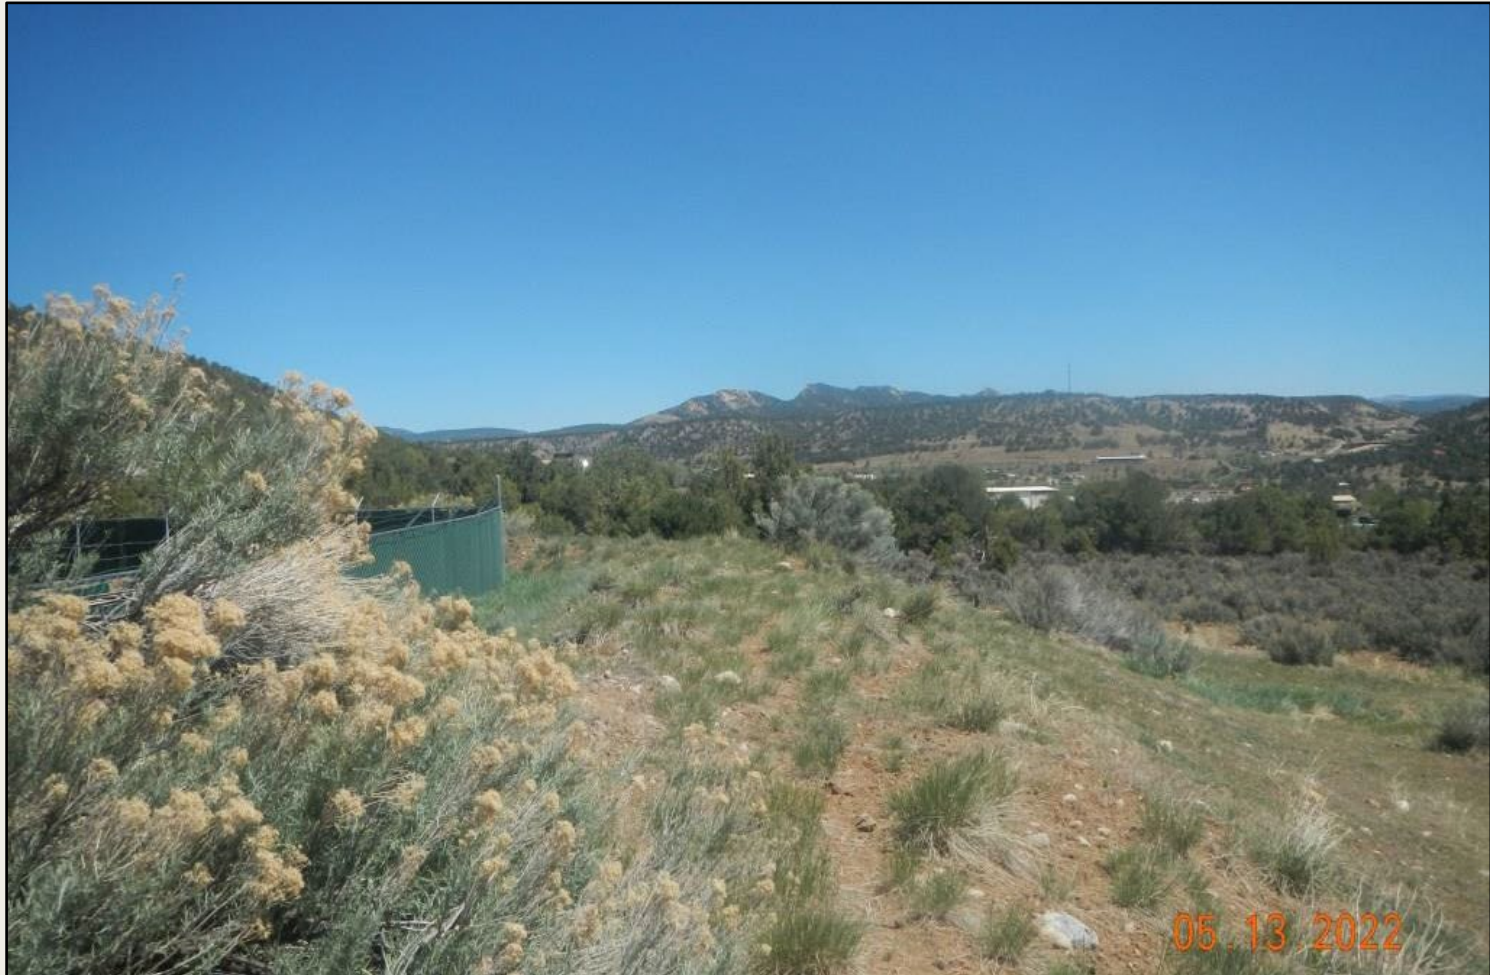
Photo 3. View of the eastern project area from the southeastern corner facing northward.

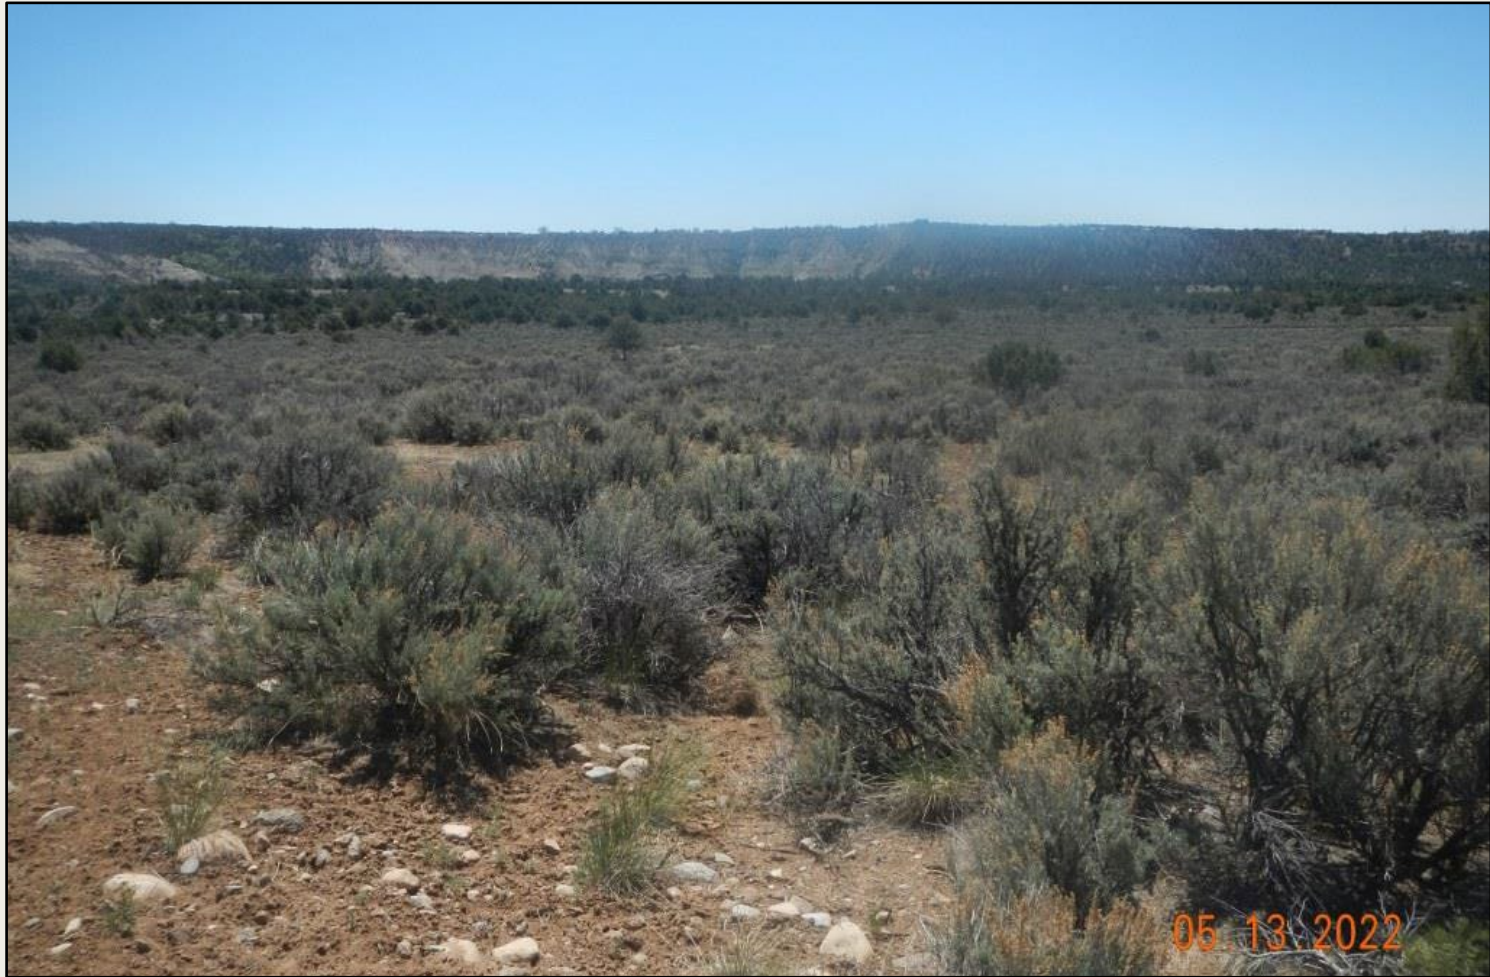
Photo 4. View of the reference area comprised of sagebrush shrubland with purple threeawn, Indian ricegrass, blue grama, and prickly pear in the understory.
