Inspection Photos
Location Name: Carter 21-33
Location ID: 329511

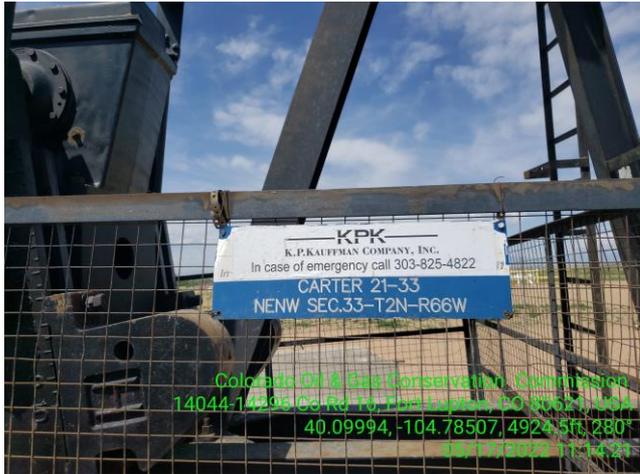
Photo 1 WH sign.

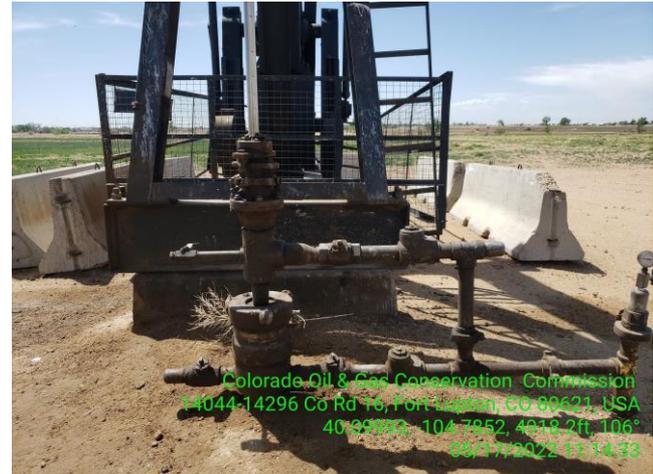
Photo 2 WH

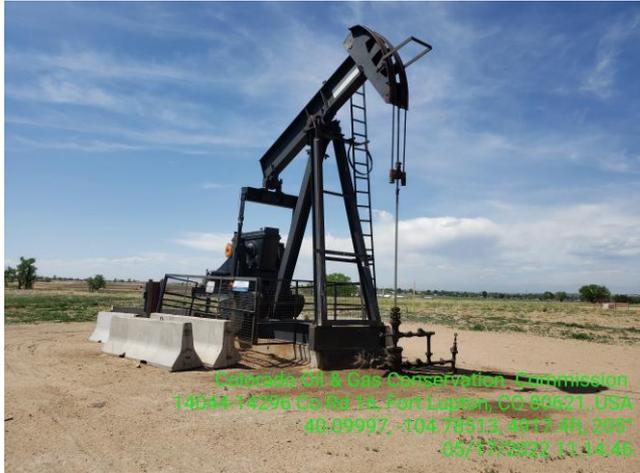
Photo 3 Pump jack.

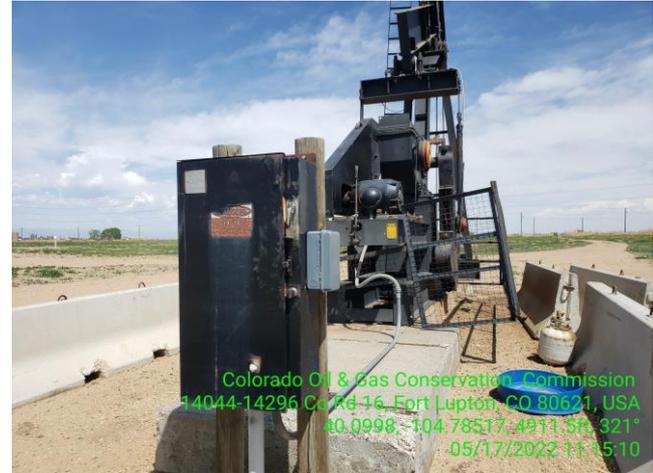
Photo 4 Ancillary equip.

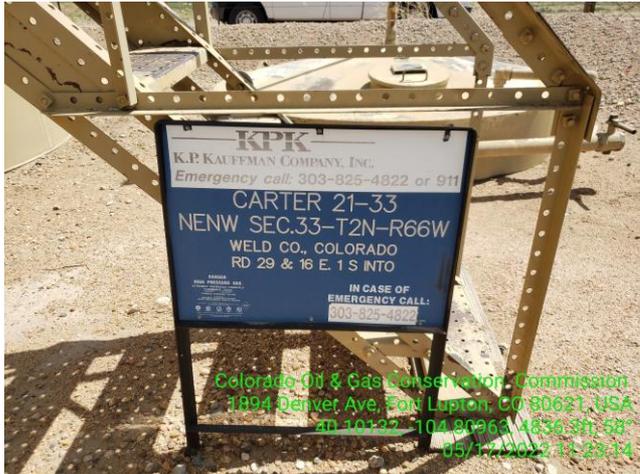
Photo 5 TB sign.

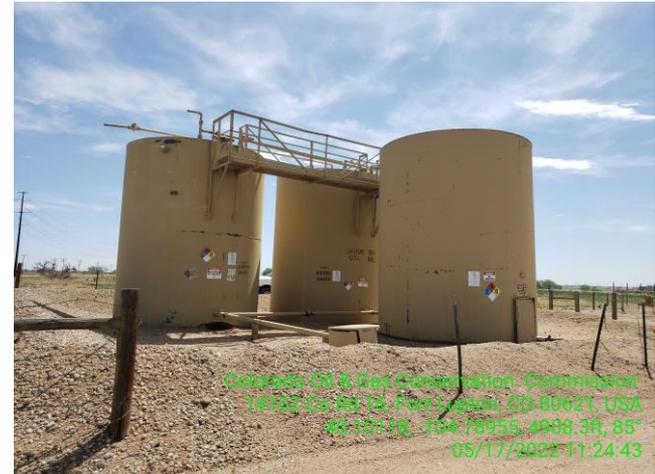
Photo 6 TB.

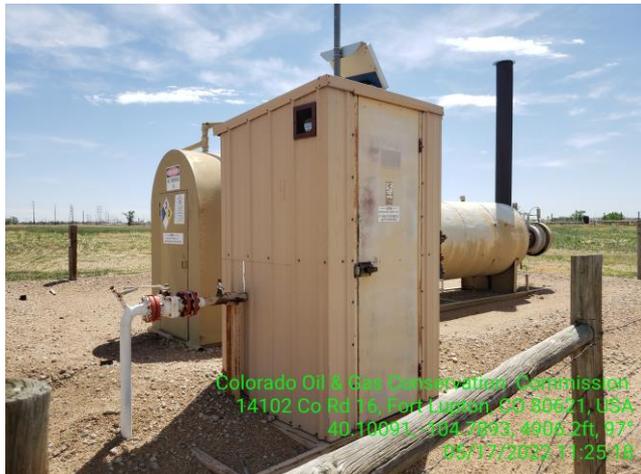
Photo 7 Gas Meter Run, No card to indicate calibration status.

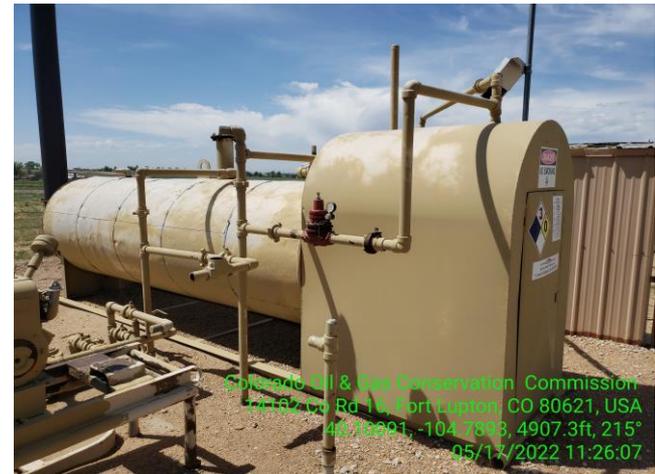
Photo 8 HHS.

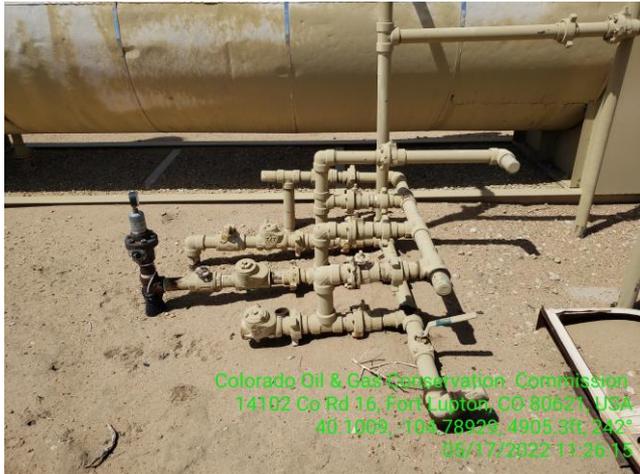
Photo 9 Flow line manifold.

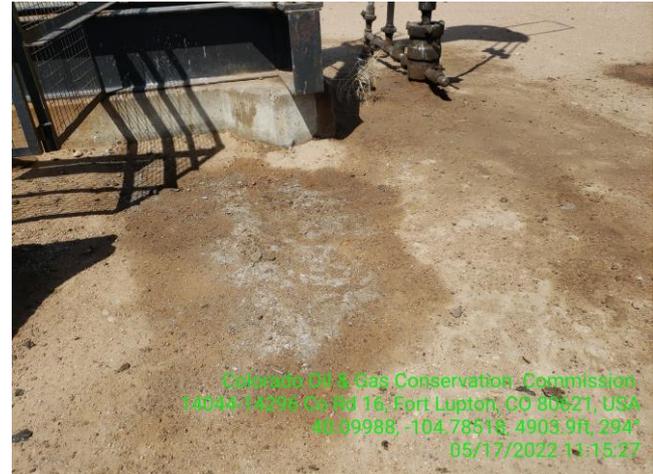
Photo 10 Stained soil by WH and Pump Jack base.

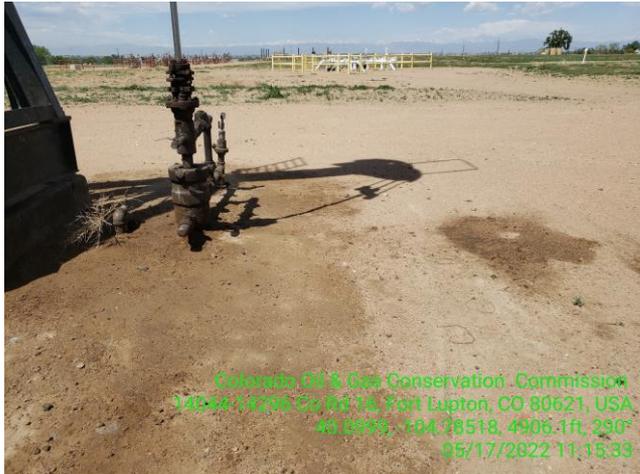
Photo 11 Stained soil by WH and Pump Jack base.

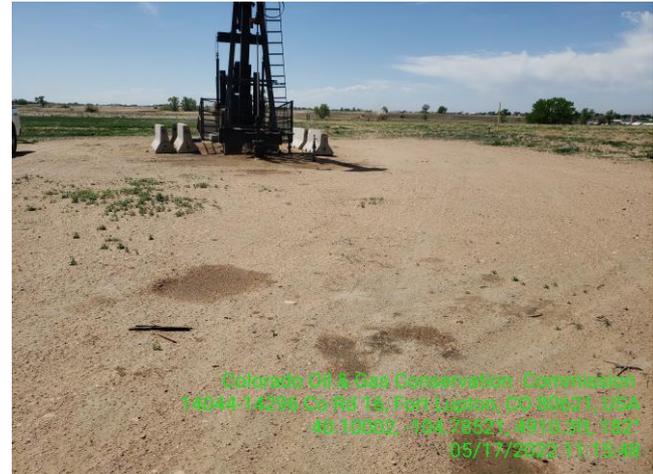
Photo 12 Stained soil on WH and Pump Jack location.

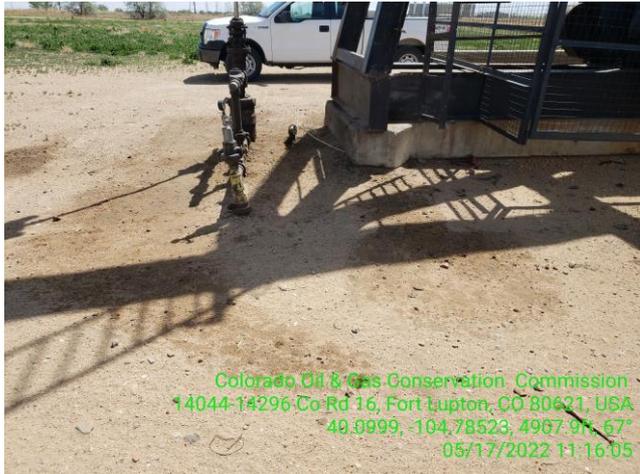
Photo 13 Stained soil by WH and Pump Jack base.

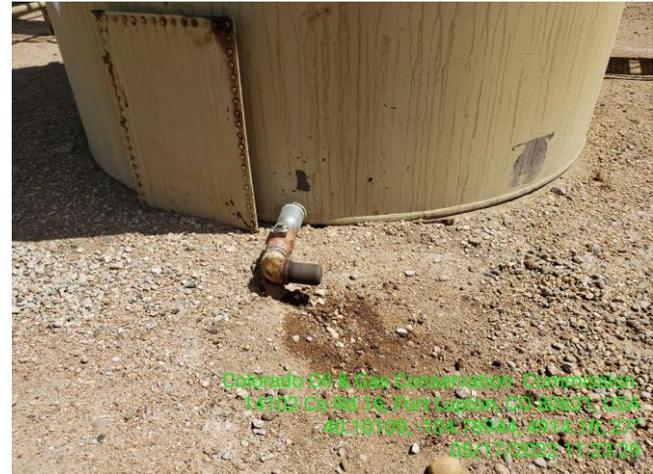
Photo 14 Stained soil by West Crude tank.

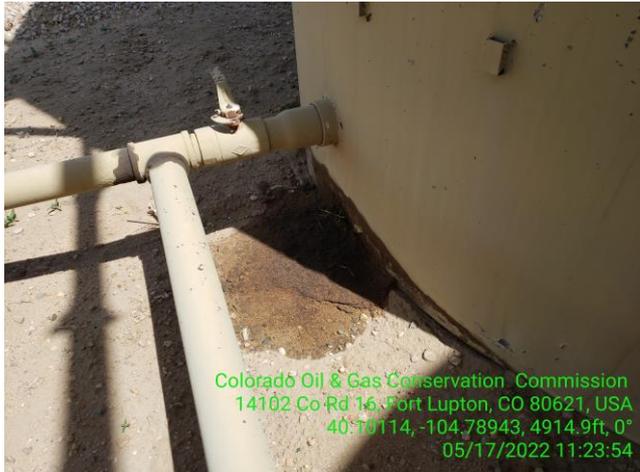
Photo 15 Stained soil by NE crude tank, Possible pin hole leak.
