Inspection Photos

Location Name: MARALEX RESOURCES INC RIFLE-BOULTON-67S91W /23NWNW

Location ID: 322369

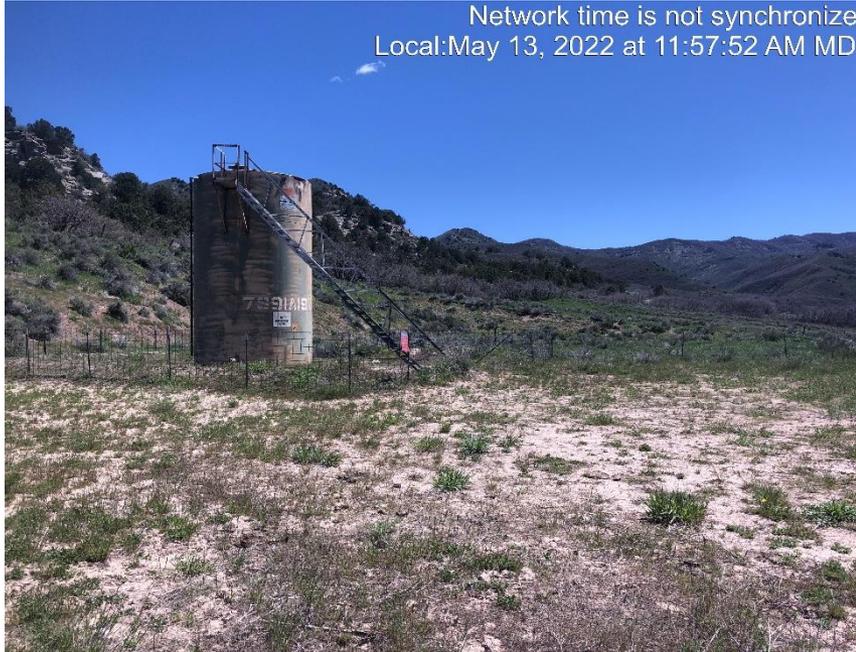
Photo #6702 from entrance to location.

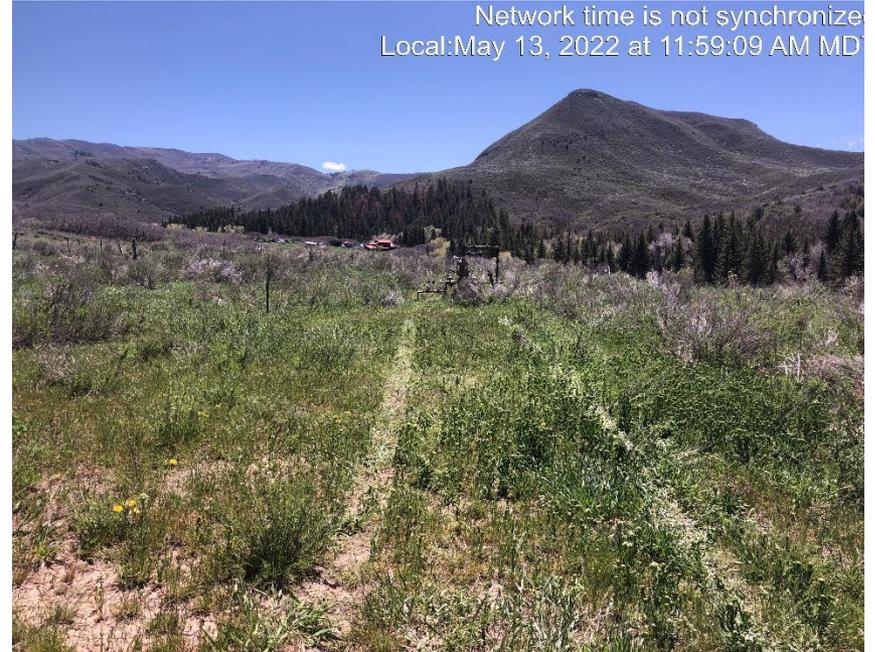
Photo #6703 from entrance to location.

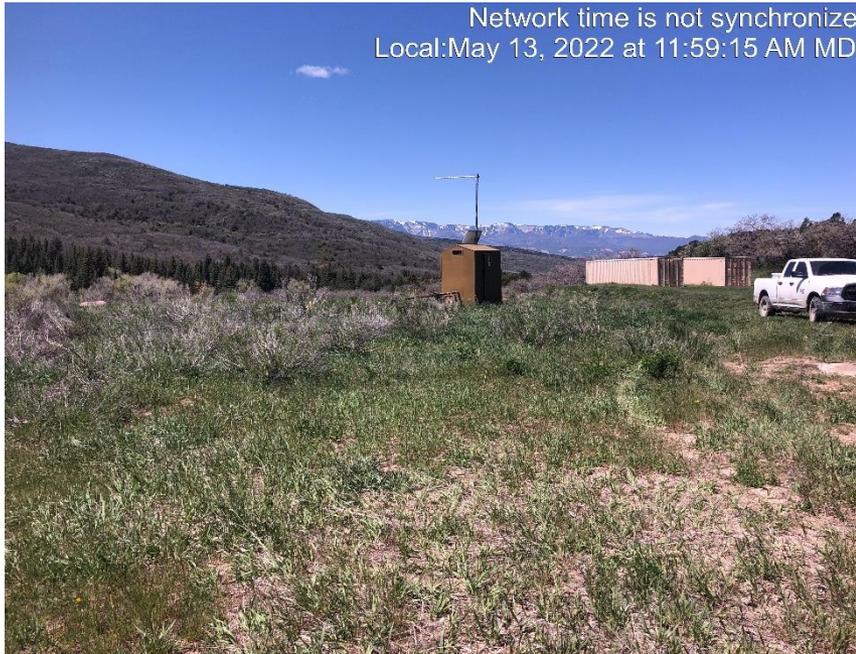
Photo #6704 from entrance to location.

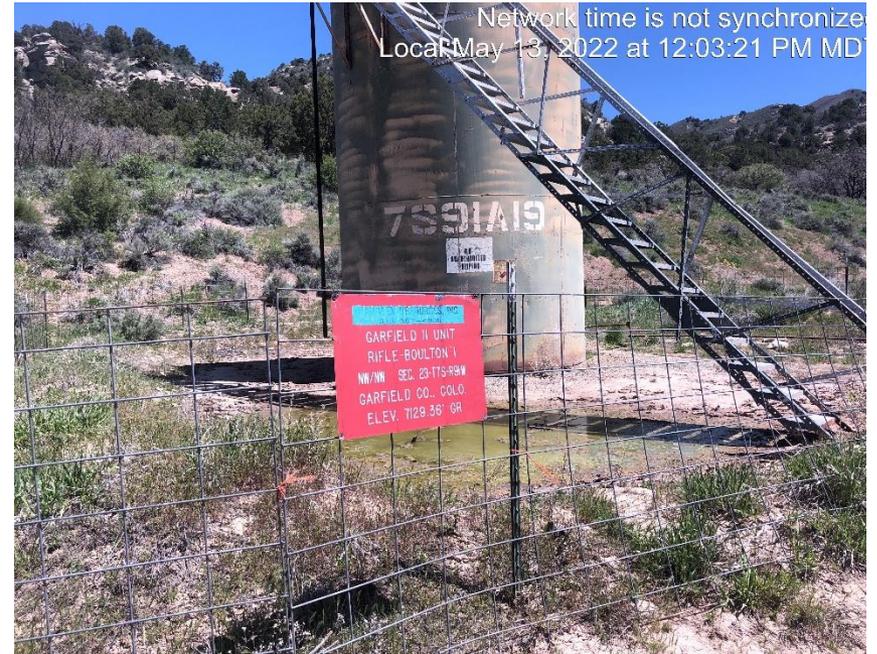
Photo #6708 Information on battery sign inaccurate.

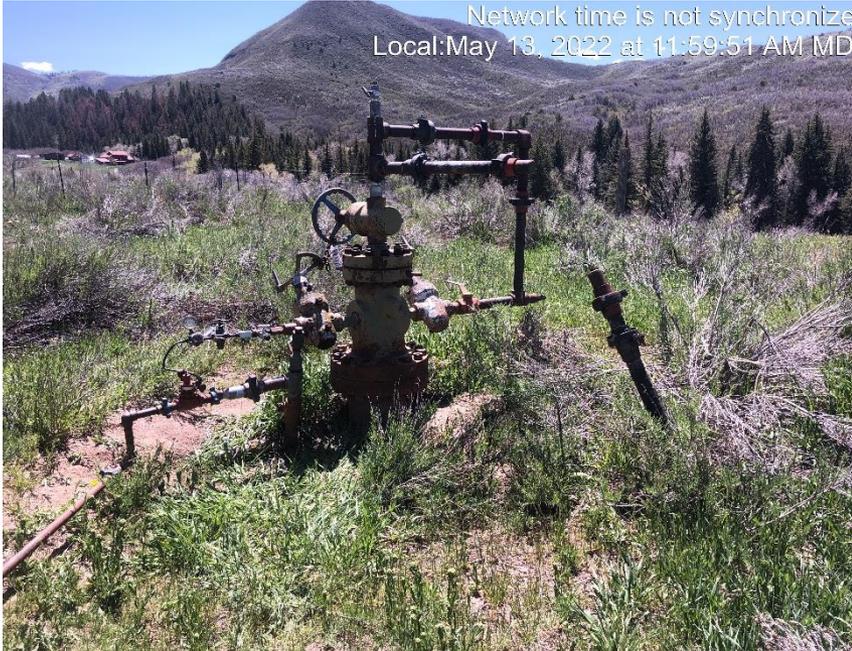
Photo #6705 No wellhead sign located at the well head.

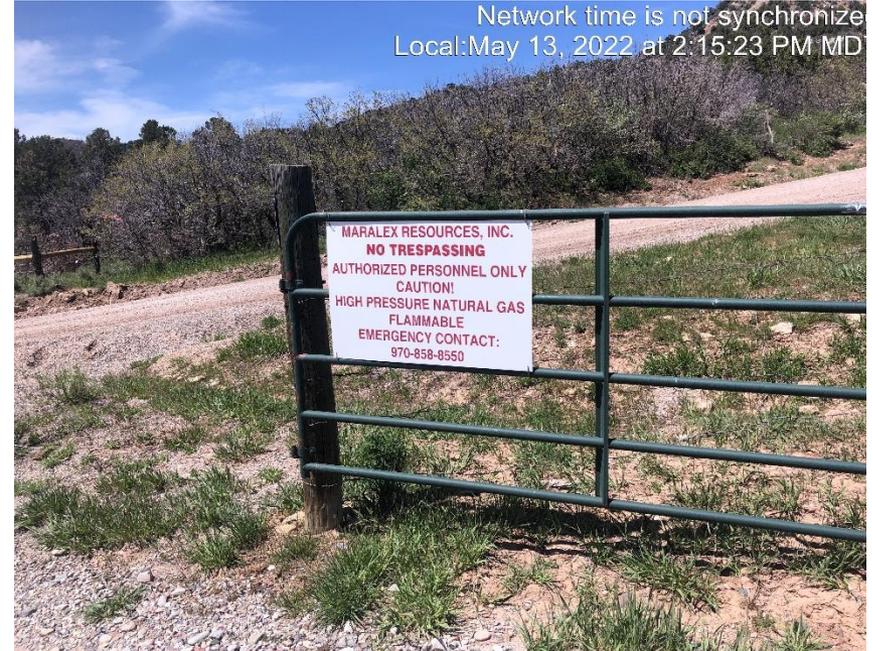
Photo #6721 Local emergency contact number not posted. Number that is posted is Maralex western slope office number.

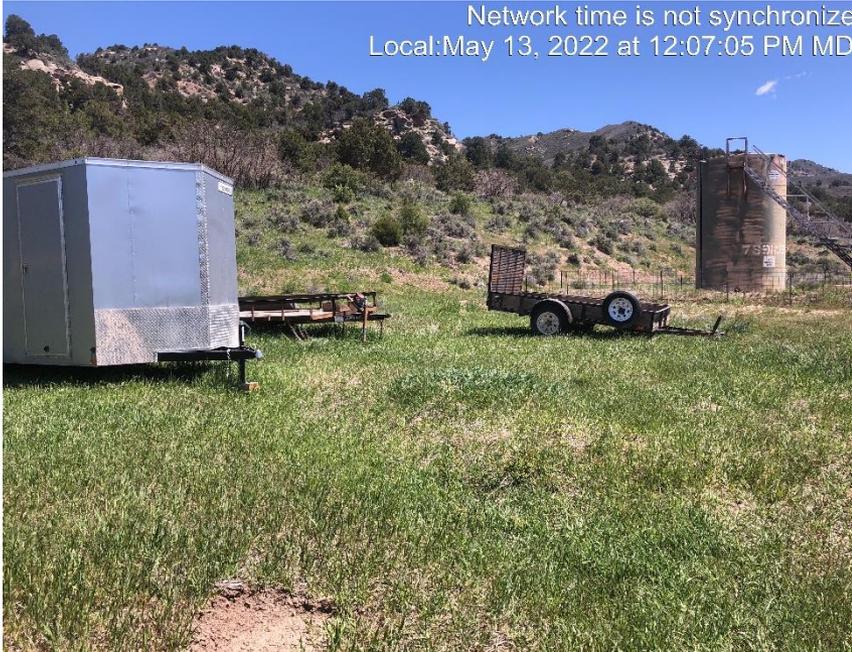
Photo #6714 Multiple trailers parked on location.

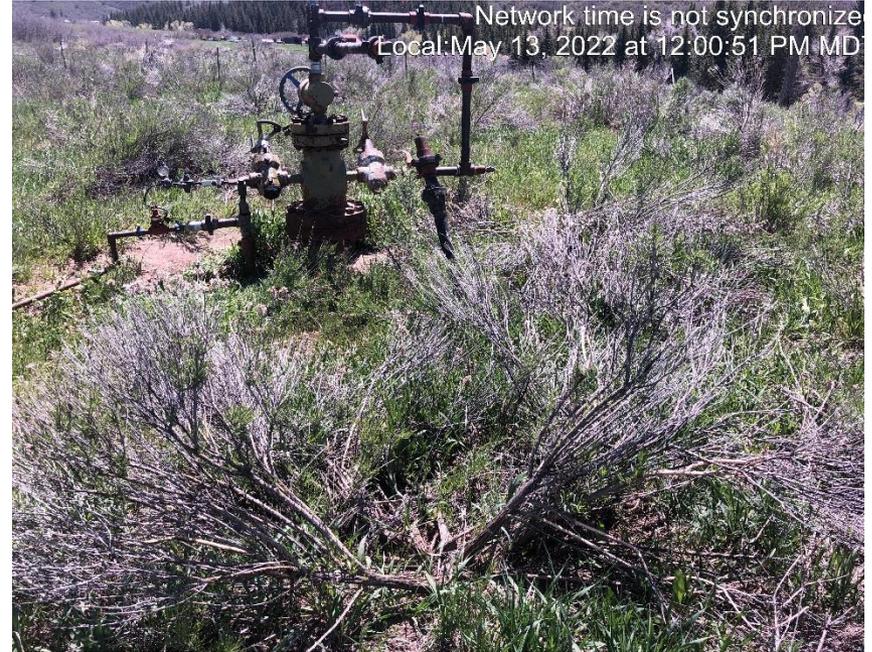
Photo #6706 Multiple places with undesirable plant species encroaching on equipment.

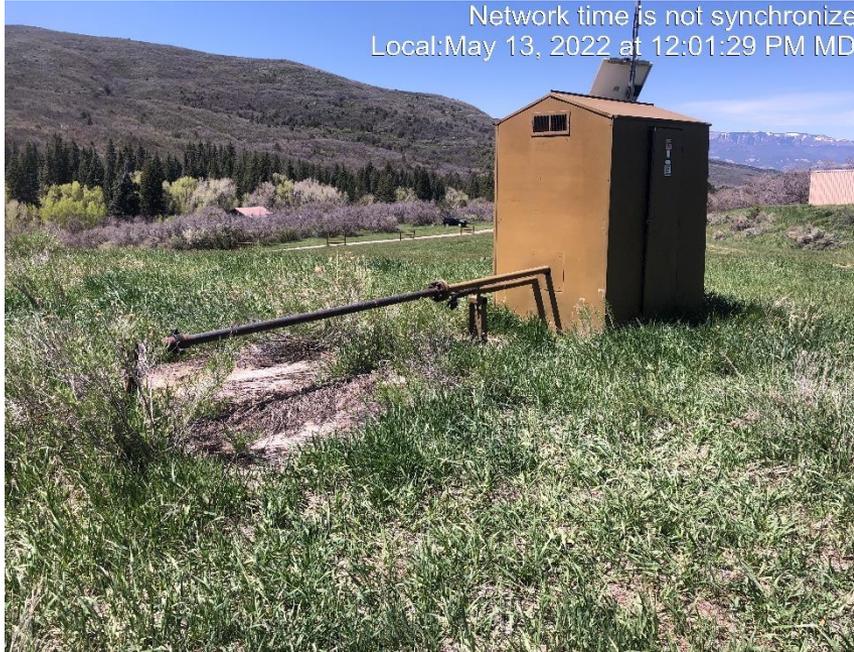
Photo #67075 Multiple places with undesirable plant species encroaching on equipment.

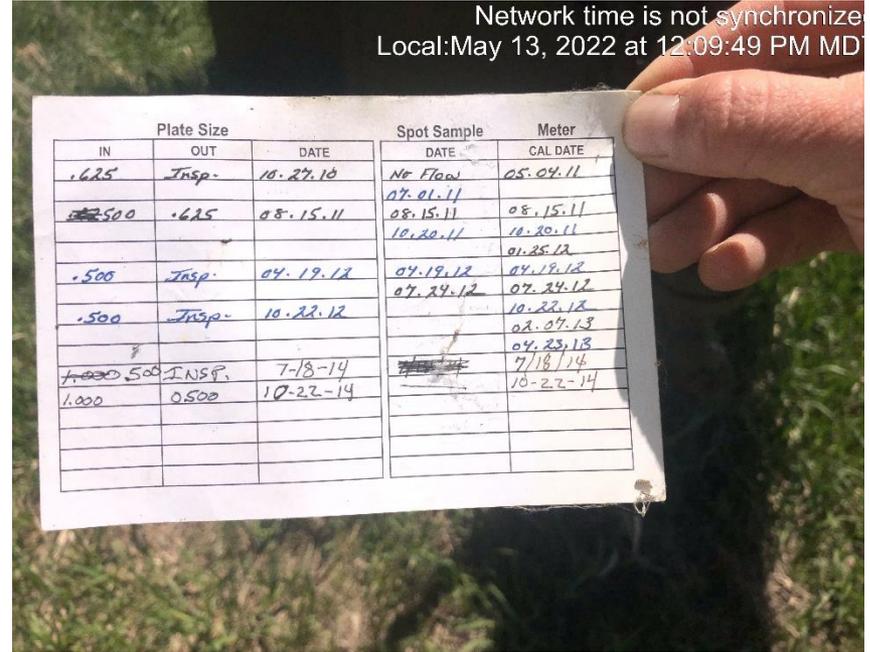
Photo #6717 Gas meter out of calibration.

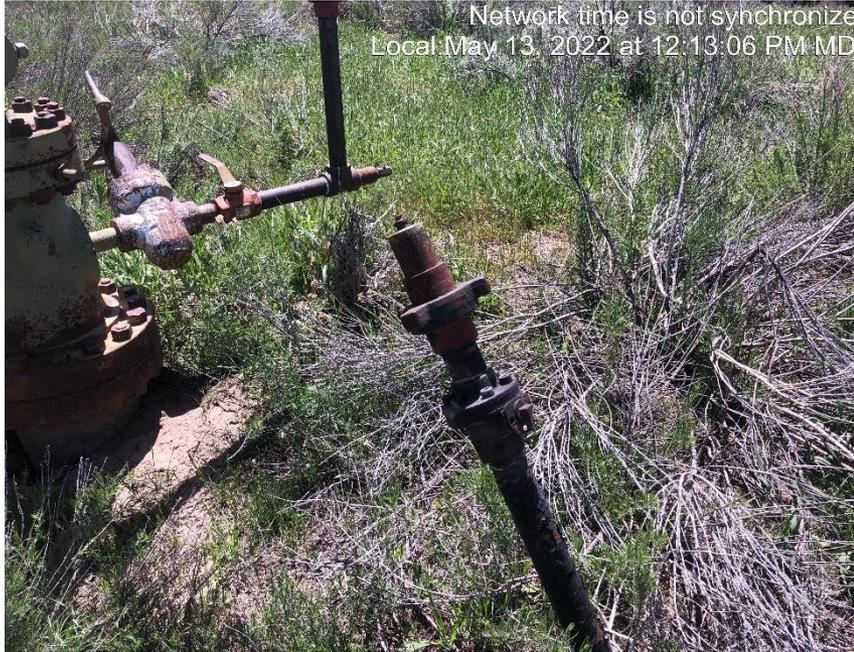
Photo #6718 Flowline improperly abandon.

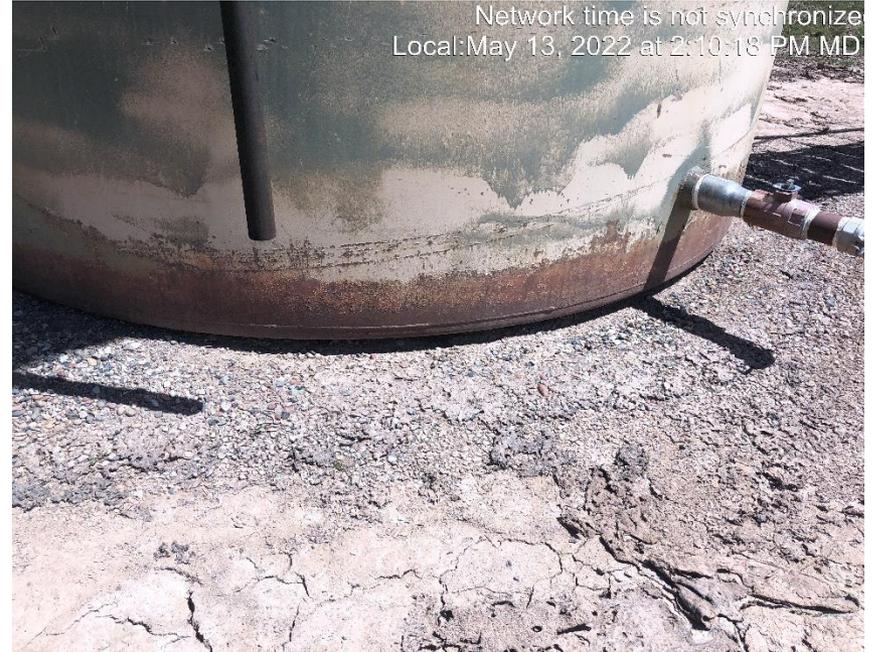
Photo #6720 Vent pipe on tank open.

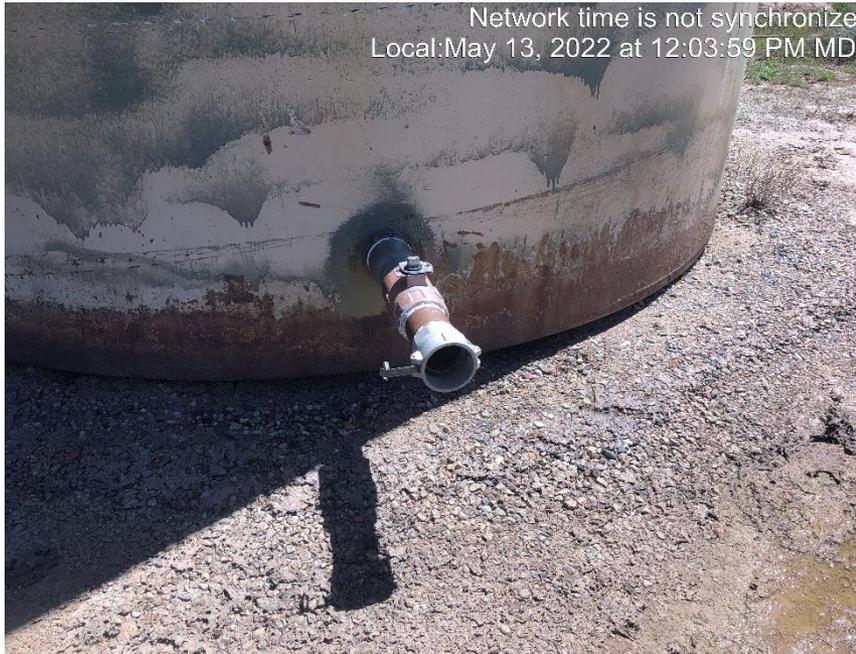
Photo #6709 Loadline open ended.

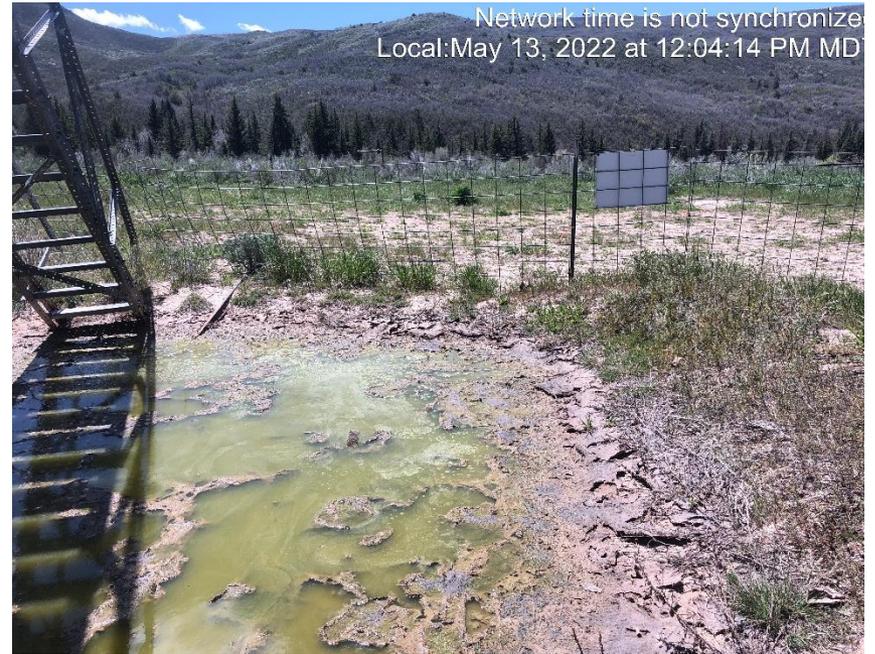
Photo #6710 Secondary containment is not sufficiently impervious to contain spilled or released materials.

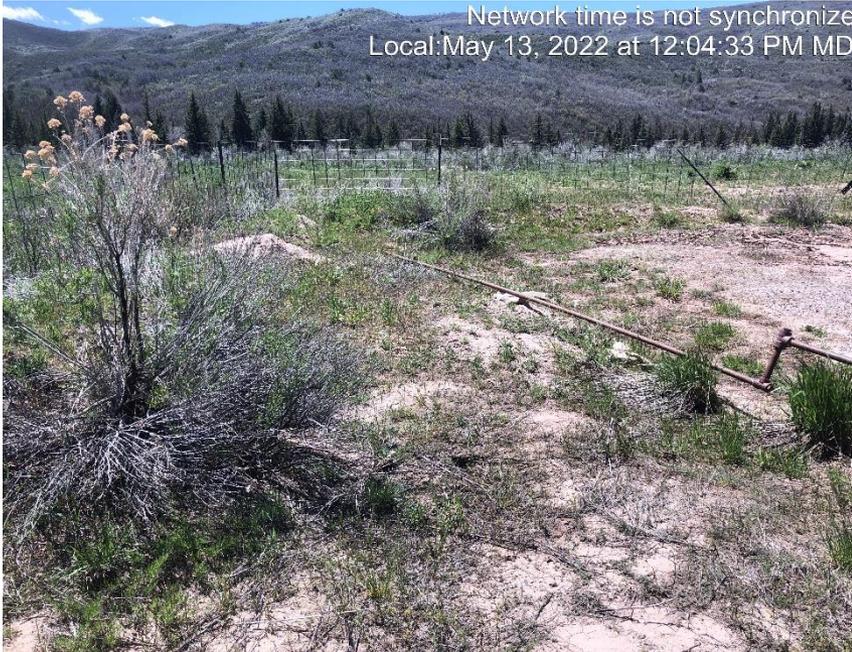
Photo #6711 Secondary containment is not sufficiently impervious to contain spilled or released materials.

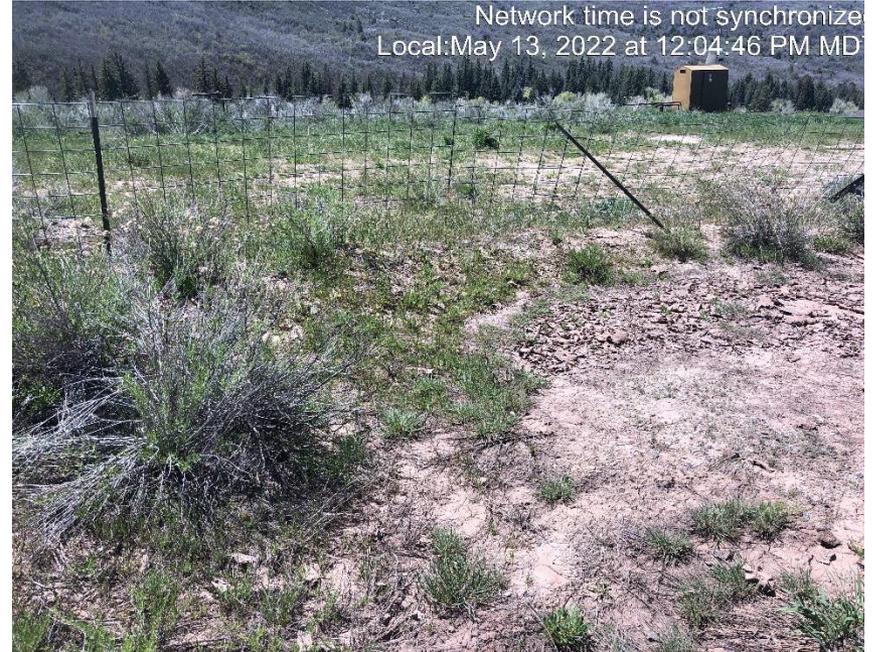
Photo #6712 Secondary containment is not sufficiently impervious to contain spilled or released materials

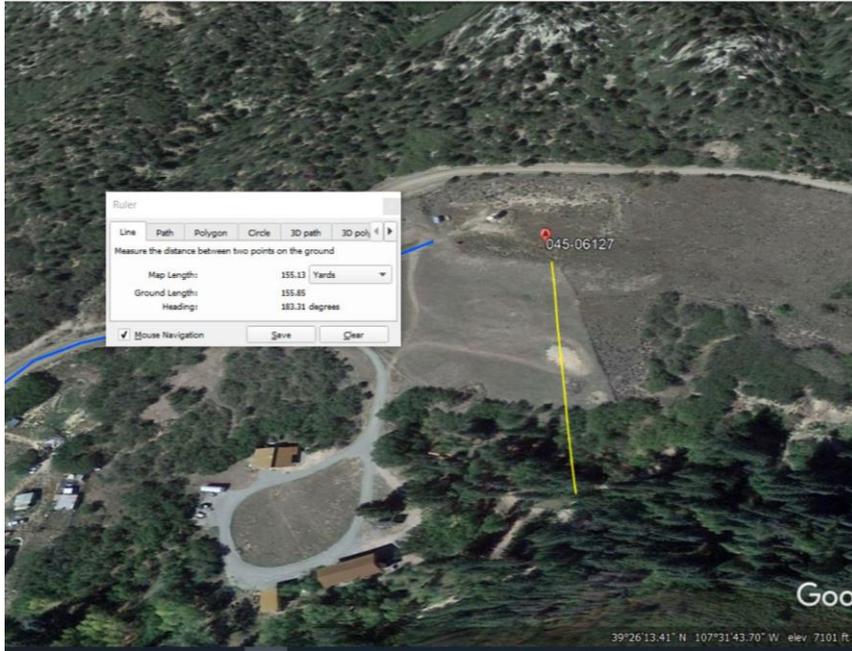
Location is approximately 150 yards from East Divide Creek.

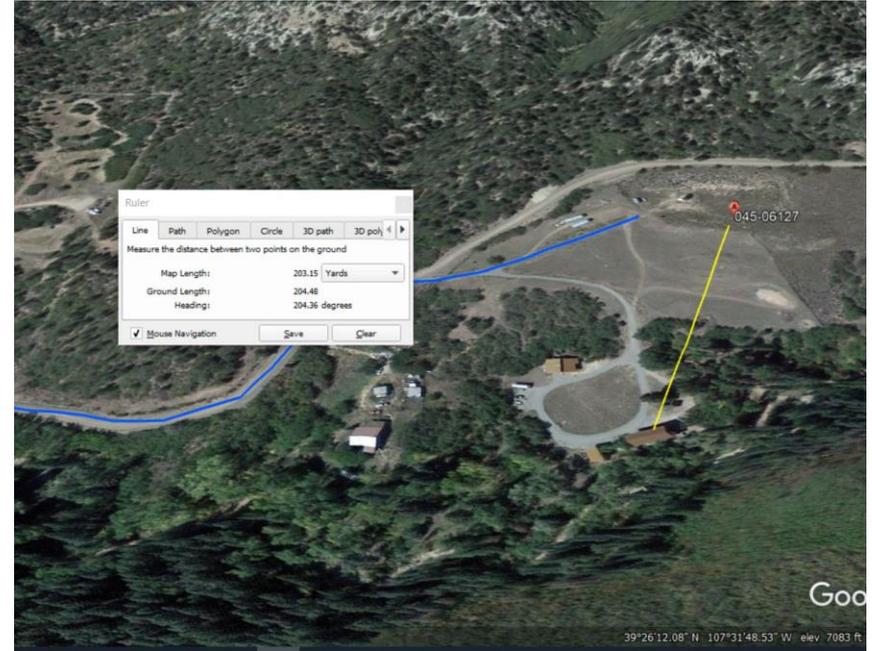
Location is approximately 200 yards from the nearest residences.
