Inspection Photos

May 13, 2022

Operator: Beeman Oil & Gas LLC - #7125

Location Name: Bulldog /5-14H-789

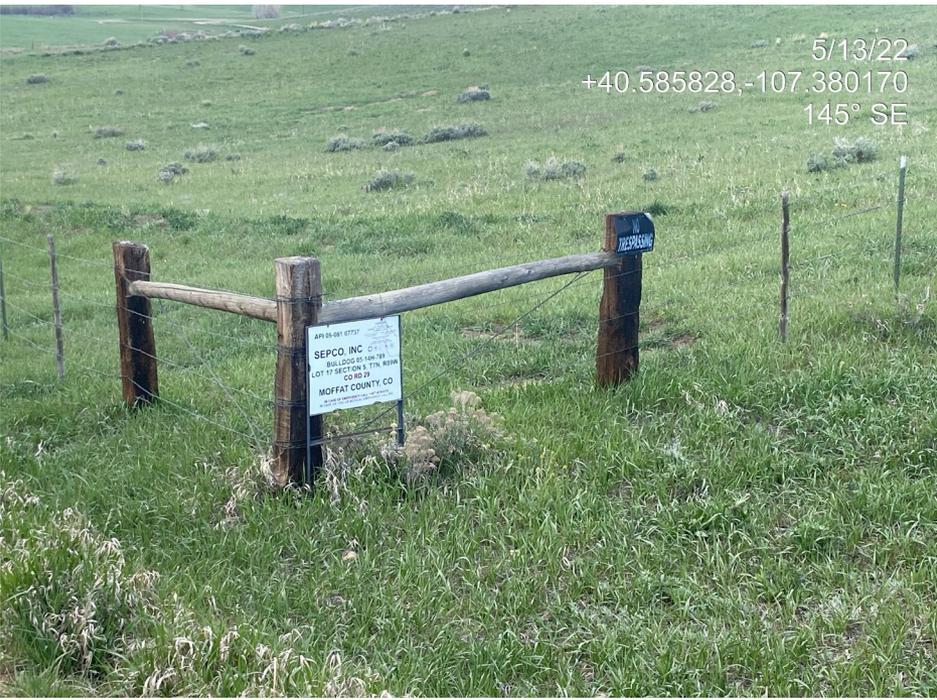
Photo 1. Photo taken from the entrance road shows Location signage with incorrect Operator information.

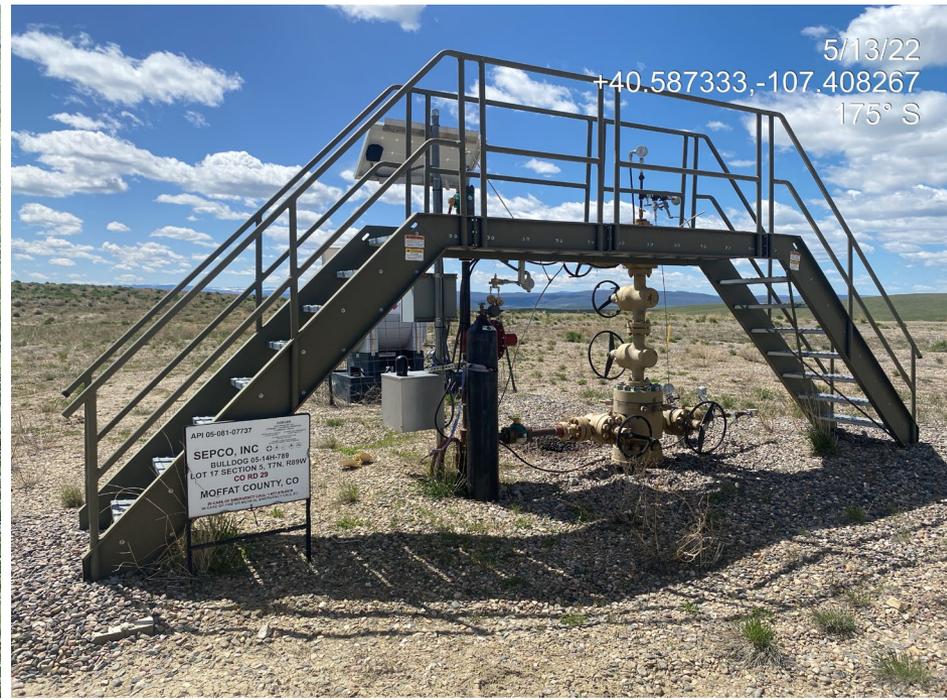
Photo 2. Photo taken from the wellhead shows signage with incorrect Operator information.

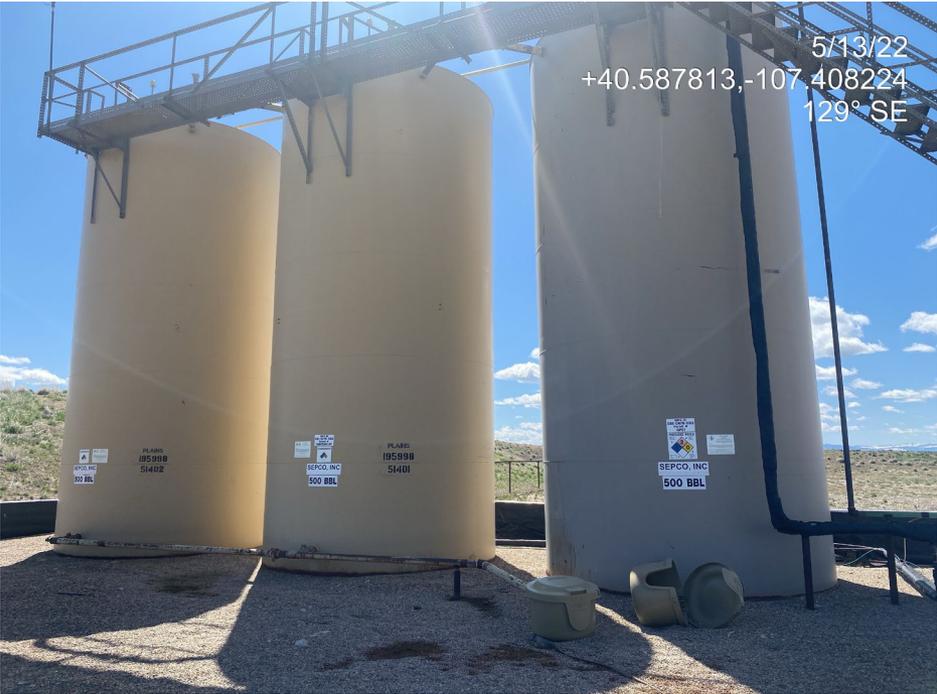
Photo 3. Photo taken from the tank battery shows incorrect Operator information on the tanks.

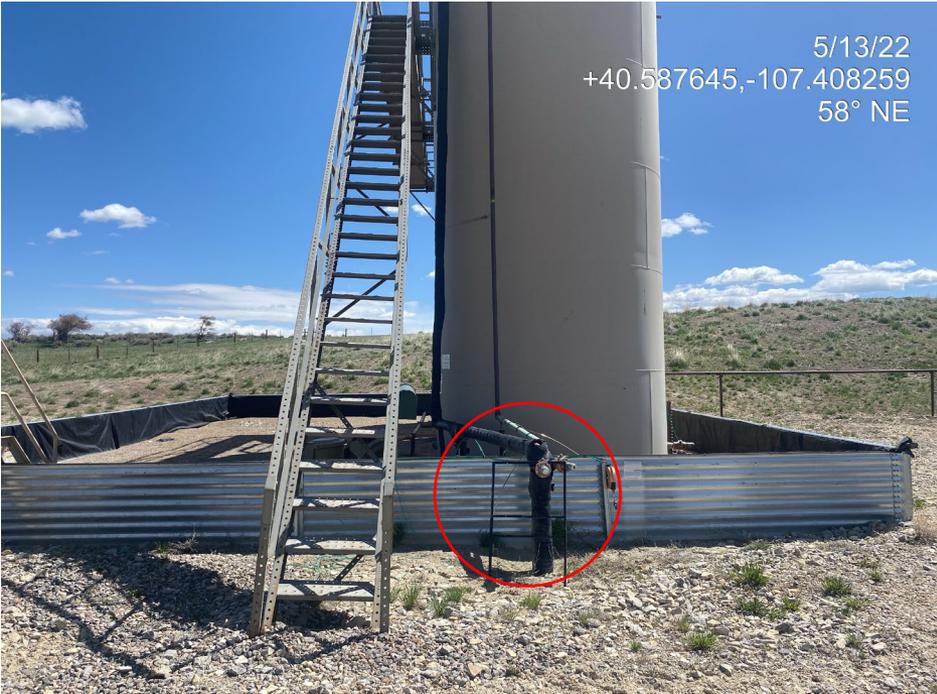
Photo 4. Photo taken from the tank battery shows Location signage is absent.

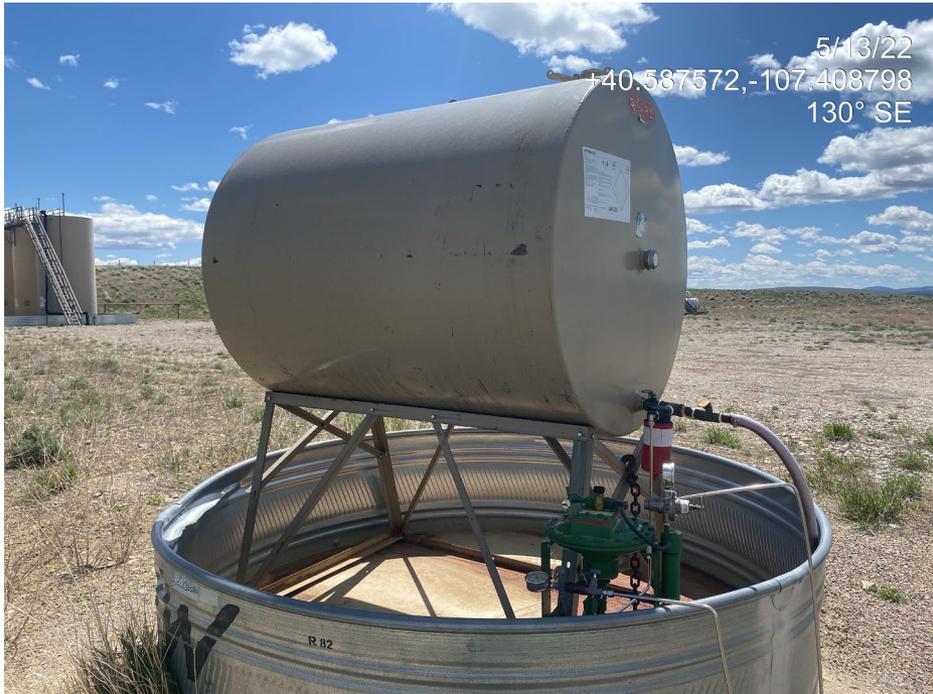
Photo 5. Photo taken from the north of the Location shows a methanol tank secondary containment stock tank lacking wildlife protection BMPs.

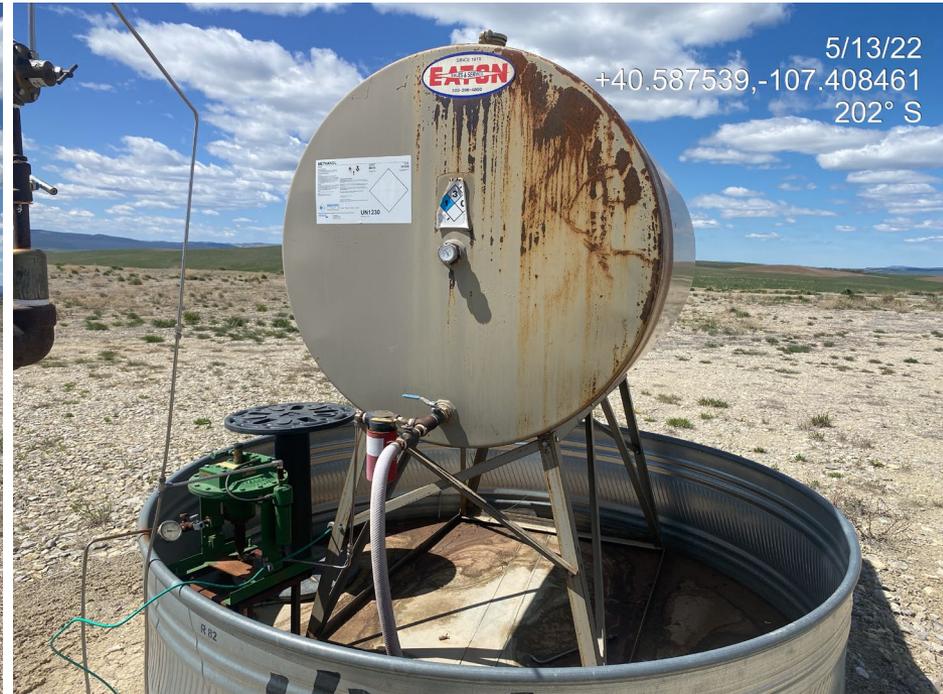
Photo 6. Photo taken from the north of the Location adjacent to the compressor shed shows a methanol tank secondary containment stock tank lacking wildlife protection BMPs.

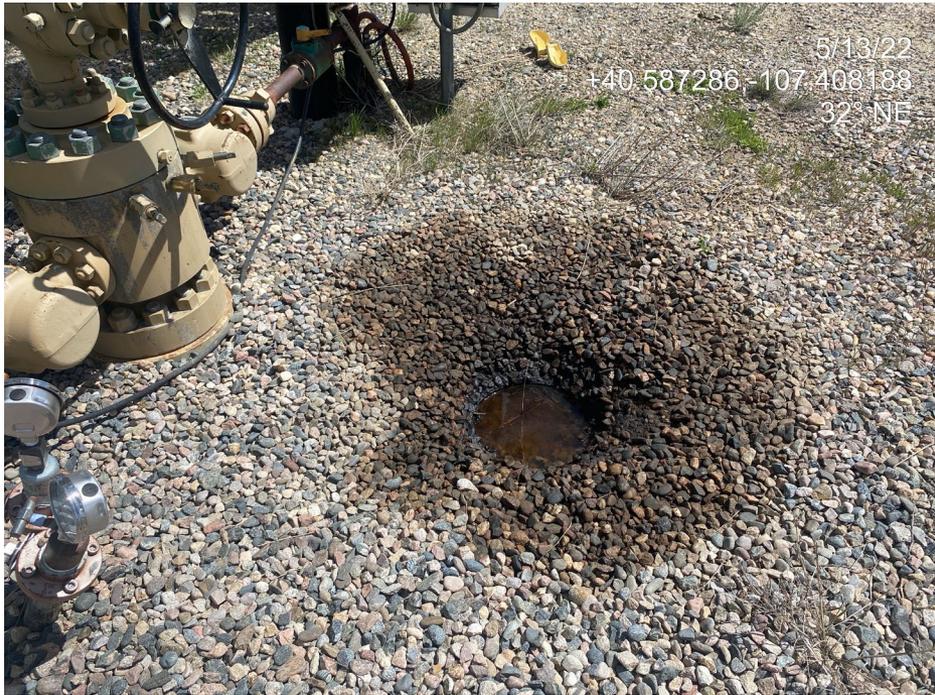
Photo 7. Photo taken from the wellhead shows an open casing.

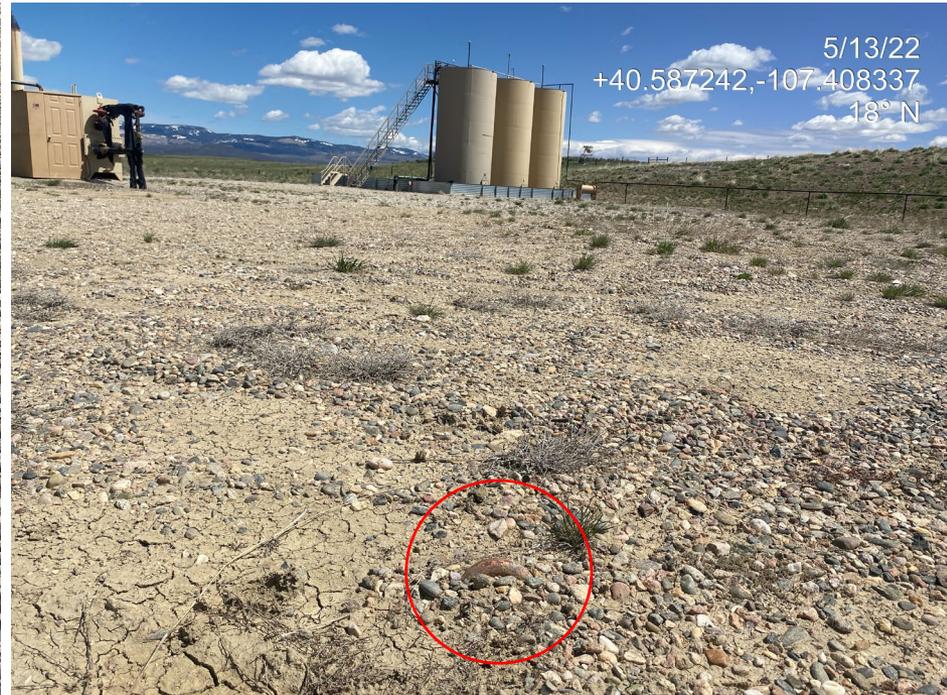
Photo 8. Photo taken from the northwest of the well shows an unmarked anchor.

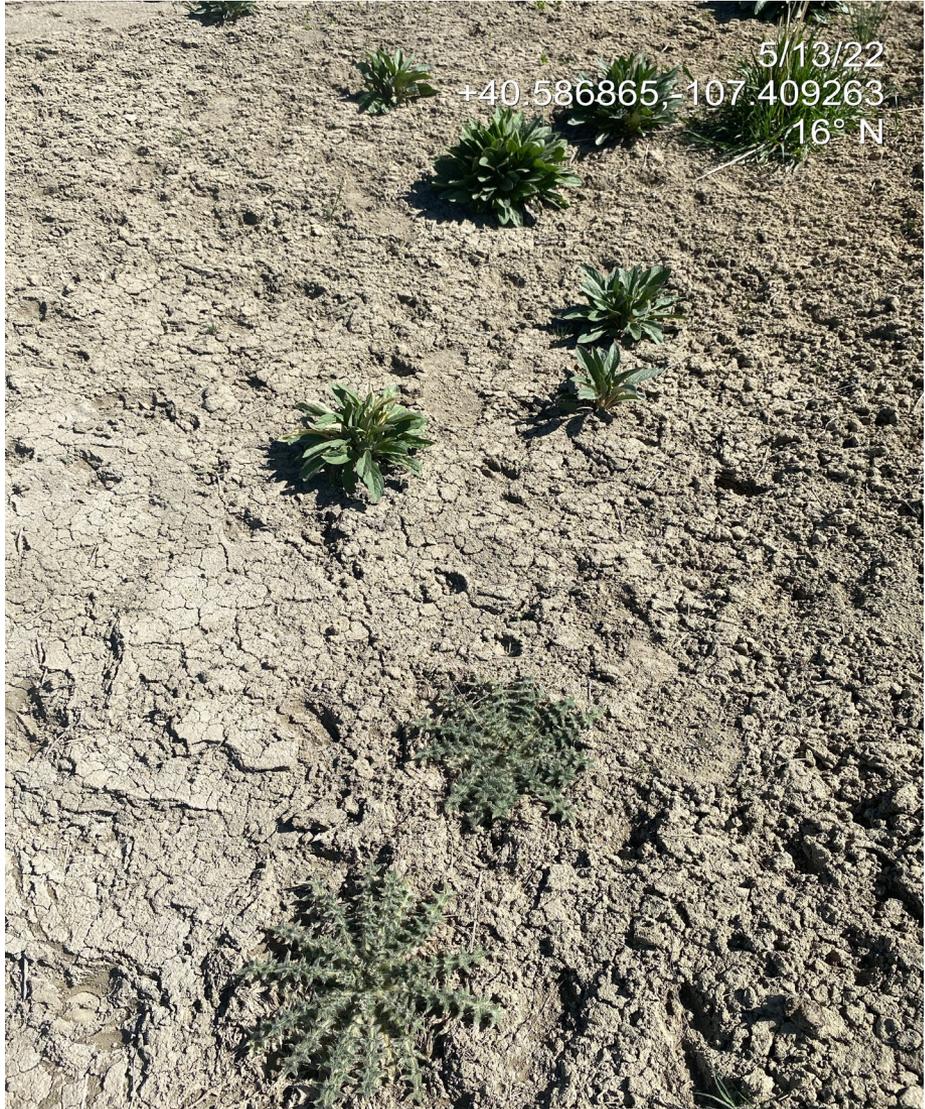
Photo 9. Photo taken from west of the Location shows houndstongue and bull thistle. CO List B Noxious weeds.

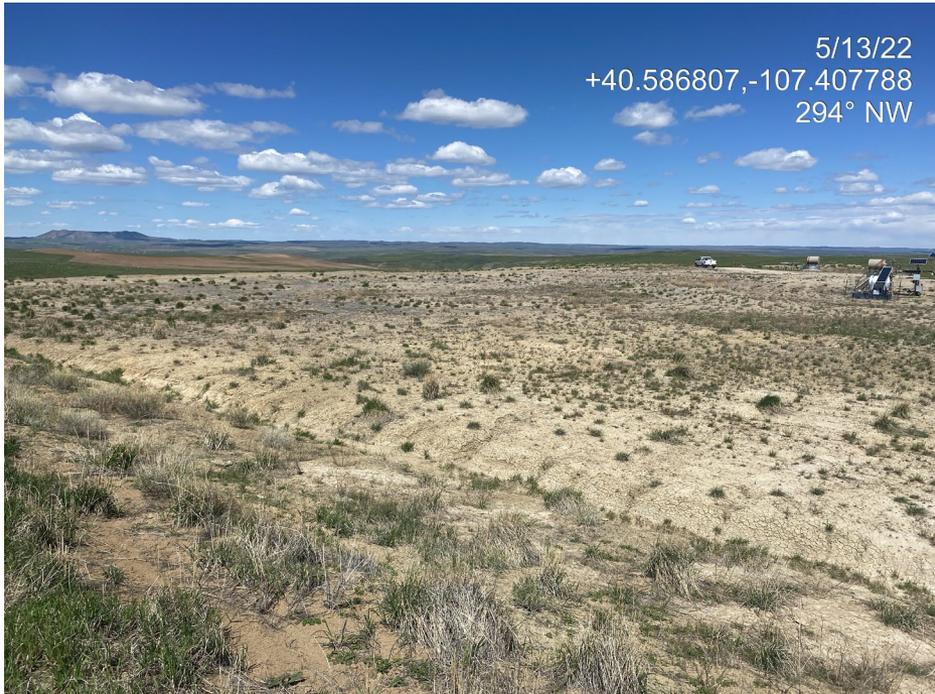
Photo 10. Photo taken from the south of the Location shows areas requiring interim reclamation.

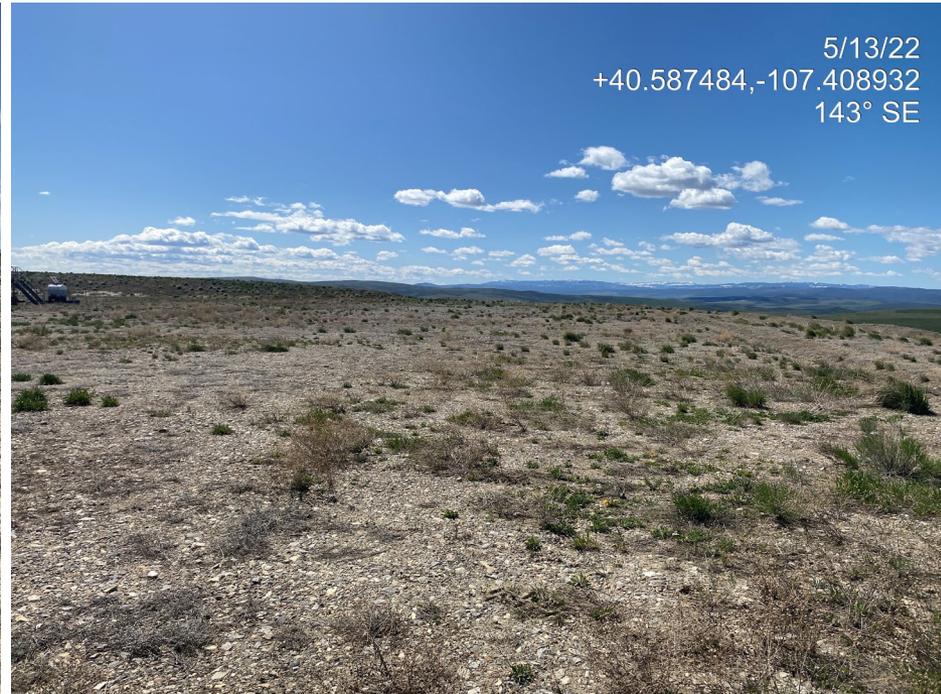
Photo 11. Photo taken from the northwest of the Location shows areas requiring interim reclamation.

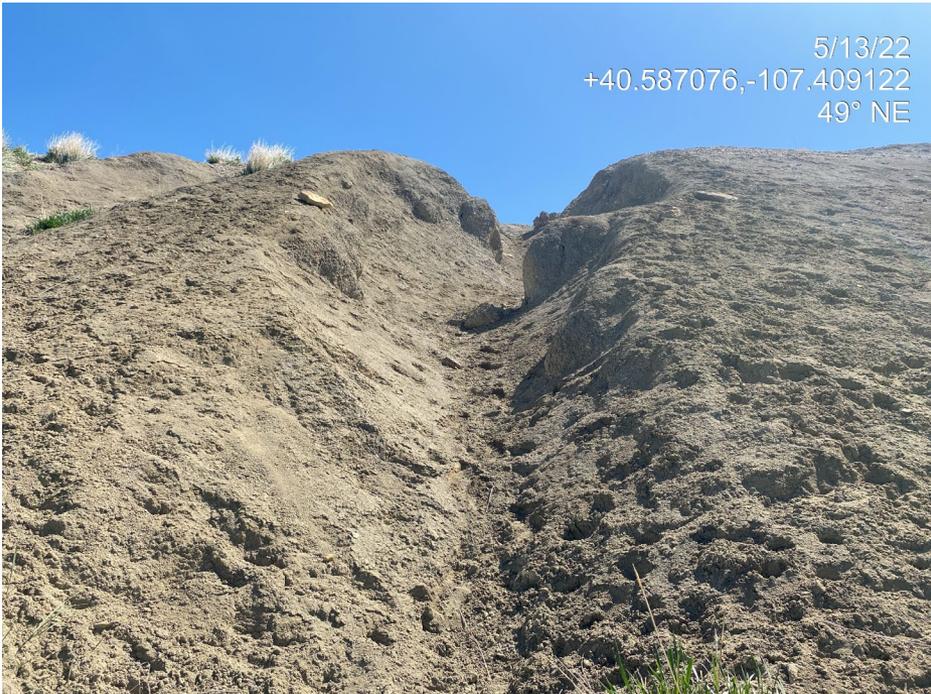
Photo 12. Photo taken from the west of the Location shows where a stormwater berm is not properly designed or maintained in proper functioning condition. Stormwater has incised the berm resulting in a large gully.

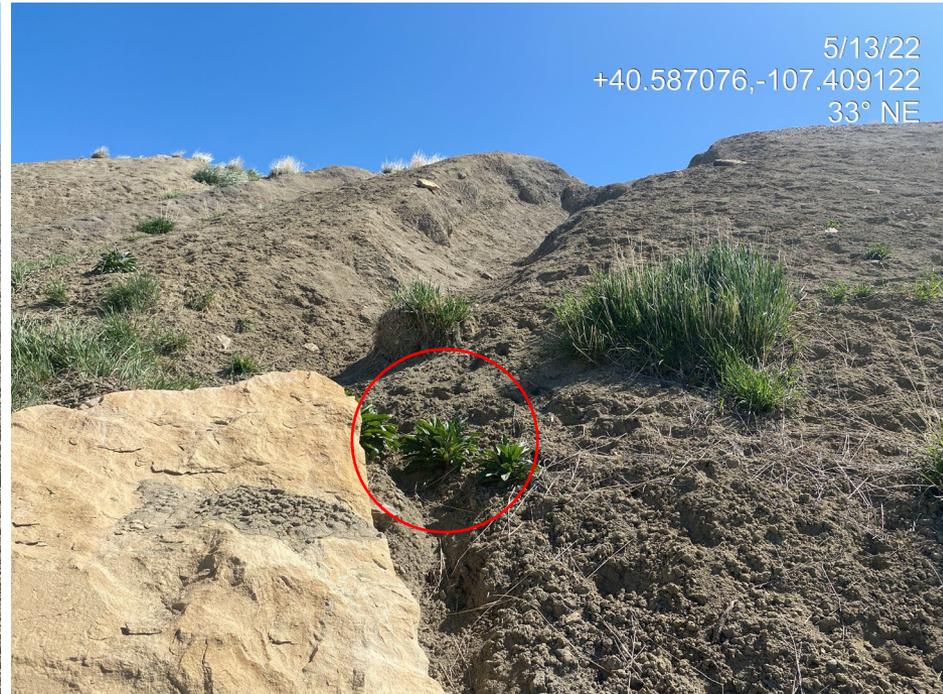
Photo 13. Refer to Photo 12 comment. Note also the houndstongue, a CO List B Noxious weed.

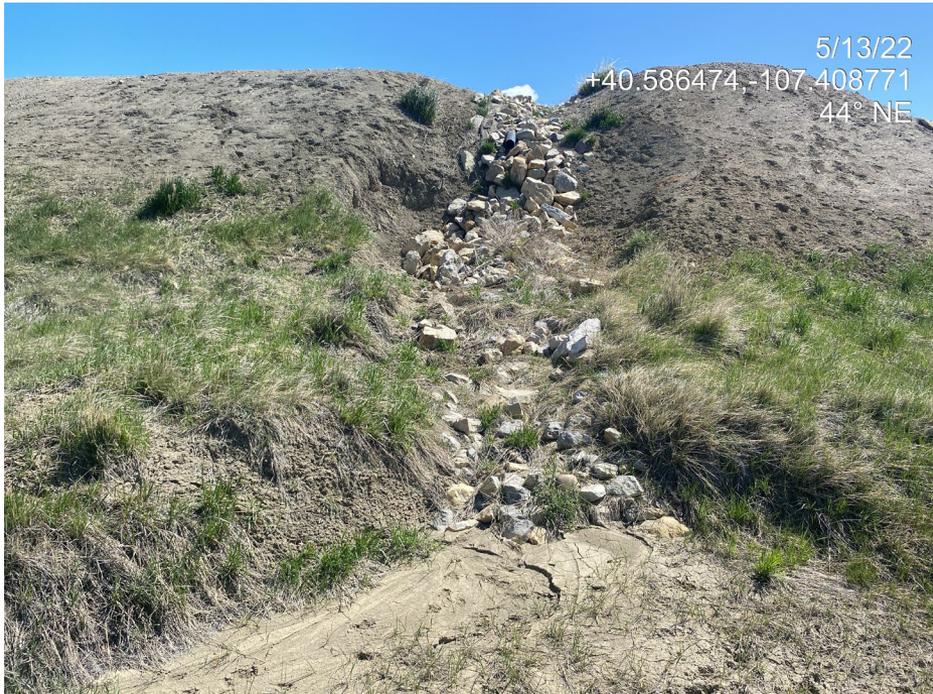
Photo 14. Photo taken from the southwest of the Location shows where a stormwater pipe is not properly designed or maintained in proper functioning condition. Stormwater has incised the berm around the pipe resulting in a large gully.

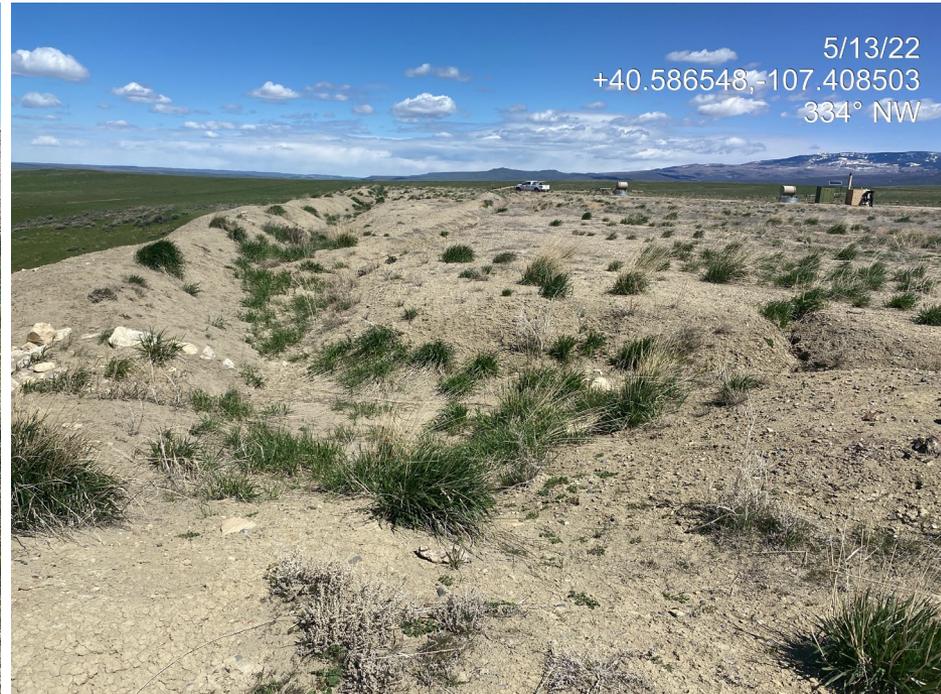
Photo 15. Photo taken from the southwest of the Location shows where perimeter ditches lead into a discharge pipe. Erosion of the pad in multiple directions leading into the ditch and pipe is evident.

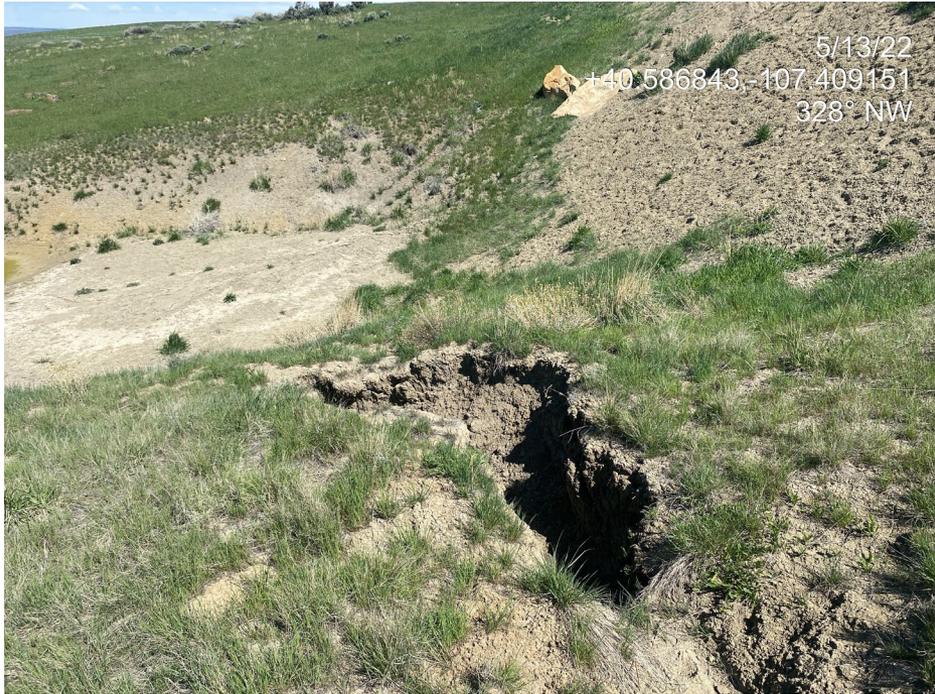
Photo 16. Photo taken adjacent from the west of the Location shows where a stormwater ditch is eroding and forming a gully.

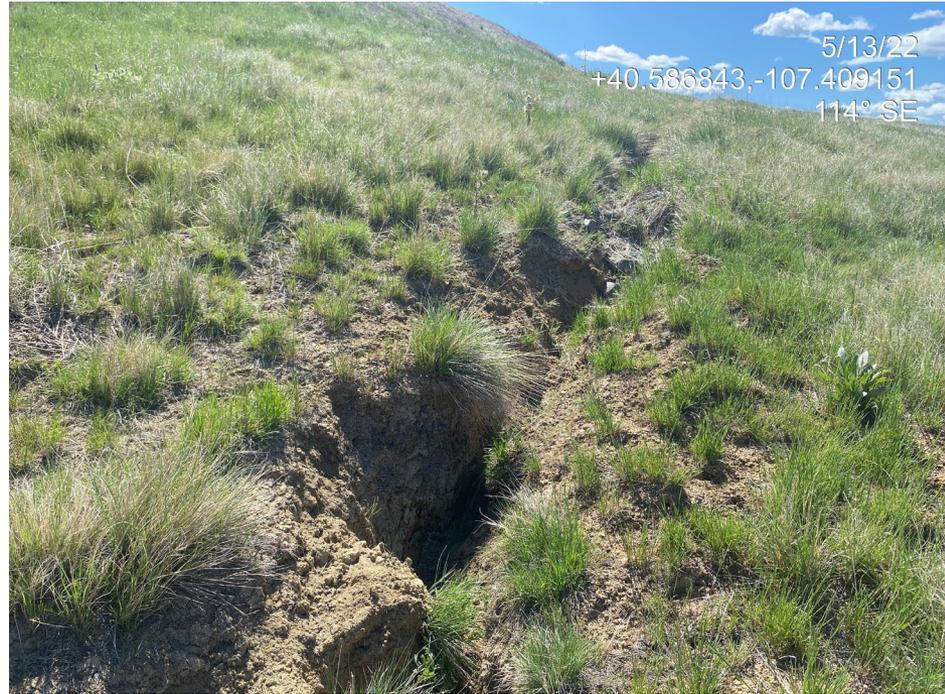
Photo 17. Refer to Photo 16 comment.
