Inspection Photos

API: 073-06189

Operator: MAGPIE OPERATING INC

Inspection Date: 5/17/2022

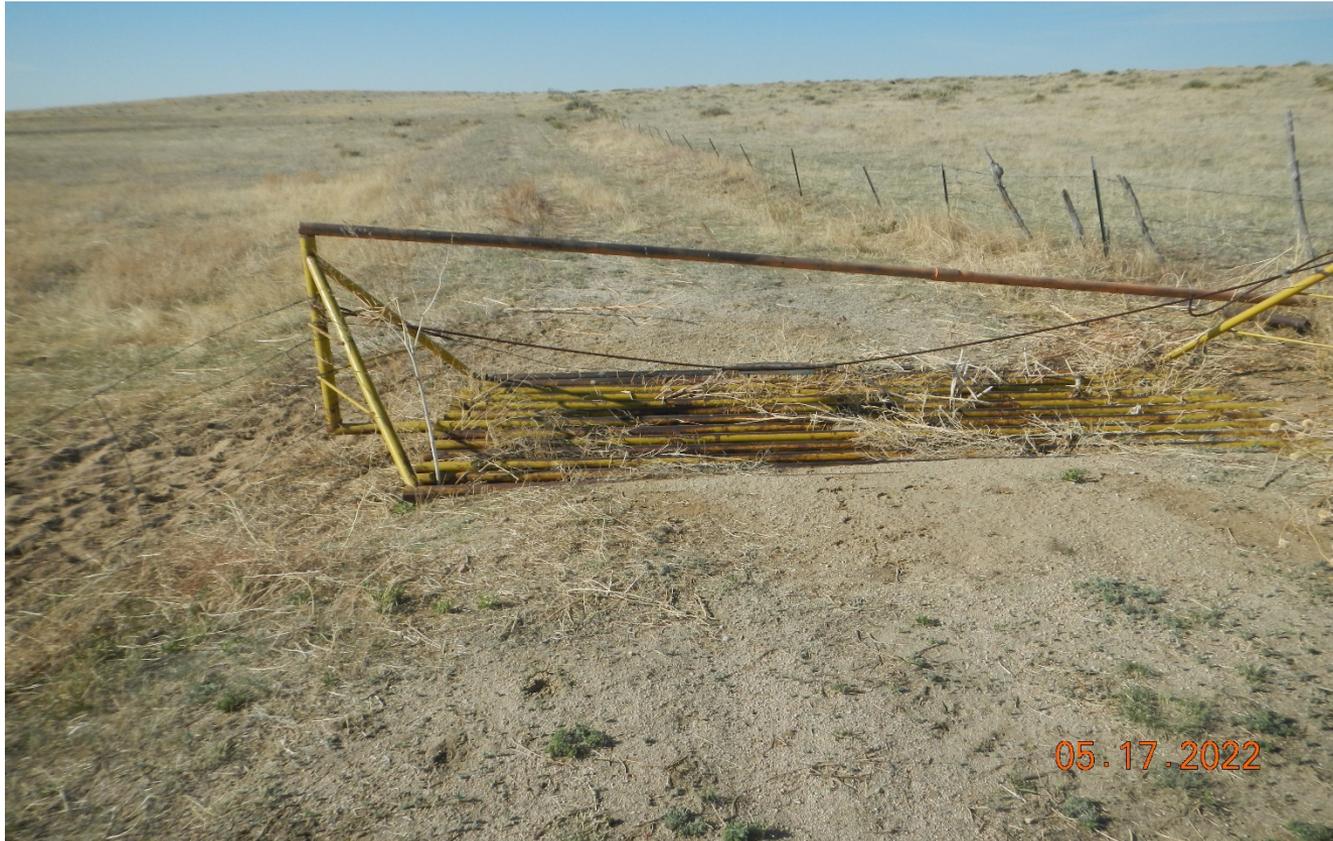
Photo 1. Facing south toward the access road. The cattle guard has not been removed and is filled in with sediment.

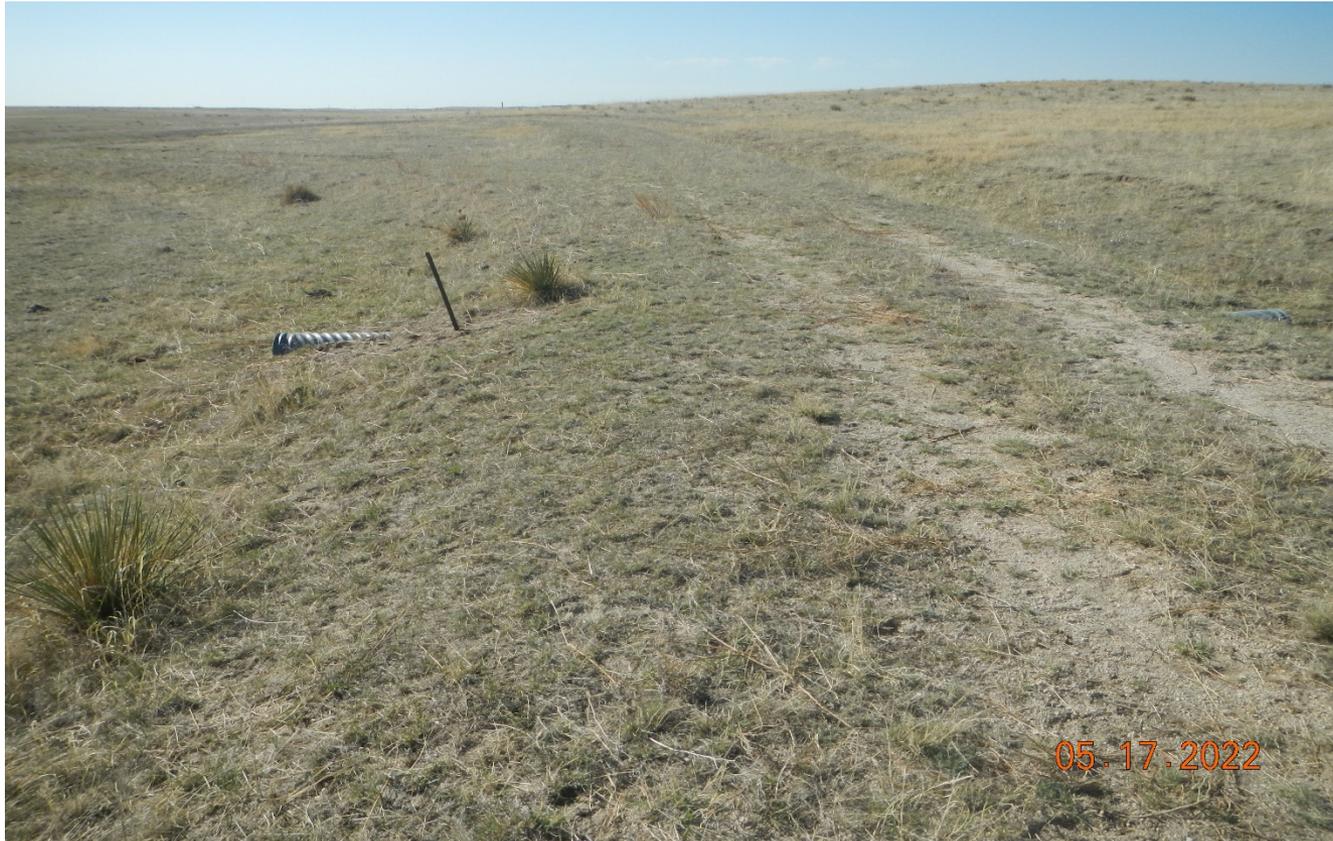
Photo 2. Facing southeast along the access road . The road has not been recontoured and culverts remain.

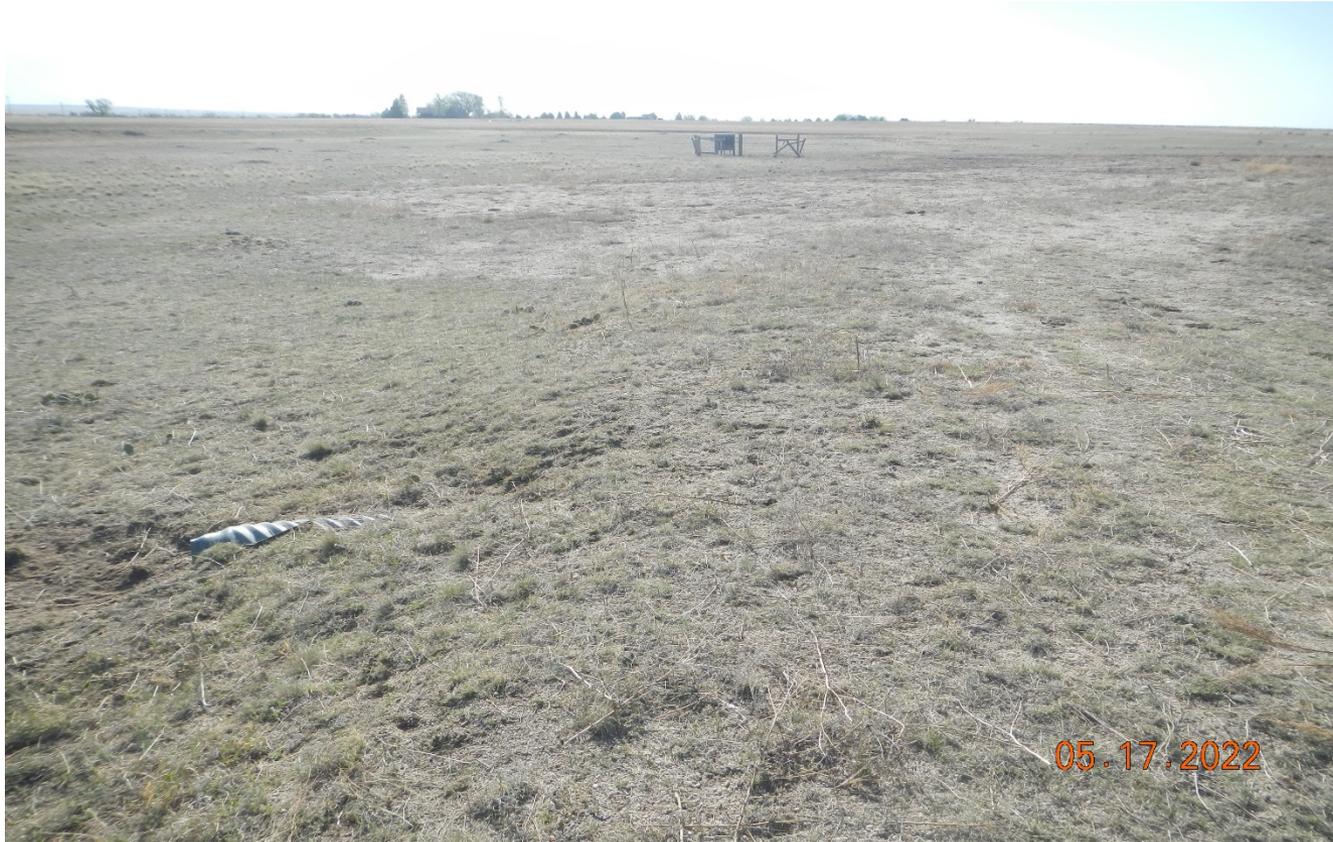
Photo 3. Facing east along the access road toward the location. The road has not been recontoured and culverts remain.

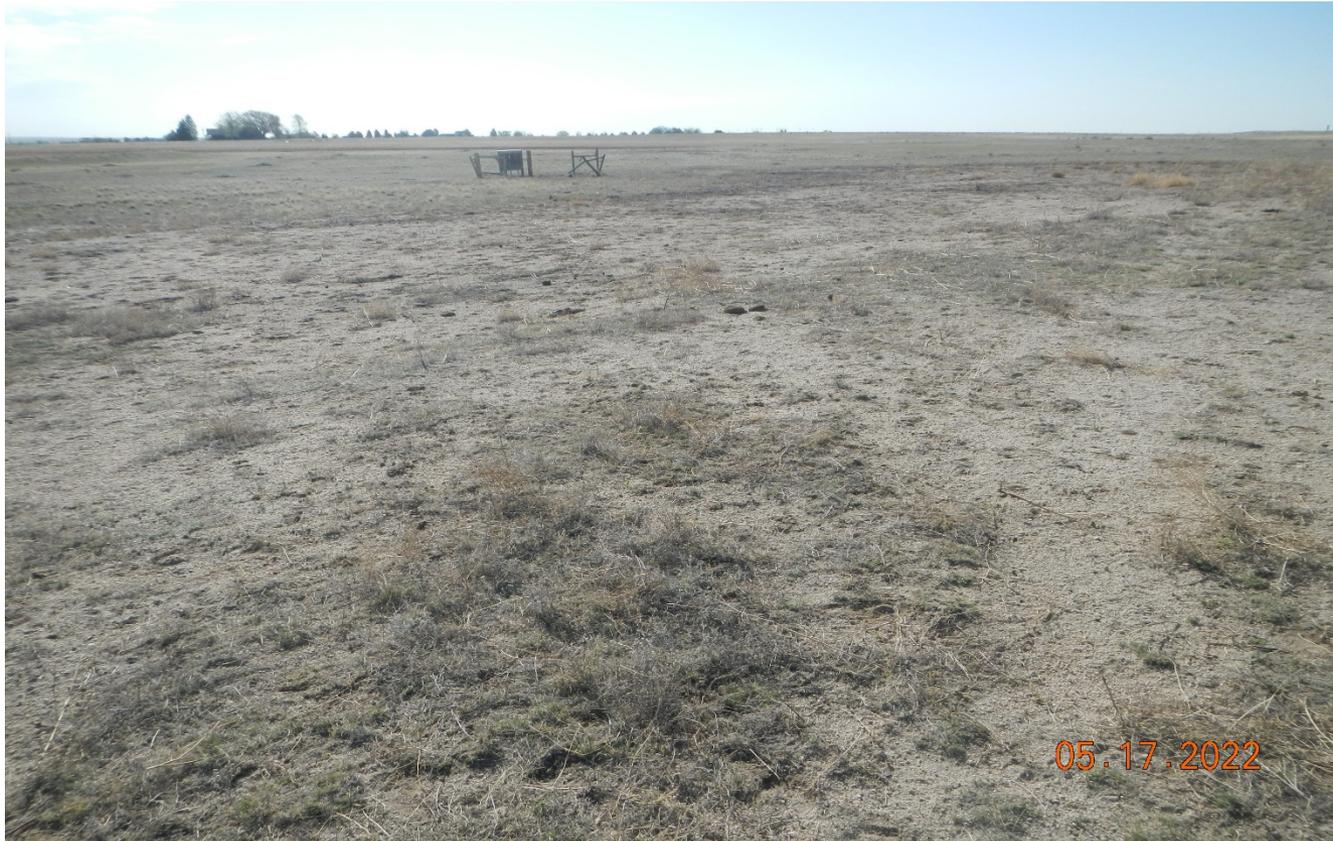
Photo 4. Facing east at the location. The location has not been reclaimed and soils are bare of vegetation.

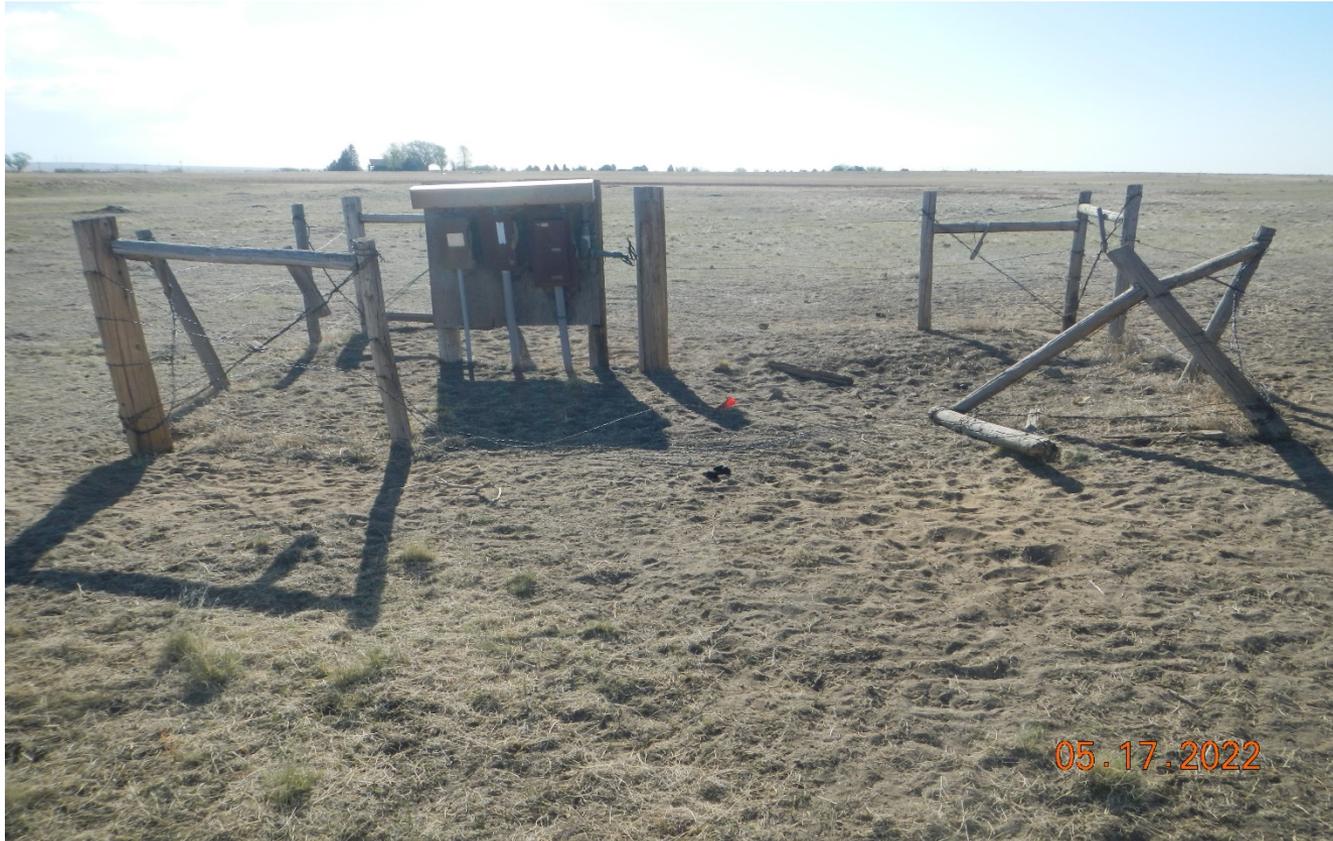
Photo 5. There is electric utilizes and a fence in disrepair that remain at the location. All equipment should have been removed within 3 months of abandonment.

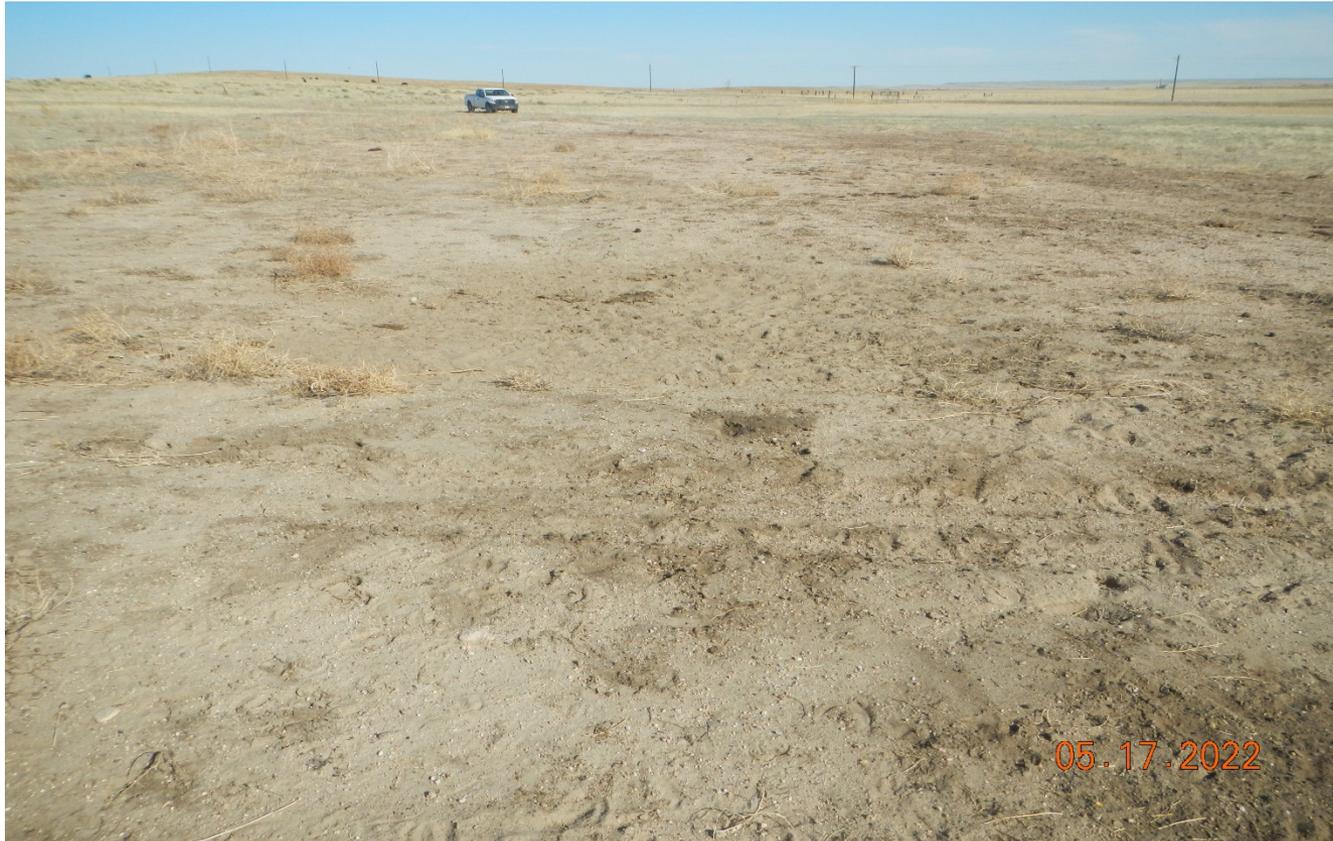
Photo 6. Facing northwest at the location. This area approximately 150'x100' is bare of vegetation. The location has not been reclaimed.

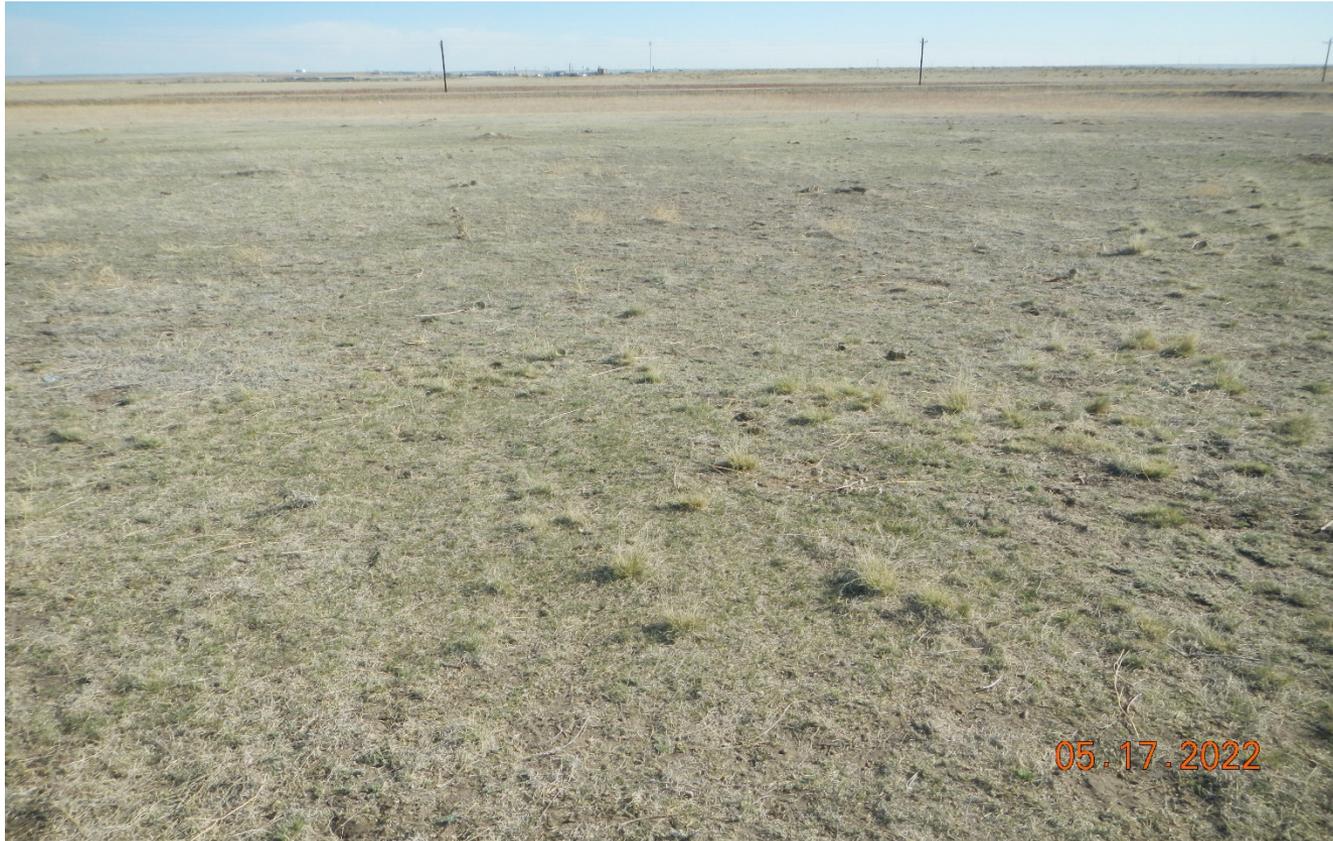
Photo 7. Facing toward the surrounding reference area consisting of Blue grama, Sand dropseed, among other native species.
