Inspection Photos
Location Name: Cundall #6-12
Location ID: 320504

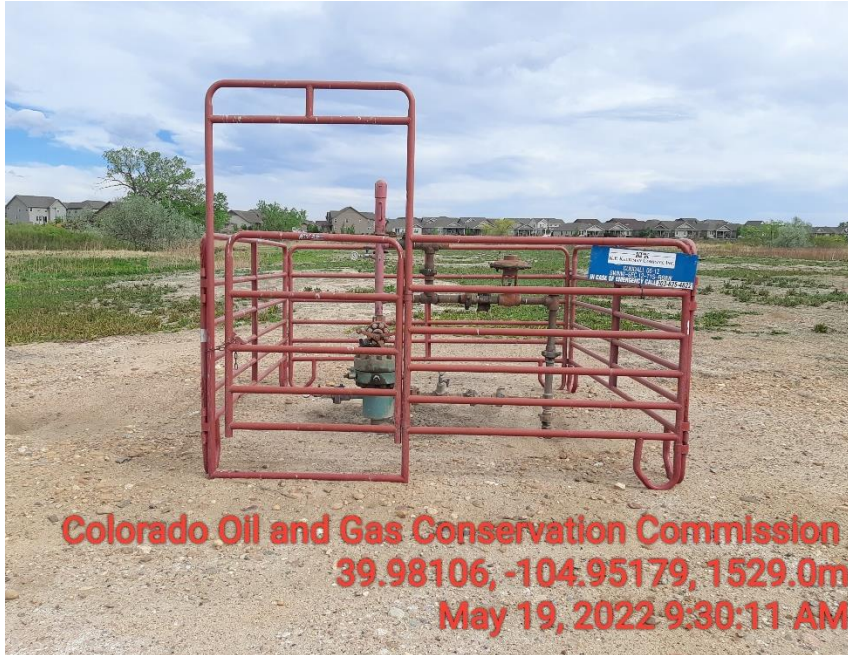
Photo 1 well head

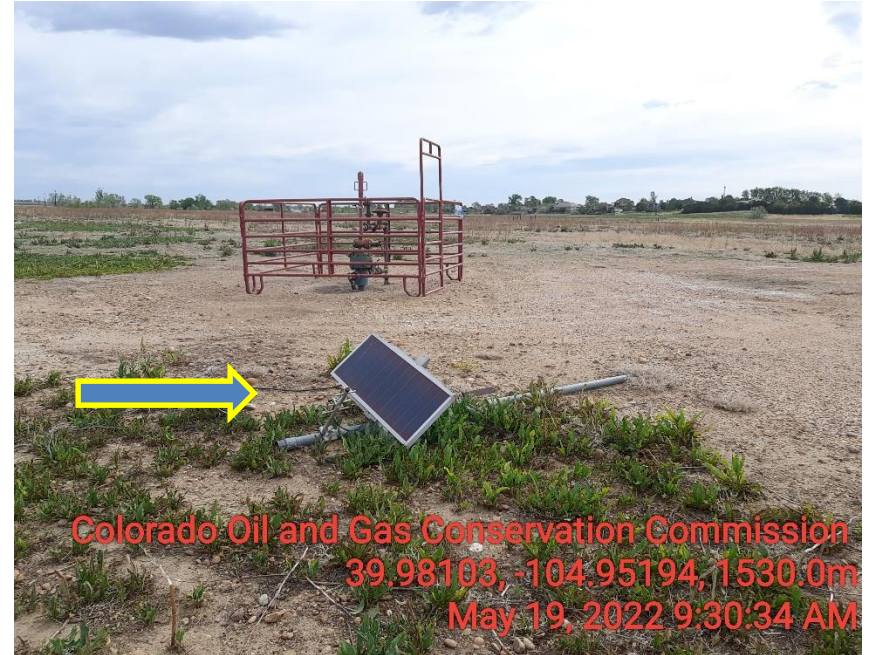
Photo 2 Trash

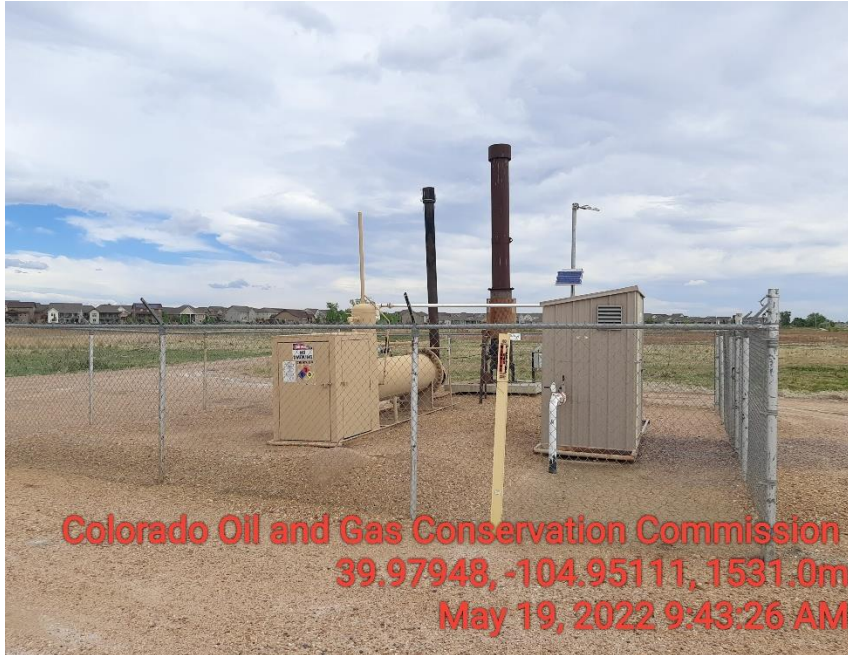
Photo 3 Production equipment

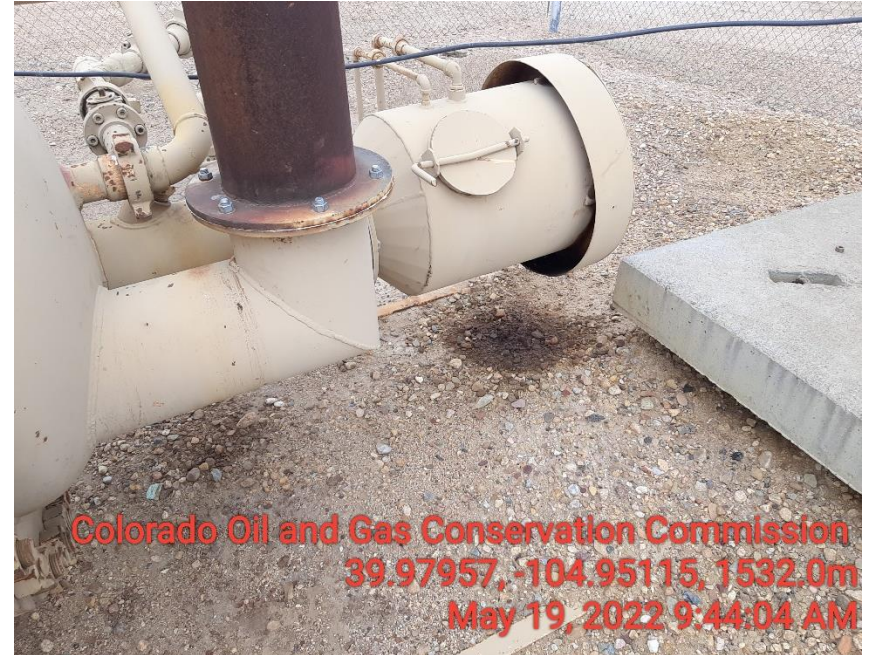
Photo 4 Stained soil and mechanical issue Hoz heated separator

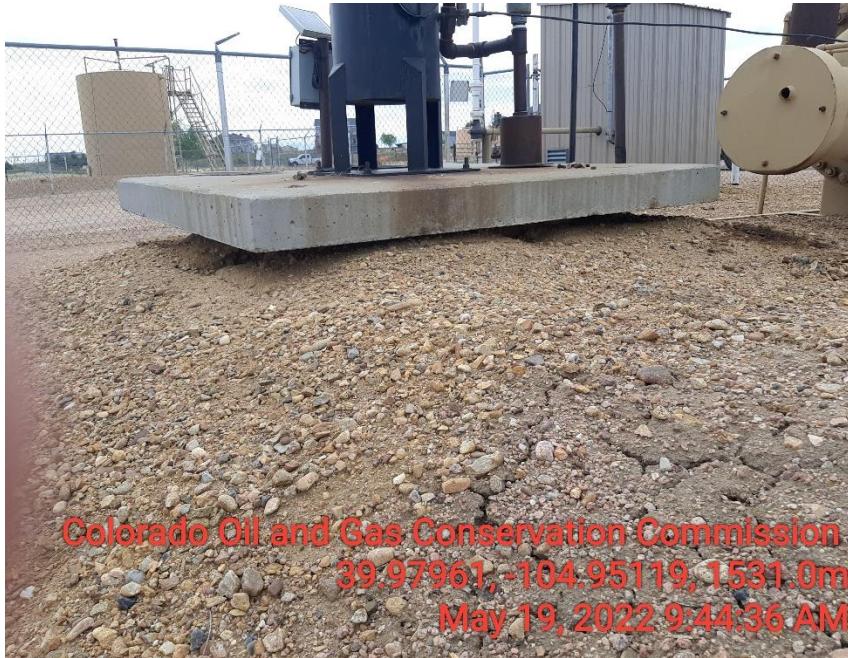
Photo 5 unsafe condition ECD cement base

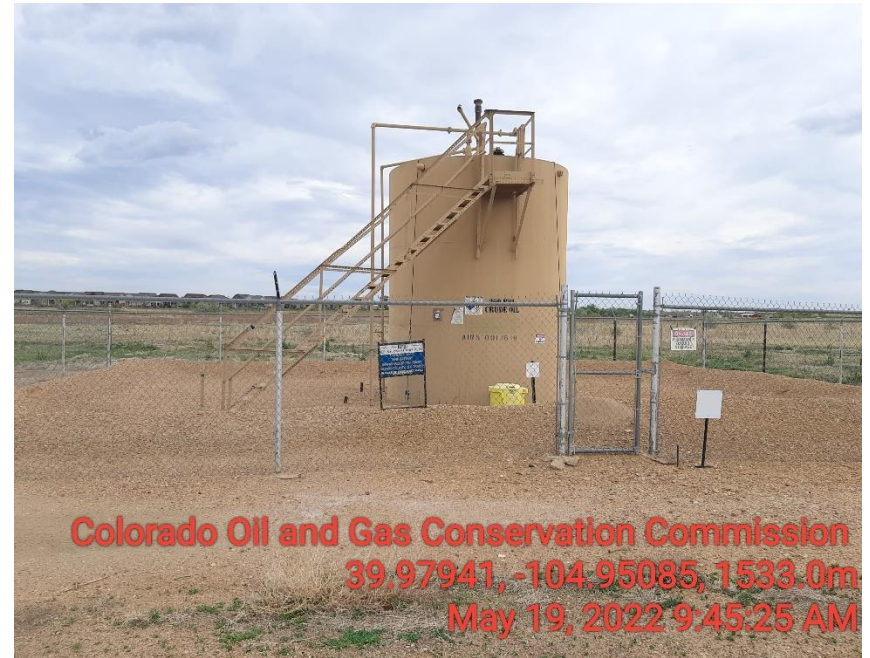
Photo 6 TNK BTRY

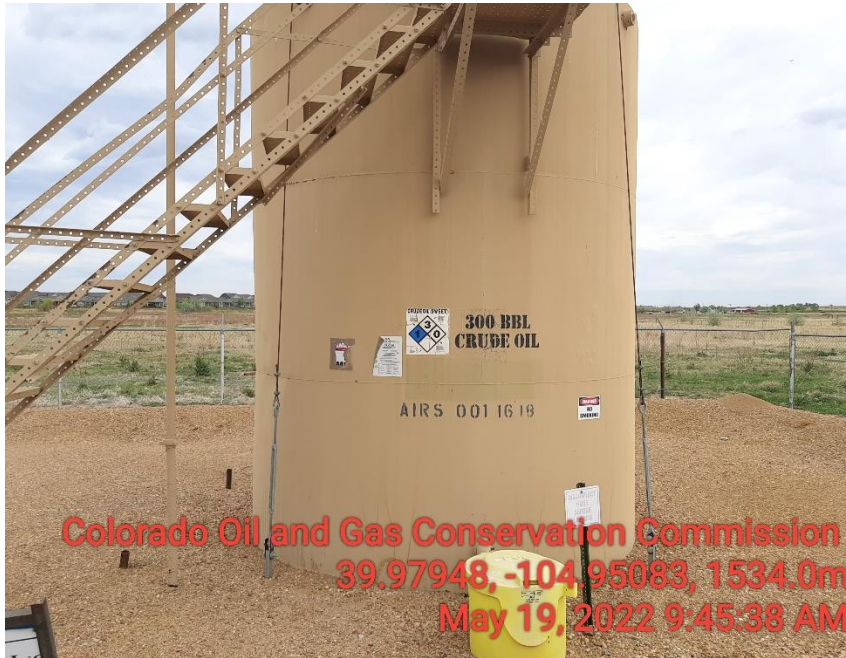
Photo 7 NFPA placards faded.
