TEP  
KP 22-22  
Location # 420972

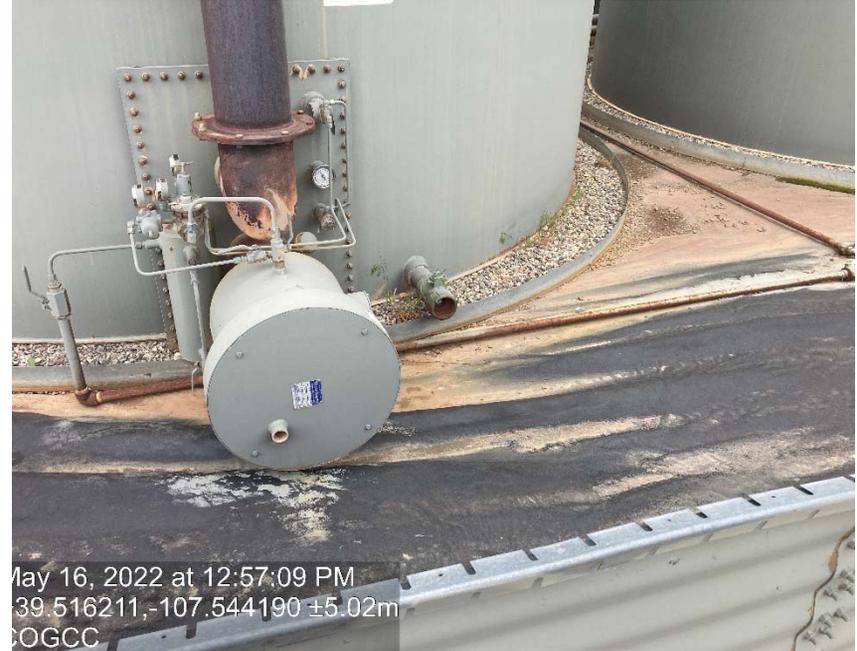
Valves missing caps/plugs

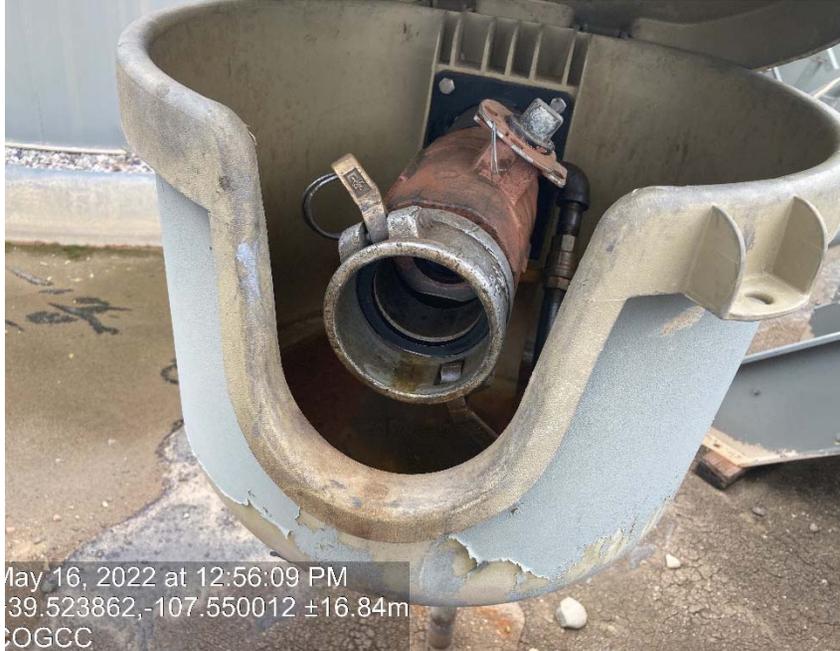
**Valves missing caps/plugs**

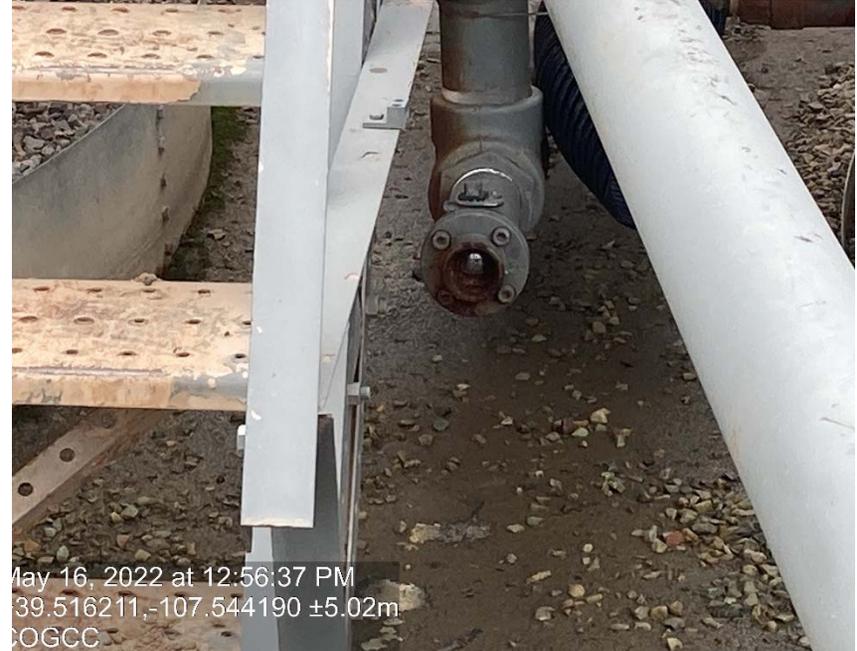
**Valves missing caps/plugs**

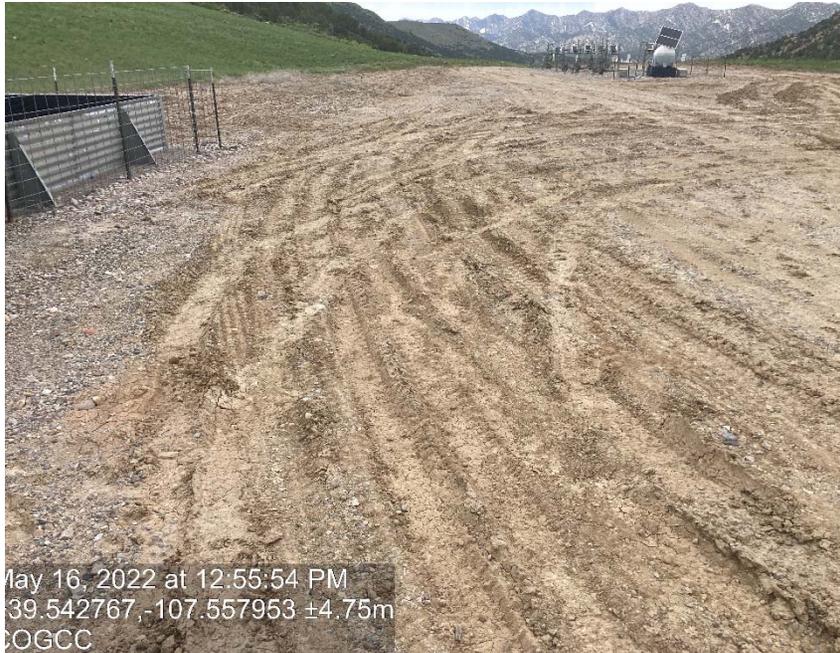
**Lack of stabilization/compaction**

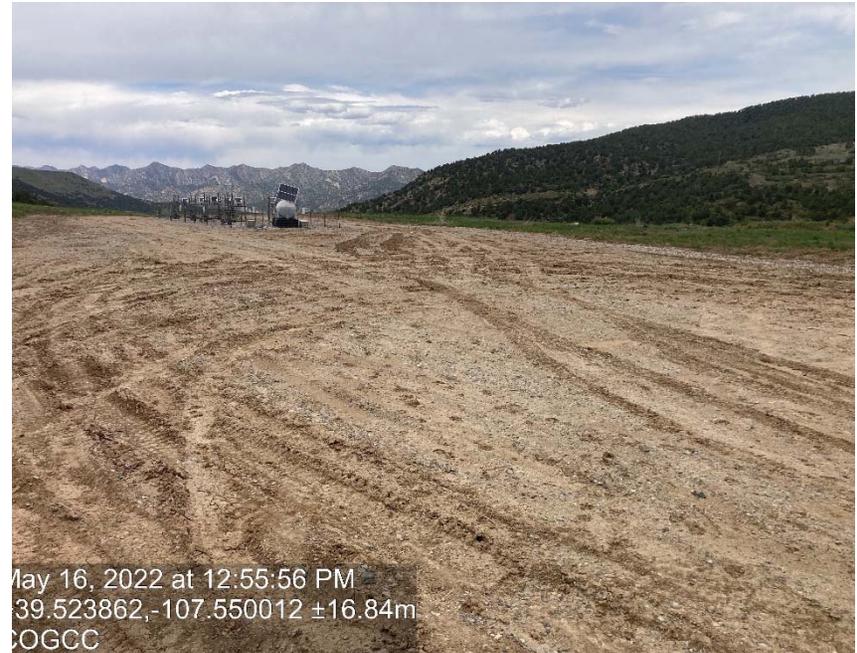
**Lack of stabilization/compaction**

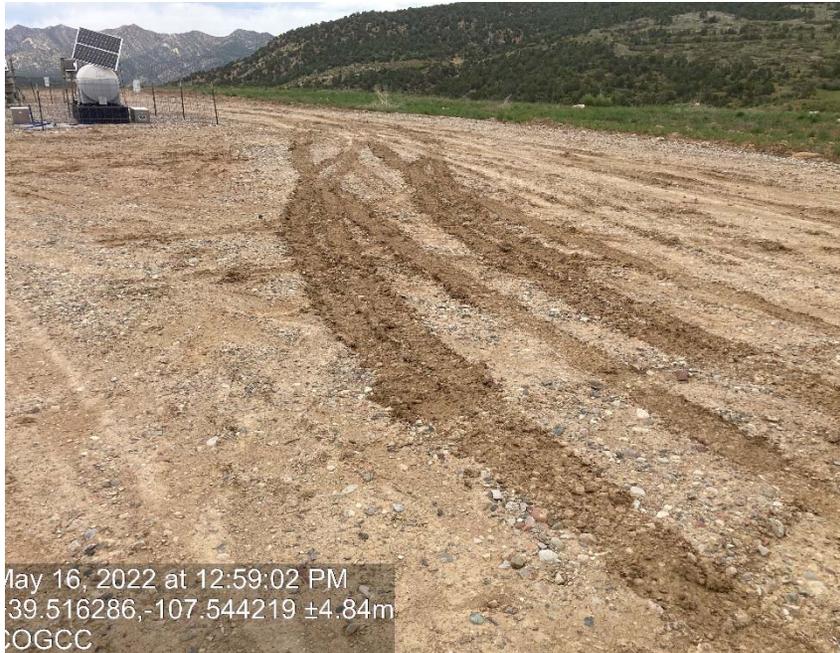
**Lack of stabilization/compaction**

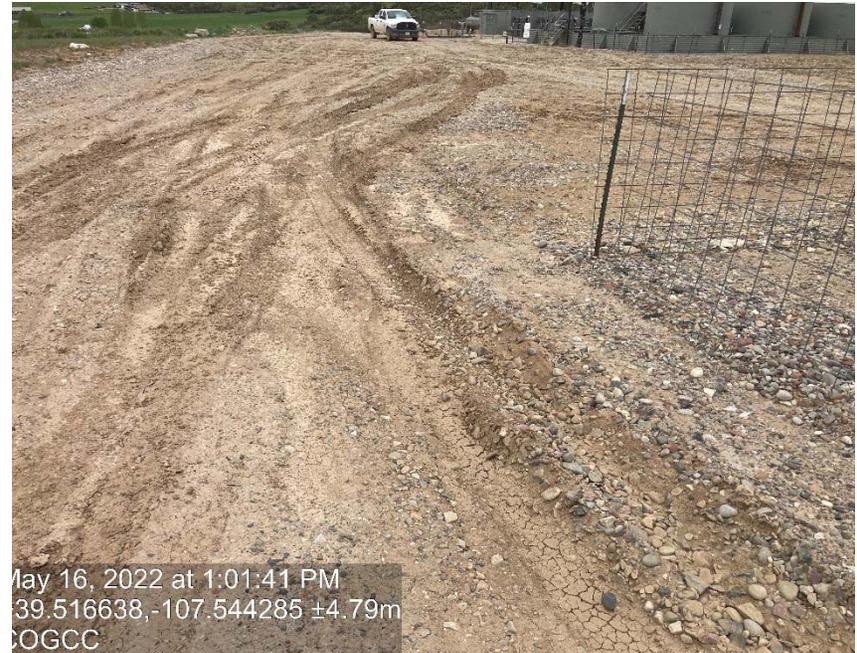
**Lack of stabilization/compaction**

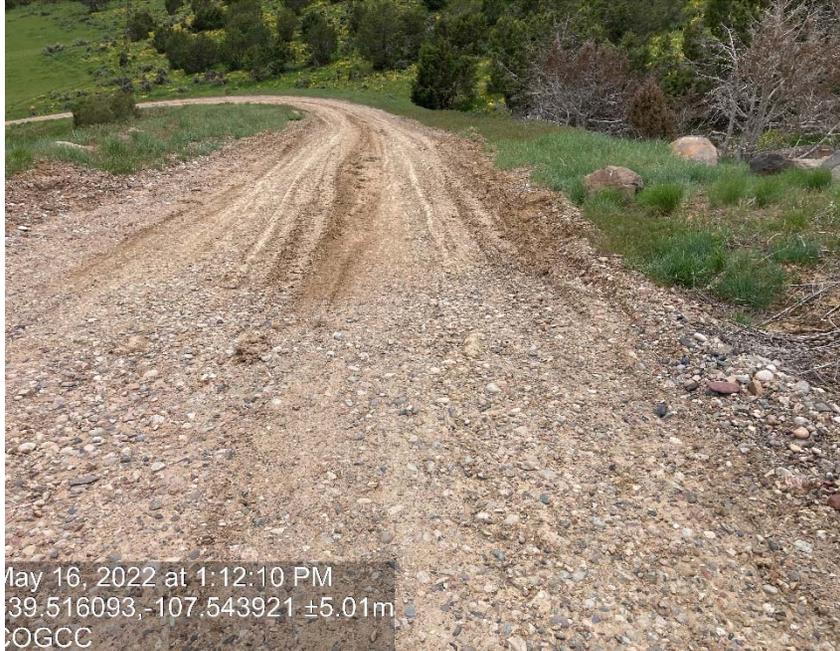
**Lack of stabilization/compaction**

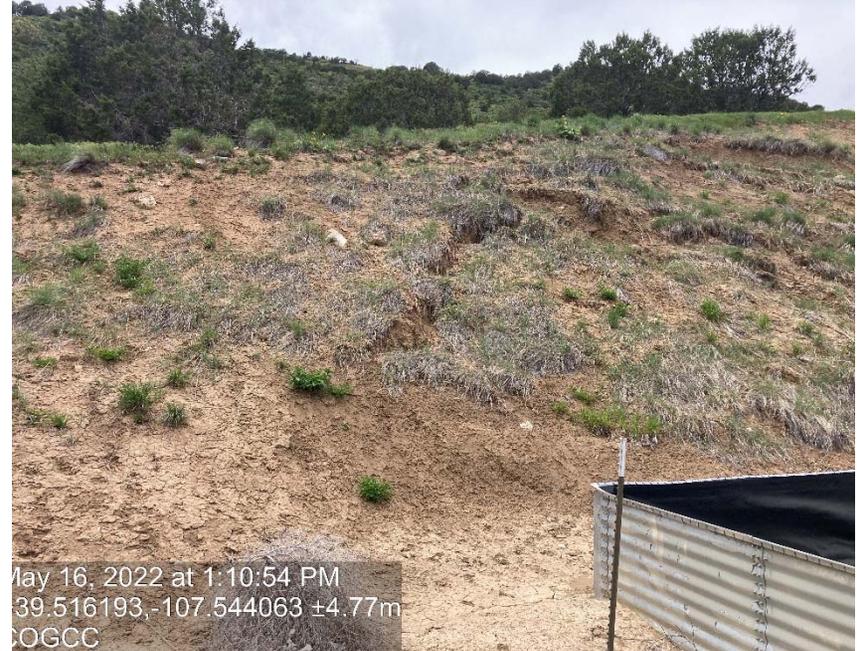
**Cut slope erosion**

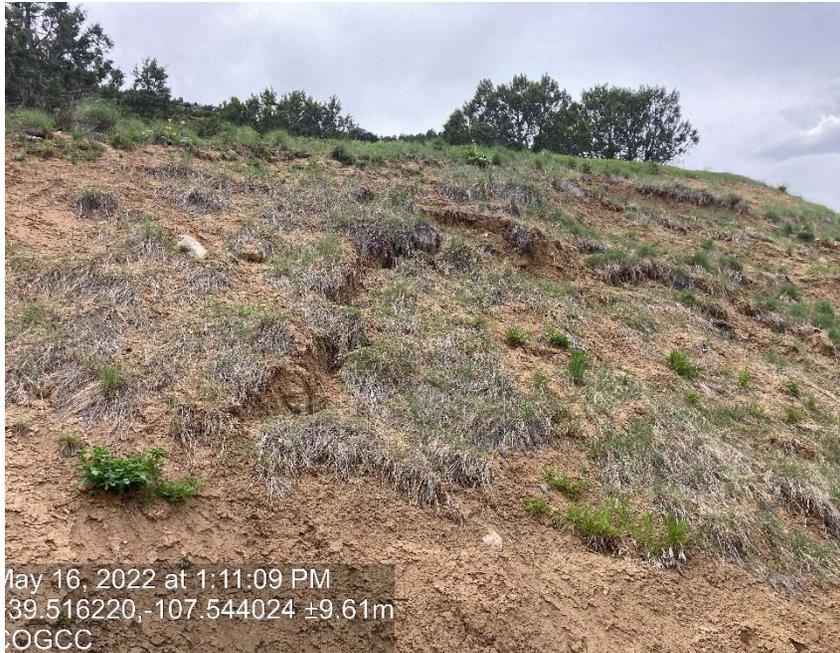
**Cut slope erosion**

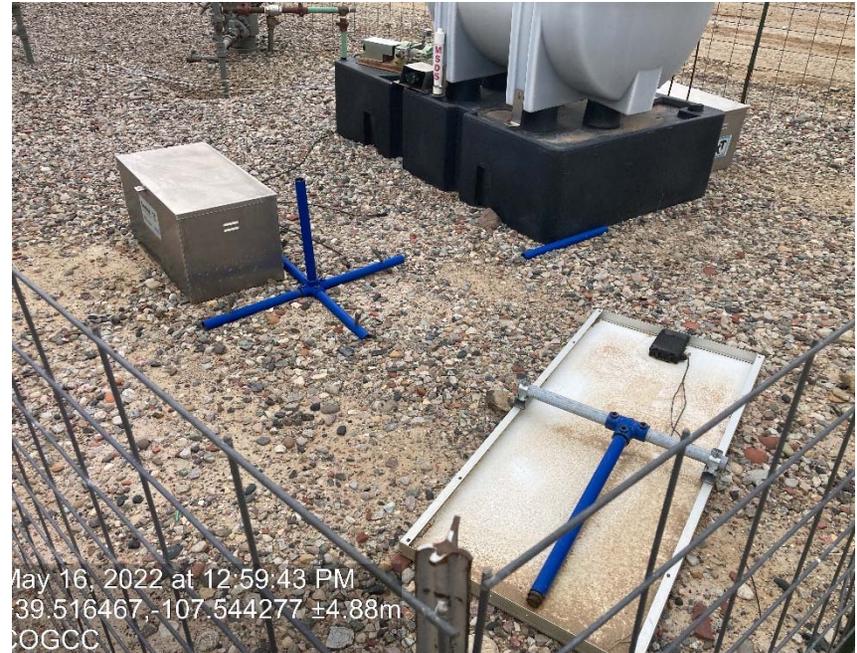
**Associated equipment with unused pumps**

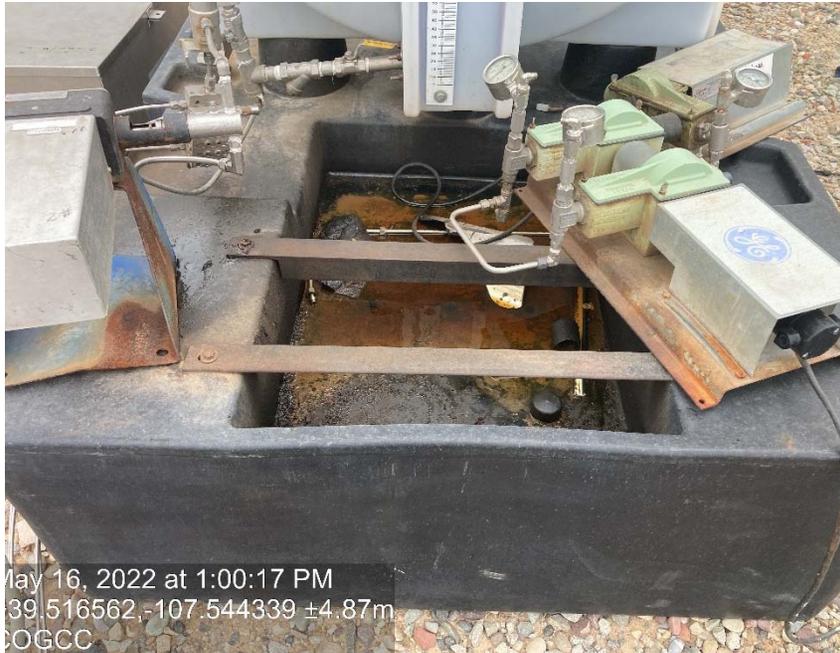
**Chemical containment full of fluid and unused pumps**

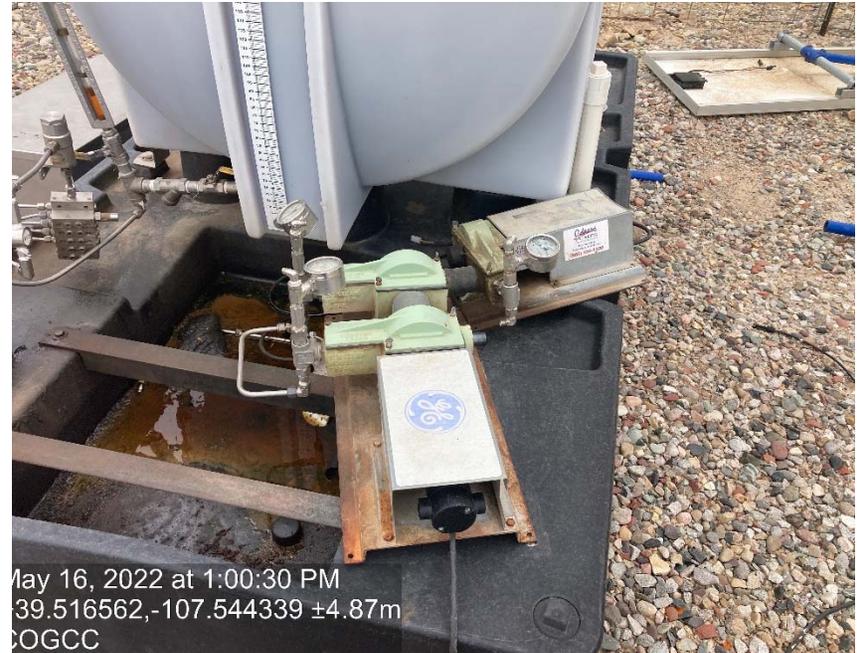
**Unused pumps**

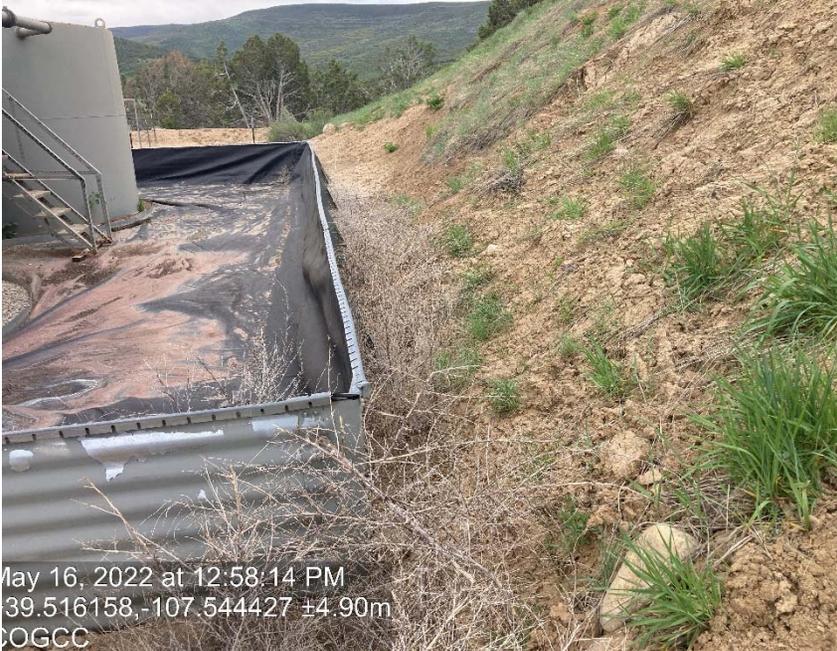
Debris

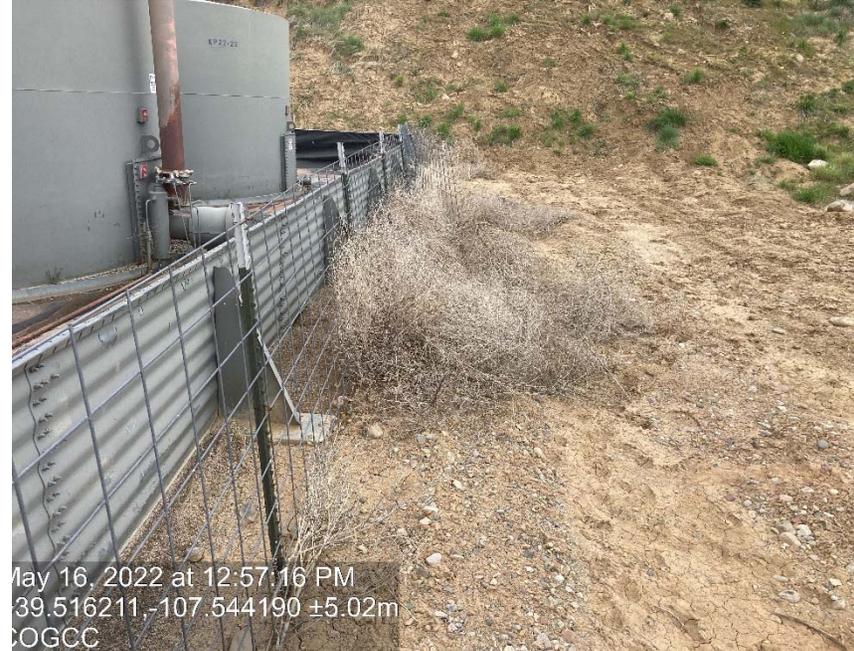
Debris

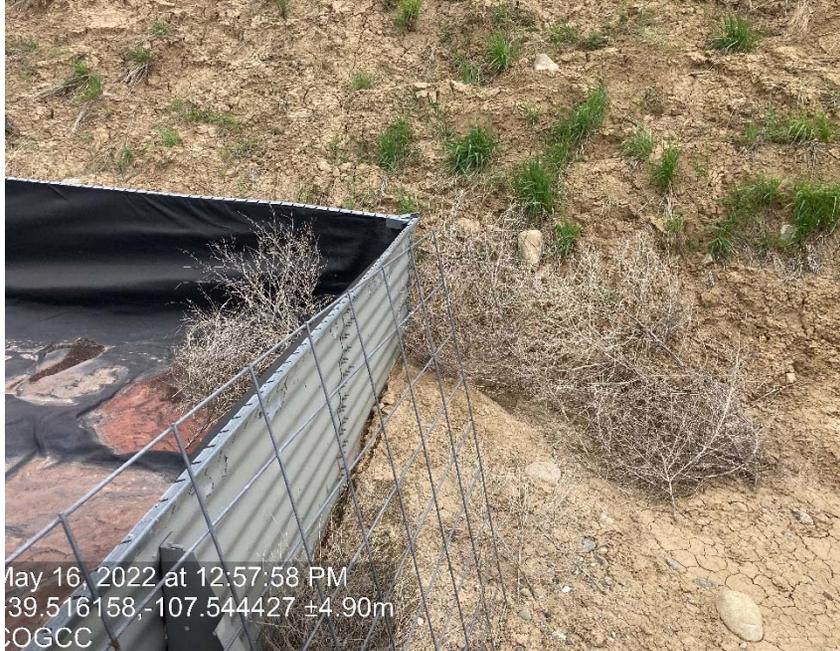
**Debris**
