Inspection Photos
Operator: Simcoe
API: 067-08883
Date: 5/18/2022

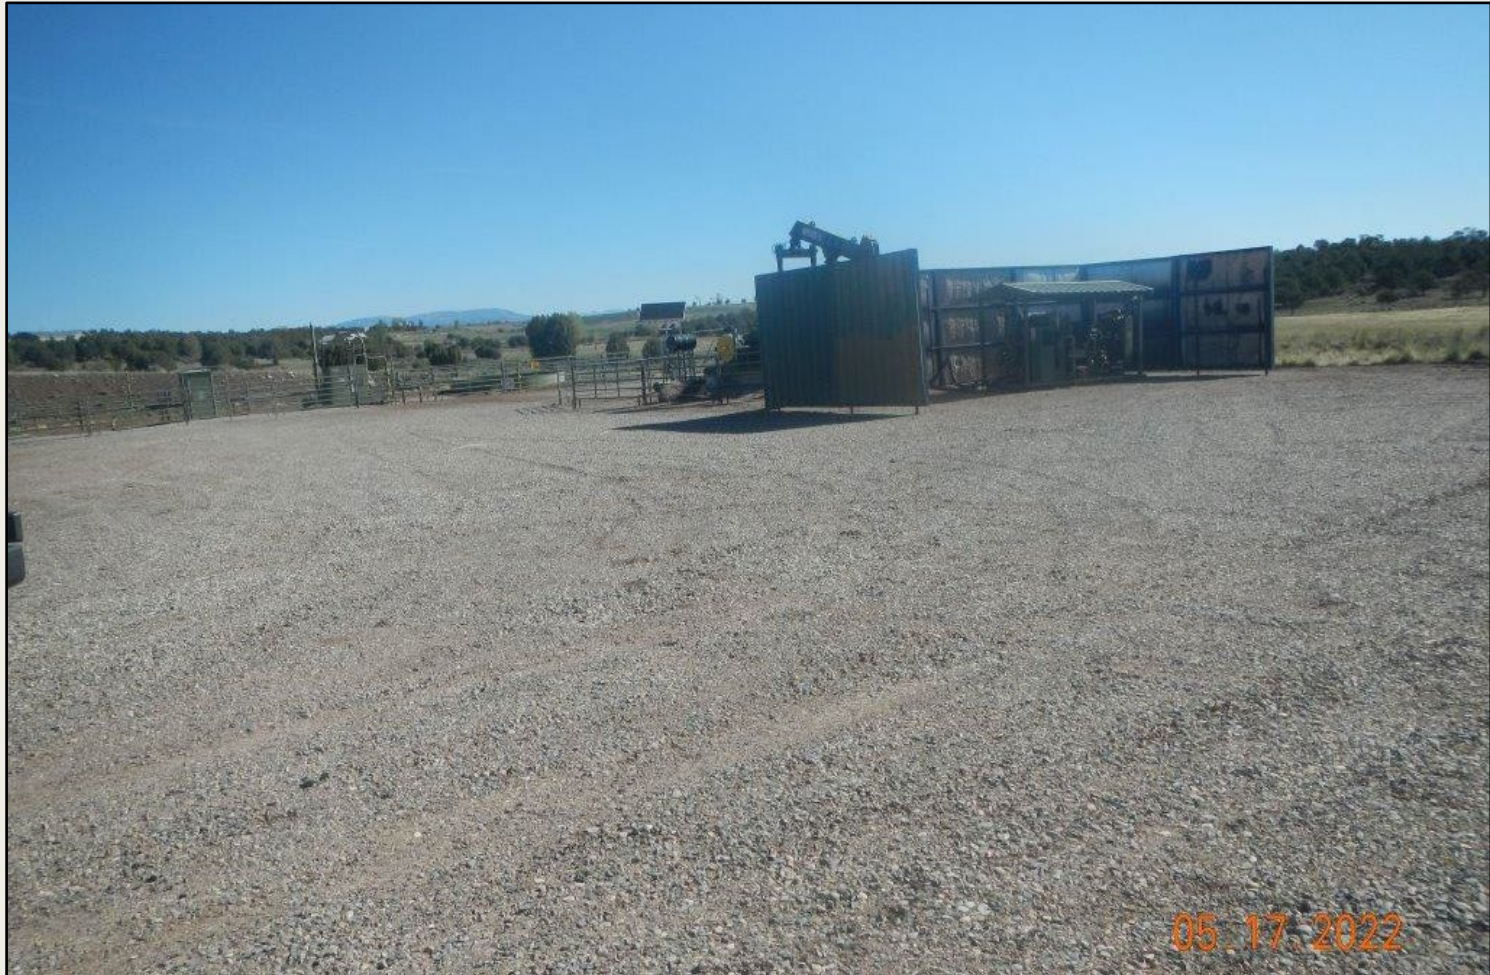
Photo 1. View of the project area from the well pad entrance facing center.

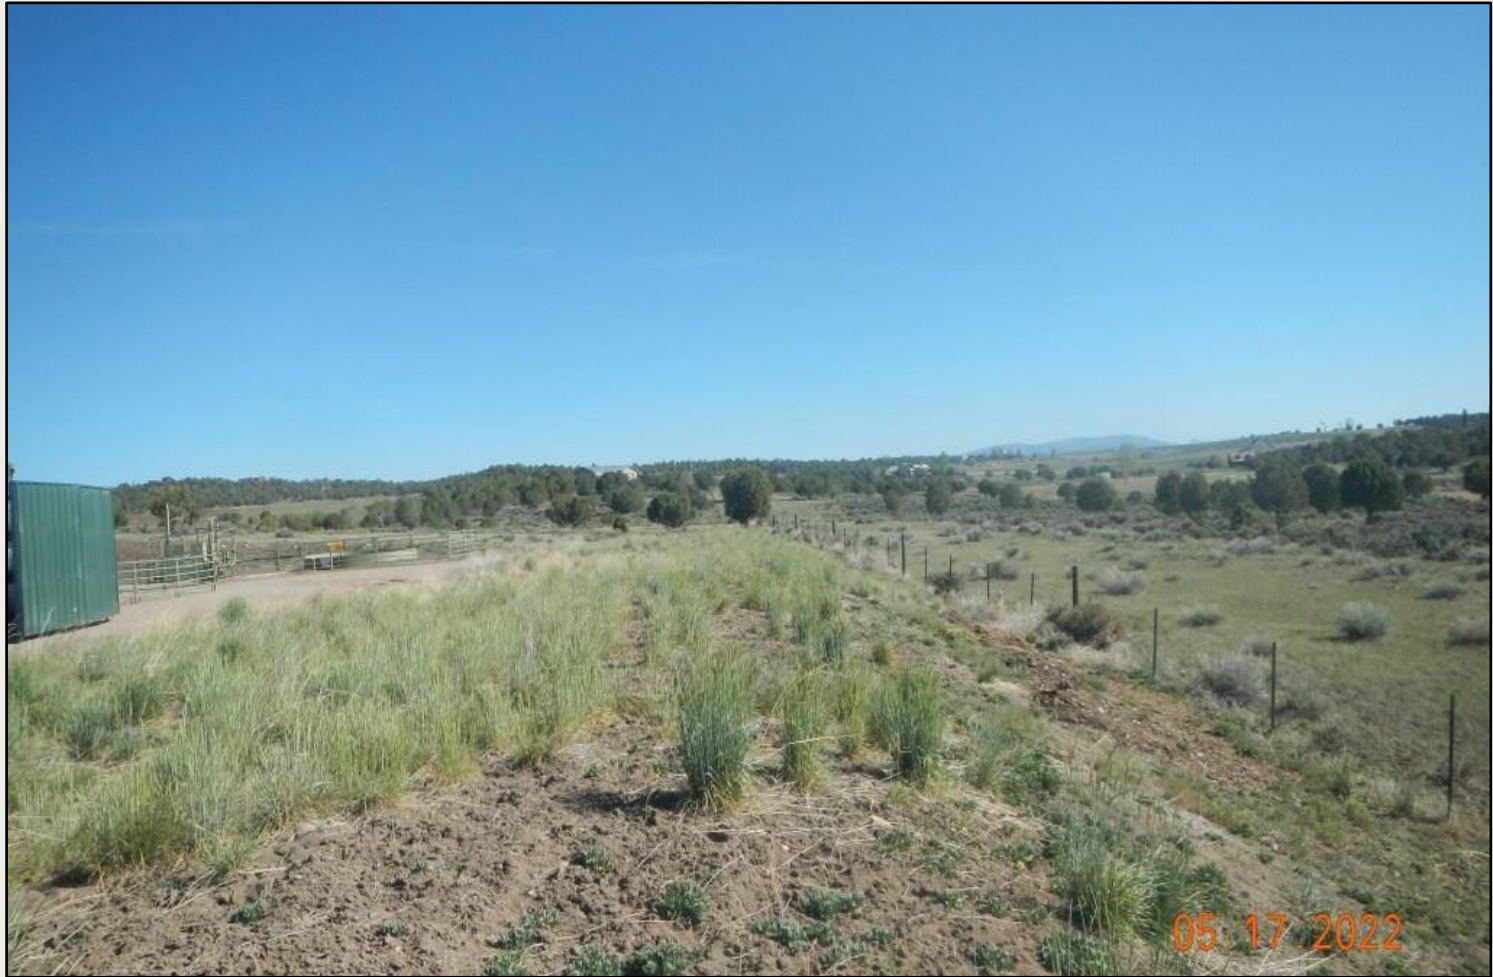
Photo 2. View of the eastern project area from the southeastern corner facing northward. Revegetation is progressing here, largely with crested wheatgrass.

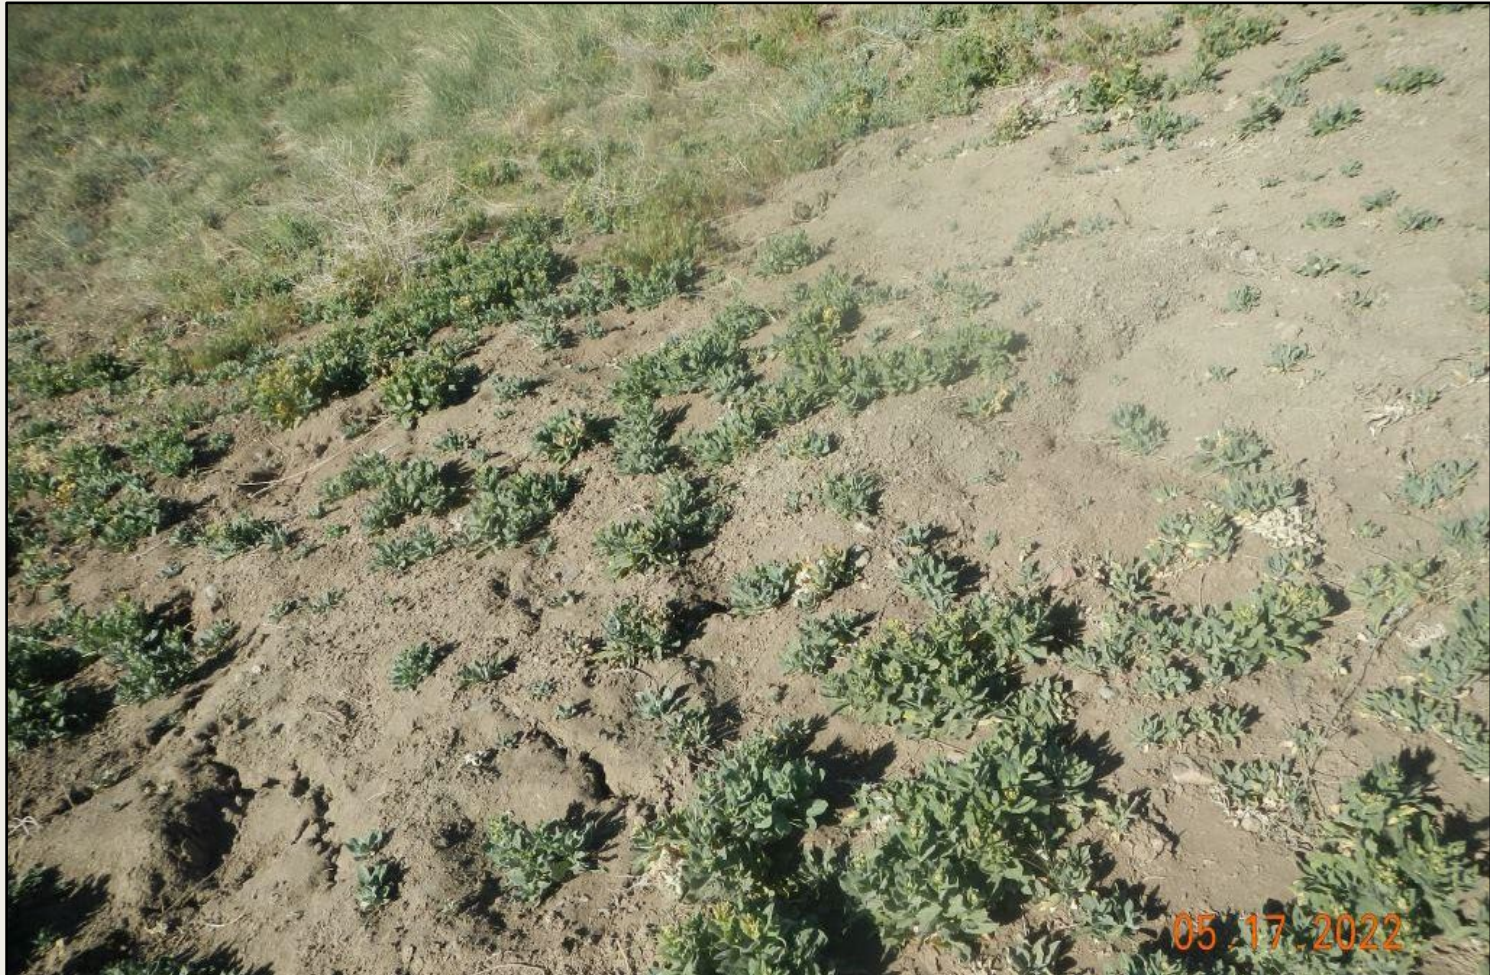
Photo 3. View of hoary cress in vegetative condition observed in the southern project area. 1000s of individuals observed.

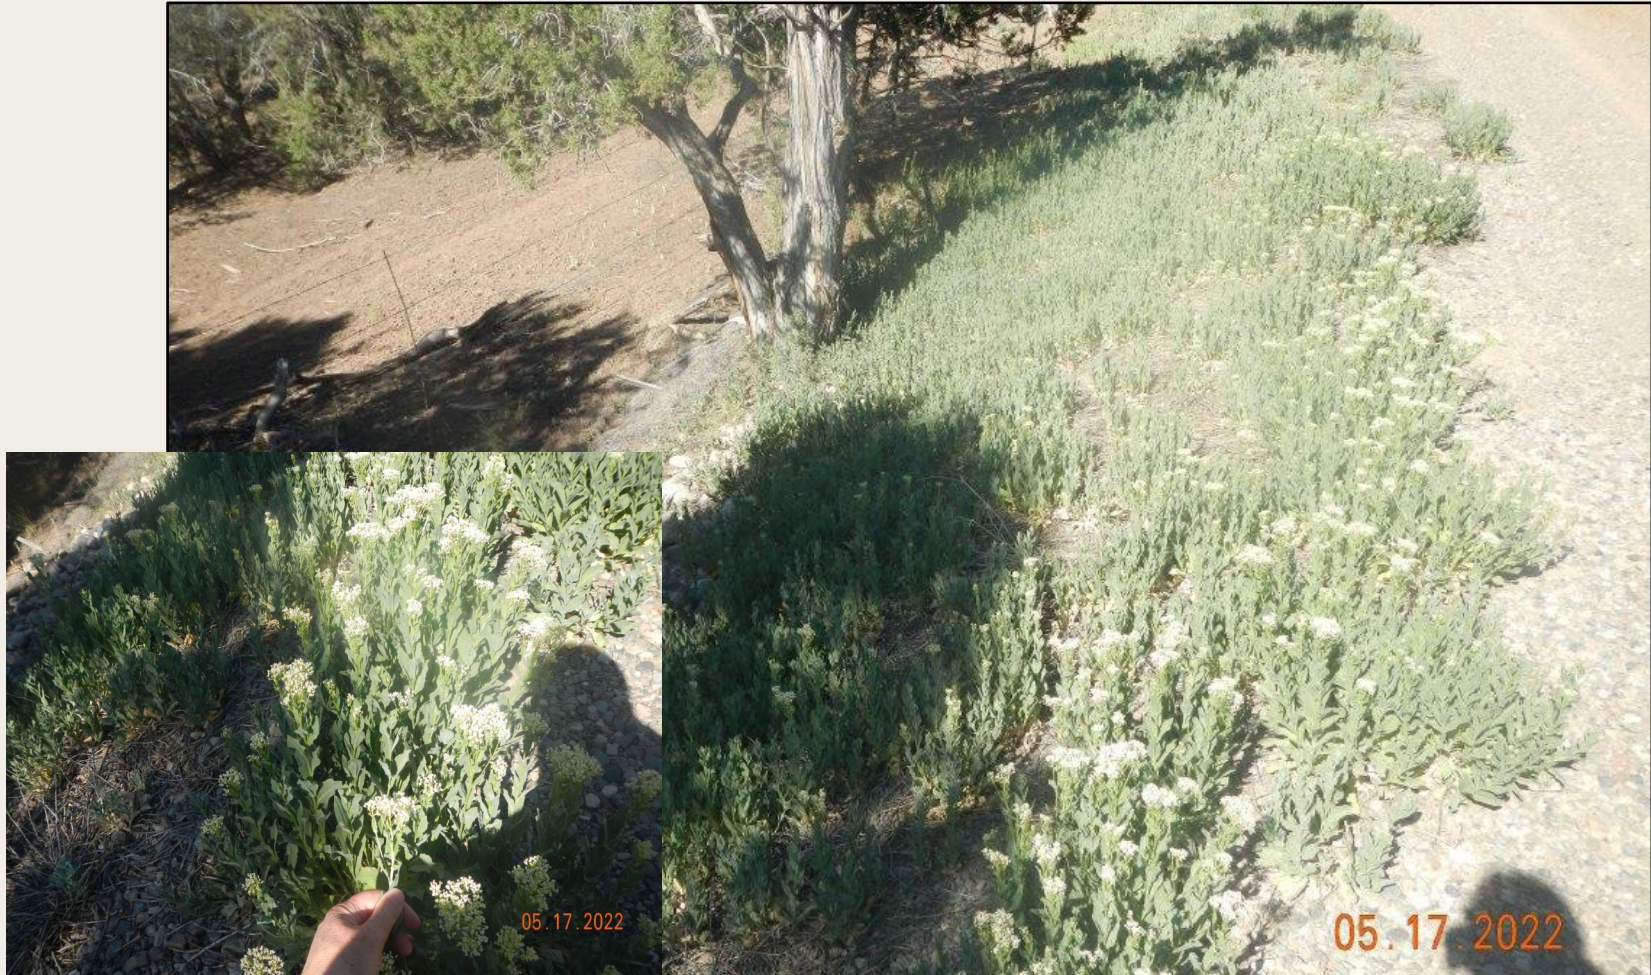
Photo 4. View of dense hoary cress in flowering condition, observed along the access road.

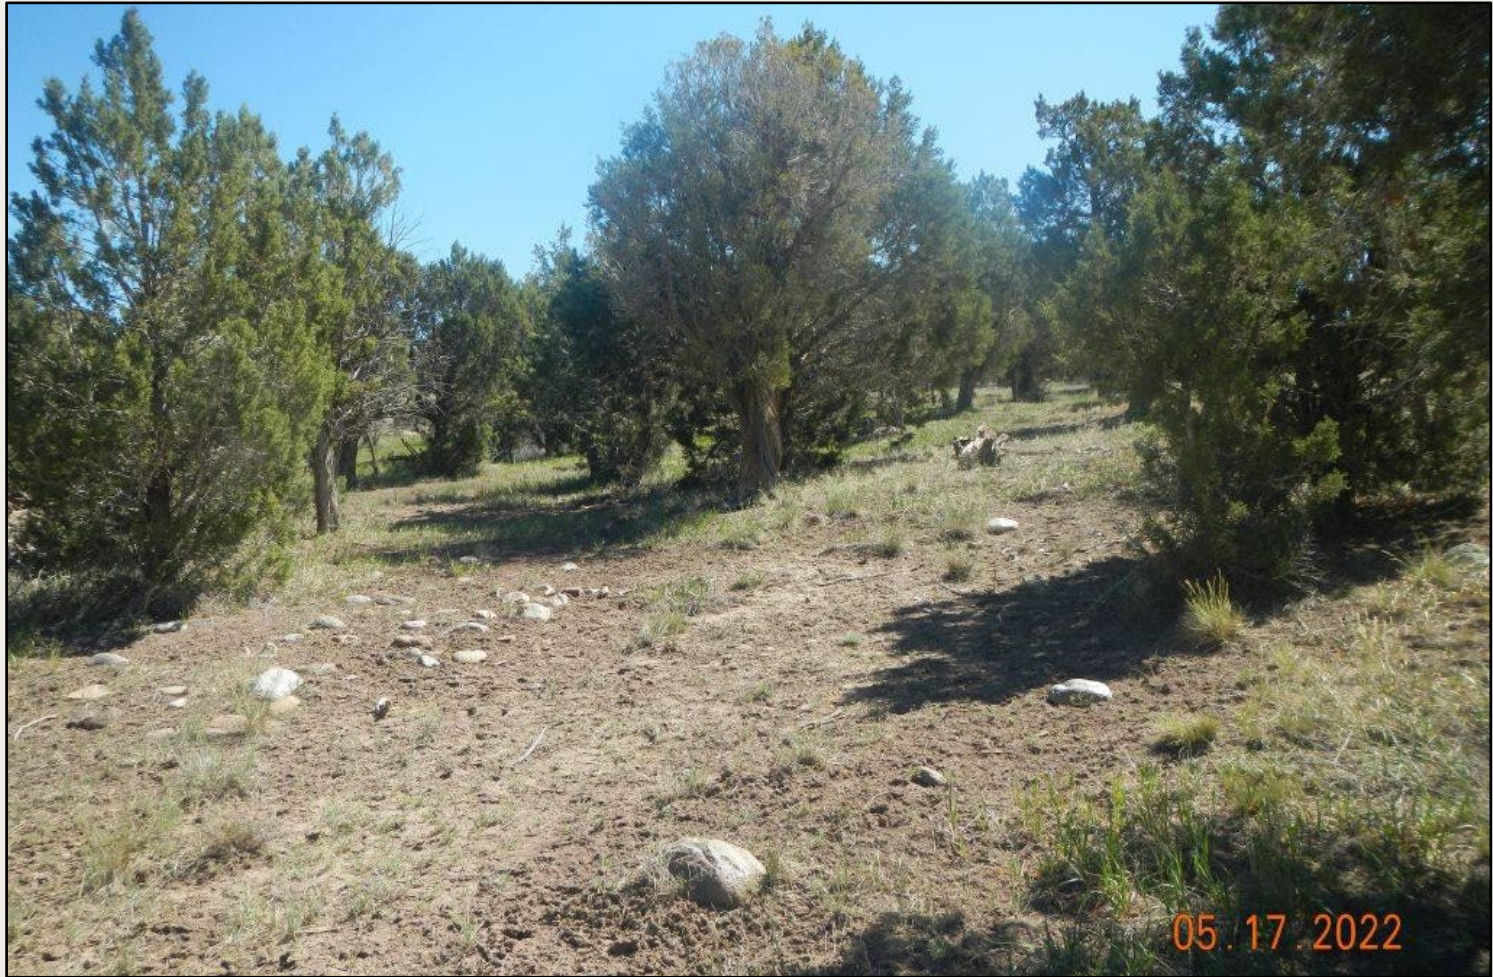
Photo 5. View of the reference area comprised of pinyon and juniper woodland with prickly pear, Indian ricegrass, sagebrush, antelope bitterbrush, and yucca in the understory.
