Inspection Photos  
Operator: Simcoe  
API: 067-06780  
Date: 5/18/2022

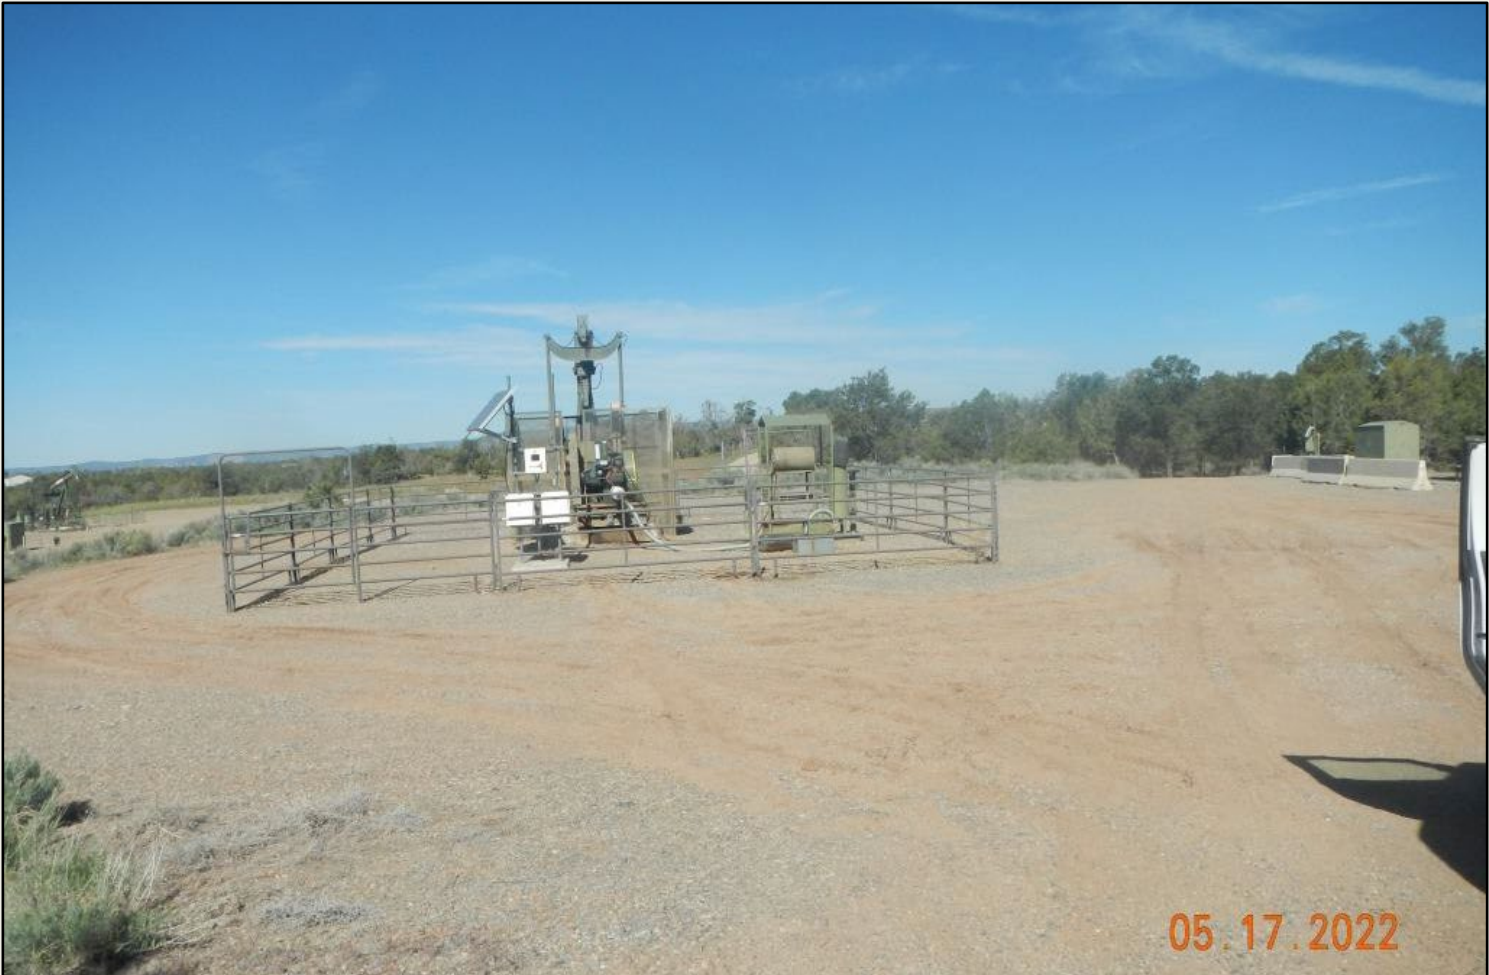
Photo 1. View of the project area from the eastern well pad entrance facing center.

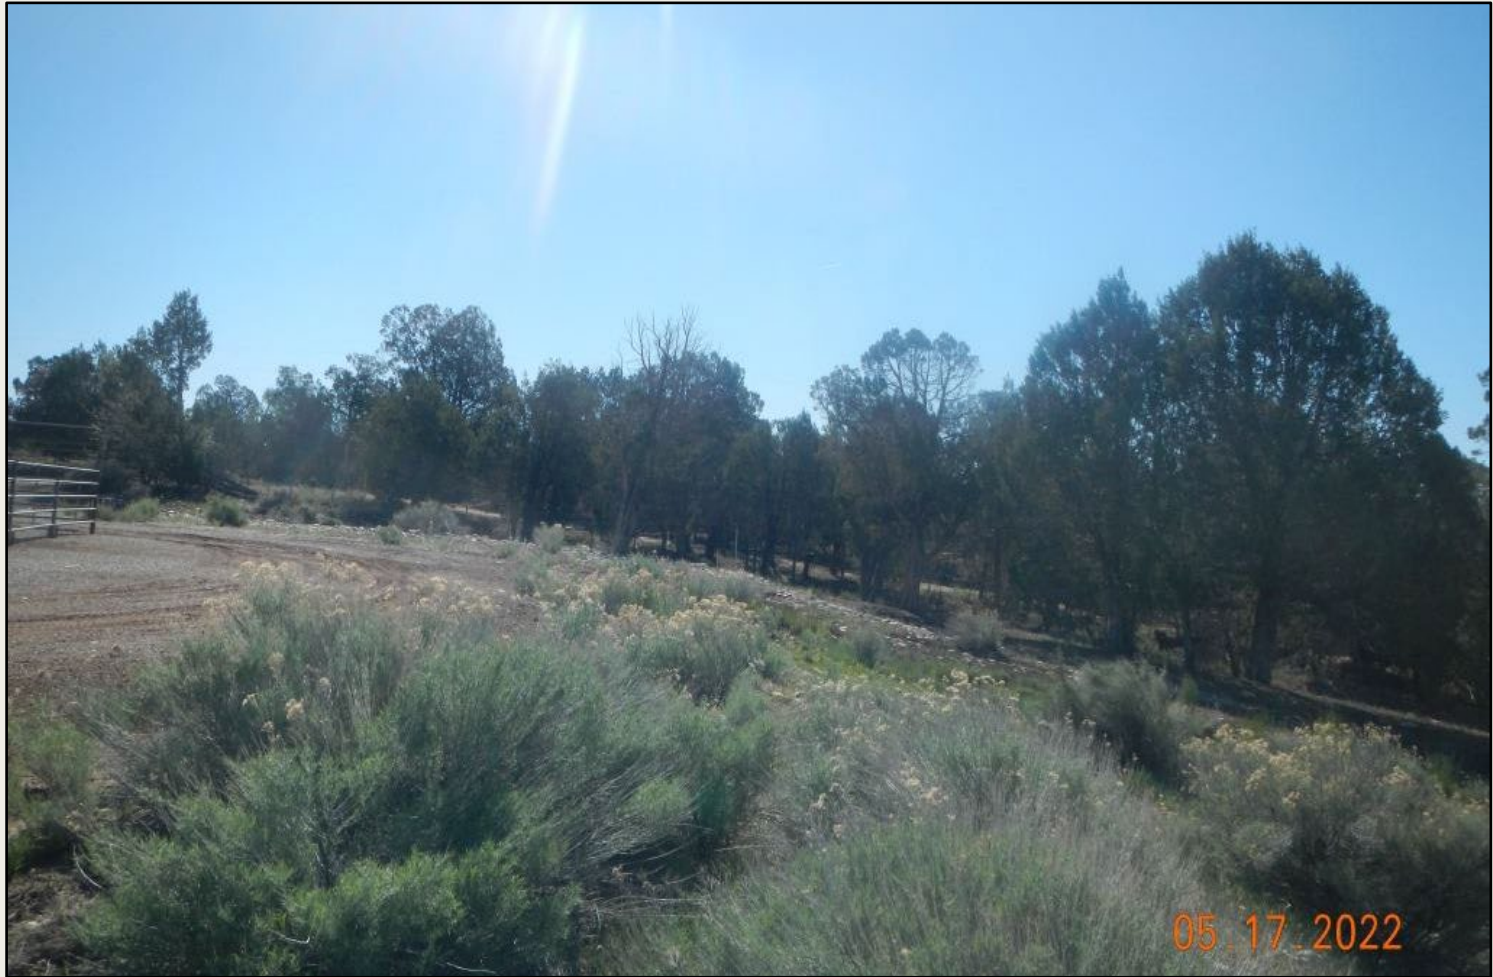
Photo 2. View of the southern project area from the southeastern corner facing westward. Revegetation is progressing here, largely with rubber rabbitbrush and western wheatgrass.

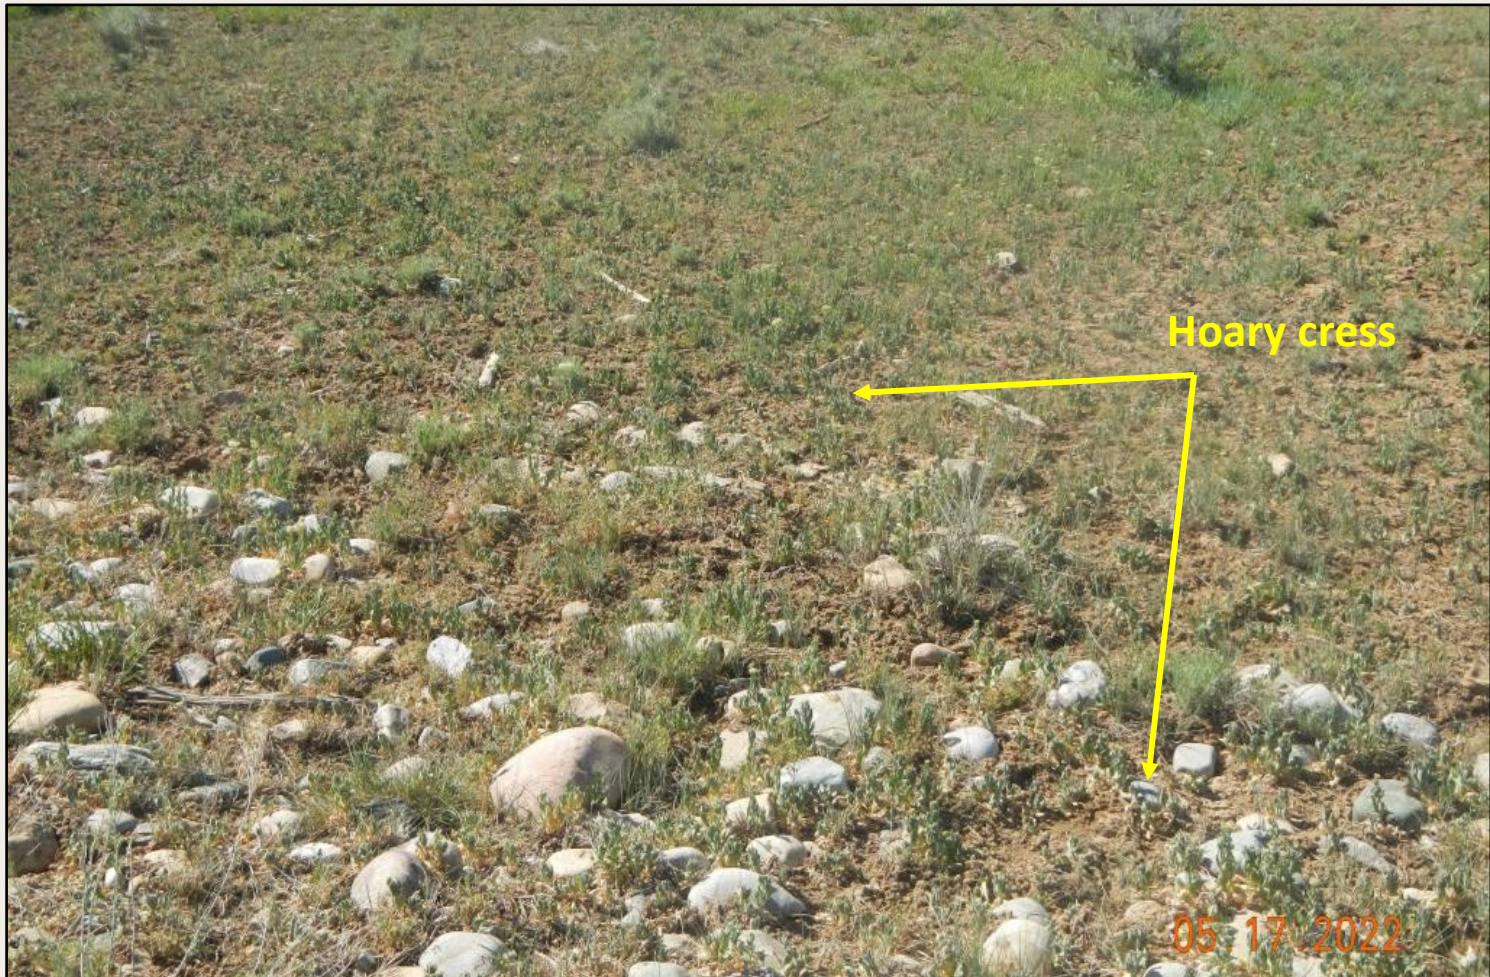
Photo 3. View of hoary cress in vegetative condition observed in the southern project area. 1000s of individuals observed.
