Inspection Photos
Operator: Simcoe
API: 067-09662
Date: 5/18/2022

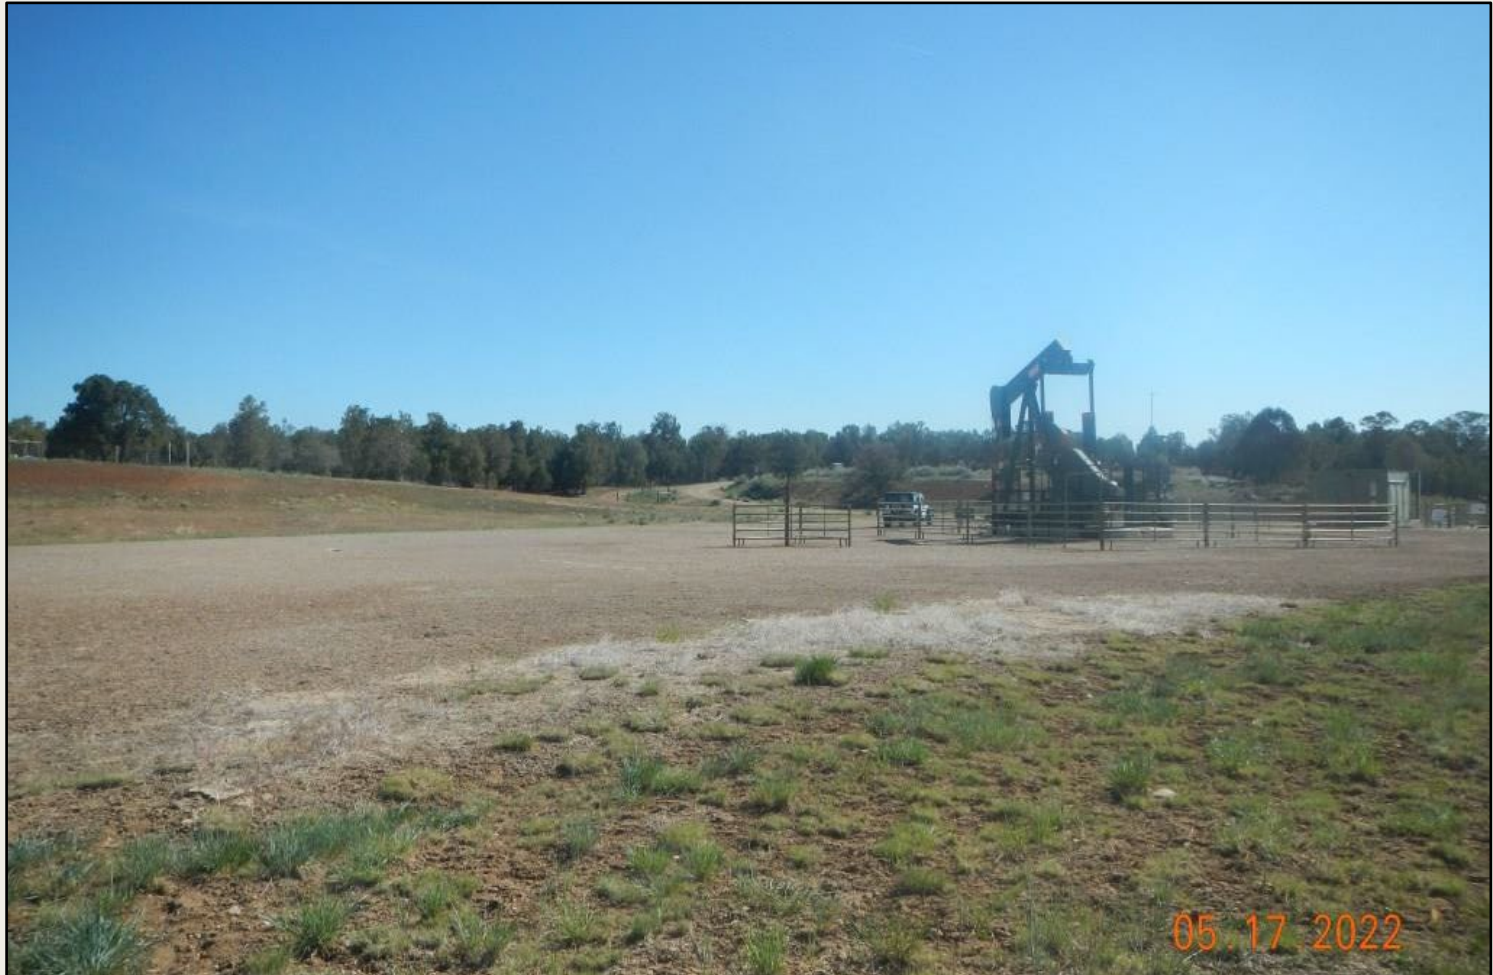
Photo 1. View of the project area from the southwestern corner facing center.

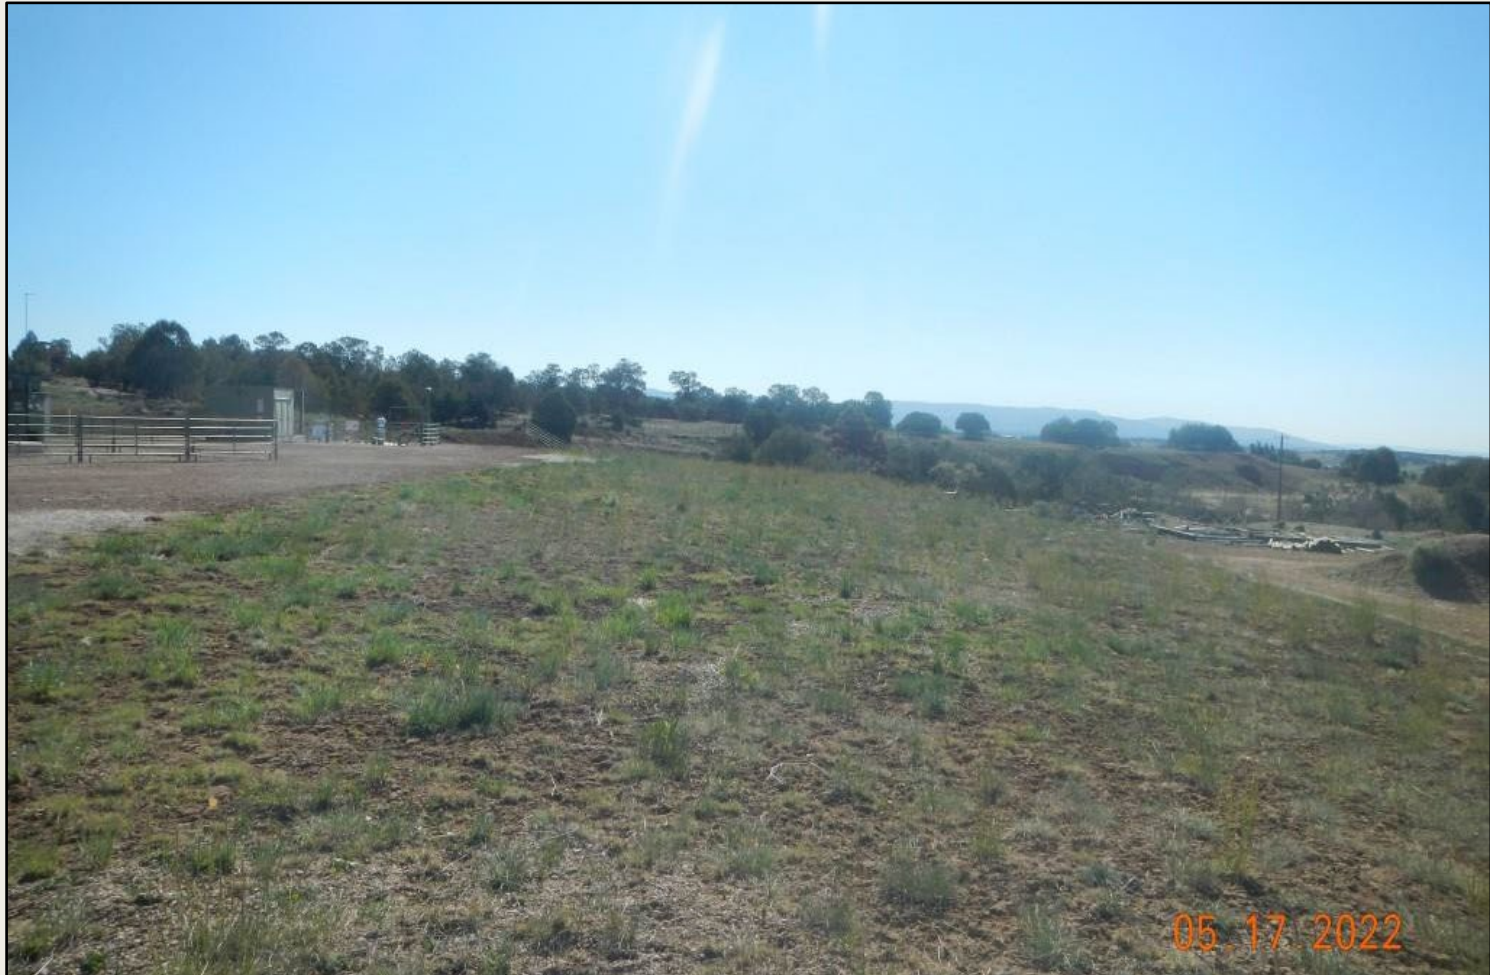
Photo 2. View of the southern project area from the southwestern corner facing eastward. Revegetation is progressing here, largely with blue grama, crested wheatgrass, and western wheatgrass.

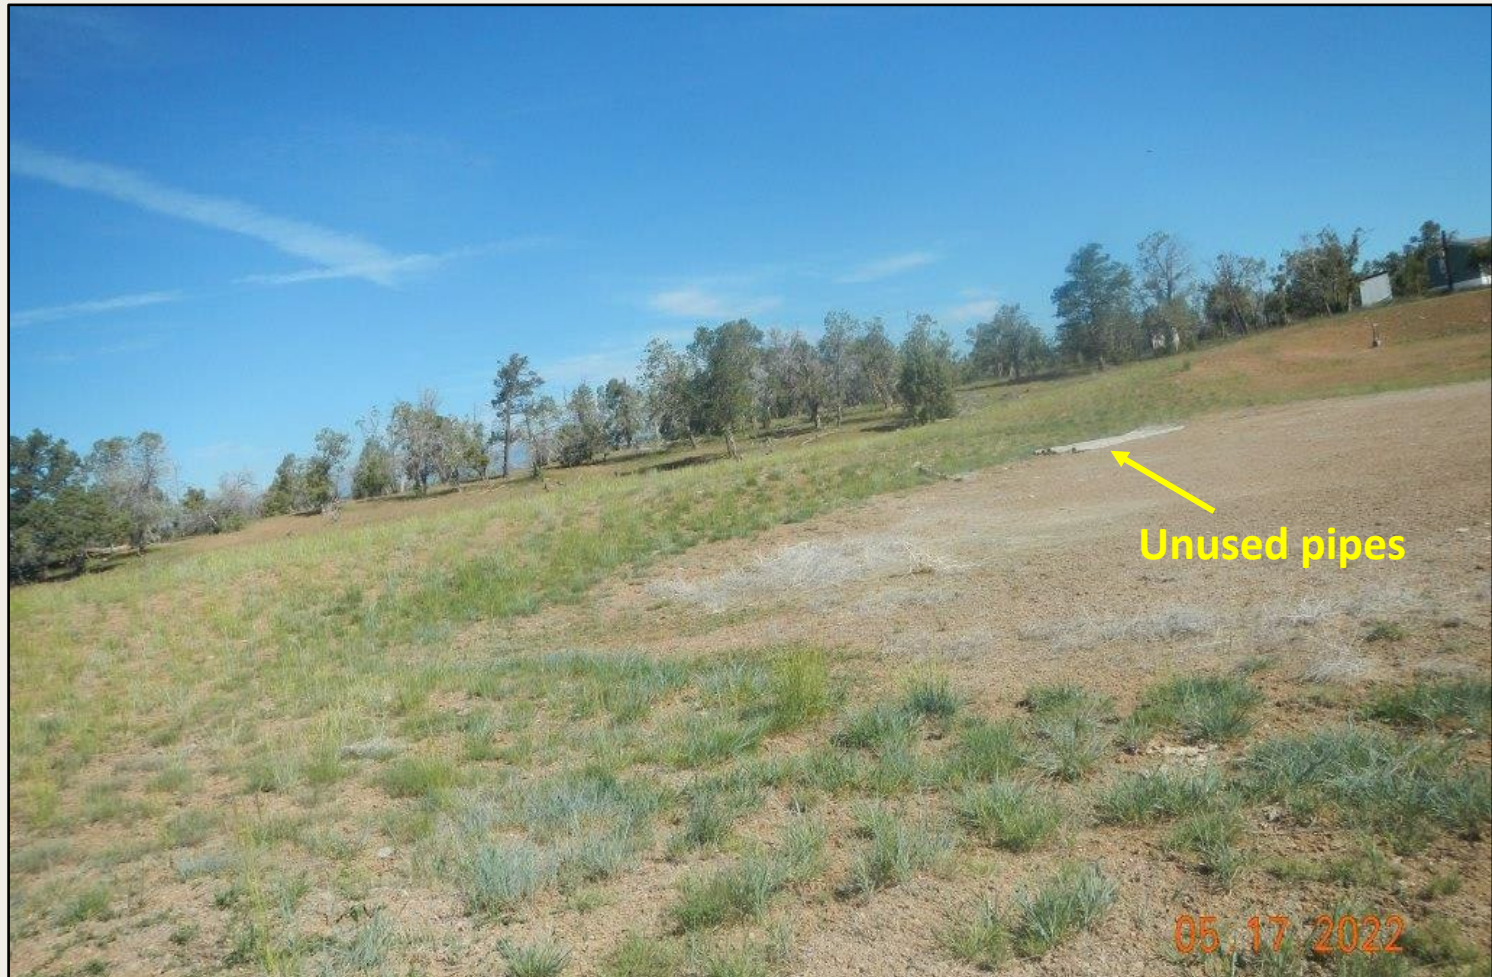
Photo 3. View of the western project area from the southwestern corner facing northward. Unused pipes stored along the western edge of the working area.
