Inspection Photos  
Operator: Simcoe  
API: 067-07010  
Date: 5/18/2022

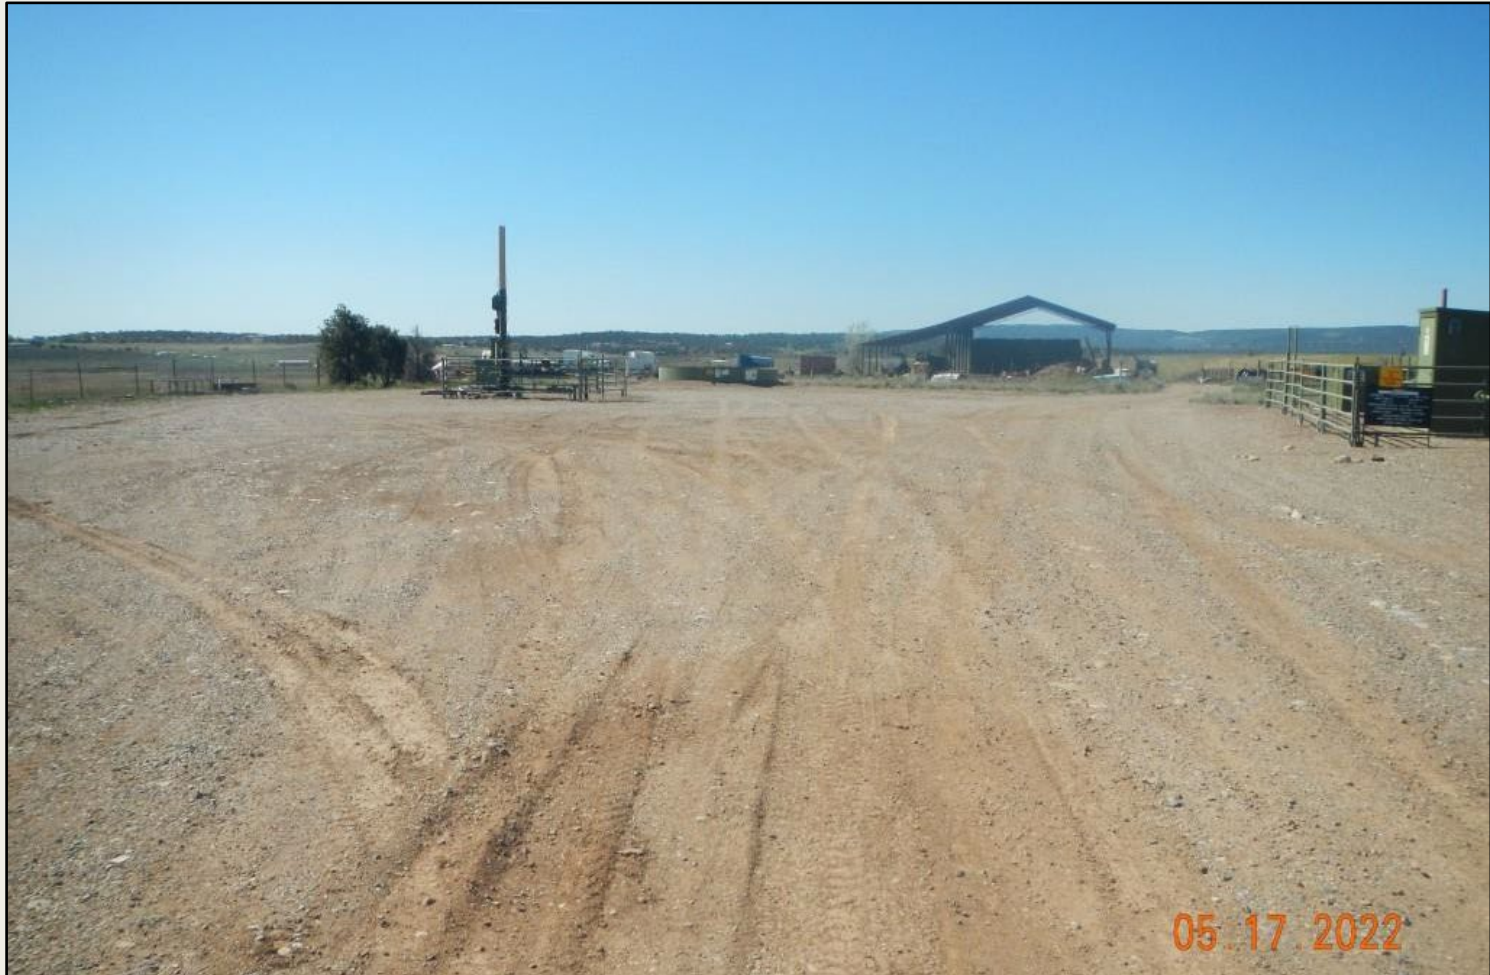
Photo 1. View of the project area from the well pad entrance facing center.

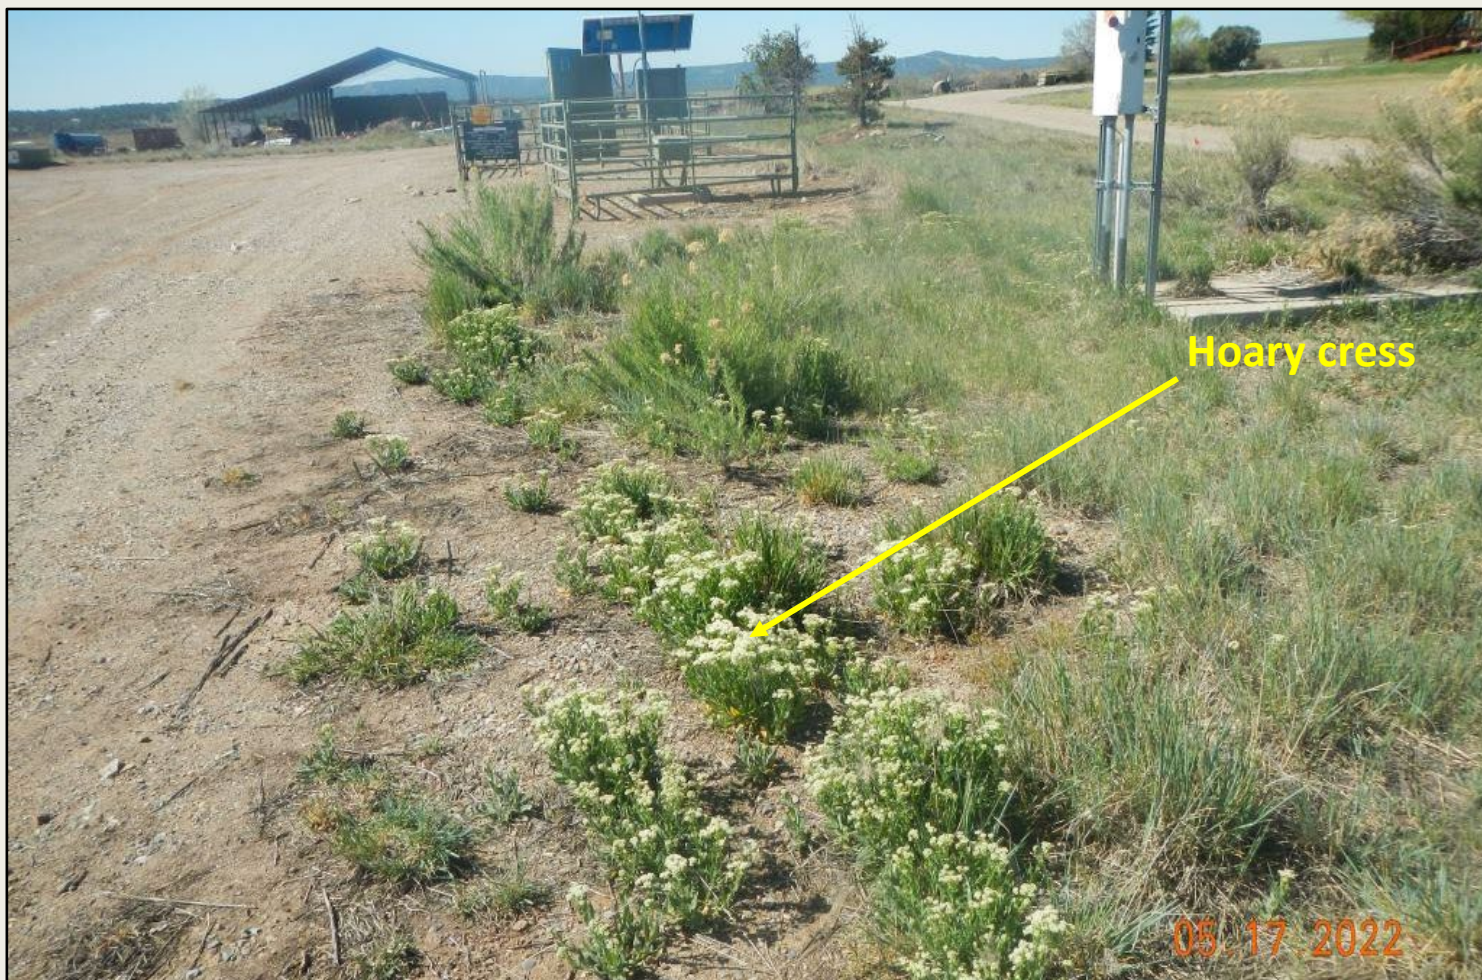
Photo 2. View of hoary cress along the western edge of the working area. Approx. 100 individuals observed.

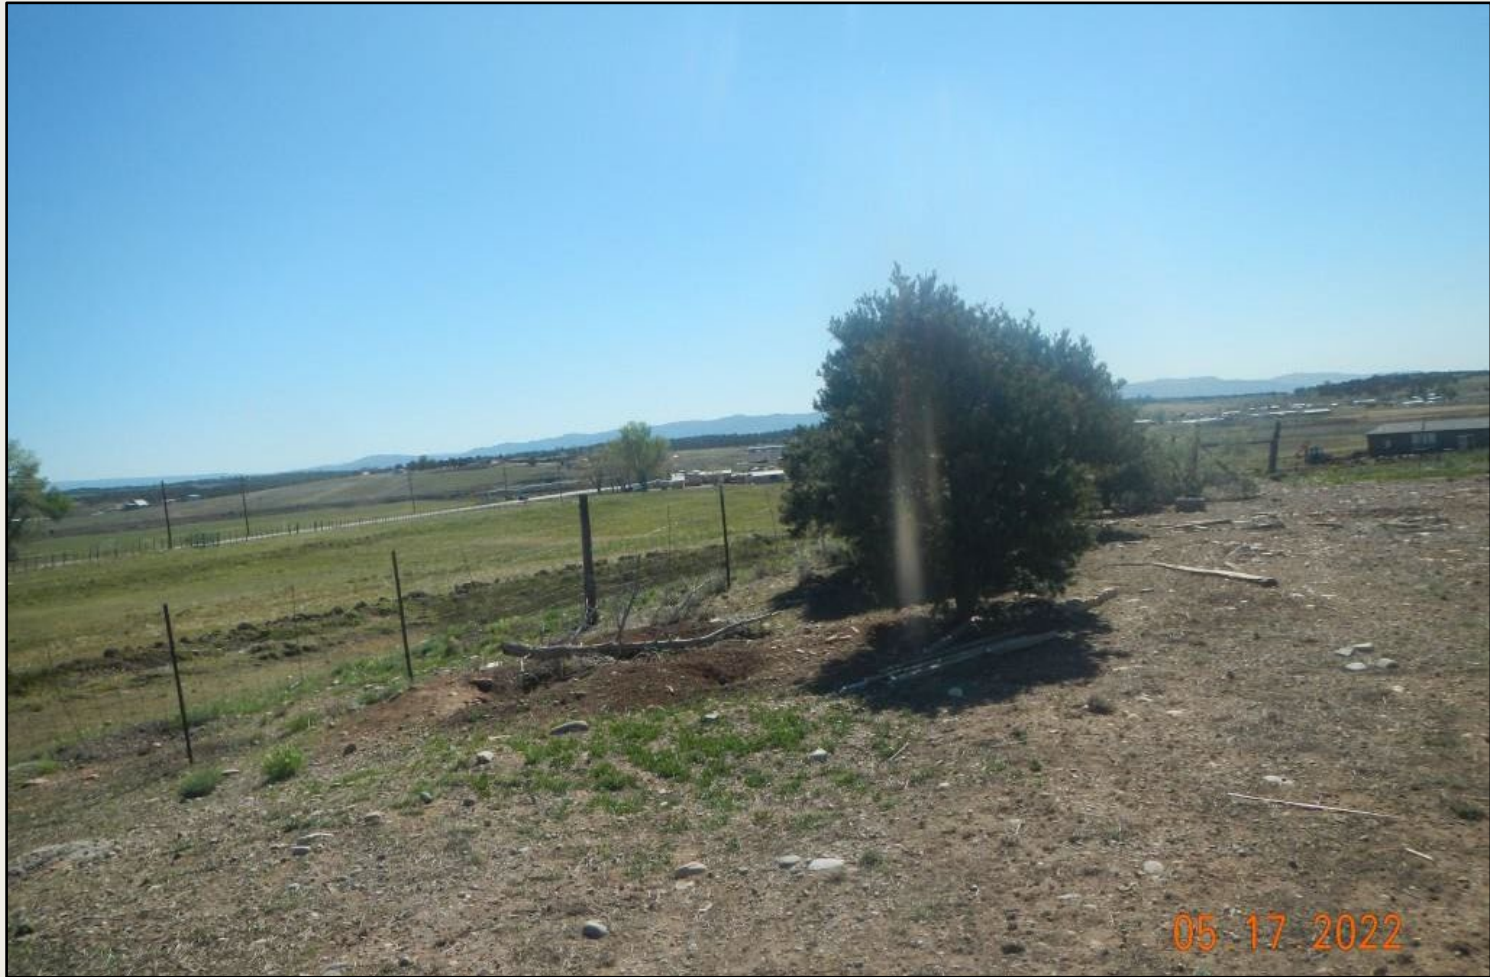
Photo 3. View of the northern project area from the northwestern corner facing eastward. Scattered wood debris and cinder blocks need to be removed and properly stored/disposed of.

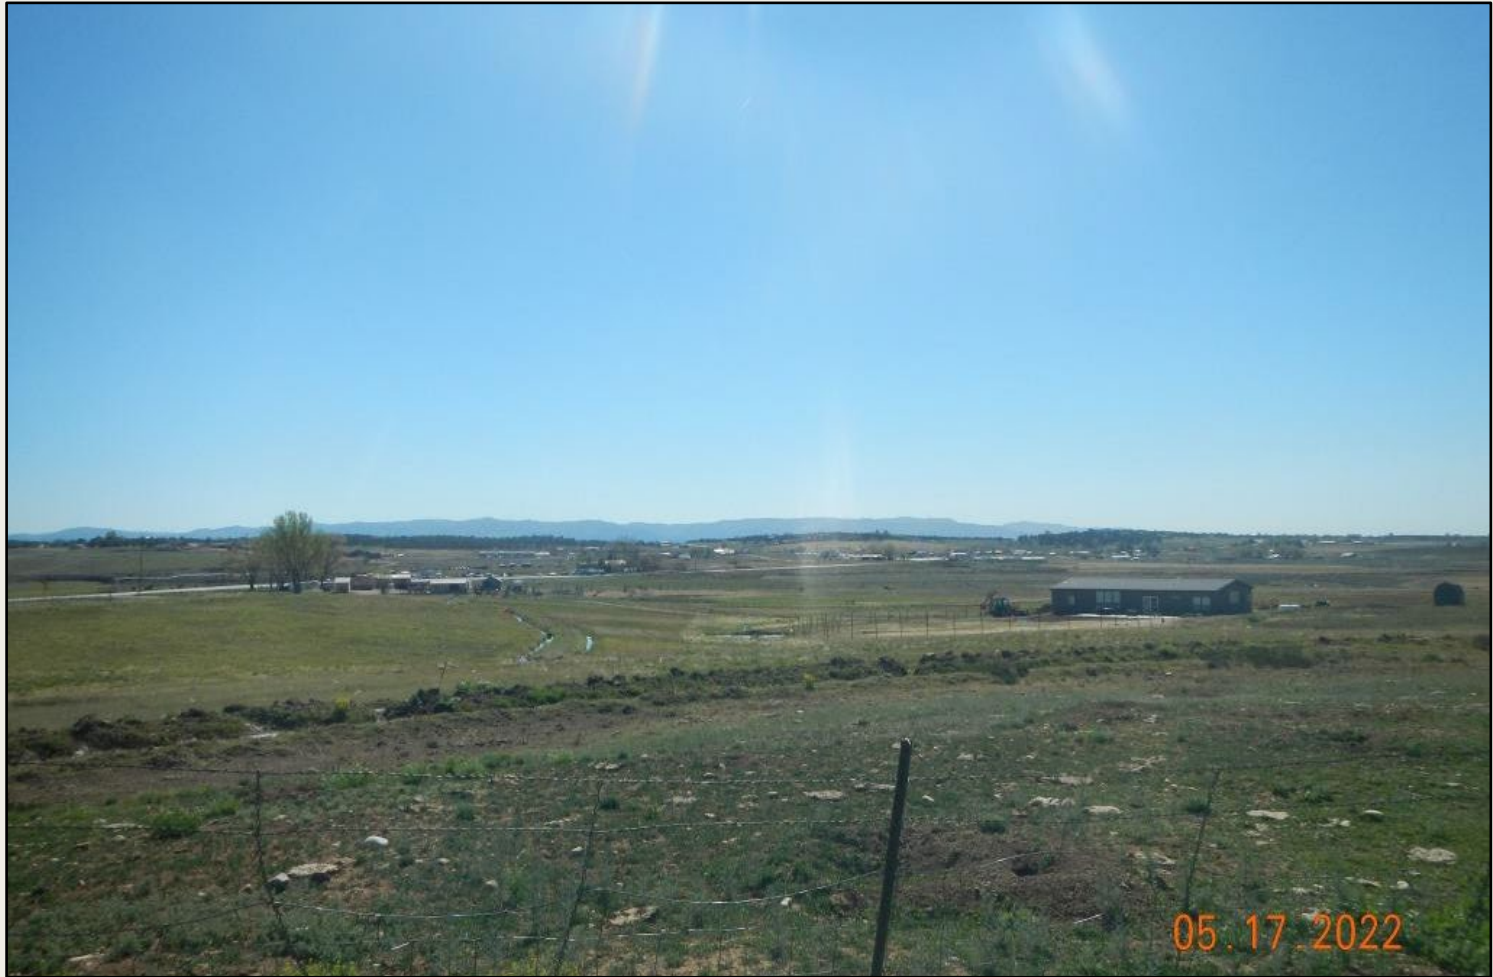
Photo 4. View of the reference area comprised of irrigated grass field.
