Inspection Photos
Operator: Simcoe
API: 067-08945
Date: 5/18/2022

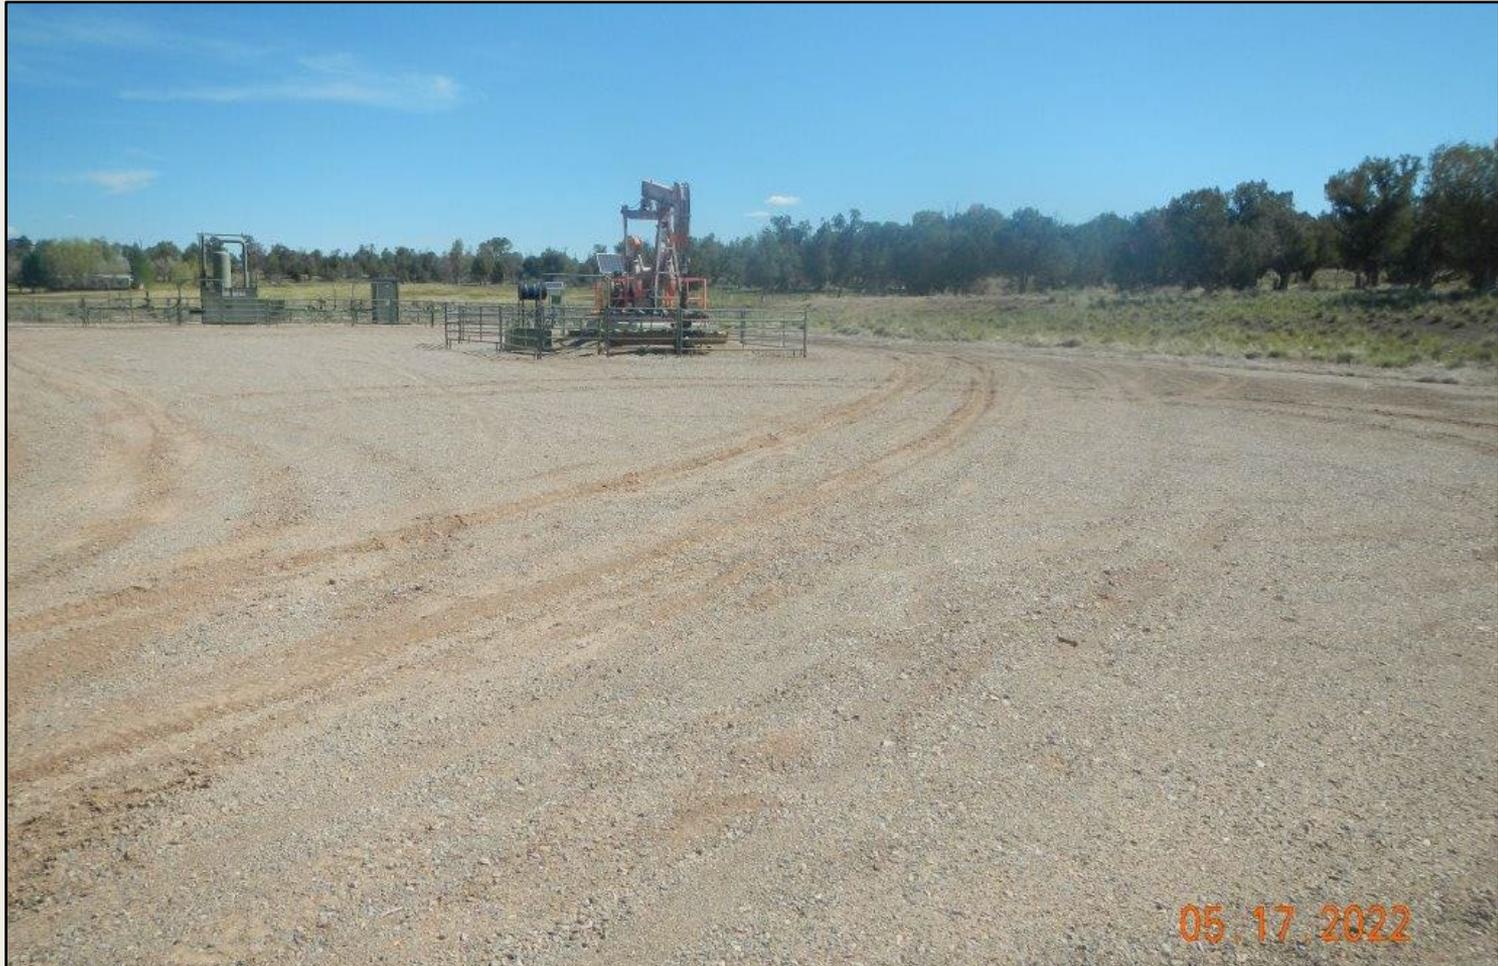
Photo 1. View of the project area from the well pad entrance facing center.

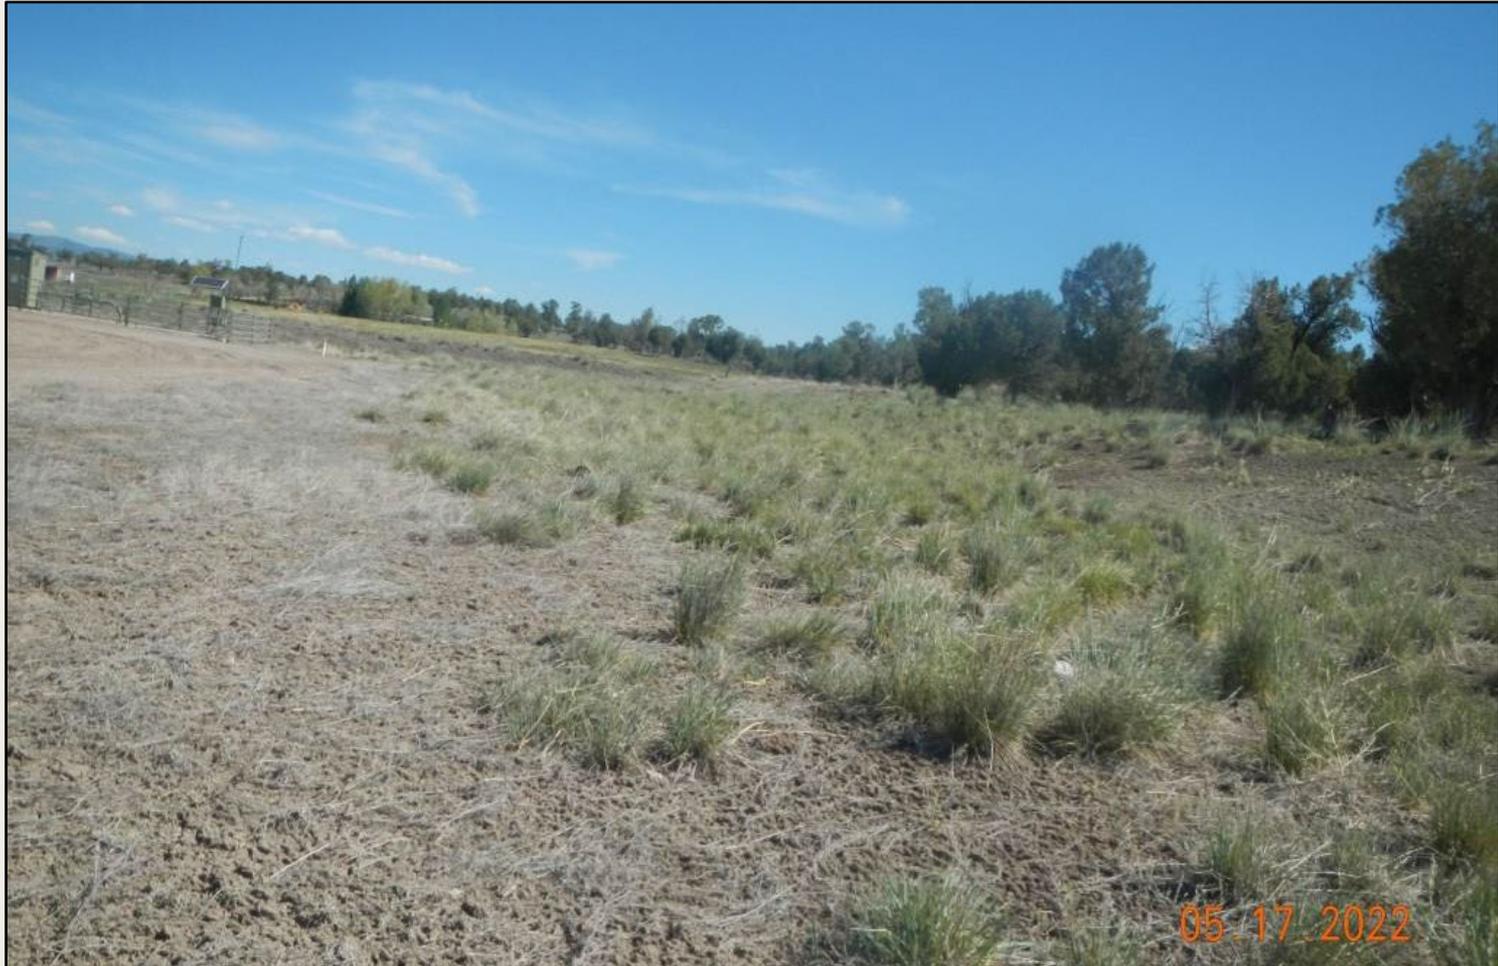
Photo 2. View of the eastern project area from the southeastern corner facing northward. Revegetation is progressing with western wheatgrass and crested wheatgrass.

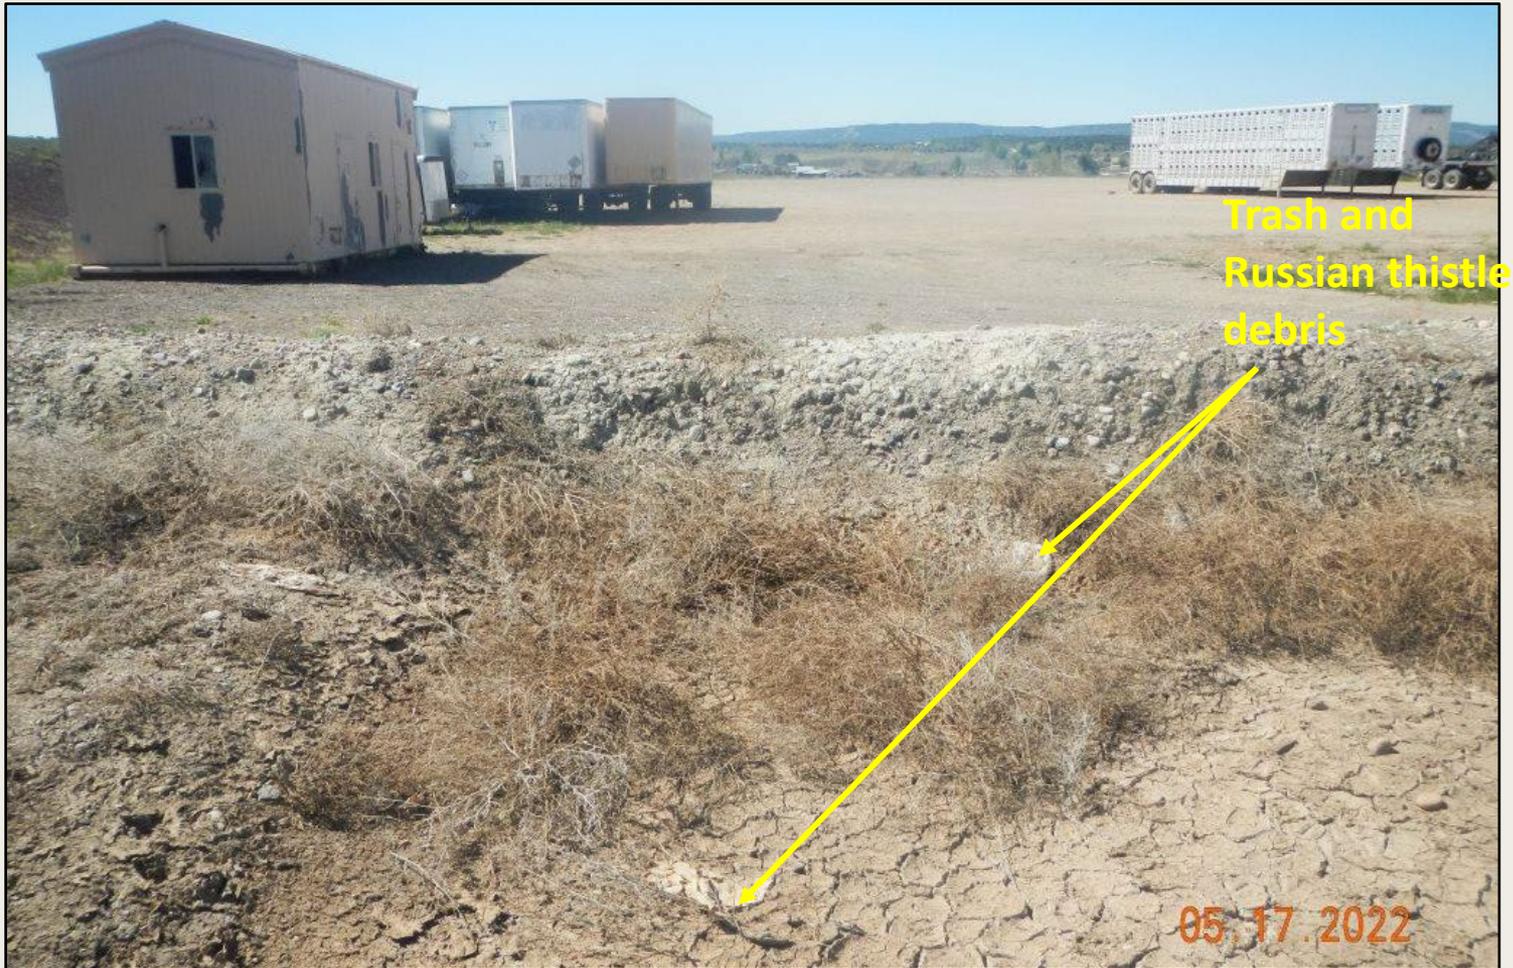
Photo 3. View of weed and trash debris within the southern silt trap.

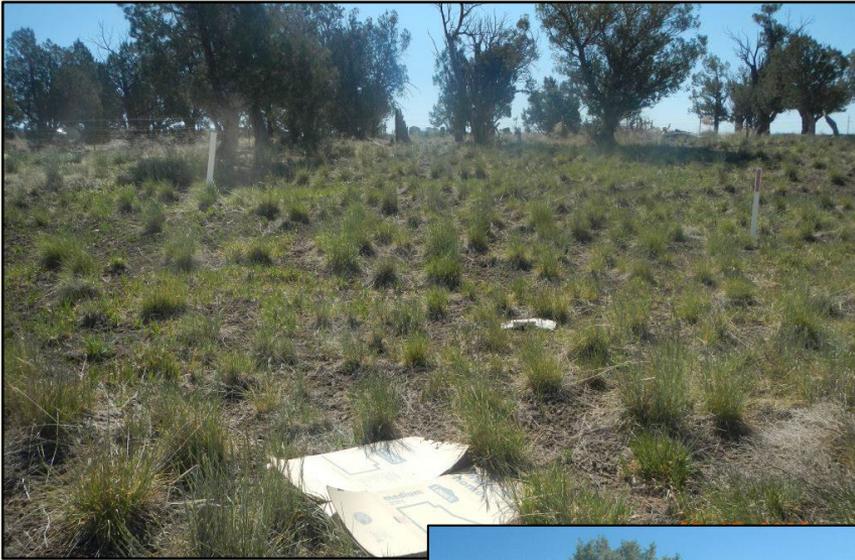
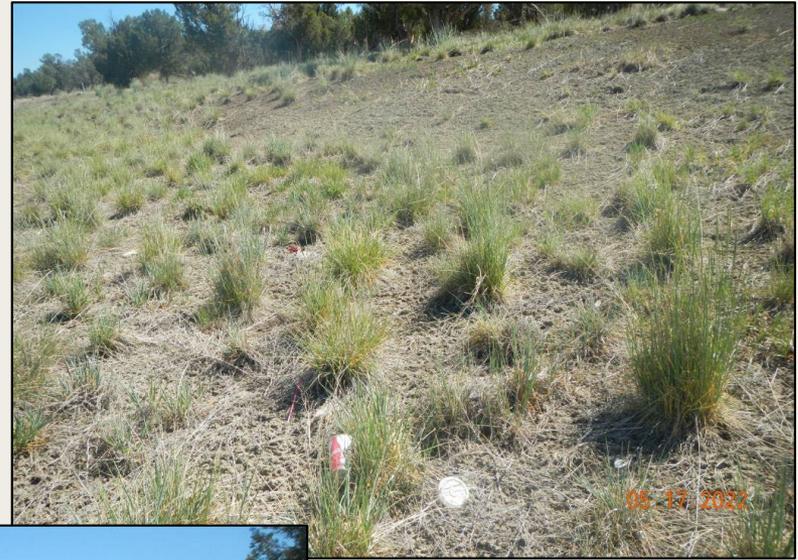
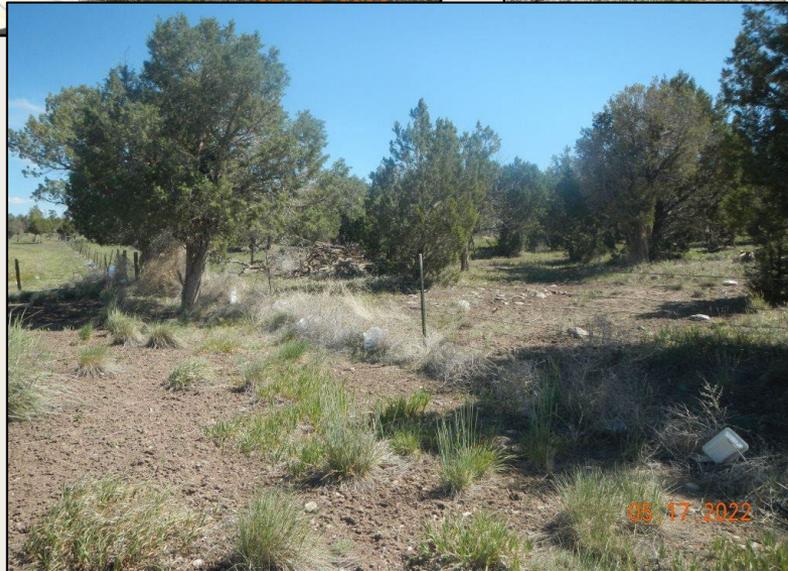
Photos 4-6. View of the trash and weed debris within the interim reclamation area and along the eastern fenceline.

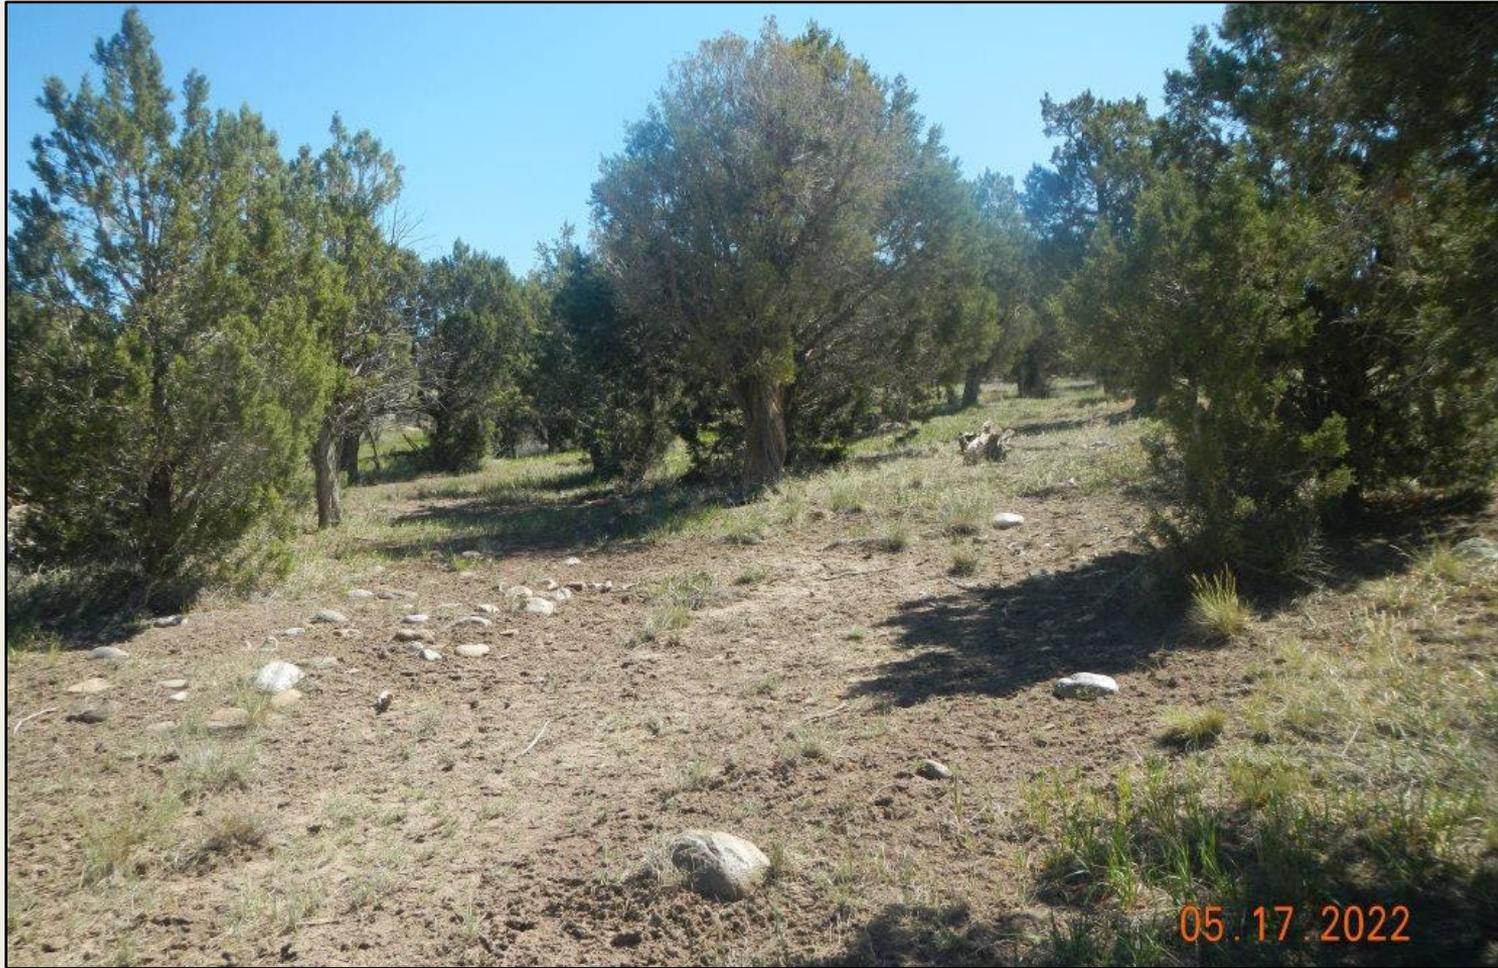
Photo 7. View of the reference area comprised of pinyon and juniper woodland with western wheatgrass and smooth brome observed in the understory along with Indian ricegrass and prickly pear.
