Inspection Photos

5/16/2022

Operator: CAERUS PICEANCE LLC - 10456

Location ID: 479149

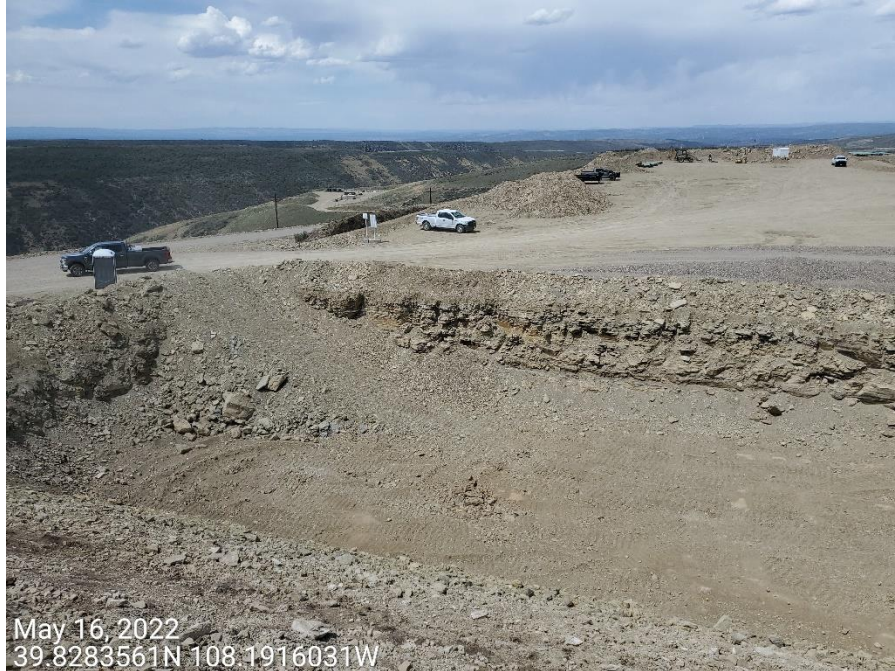
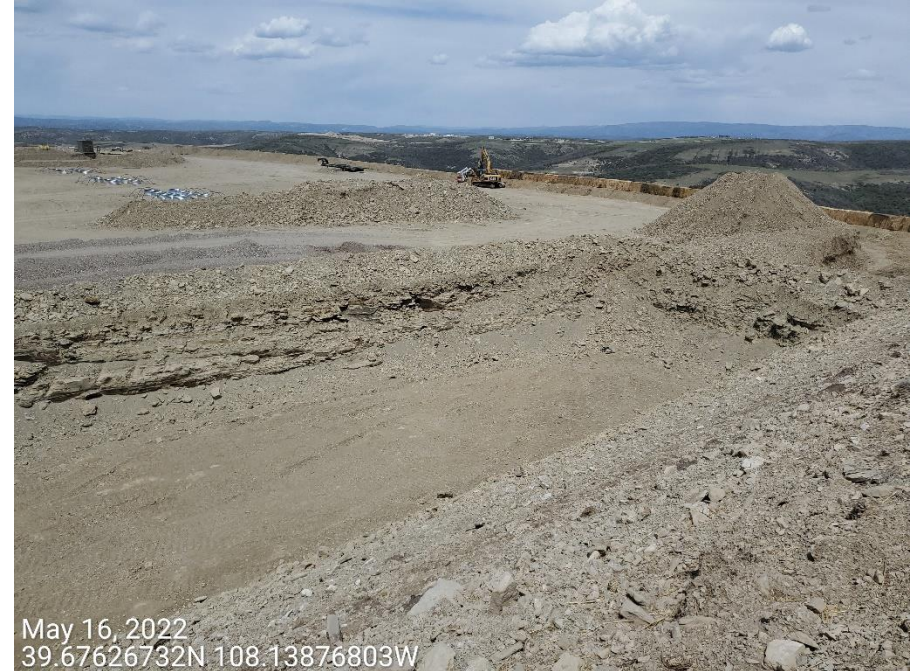
Photo 1: Photos taken from the south end of the Location, facing northwest/northeast. Photos provide an overview of the Location; location constructed, well conductors set, drilling operations have not commenced.

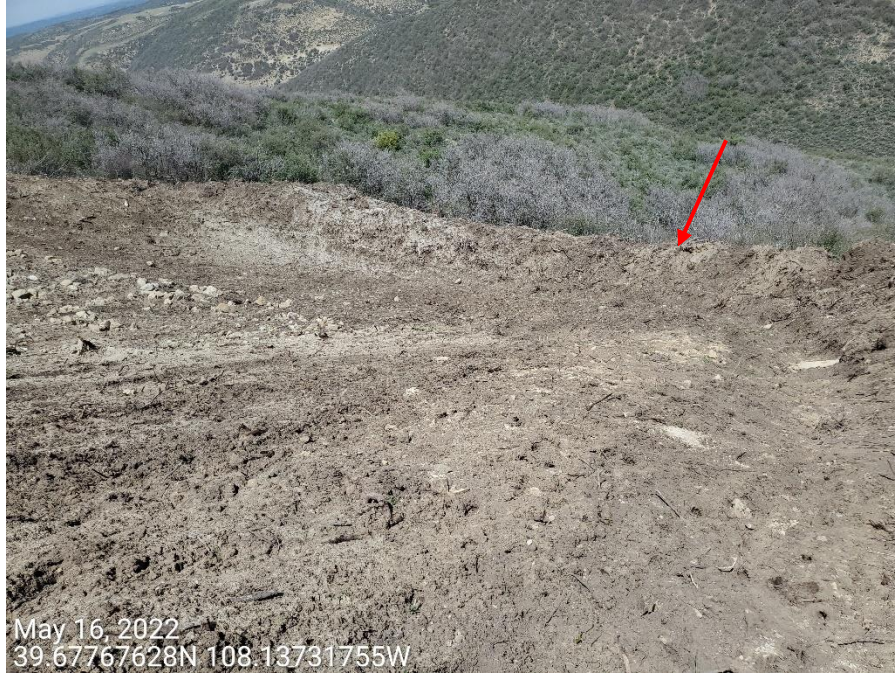
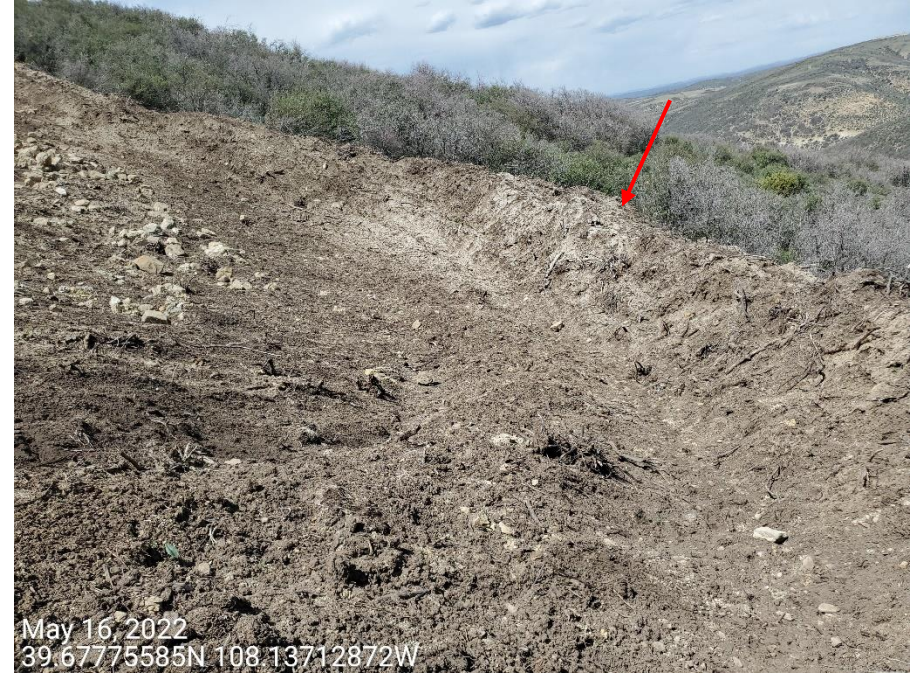
Photo 2: Photos taken from the east end of the Location. Operator has 3 stormwater sediment traps/pond (2 on the east end of the Location, 1 on the northwest). Photo shows stormwater controls have been constructed with the use of topsoil as the perimeter berm (arrow). Additionally, trap/pond has not been constructed with an engineered outlet to allow for proper discharge. Stormwater controls have not been installed per good engineering practices, and the use of topsoil as a stormwater control does not comport with Rule 1002.b and 1002.c; BMPs to protect soils from stormwater, erosion, and mixing of subsoils are inadequate. Operator has implemented a hydromulch at soil stockpile; BMP largely intact, however it was observed to be degraded/inadequate along many sections of the stockpile resulting in degradation

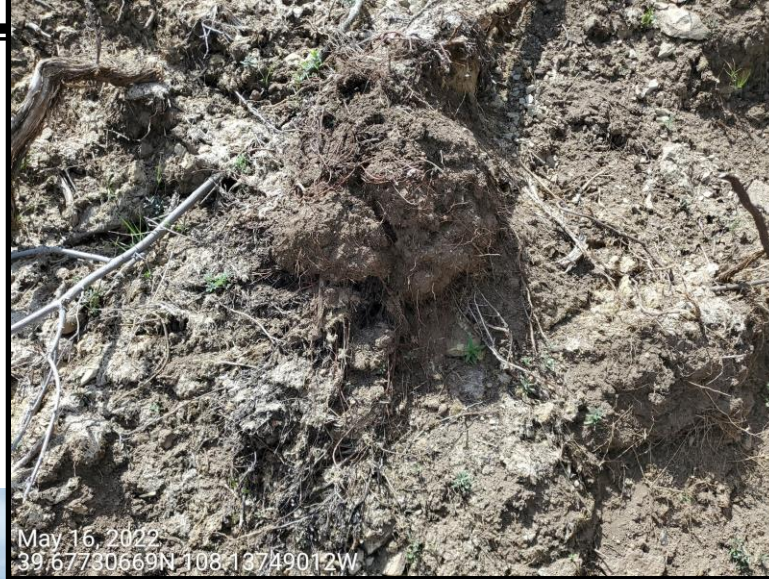
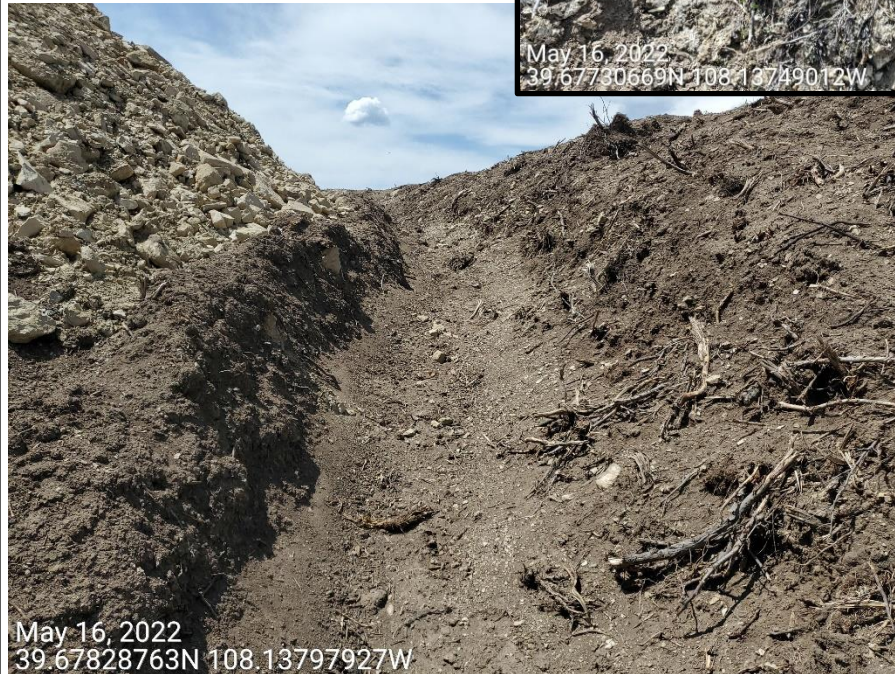
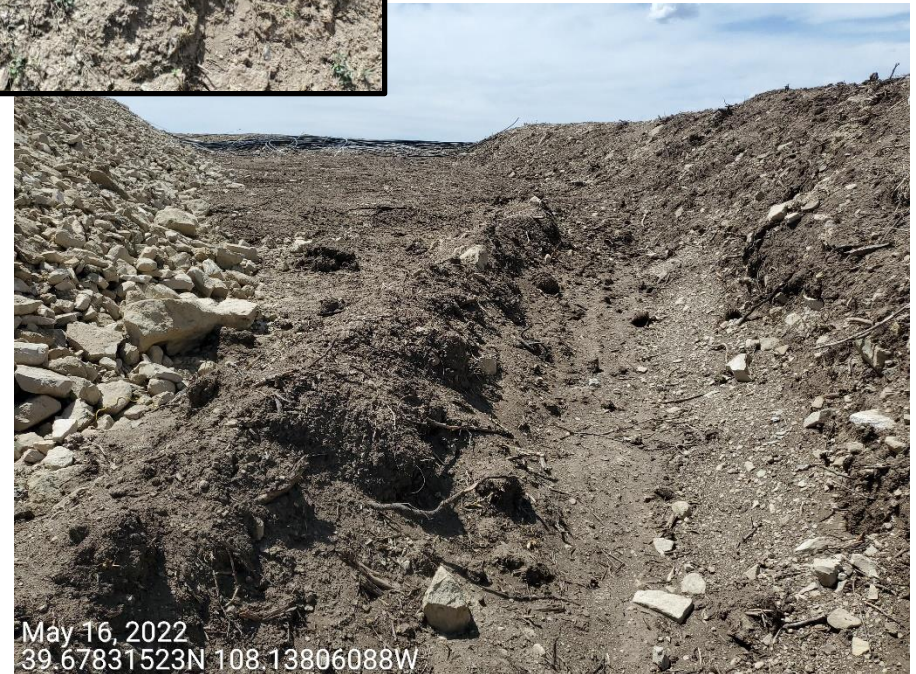
Photo 3: See comments under photo 2. Photo also shows loose soils within the ditch, unstabilized slopes within the ditch BMP and along the topsoil stockpile, and that topsoil is evident within slopes of the ditch. BMPs to protect the soil stockpile remains inadequate.

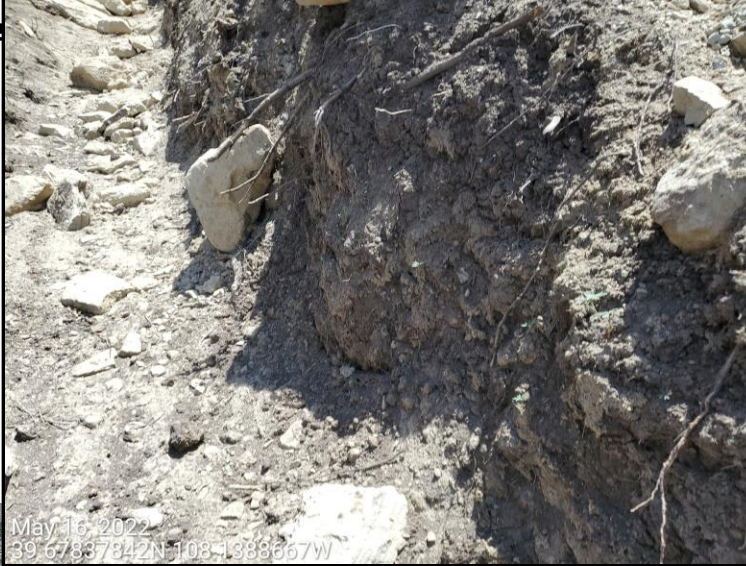
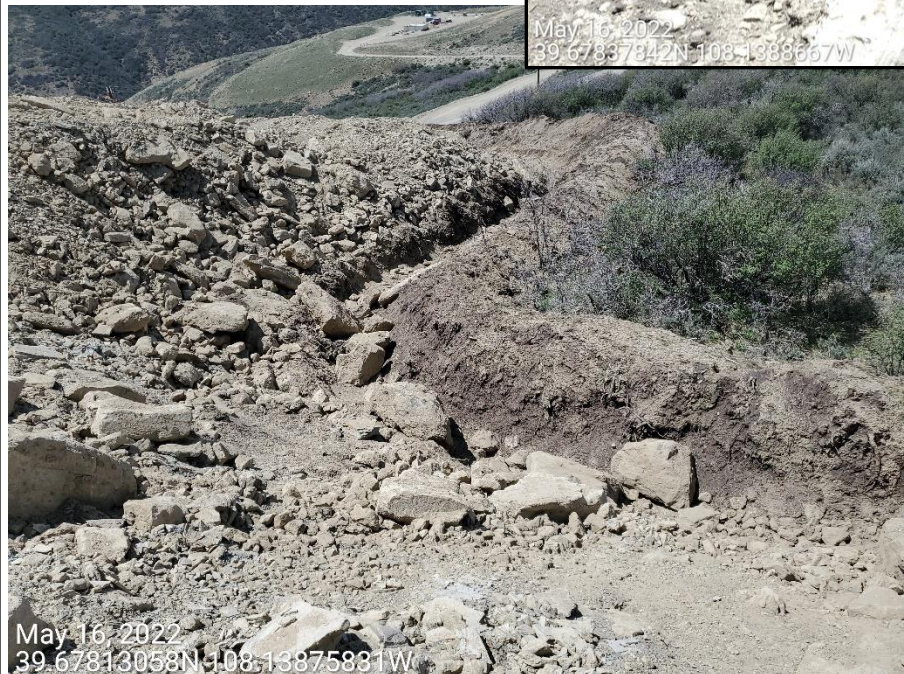
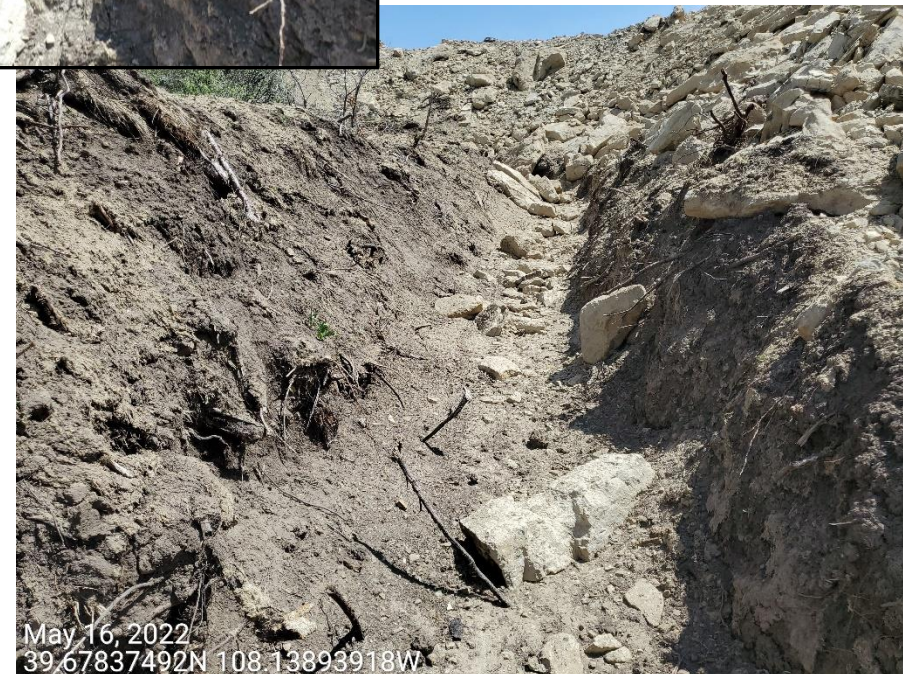
Photo 4: See comments under photo 2. Photo also shows loose soils within the ditch, unstabilized slopes within the ditch BMP and along the topsoil stockpile, and that topsoil is evident within slopes of the ditch. BMPs to protect the soil stockpile remains inadequate.

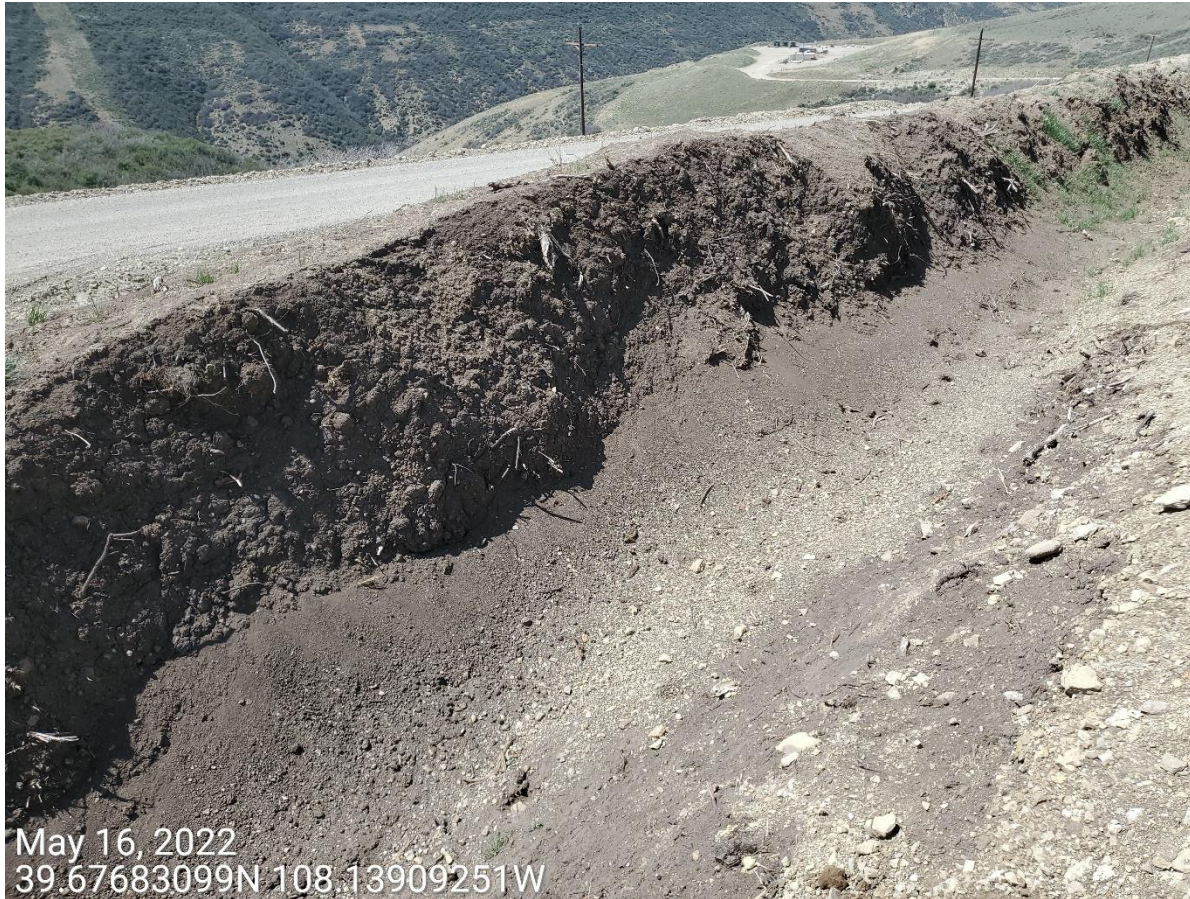
Photo 5: Photo example showing erosion occurring at the topsoil stockpile, and topsoil is being utilized as a stormwater control BMP.

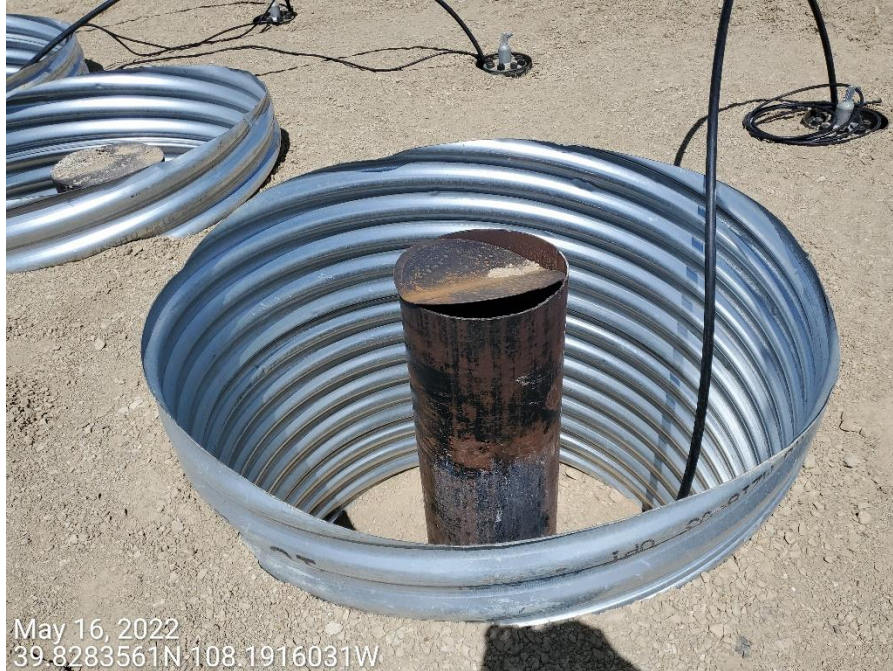
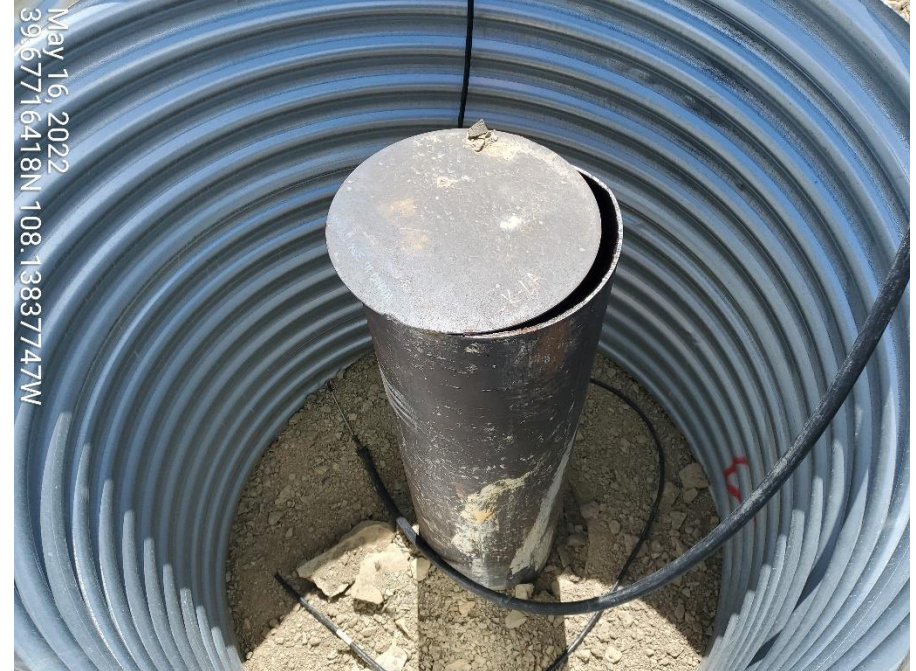
Photo 6: Photo taken from the preset conductors on site. Conductors on Location set 9/28/2021; pursuant to Rule 406.e, if well has not been drilled within 30 days of setting, Operator shall weld a plate on the top of the pipe until conductor is opened for drilling, cover and fence rat/mouse holes and cellars and maintain within 15 days; if the well has not been drilled within 6 months on rangeland, then Operator will plug conductor and perform reclamation. Photos examples showing several conductors with an improperly welded plate on top of the pipe, and that the cellars have not been covered or fenced; this was required by 10/13/2021. Photo also shows that conductors have not been plugged, and reclamation performed pursuant to Rule 1003 or 1004; this was required by 3/28/2022.

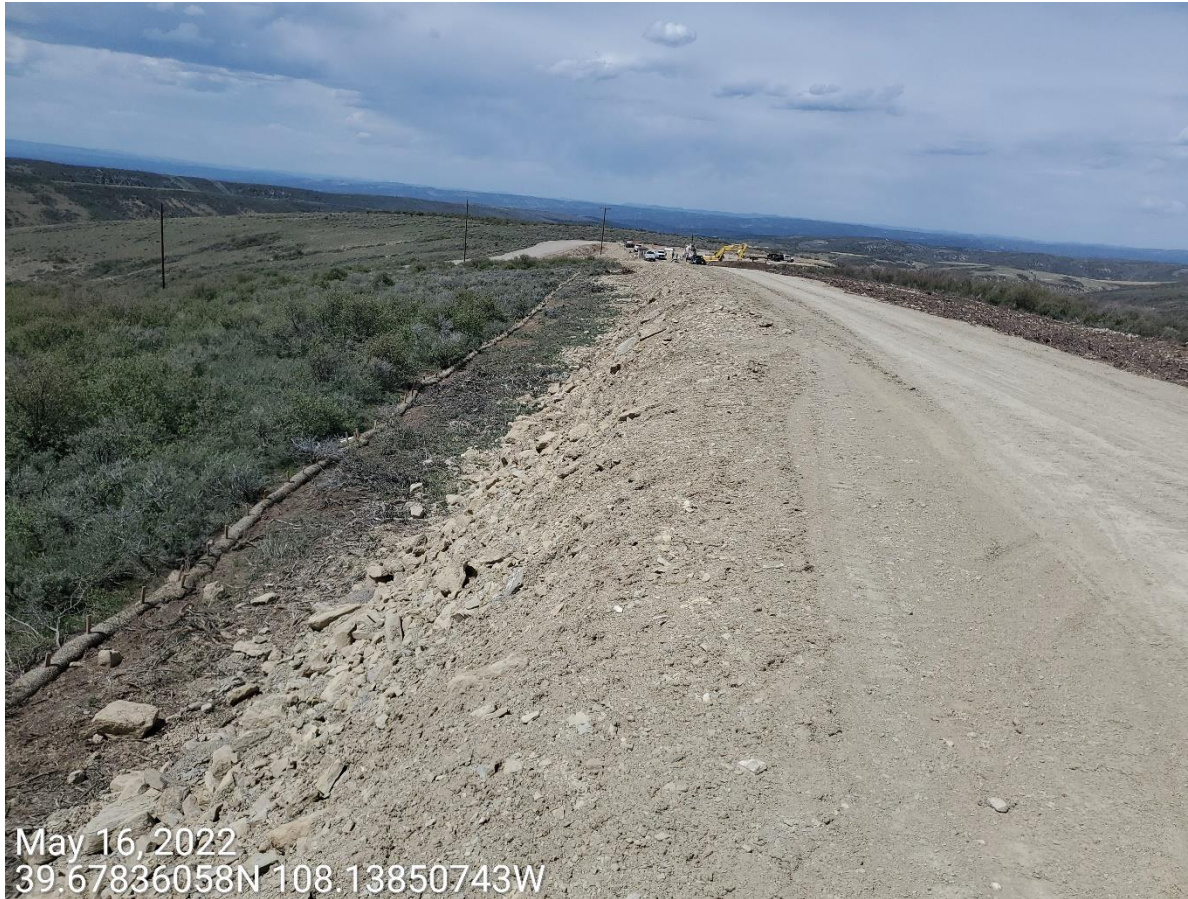
Photo 7: Photo taken from the north end of the Location, facing north. Photo shows access road that travels north to the BJU N26-496 Location. Inspection No. 696203136 documented that Operator failed to properly salvage/segregate and protect topsoil from areas beneath the access road disturbance.
