TEP
RWF 331-27
Location # 335380

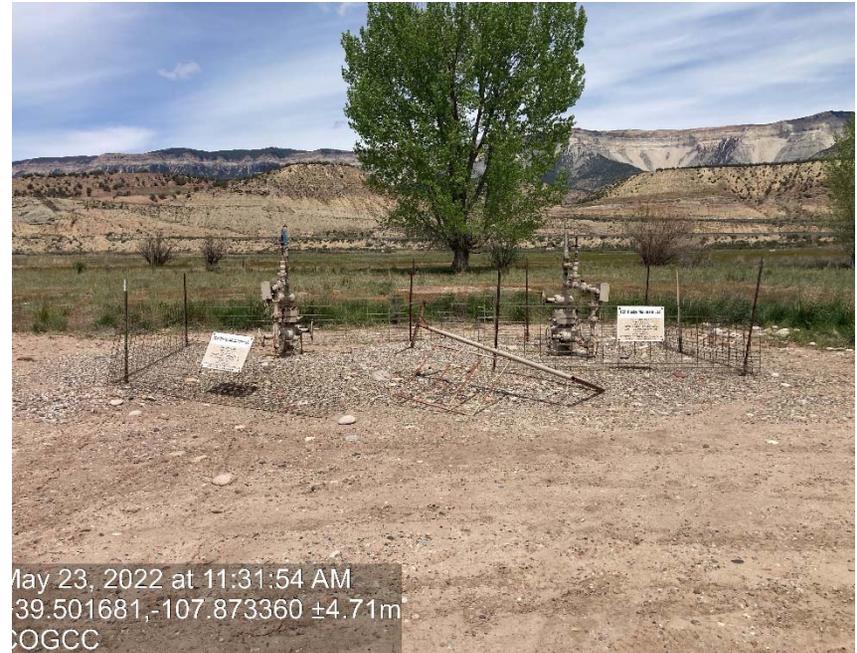
Well heads gate and fence falling down

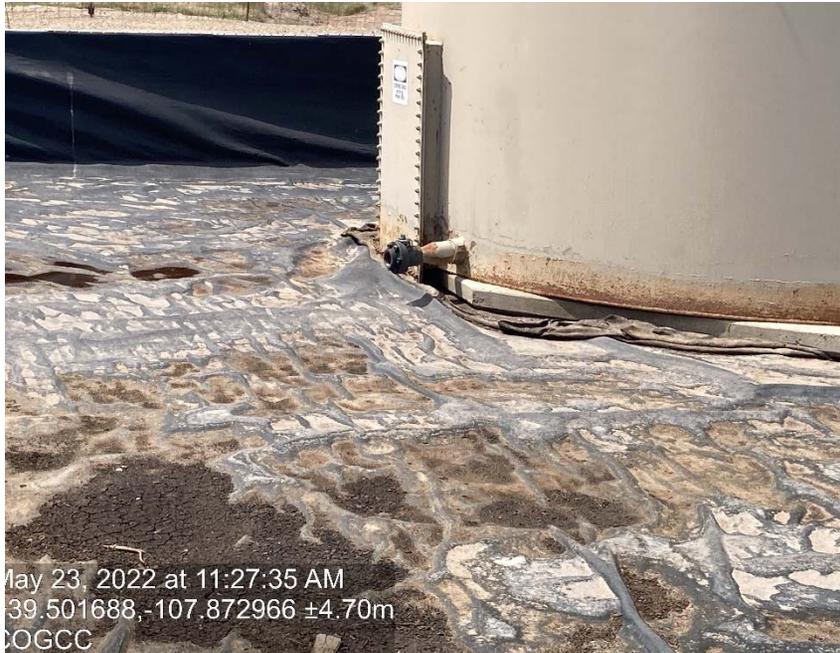
Missing cap/plug

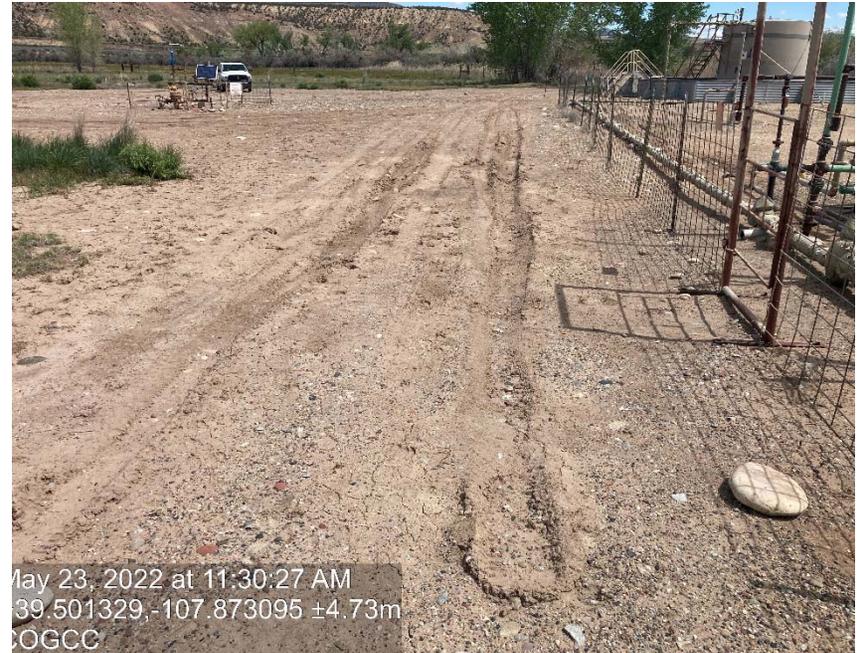
Lack of stabilization/compaction

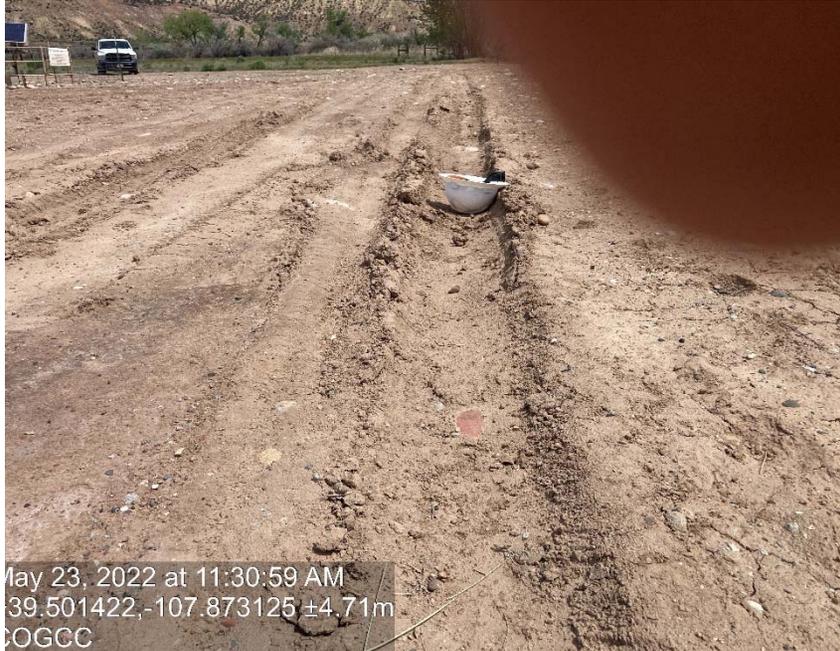
Lack of stabilization/compaction

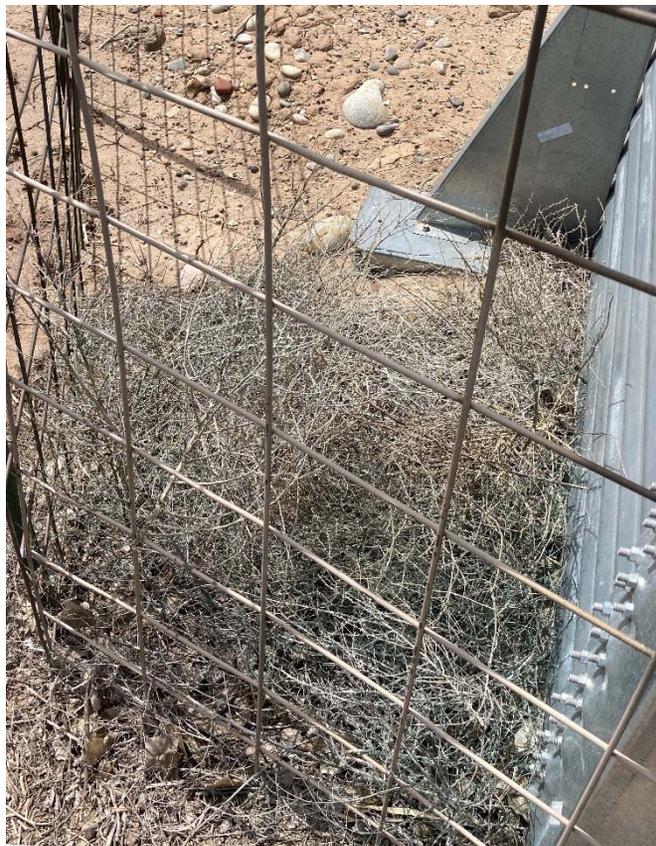
Debris
