Colorado Oil and Gas Conservation Commission

# Federal WMC 24-17 #480732

# Issue Report

Inspection Photos  
Operator Name: TEP ROCKY MOUNTAIN LLC - 96850  
Location ID: 480732

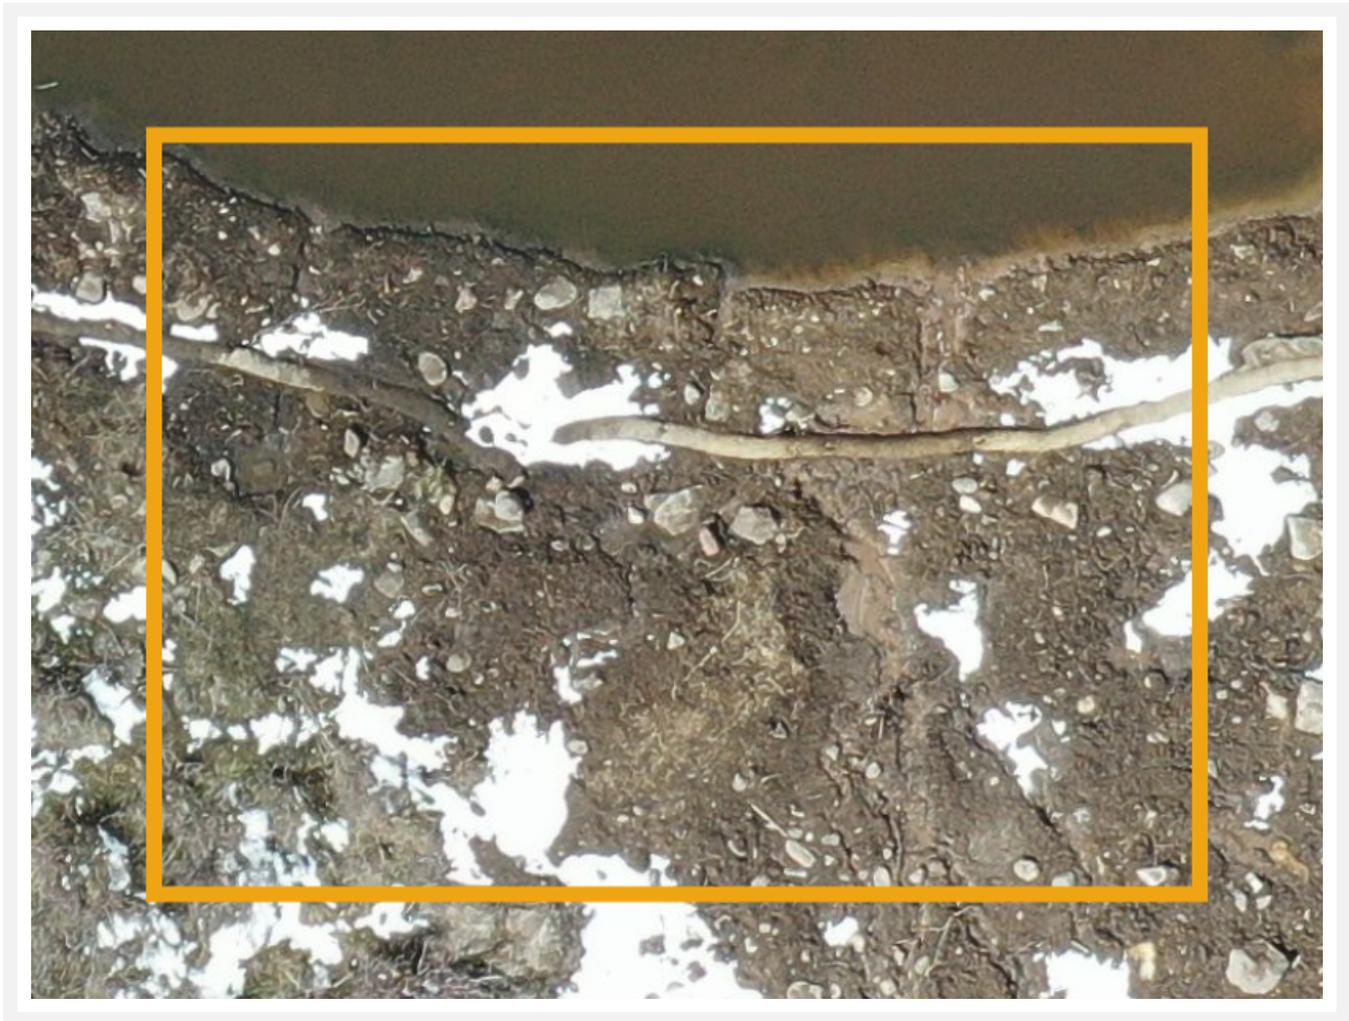
# 1 - Erosion

Summary:	Stormwater discharge from from areas of trap without an outlet.
Created:	May 23, 2022, 2:31pm by Aaron Trujillo
Cost of Repair:	—
Coordinates:	39.43892, -107.79810

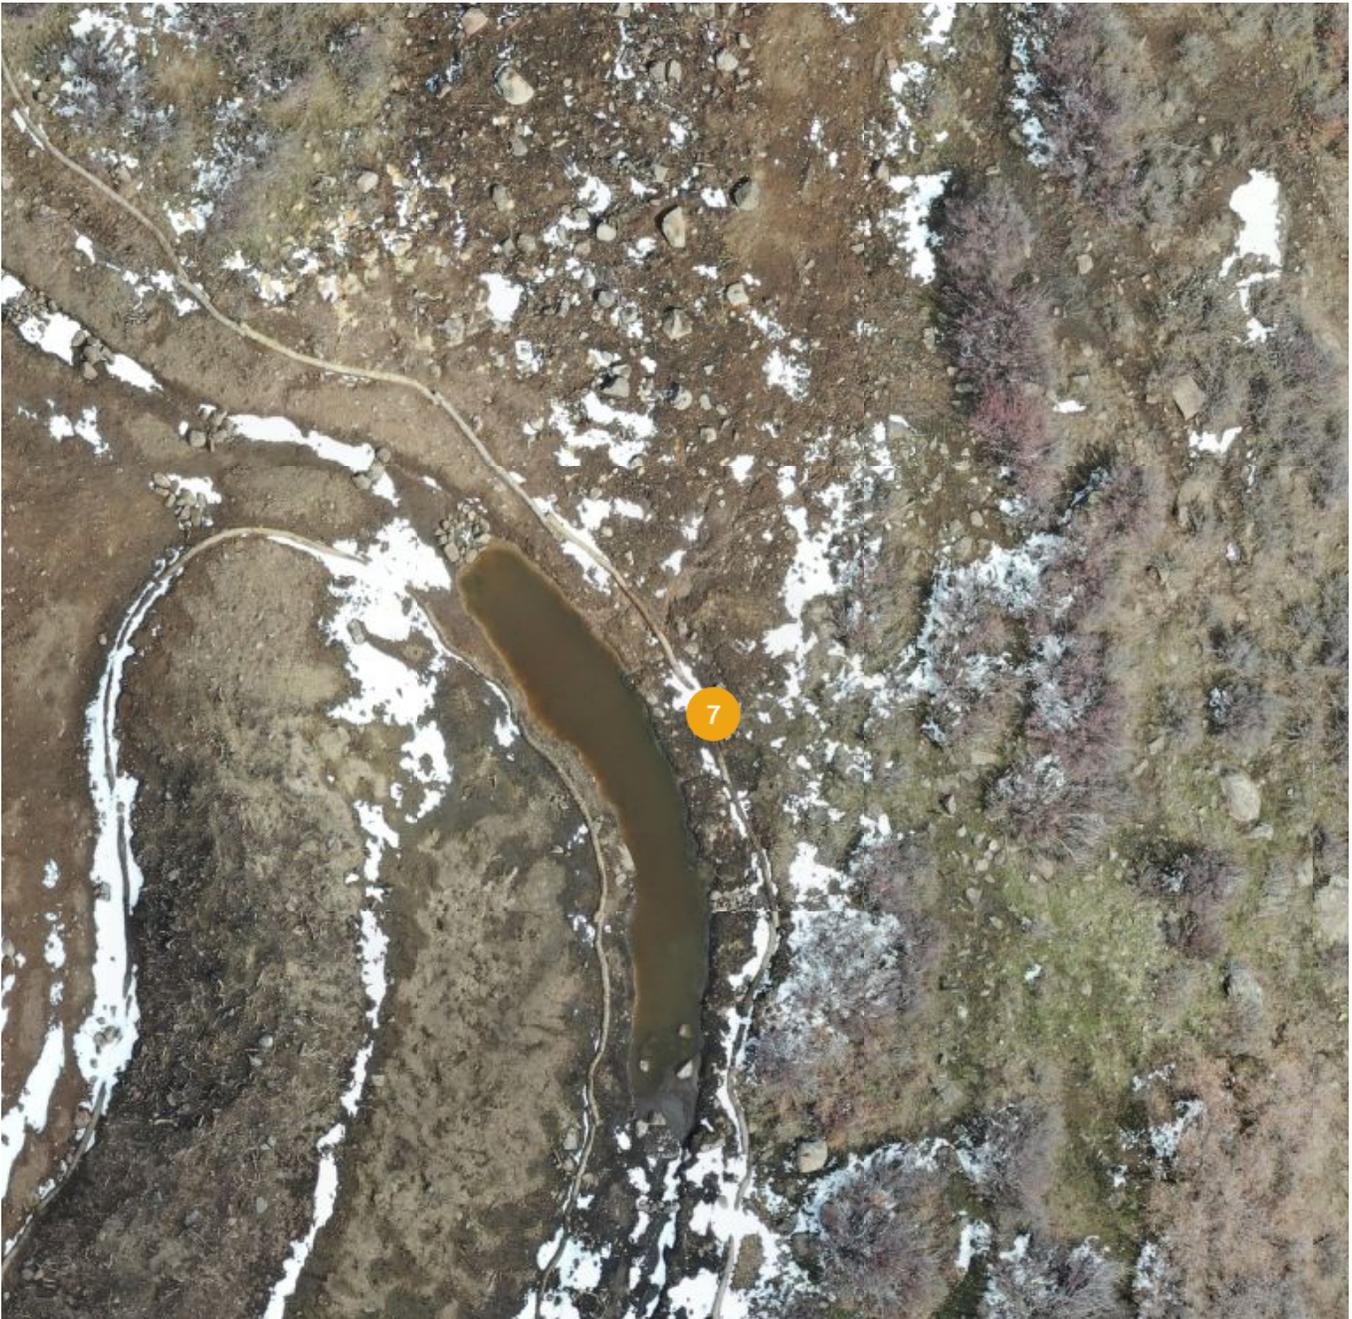
## 7 - Observation

Inadequate outlet

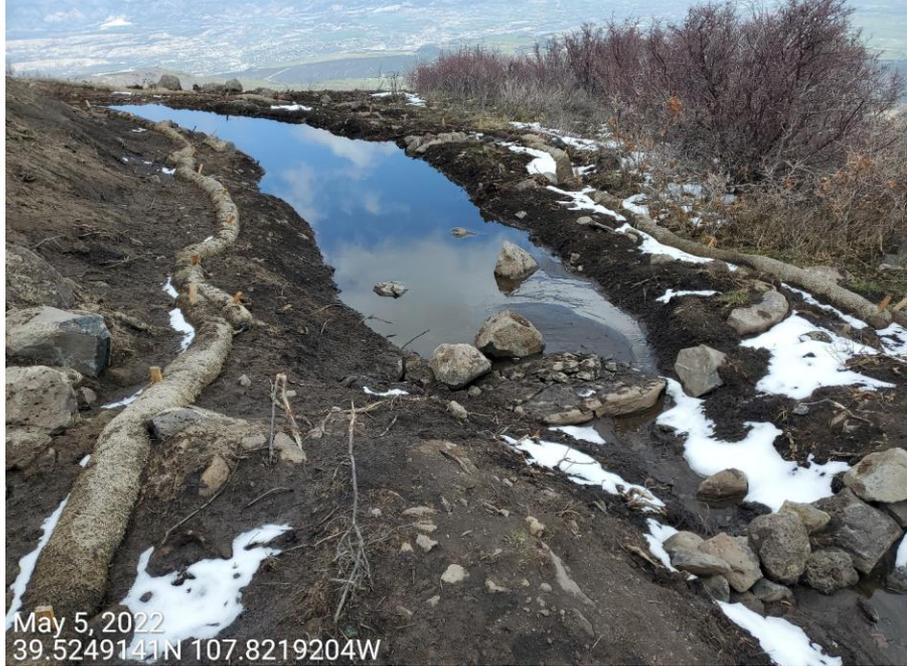
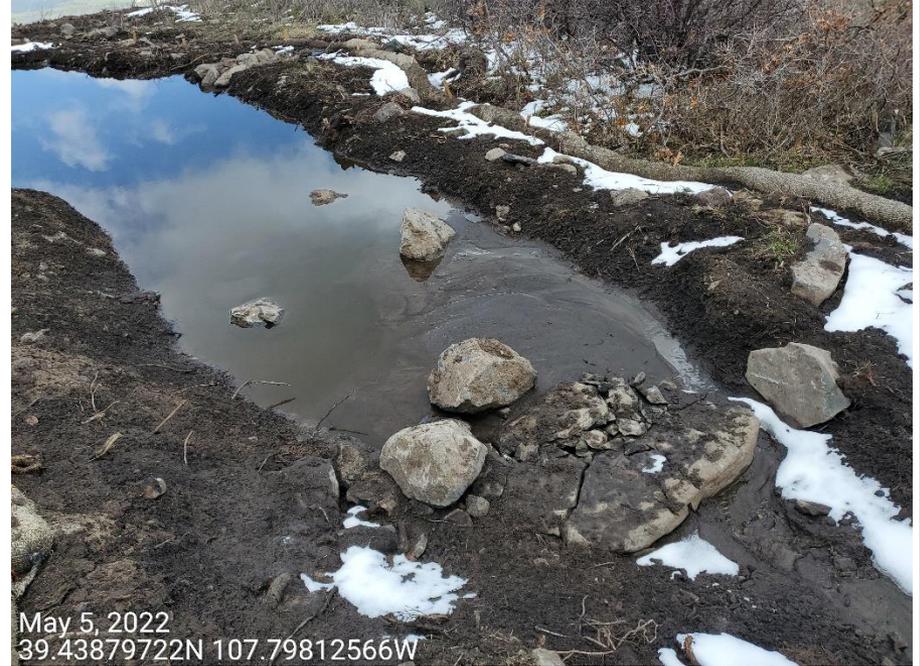
**Photo 1:** Photos taken from the sediment trap on the northeast end of the Location. Photo right shows sediment deposition due to un stabilize soils within the stormwater ditch.

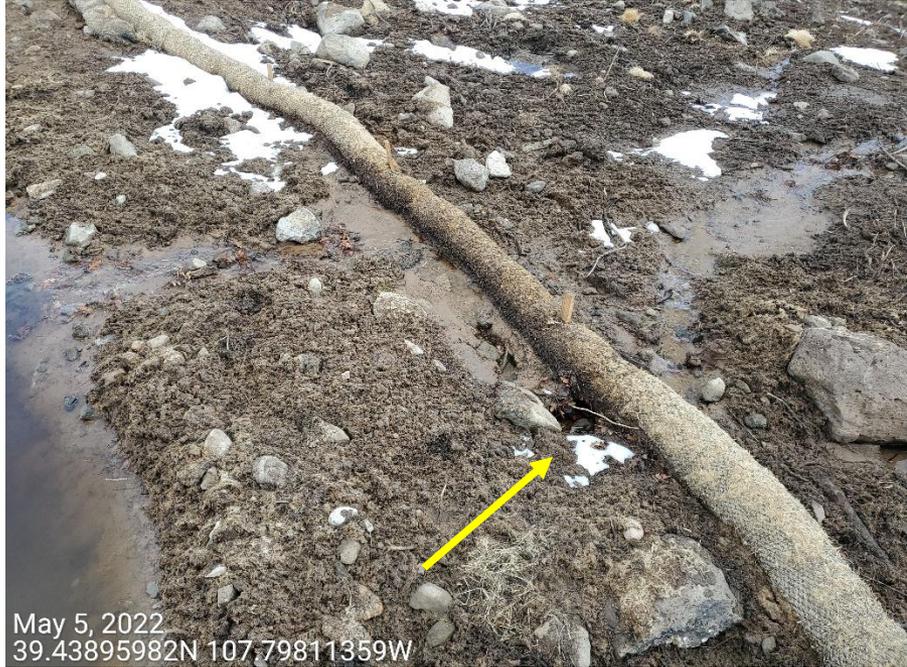
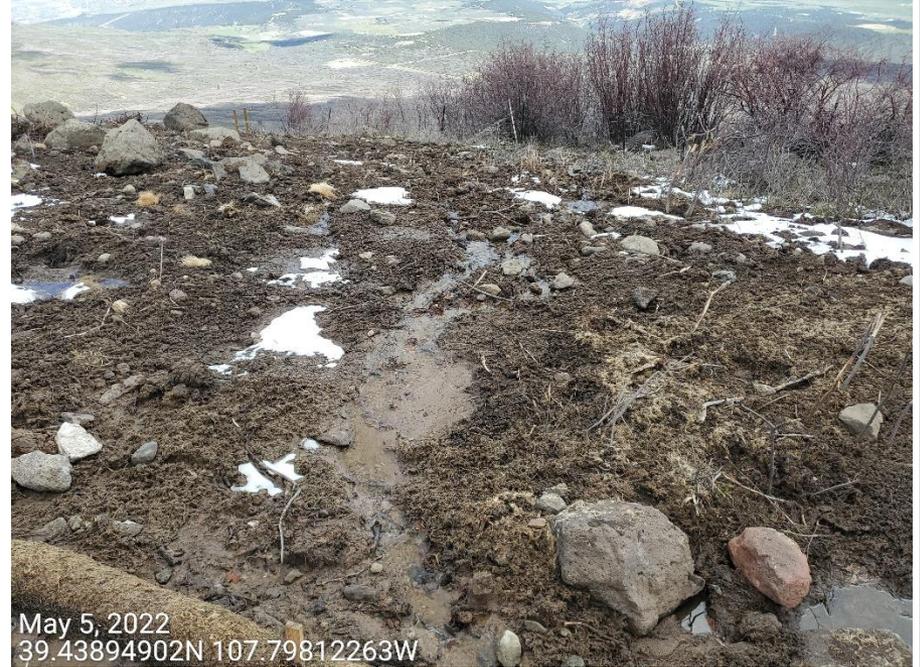
**Photo 2:** Continued from photo 1. Photos example of the sediment trap where an outlet has not been constructed, but where stormwater is discharging, resulting in erosion degradation and sediment transport. Photo left shows water has cut beneath the straw wattle.

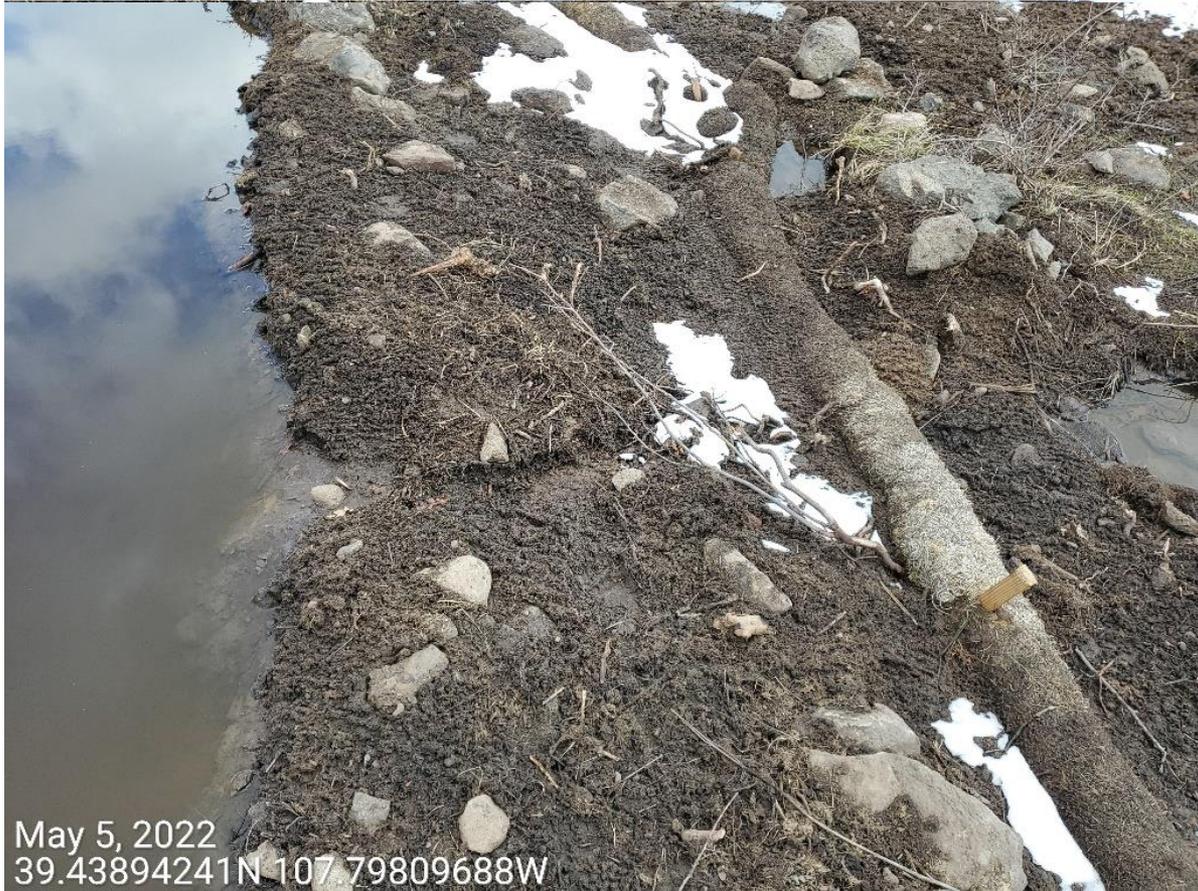
**Photo 3:** Continued from photo 1. Photo a second example of the sediment trap where an outlet has not been constructed, but where stormwater is discharging, resulting in erosion degradation and sediment transport. Photo left shows water has cut beneath the straw wattle.

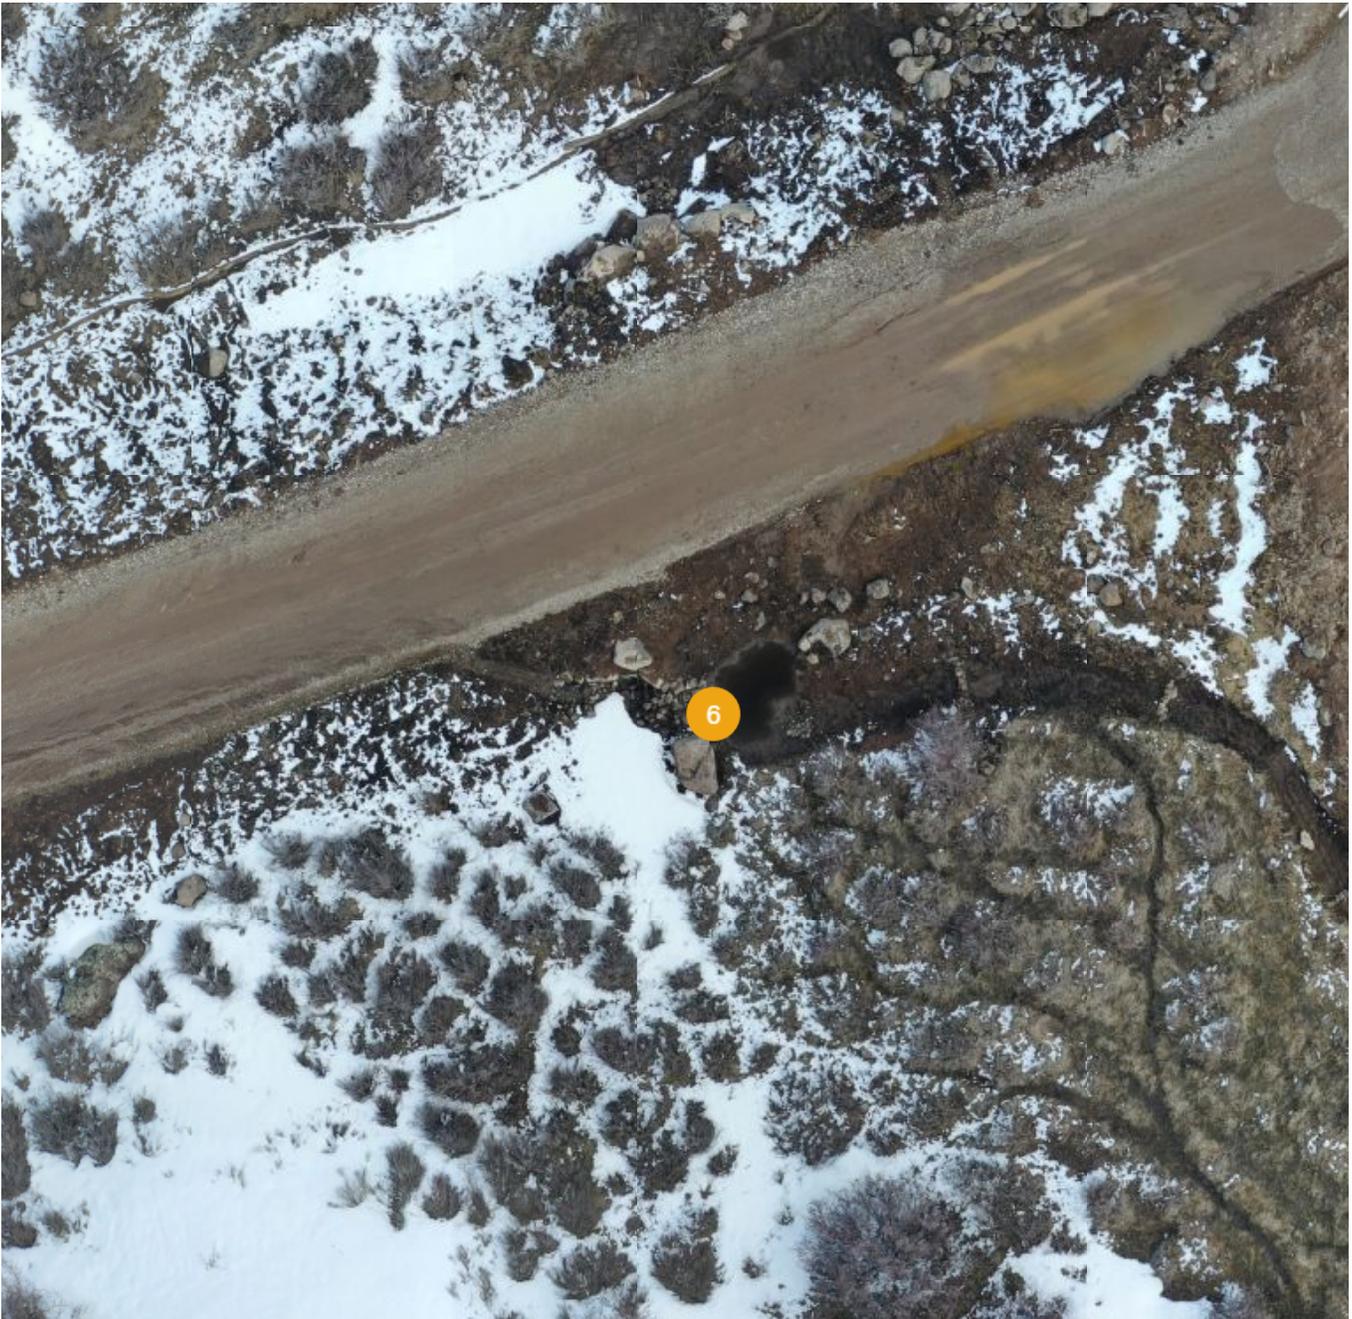
## 6 - Observation

Summary:	Inadequate outlet
Created:	May 23, 2022, 2:37pm by Aaron Trujillo
Cost of Repair:	—
Coordinates:	39.43864, -107.80040
Elevation:	-0.27 ft

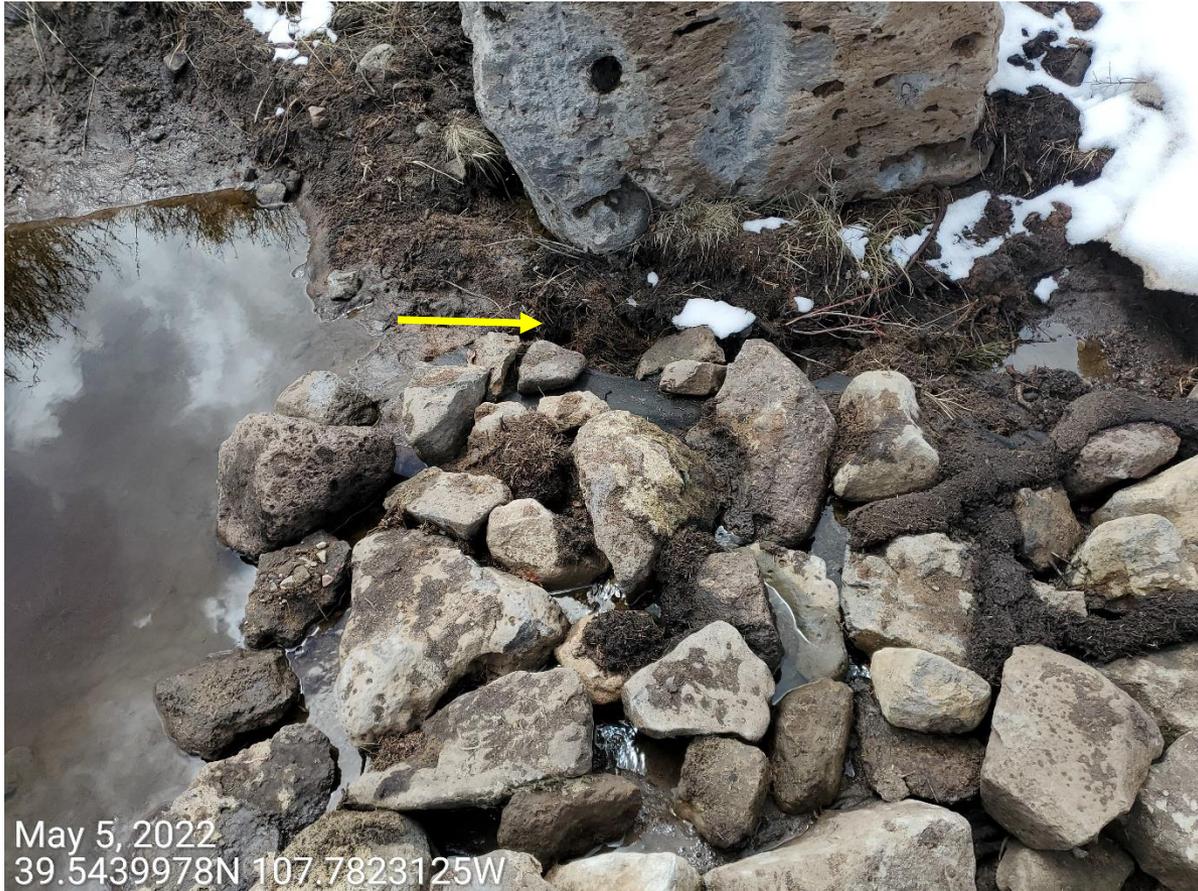
**Photo 4:** Photo taken from the sediment trap on the southwest end of the Location. Outlet inadequate; stormwater runoff discharging to areas around the trap's outlet, resulting in degradation to the control.

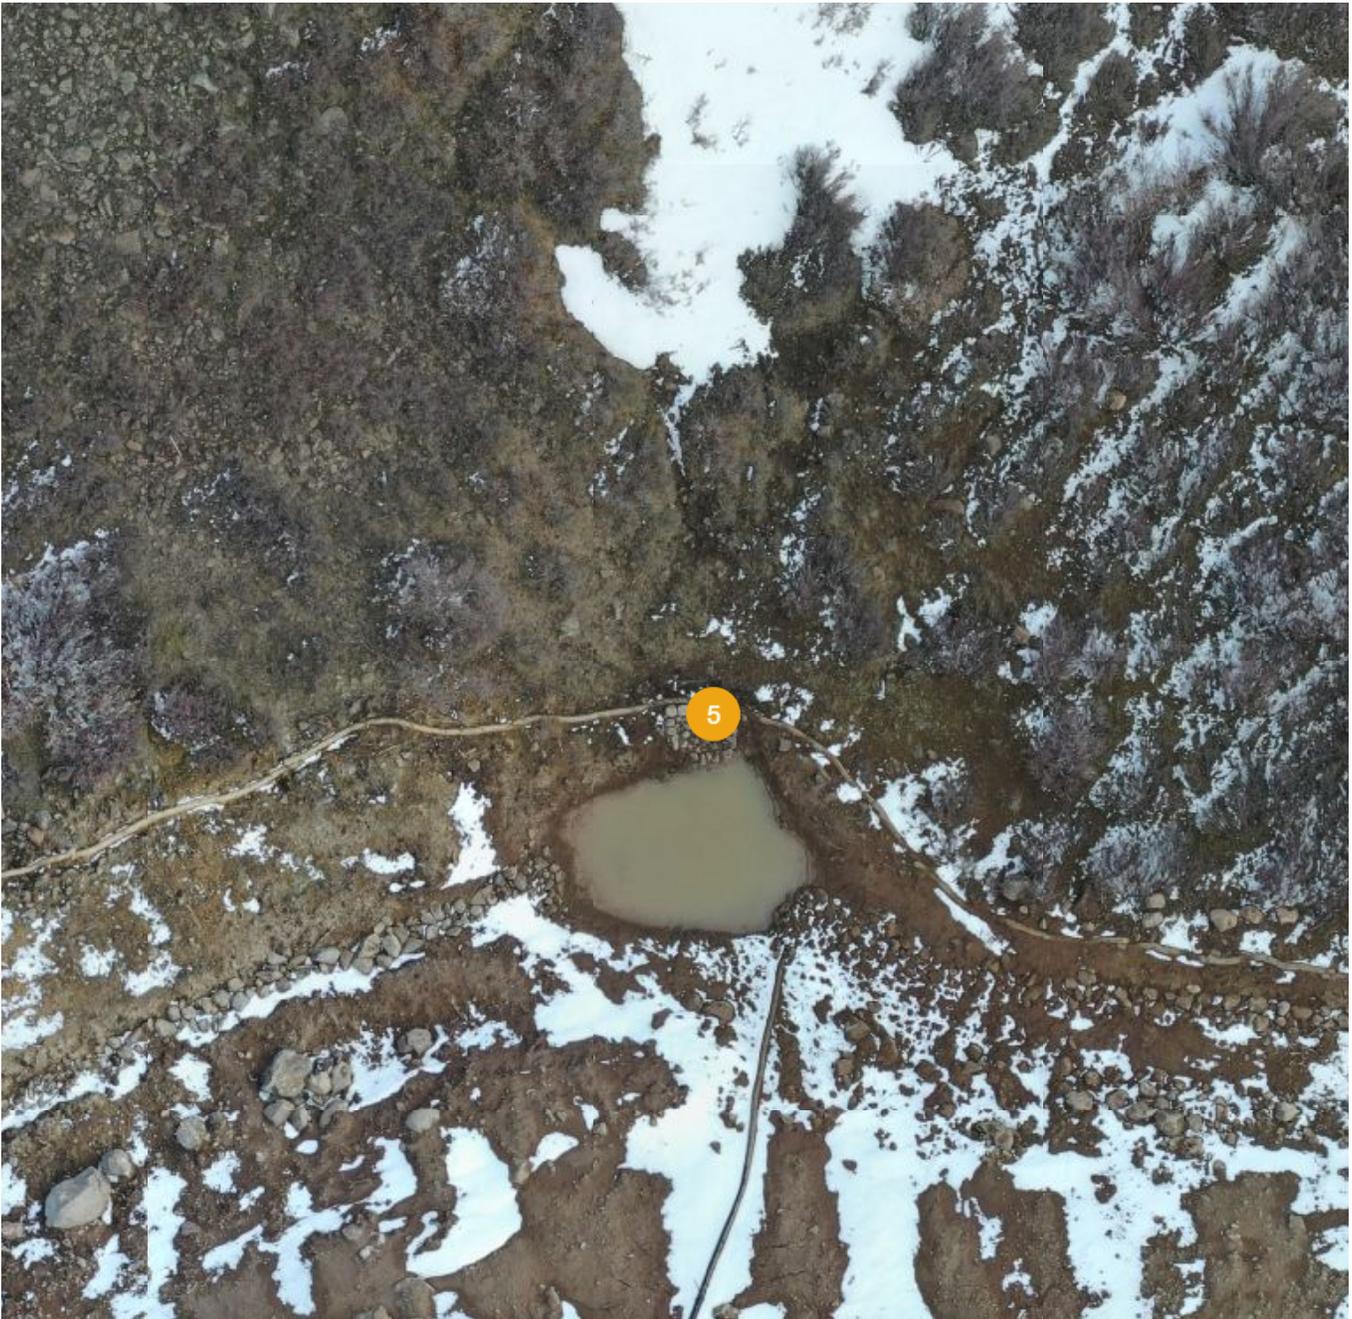
## 5 - Observation

Summary:	Inadequate outlet
Created:	May 23, 2022, 2:36pm by Aaron Trujillo
Cost of Repair:	—
Coordinates:	39.43976, -107.79987
Elevation:	-52.25 ft

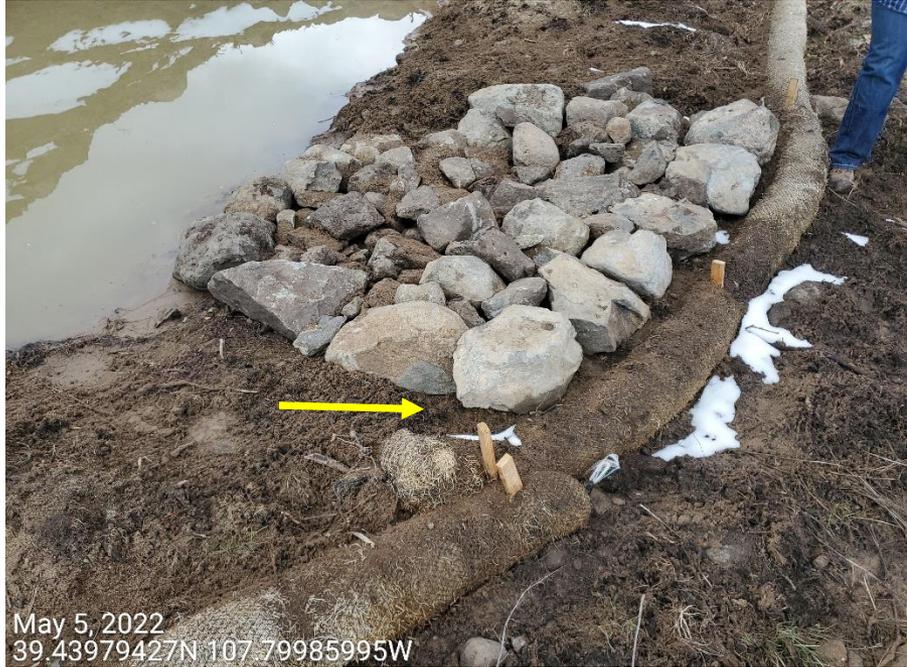
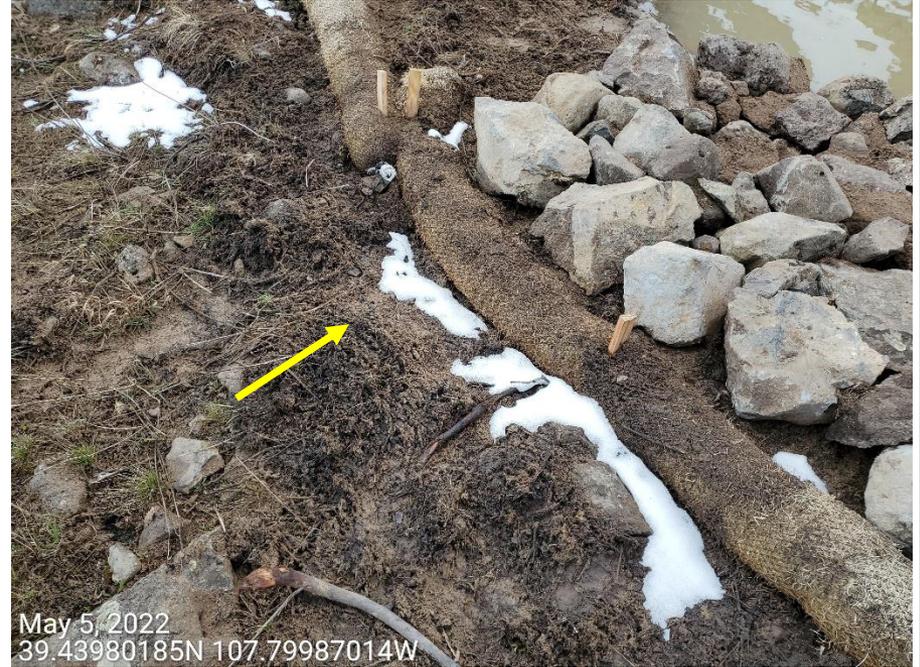
**Photo 5:** Photo taken from the sediment trap on the north end of the Location. Outlet inadequate; stormwater runoff discharging to areas around the trap's outlet, resulting in degradation to the control. Photo also shows sediment deposition on top of the straw wattle leading offsite.

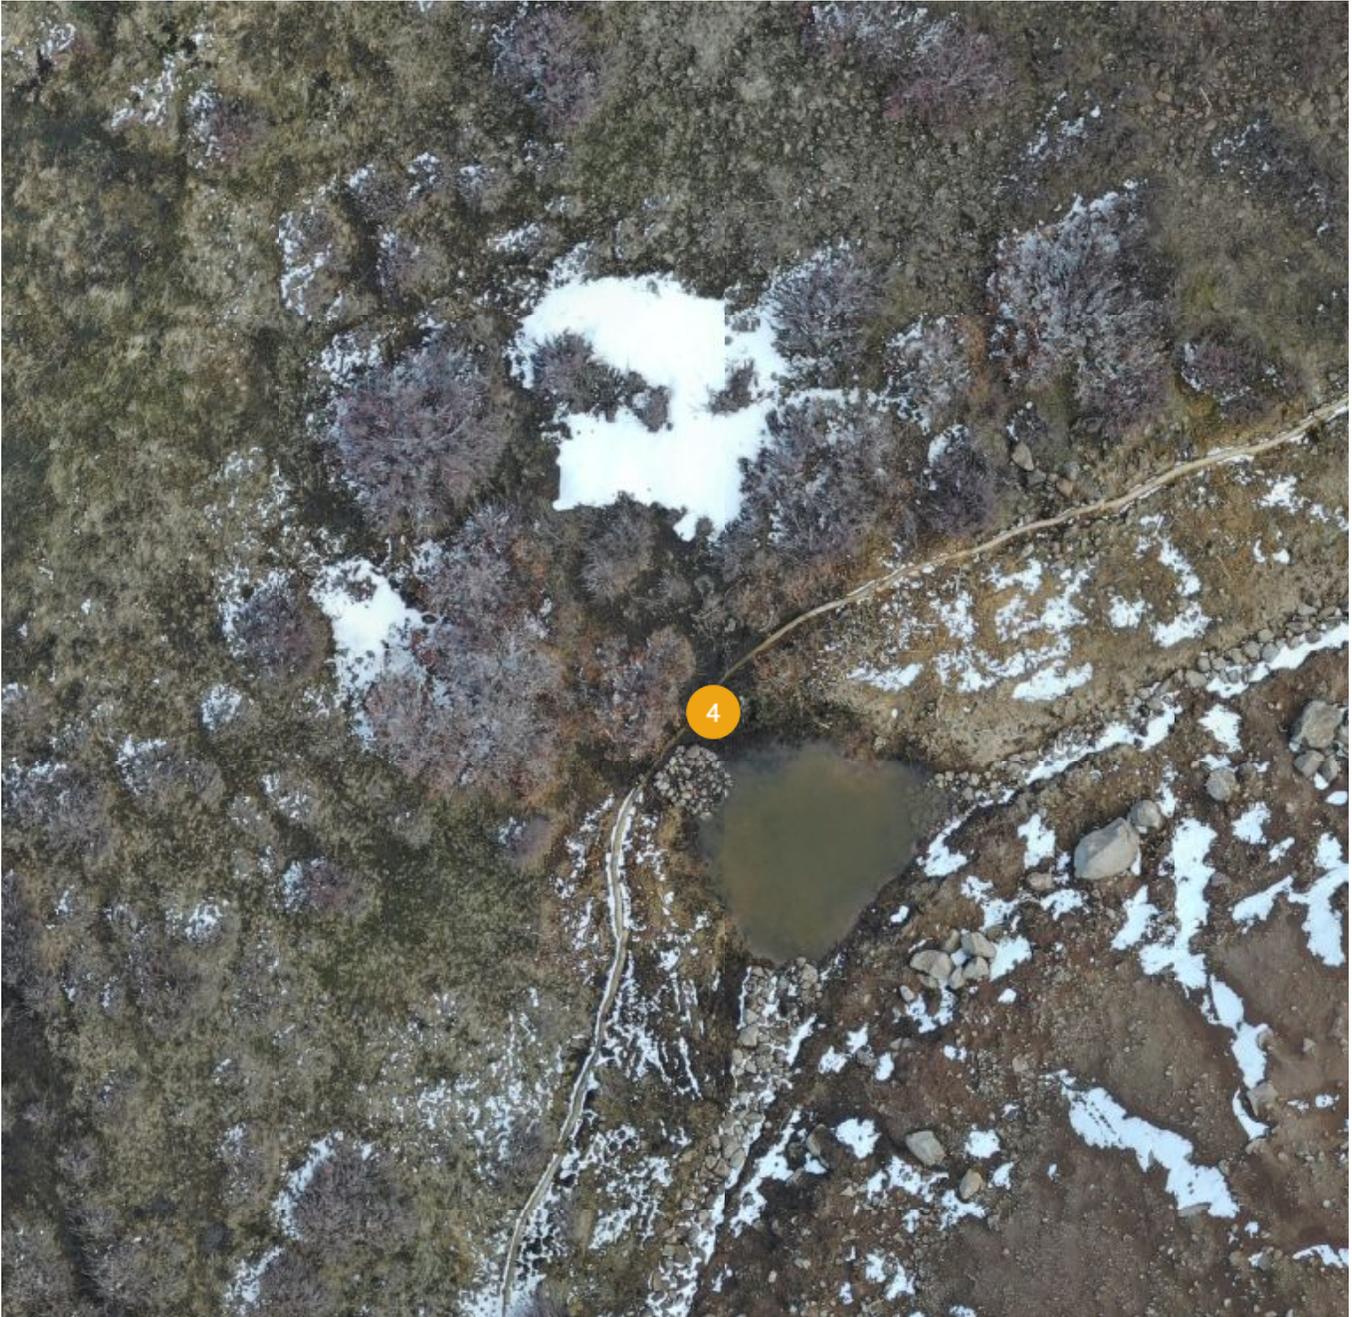
## 4 - Observation

Summary:	Inadequate outlet
Created:	May 23, 2022, 2:36pm by Aaron Trujillo
Cost of Repair:	—
Coordinates:	39.43966, -107.80026
Elevation:	-49.04 ft

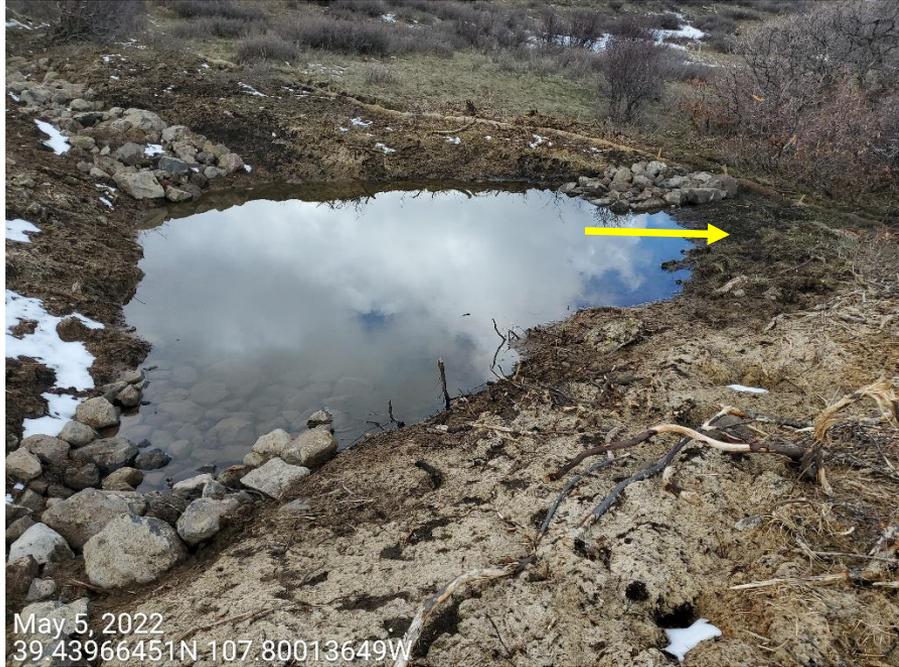
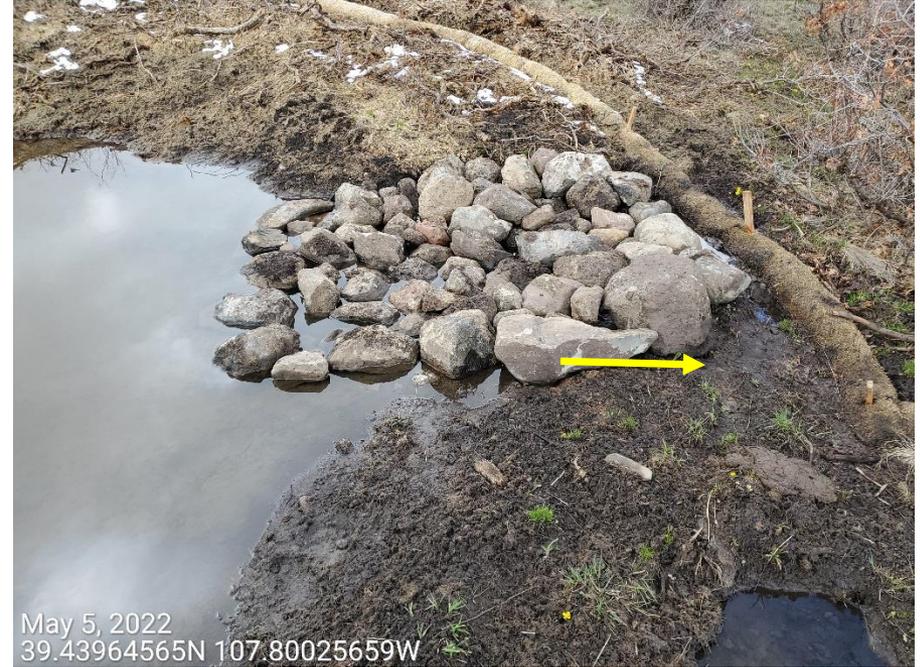
**Photo 6:** Photo taken from the sediment trap on the northwest end of the Location. Outlet inadequate in side; stormwater runoff discharging to areas around the trap's outlet.

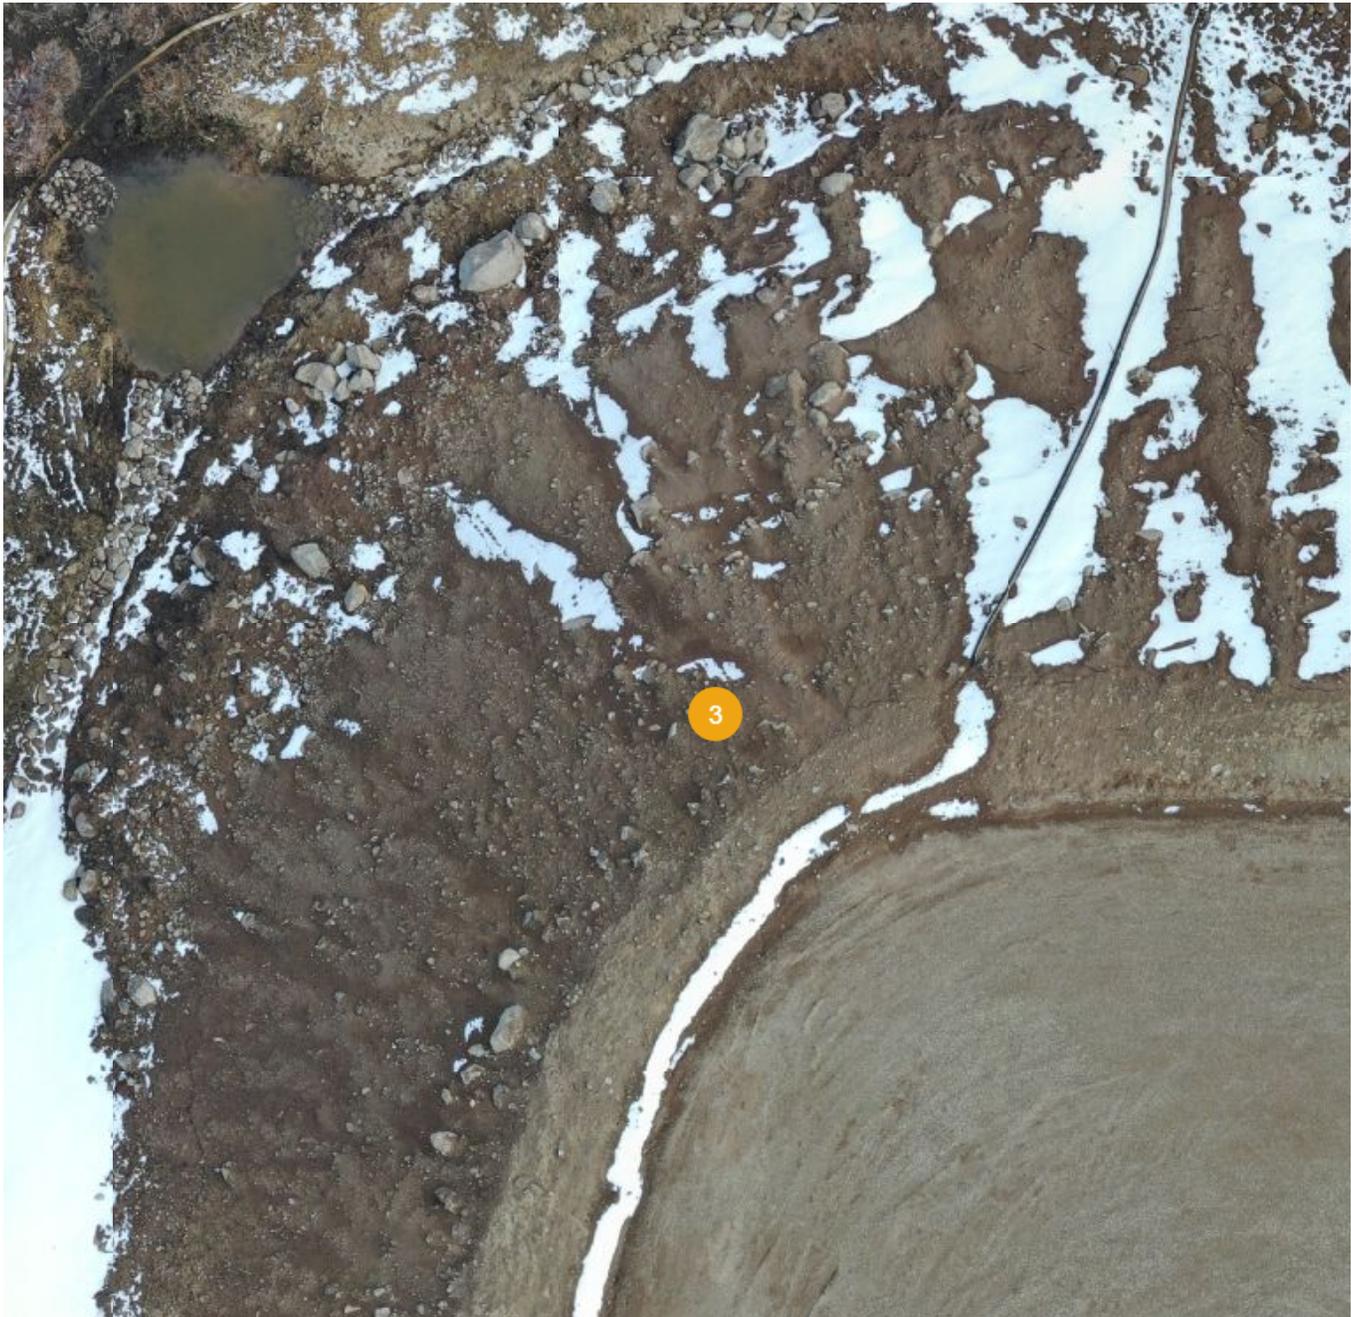
### 3 - Observation

Summary: **BMPs to minimize erosion/degradation missing or insufficient along entire fill slope; hydromulch in disrepair.**

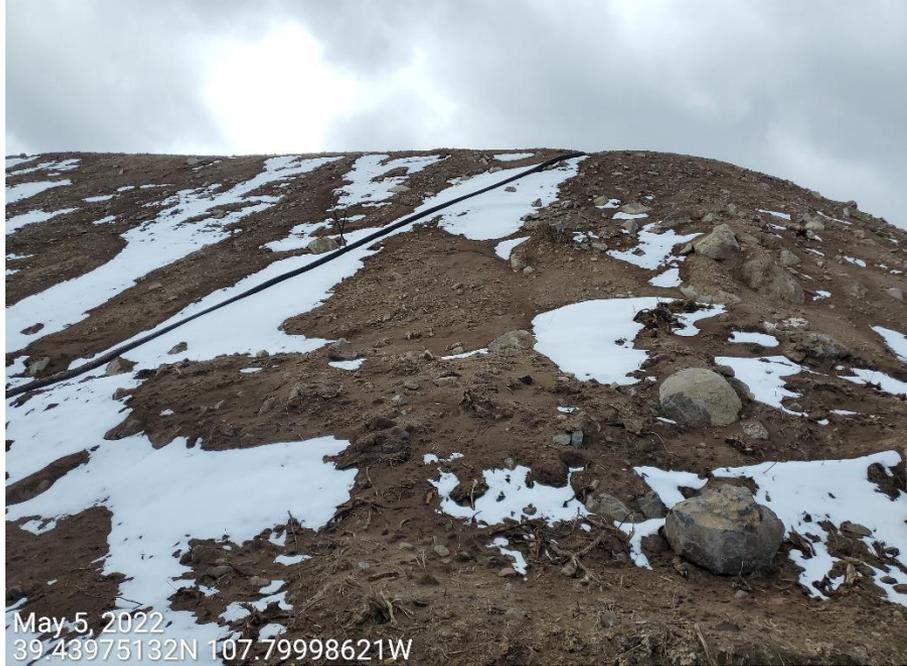
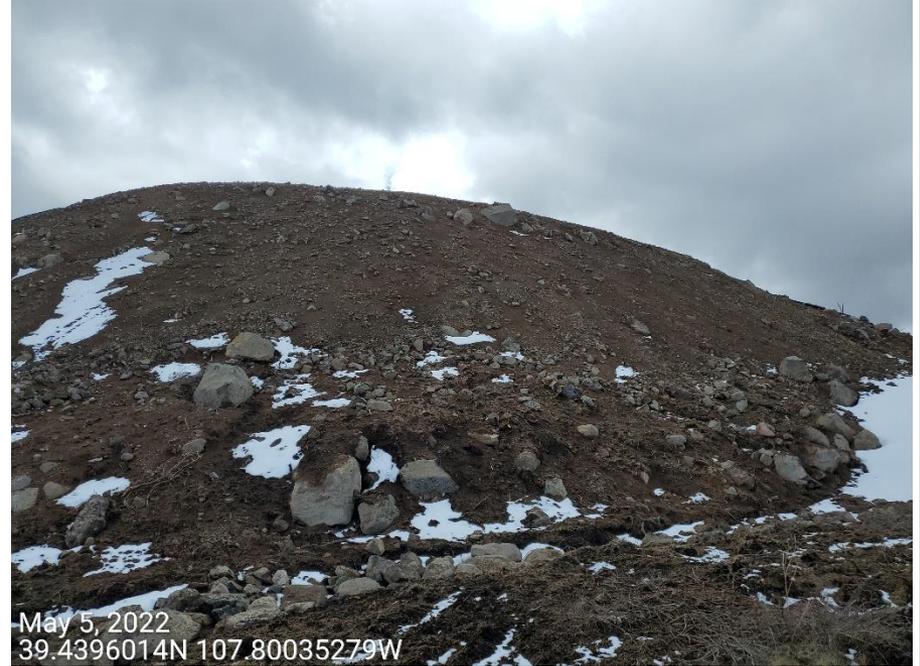
**Photo 7:** Photos provide examples showing control measures on the fill slopes of the Location have not been maintained in proper functioning condition; soils currently exposed and unstabilize resulting in erosion degradation and offsite sediment transport and deposition.

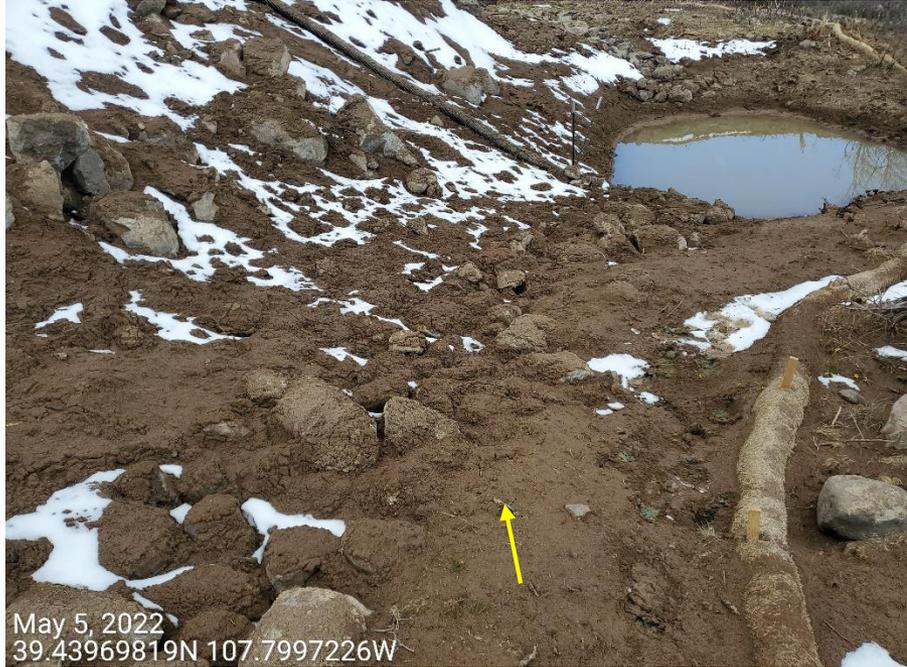
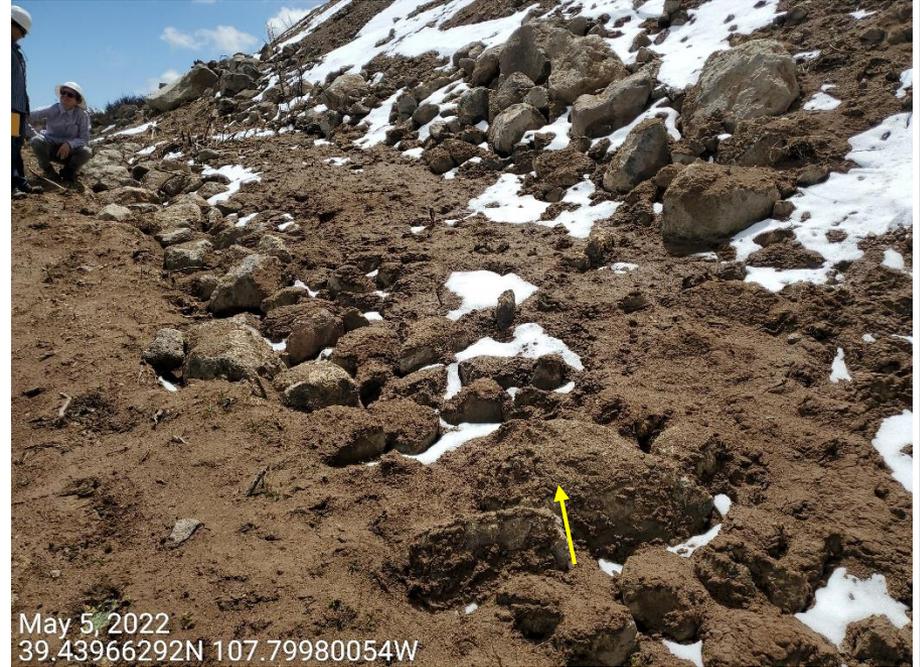
**Photo 8:** Continued from photo 7. Photos example shows sediment deposition as a result of the erosion degradation from the unstabilized fill slopes

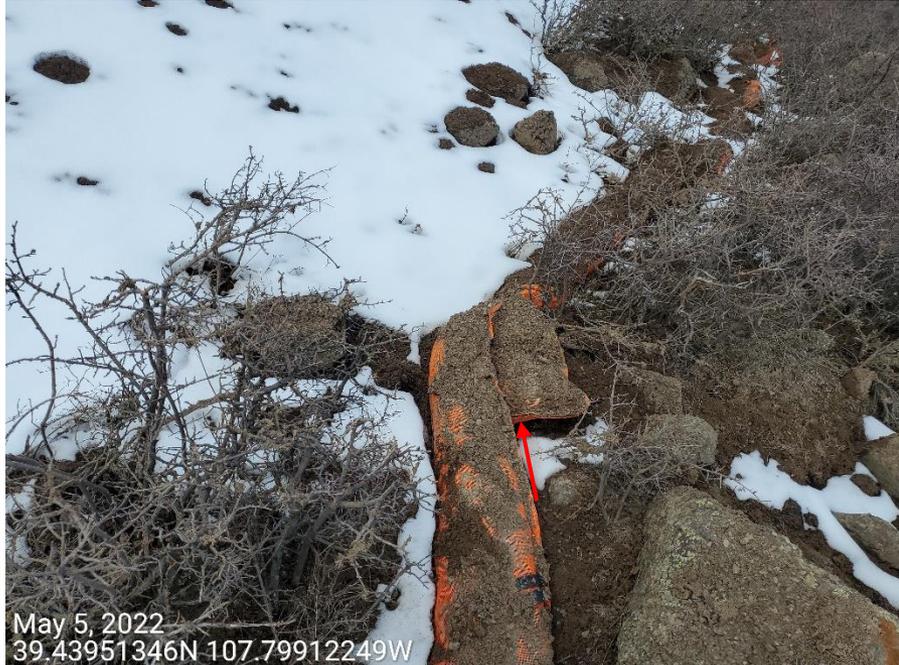
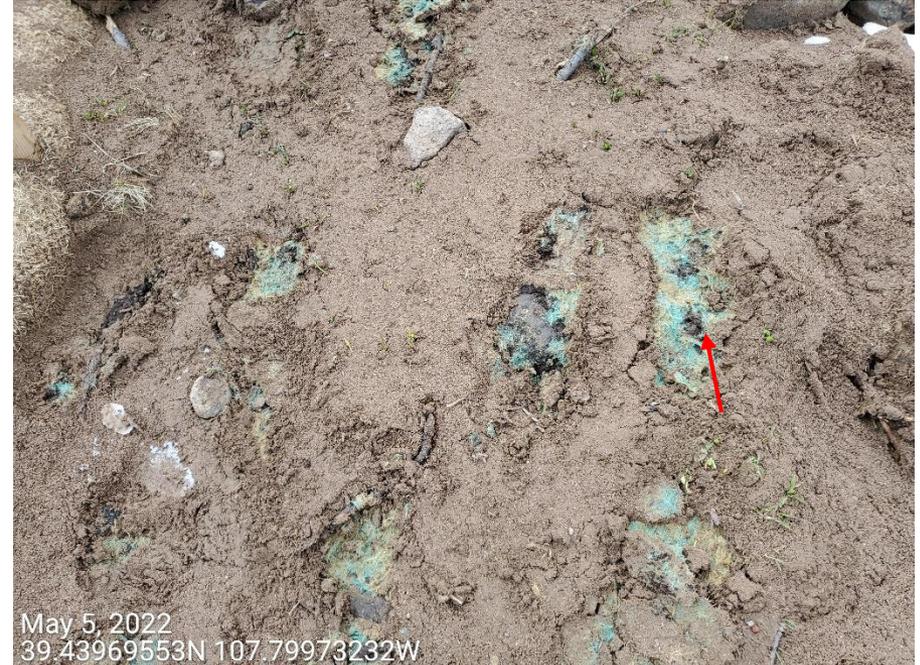
**Photo 9:** Photos example shows sediment deposition as a result of the erosion degradation from the unstabilized fill slopes. Photo right also shows remnants of the hydromulch that was previously applied, and is now covered with sediment from the fill slopes.
