Colorado Oil and Gas Conservation Commission

# Federal WMC 24-17 #480732

# Issue Report

Inspection Photos  
Operator Name: TEP ROCKY MOUNTAIN LLC - 96850  
Location ID: 480732

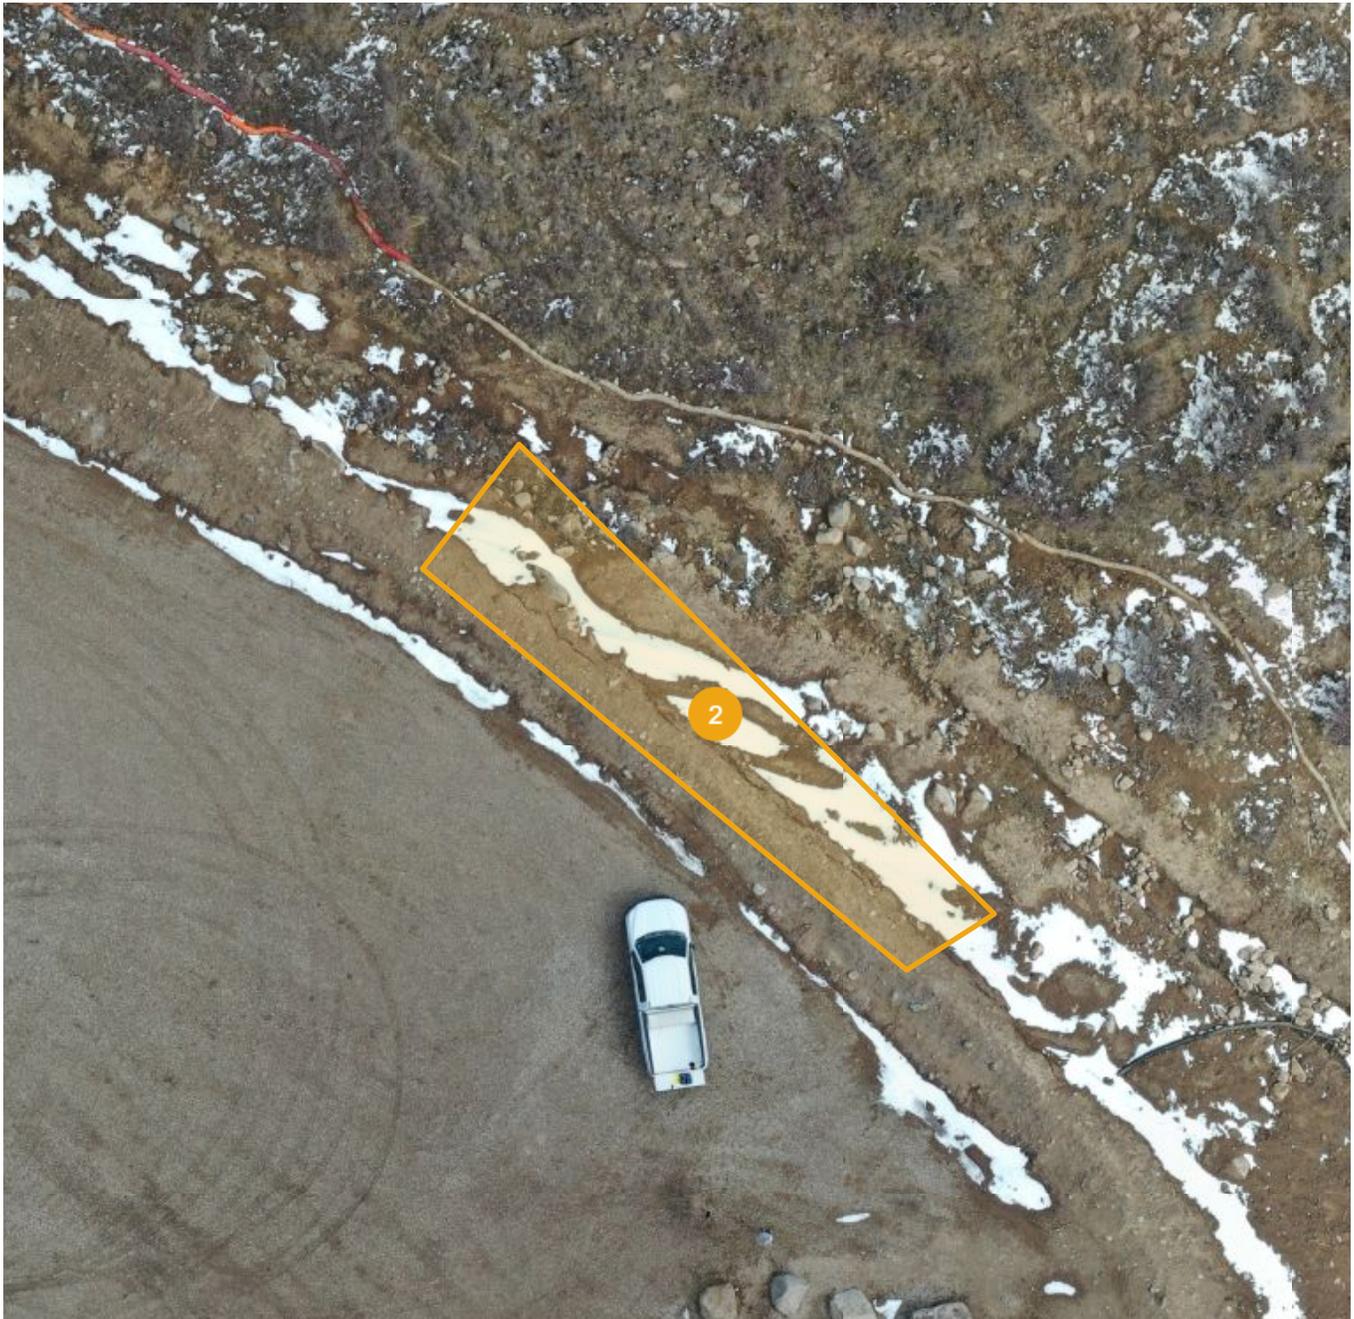
## 2 - Observation

Summary:	Stabilization issues at fill slopes resulting in crack.
Created:	May 23, 2022, 2:33pm by Aaron Trujillo
Cost of Repair:	—
Coordinates:	39.43912, -107.79860
Area:	1083.26 ft <sup>2</sup>
Surface Area:	1016.45 ft <sup>2</sup>

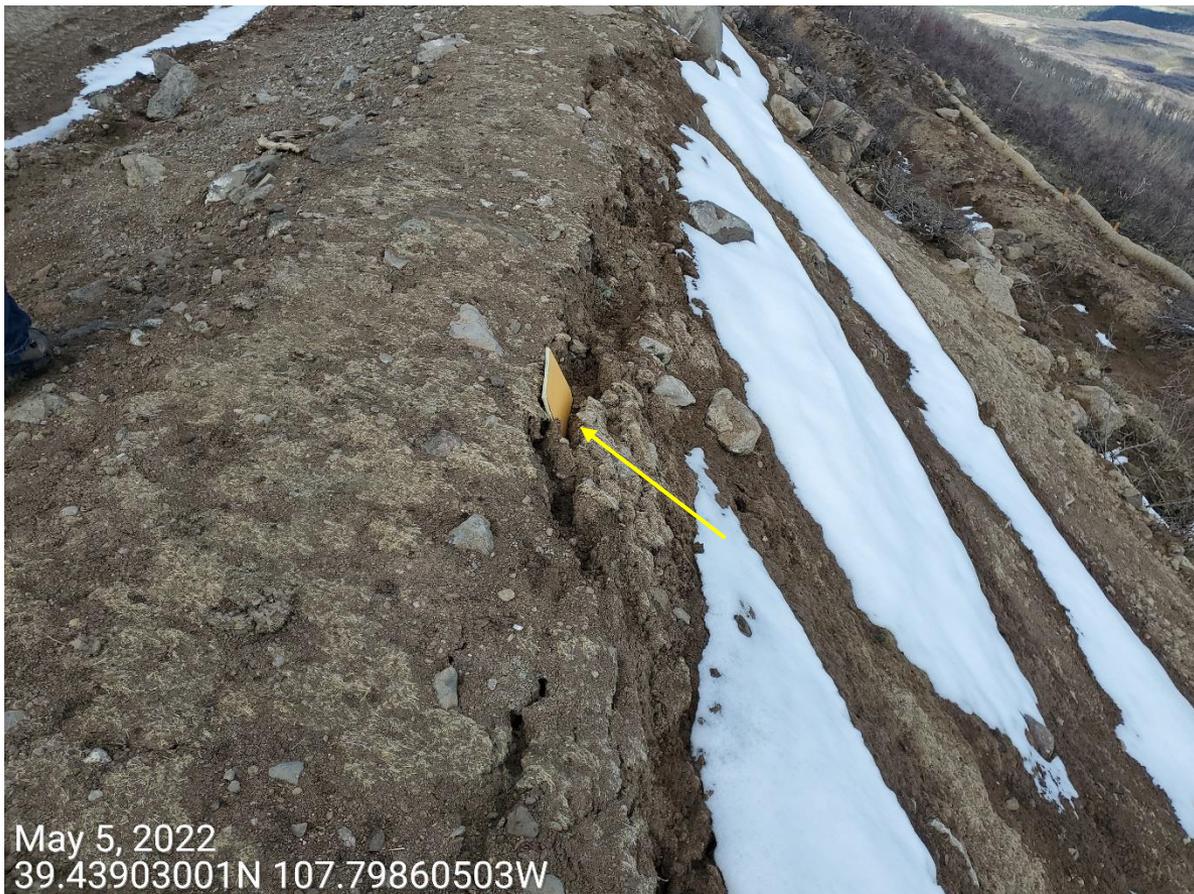
**Photo 10:** Photo taken from the fill slopes on the north end of the Location. Photo shows large crack forming on the slopes. Notebook for reference; slopes unstabilized and appear to be sloughing.

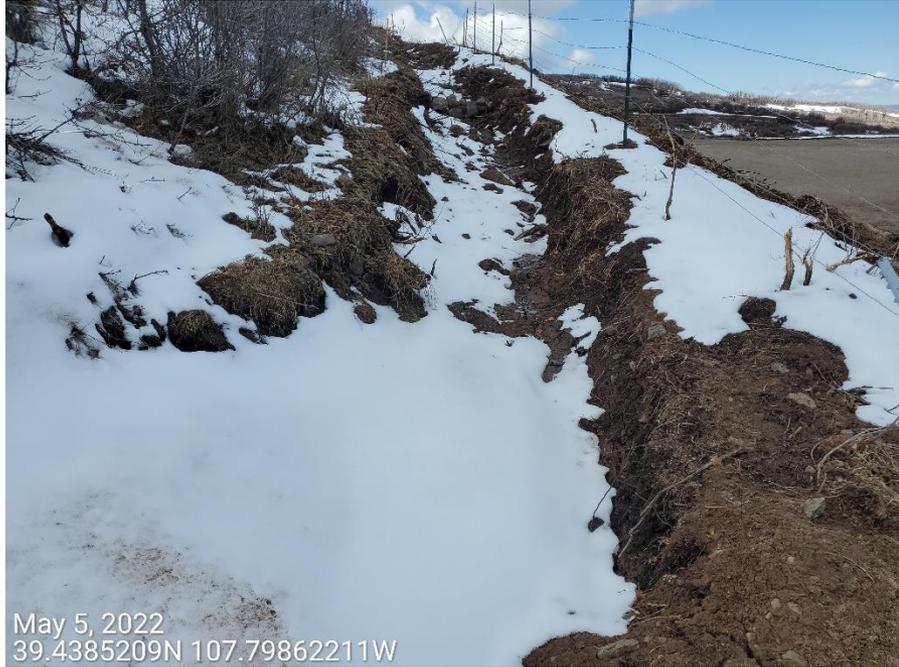
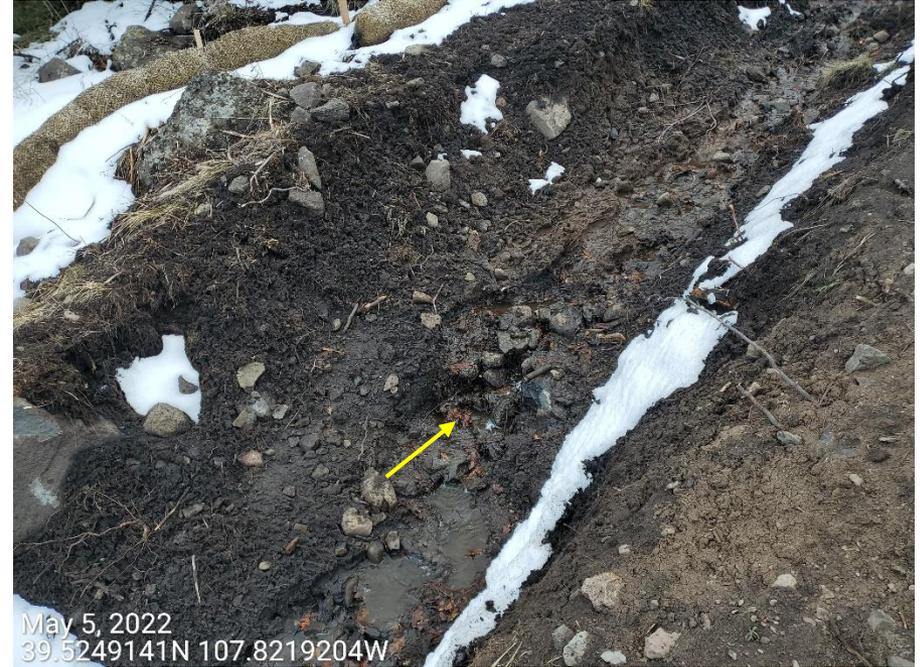
**Photo 9:** Photos example showing the perimeter stormwater diversion ditch of the Location; majority of the ditch has been constructed with vertical slopes and unconsolidated soils; this is not per good engineering practices. Photo right shows stormwater degradation within the control, and unsoncolidated “fine soils” have eroded away.

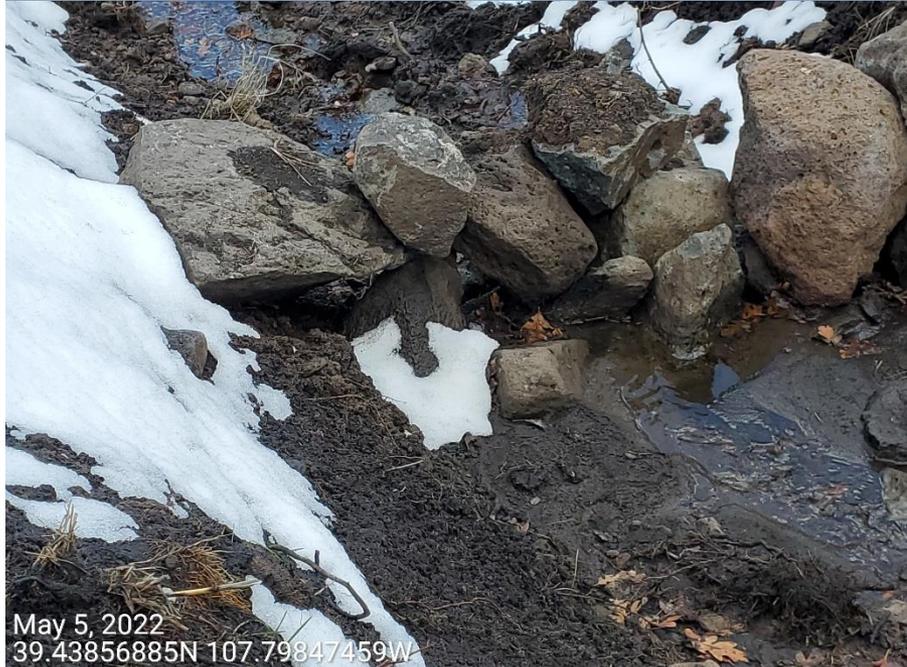
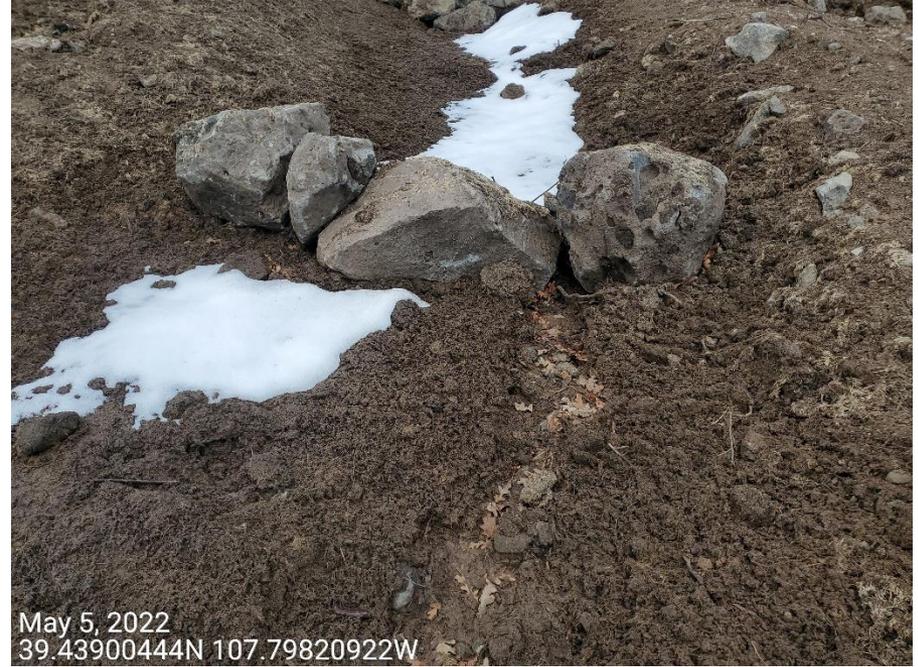
**Photo 10:** Photos examples showing velocity checks within the stormwater ditch that have not been installed per good engineering practices. Majority of the velocity checks have been constructed with inappropriate sized material; large voids observed within the checks and will not interrupt stormwater velocity; inappropriate sized materials will accelerate and concentrate stormwater, resulting to erosion within the ditch, as seen in these photos.

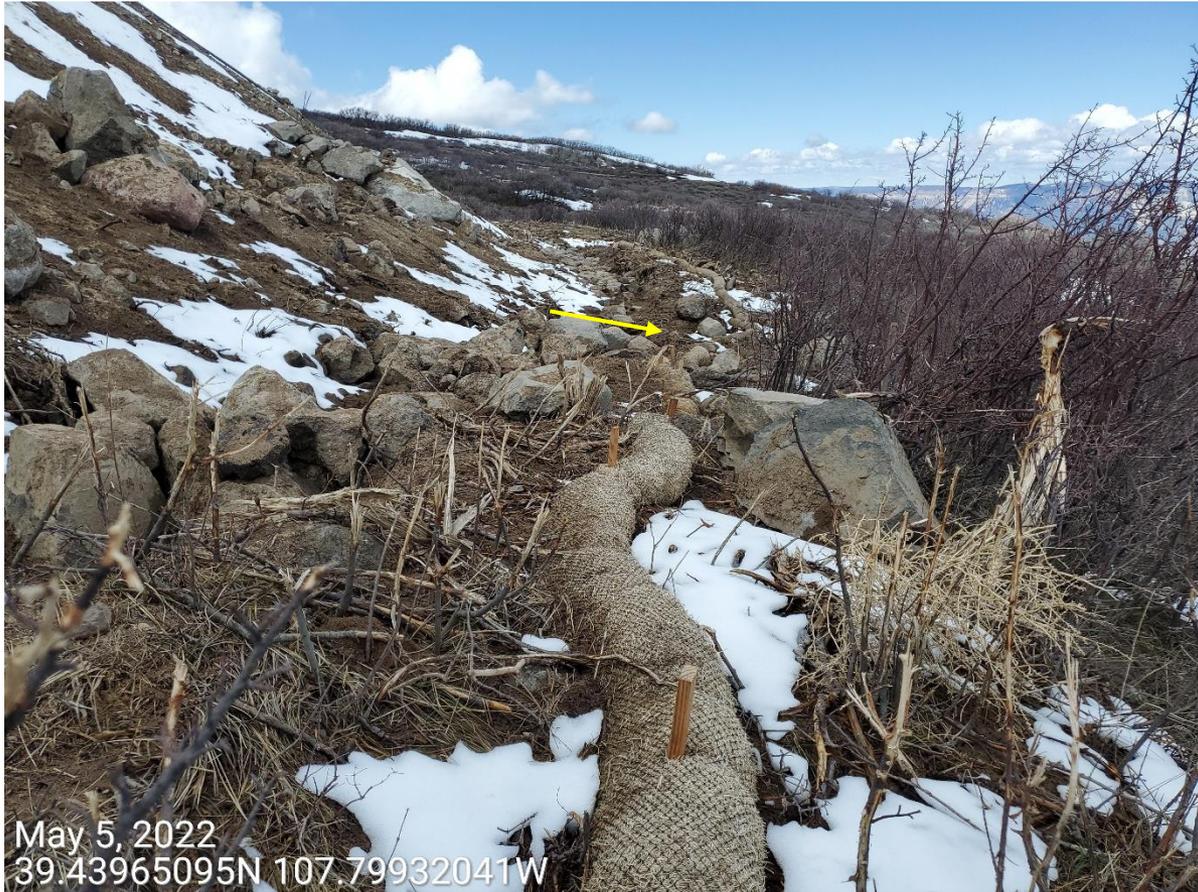
**Photo 11:** Photo example showing low points within the ditch along the north end of the Location, where stormwater is discharging from, rather than flowing into the northwestern sediment traps.

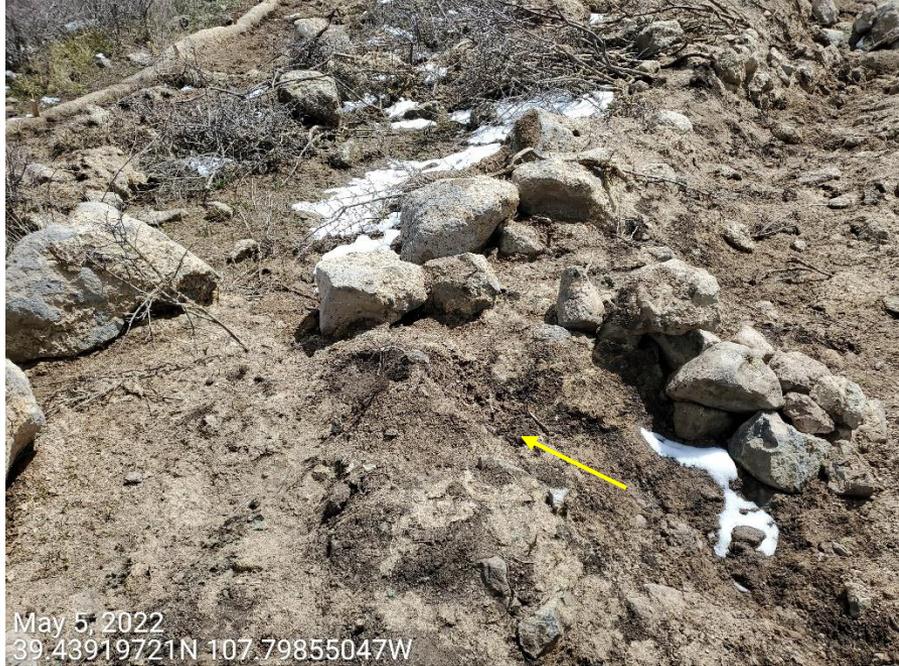
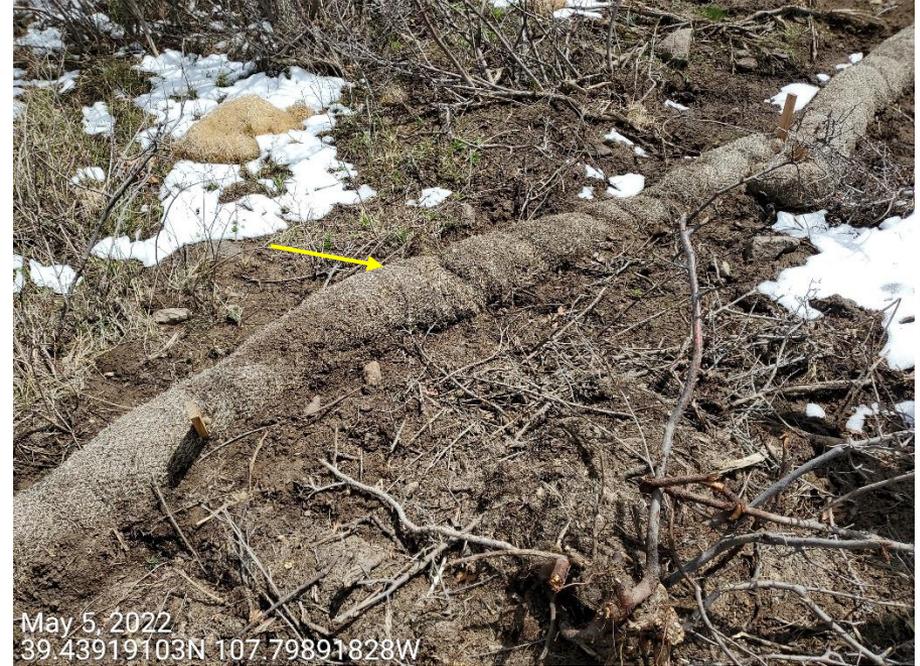
**Photo 12:** Continued from photo 11. Photo example showing low points within the ditch along the north end of the Location, where stormwater is discharging from, rather than flowing into the northwestern sediment traps.

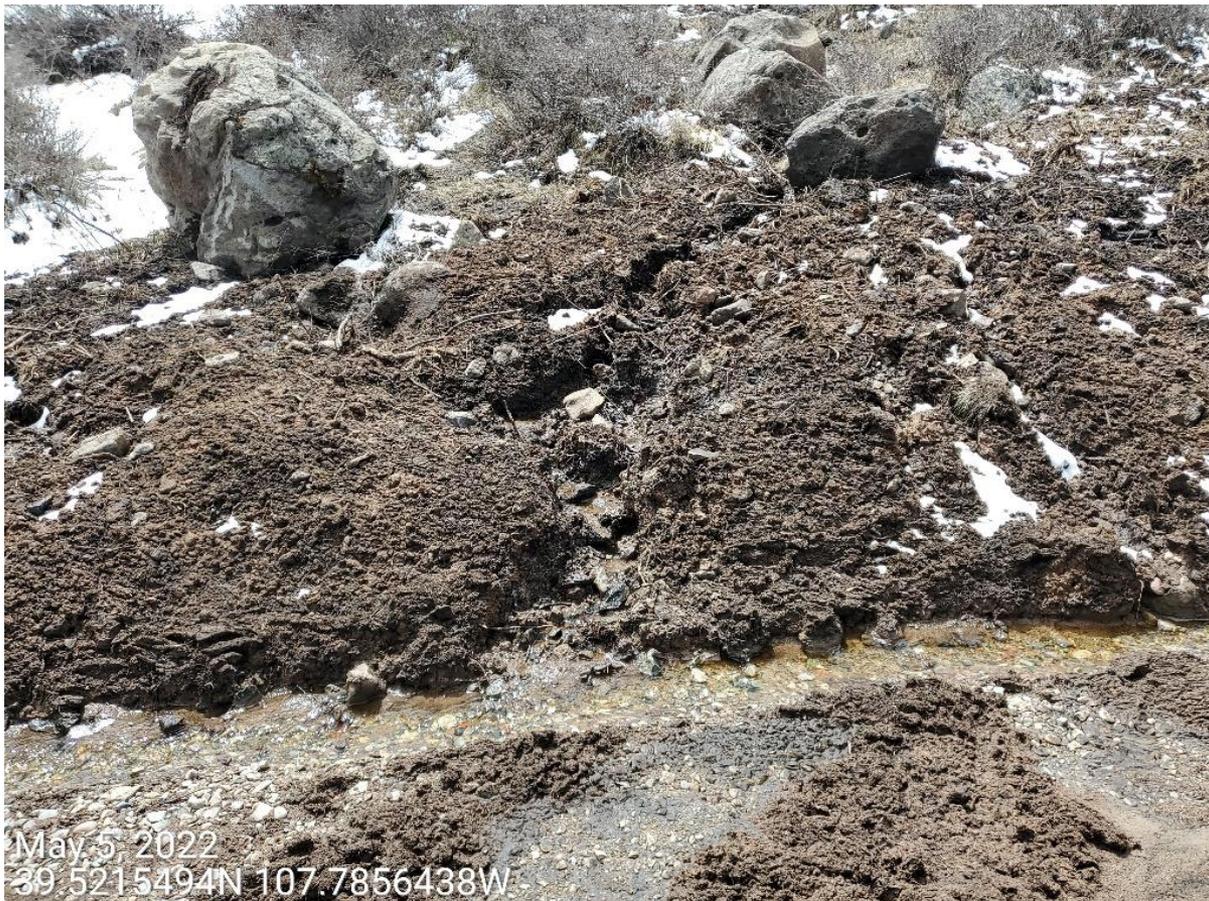
**Photo 13:** Photo example showing BMPs at the topsoil along the access road have not been maintained.

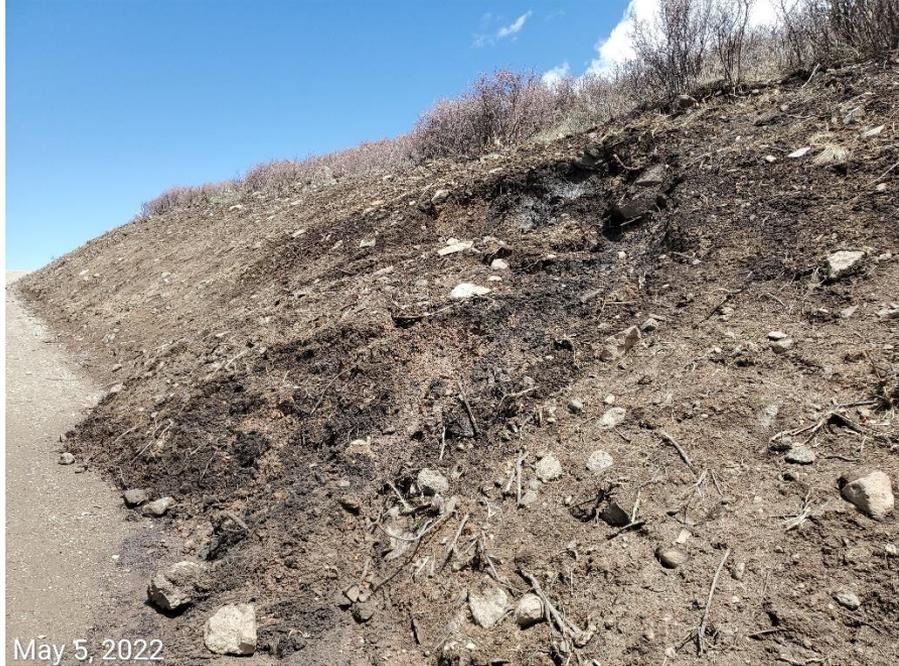
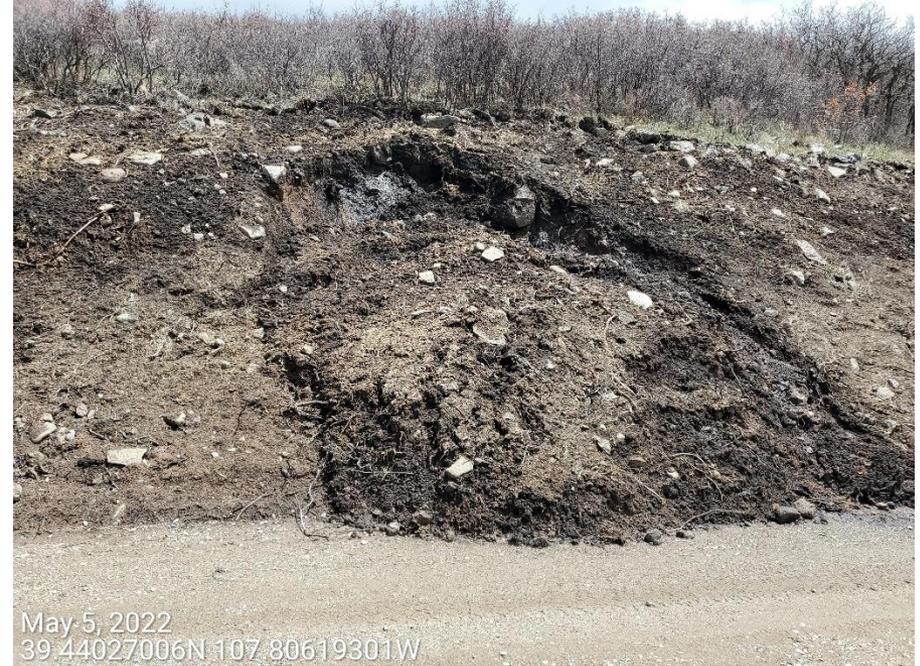
**Photo 14:** Photo example showing BMPs along access road have not been maintained. A large section of the slope as sloughed onto the access road.

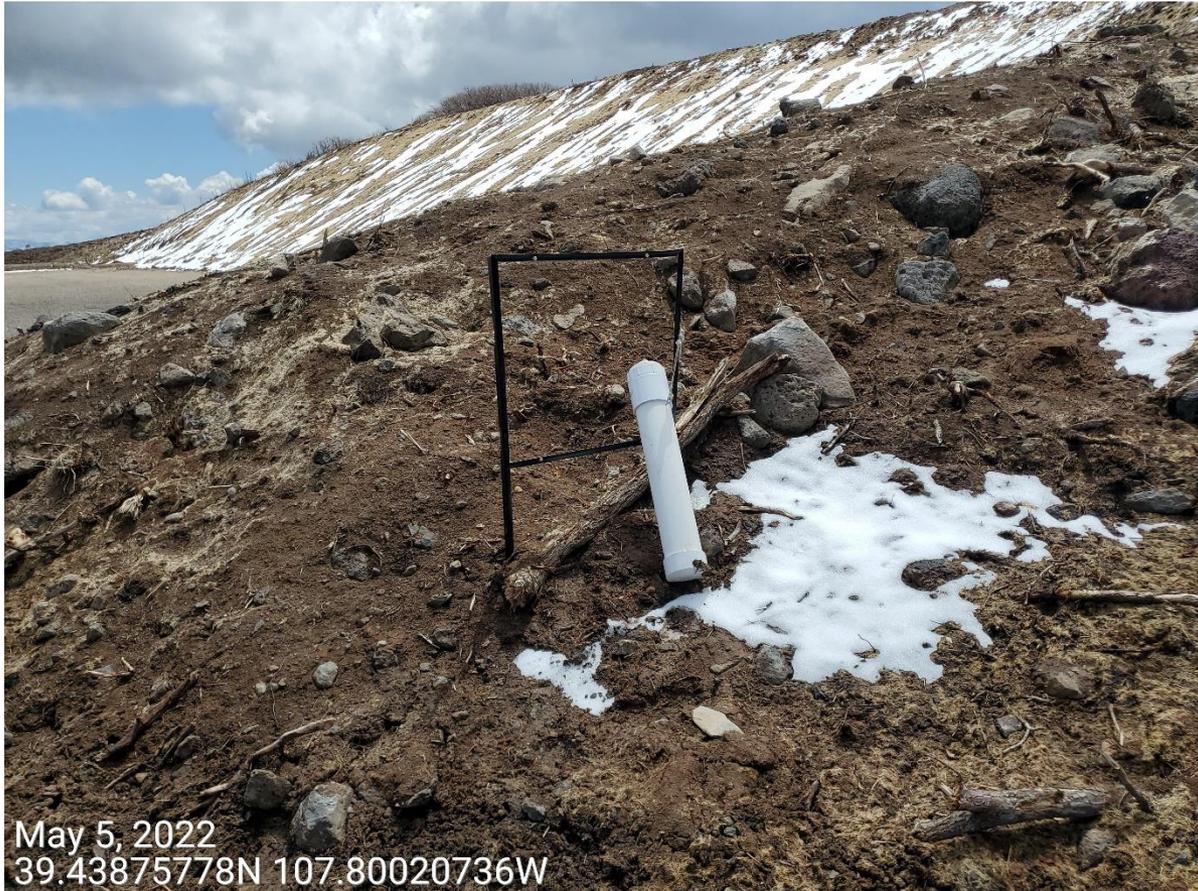
**Photo 15:** Sign missing at location entrance.

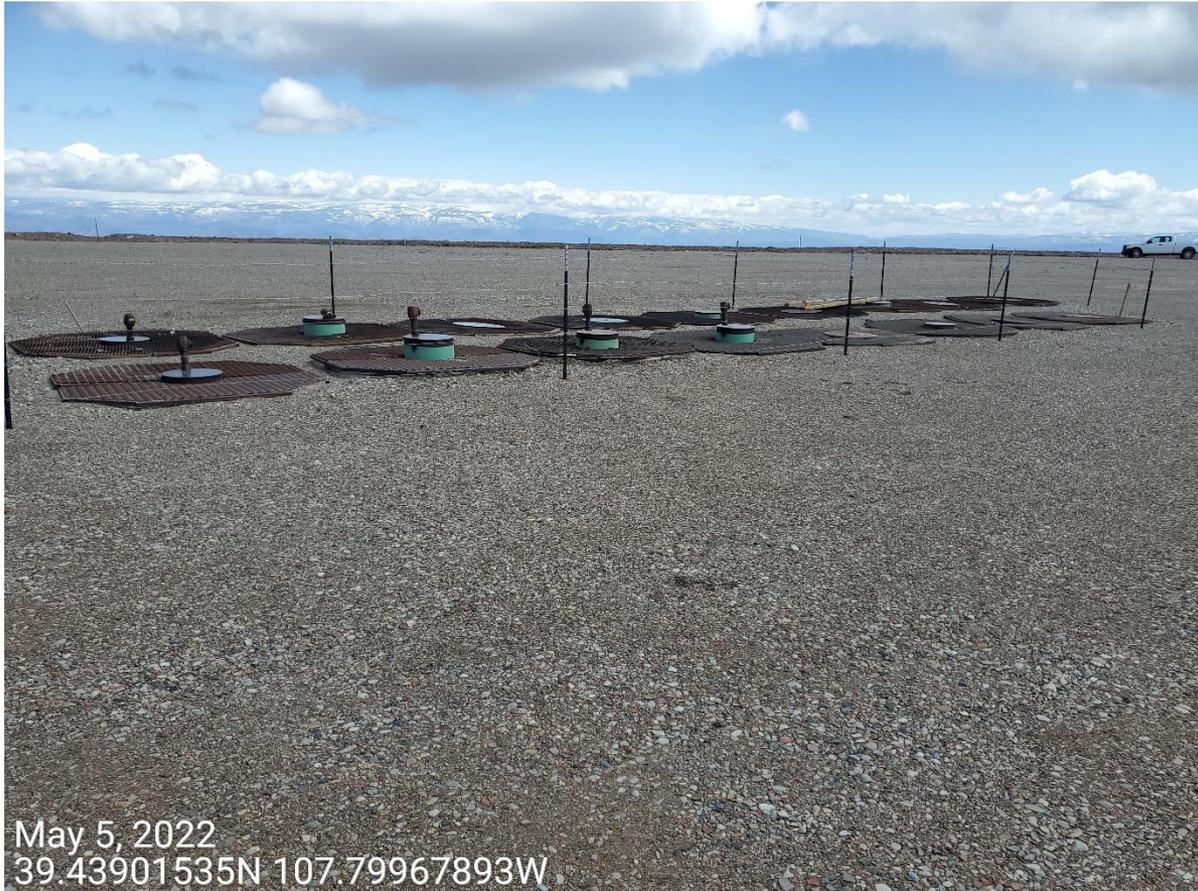
**Photo 16:** Photo shows conductor settings on Location; wells have not been drilled.

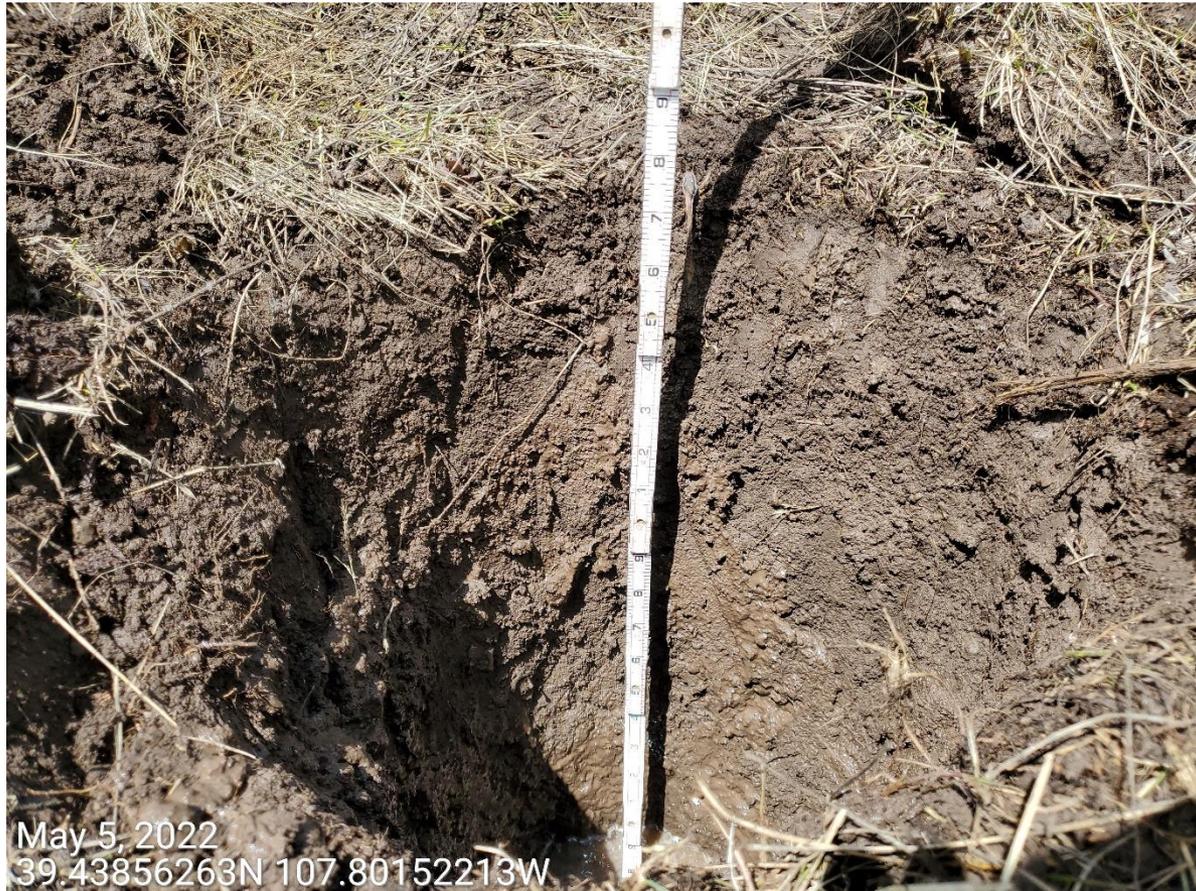
**Photo 17:** Photo example of one of the topsoil test pit conducted within the adjacent reference area. Topsoil on Location could have exceeded 22 inches in depth. Operator topsoil plan stated 4,700 cy of material would be salvaged; actual amount salvaged by Operator was 2,300 cy.
