Inspection Photos
Operator: Hilcorp Energy
API: 067-05008
Date: 5/24/2022

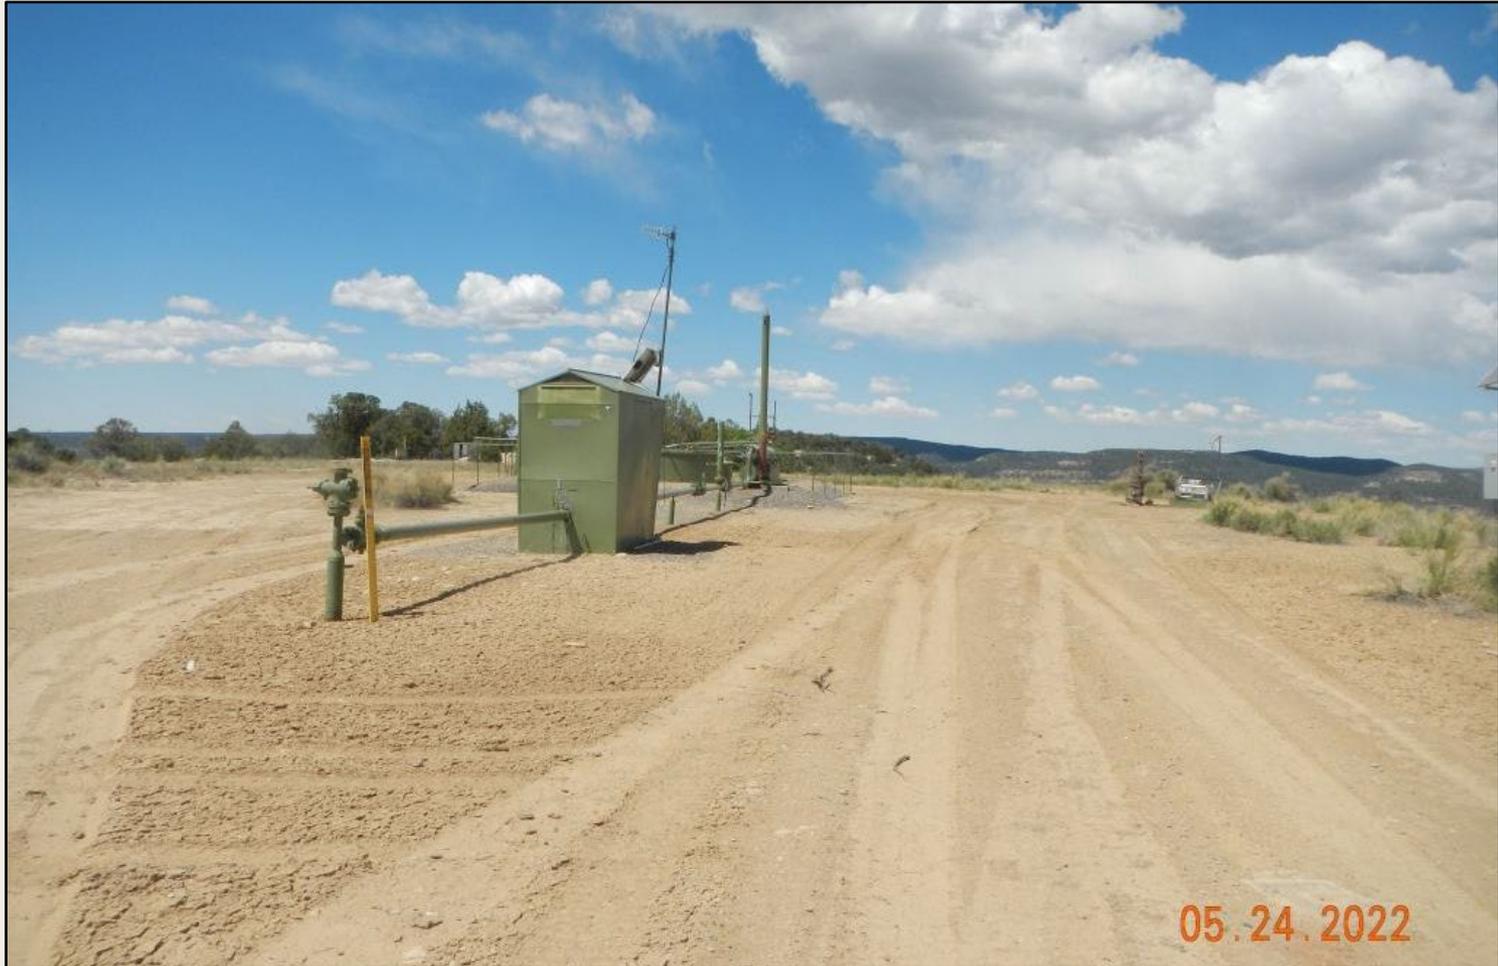
Photo 1. View of the project area from the well pad entrance facing center.

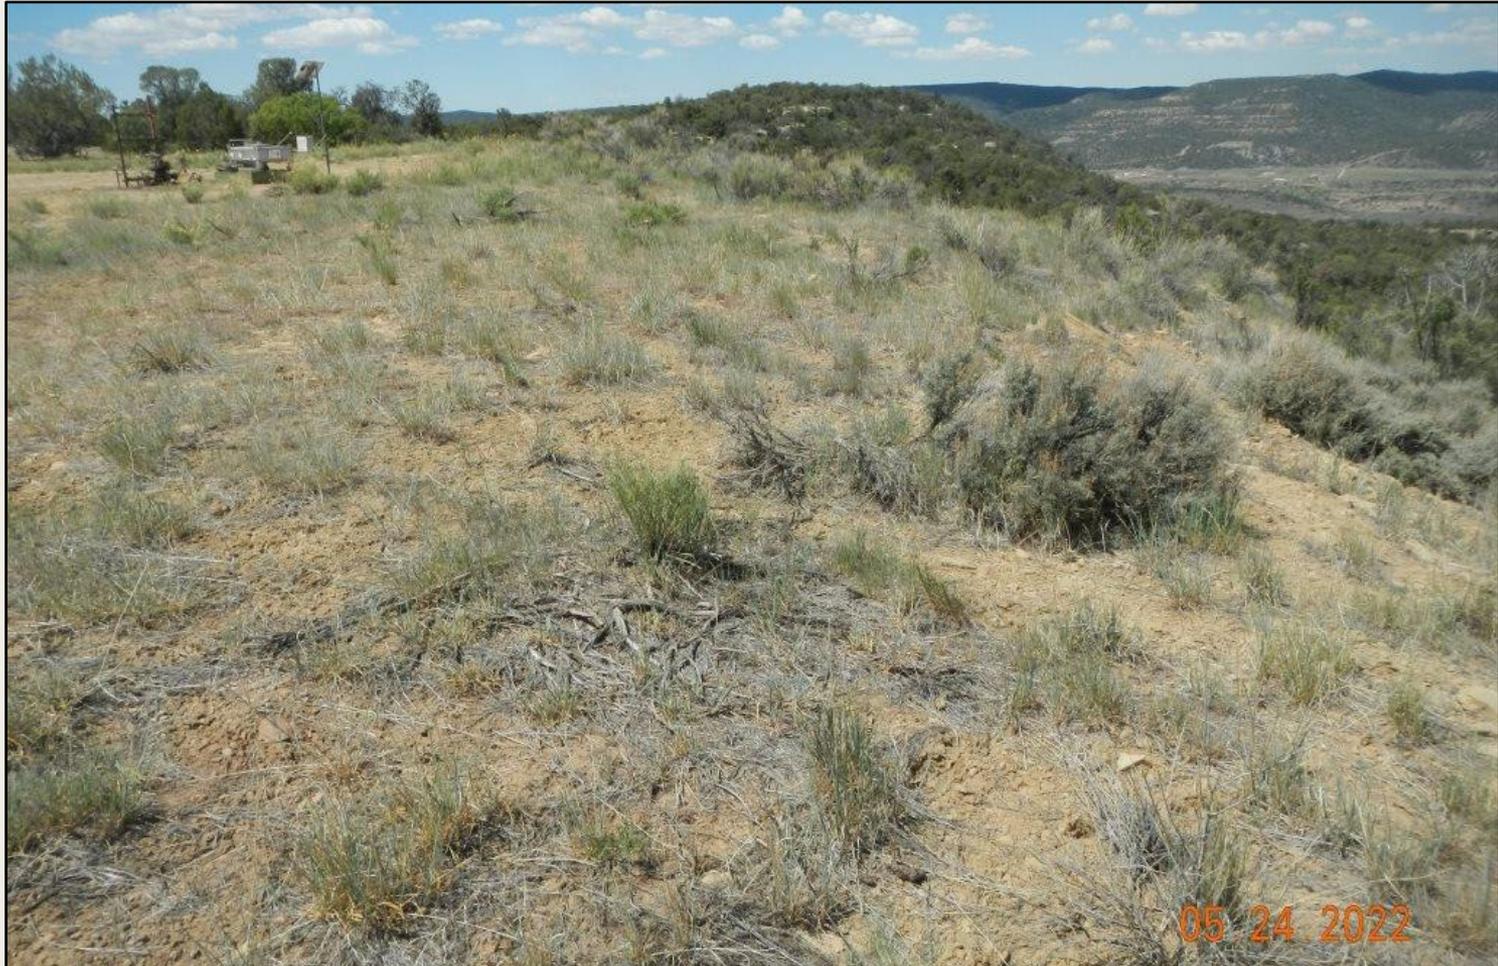
Photo 2. View of the northern project area from the northeastern corner facing westward. Revegetation is progressing within crested wheatgrass, smooth brome, western wheatgrass, and rubber rabbitbrush.

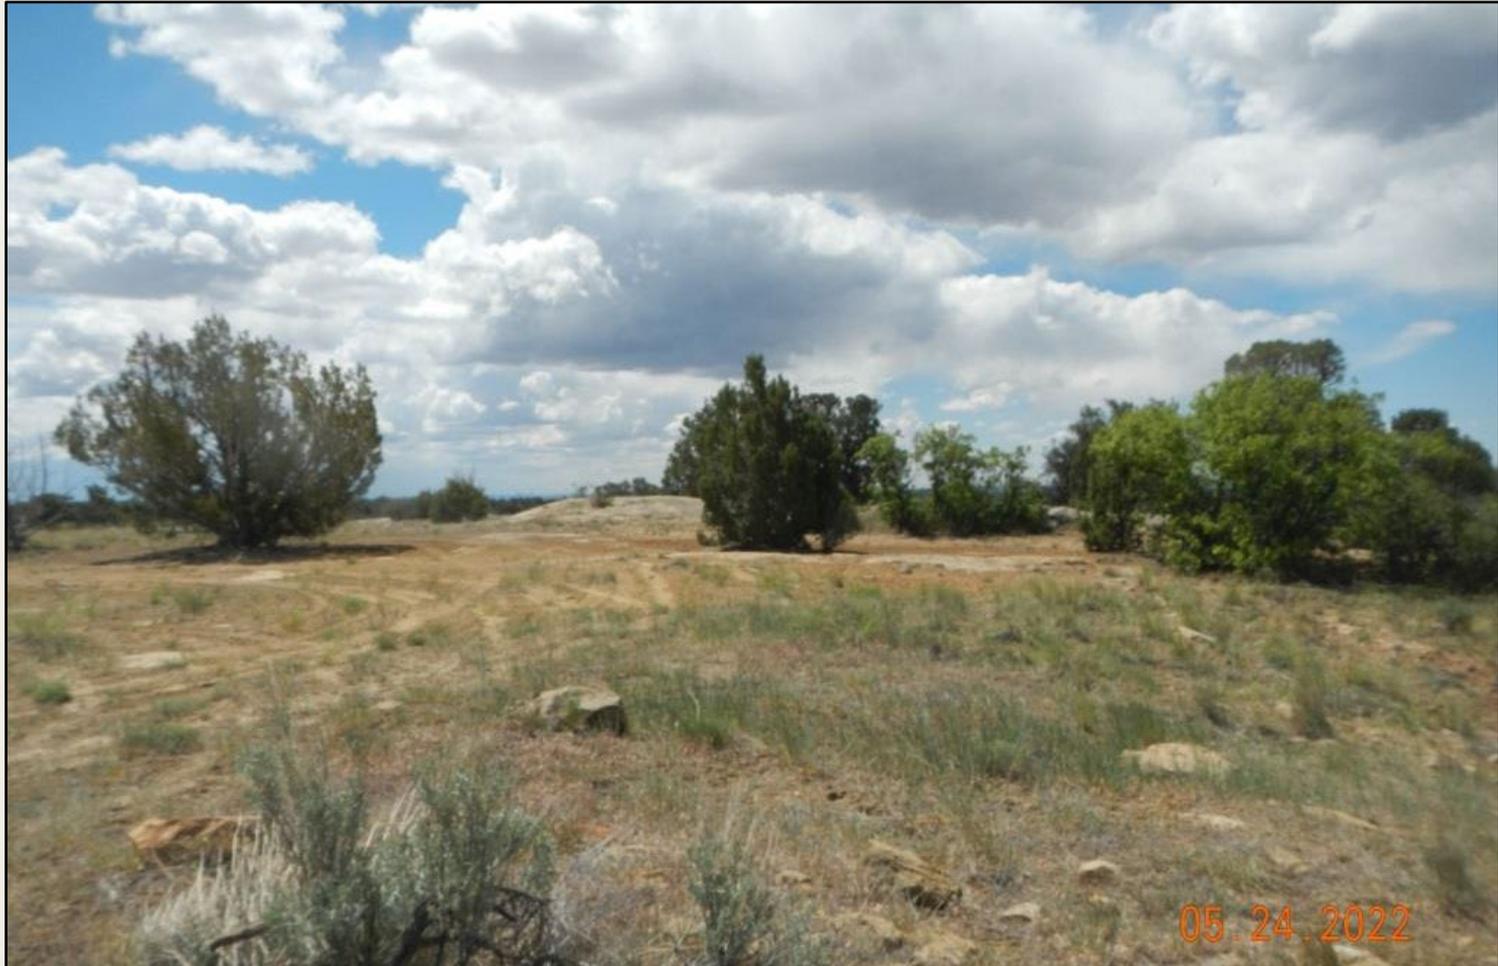
Photo 3. View of the western project area from the northwestern corner facing southward.

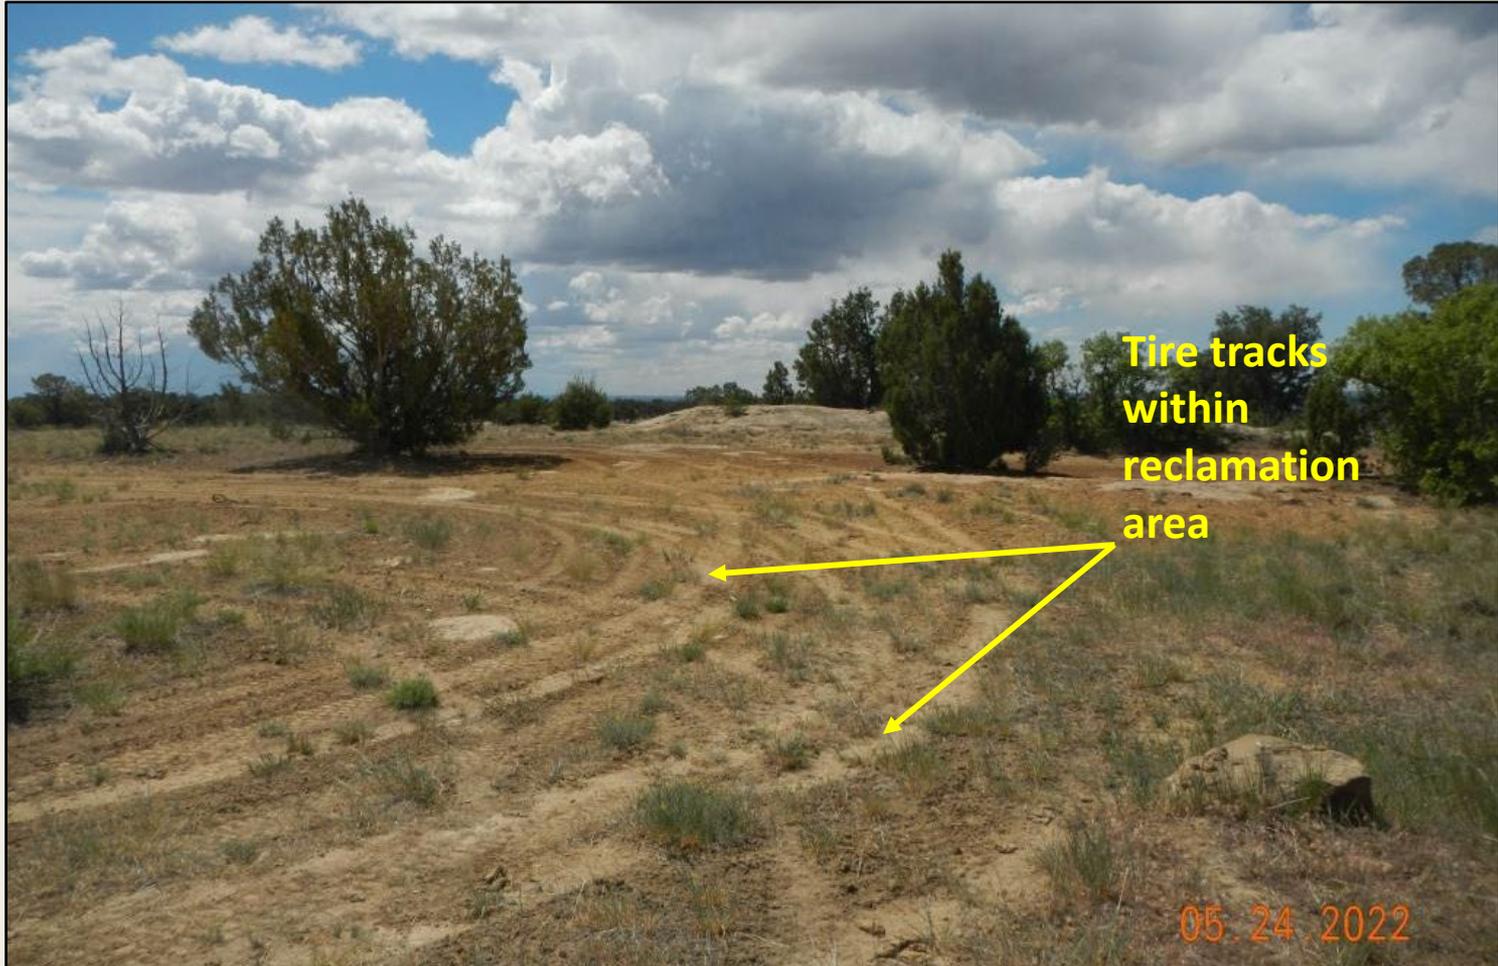
Photo 4. View of area within the western interim reclamation area where tire tracks observed and are resulting in site degradation.

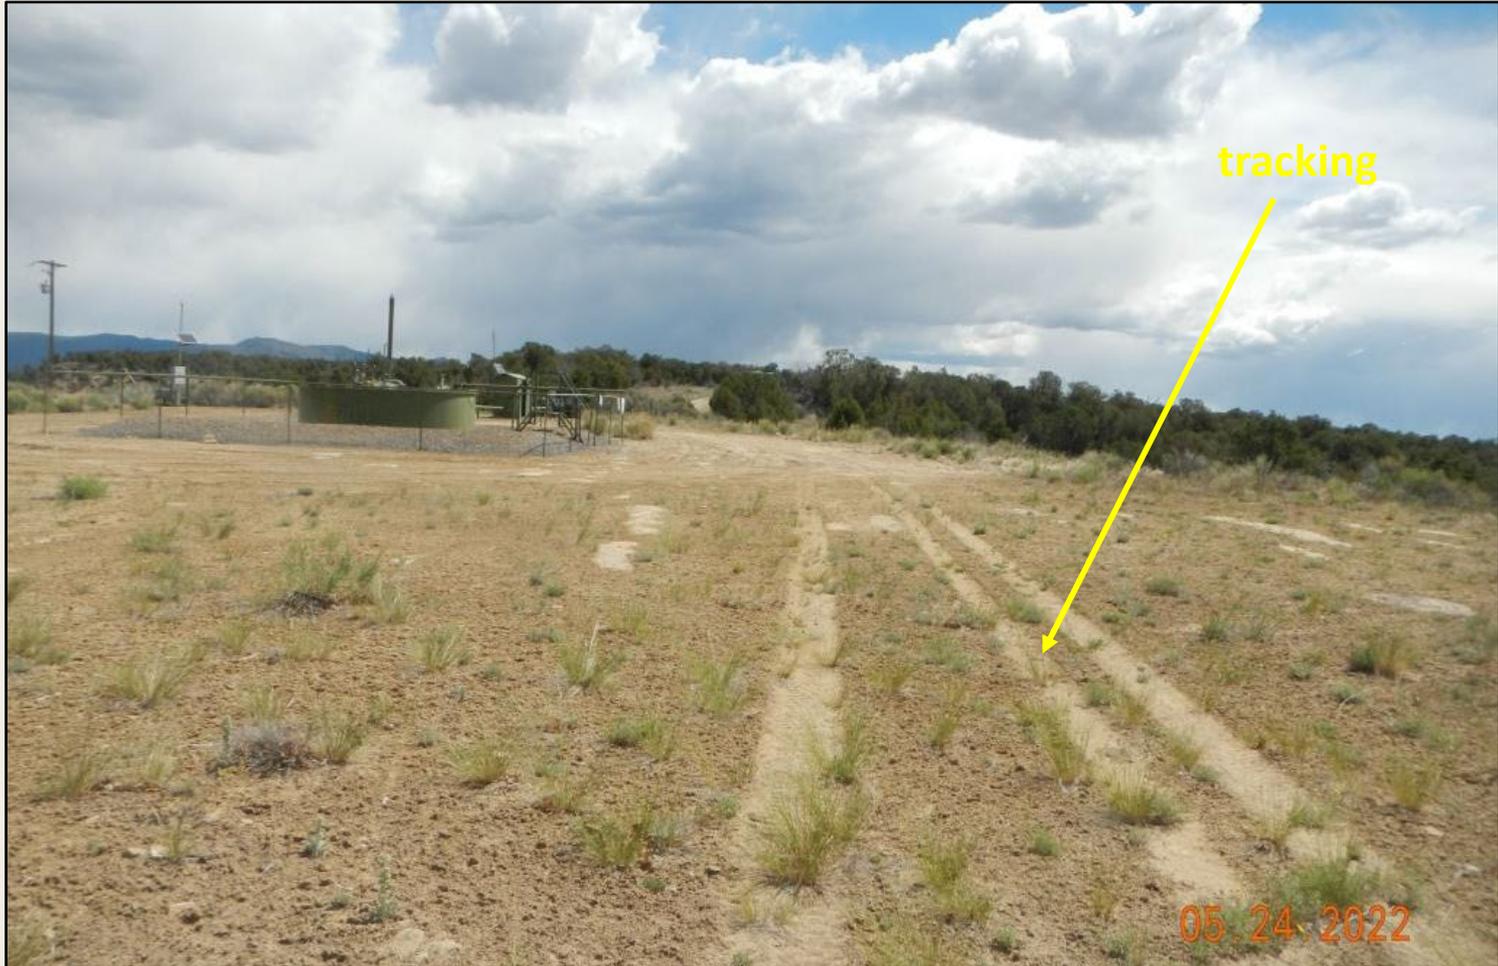
Photo 5. Another view of tracking within the western project area, facing center.

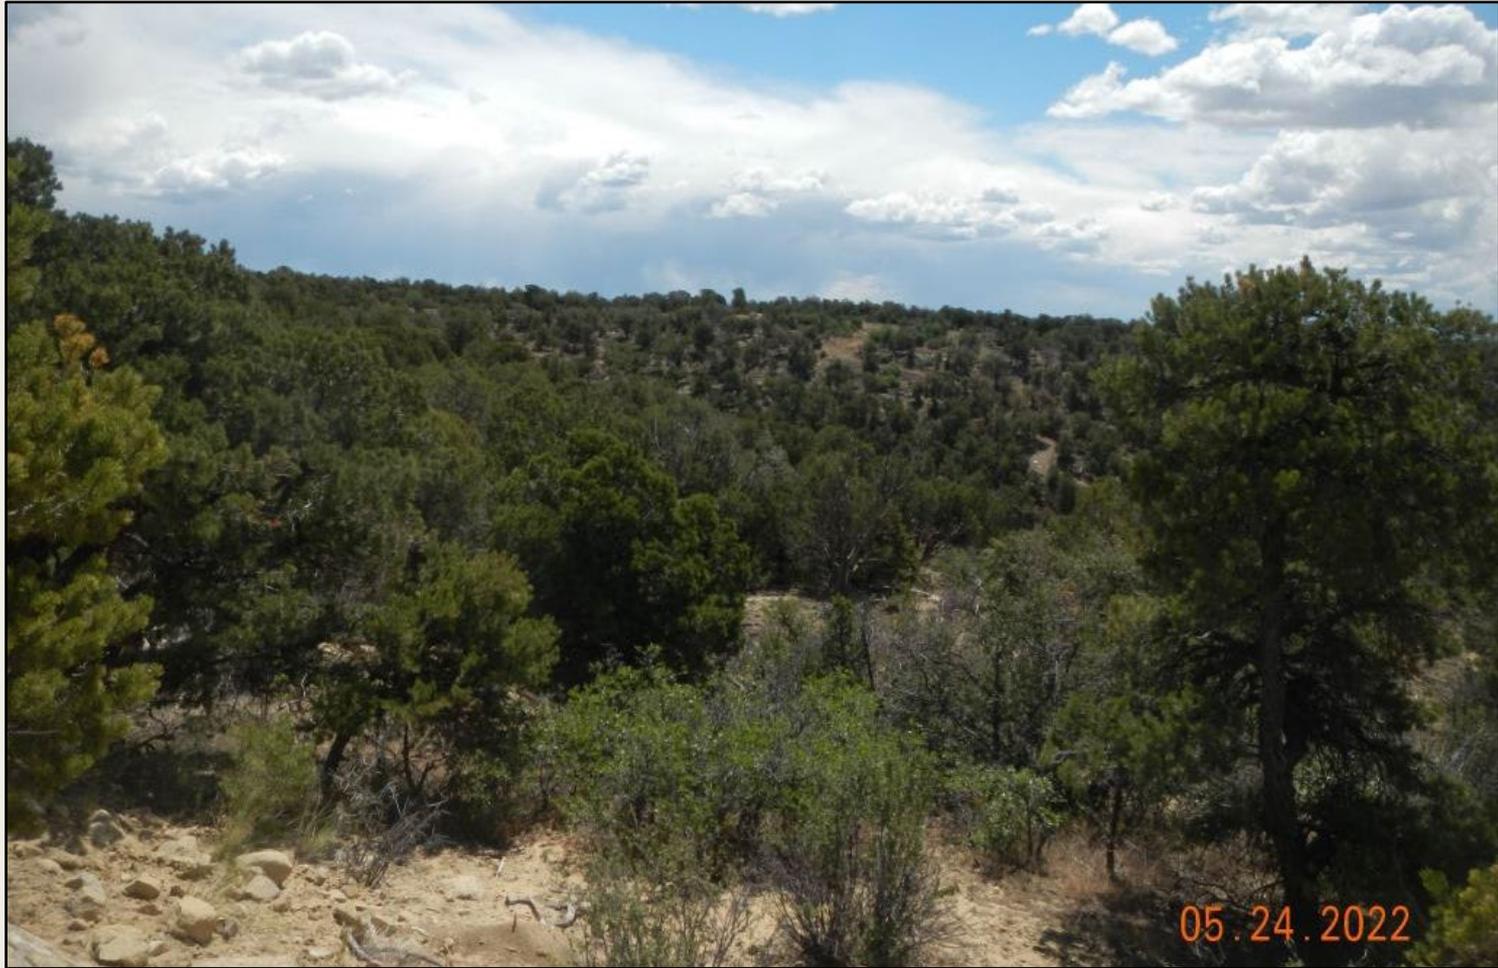
Photo 6. View of reference area comprised of pinyon and juniper woodland with gambel oak, Indian ricegrass, antelope bitterbrush, mountain mahogany, and sulfur flower.
