Inspection Photos

Operator: Hilcorp Energy
API: 067-09345
Date: 5/24/2022

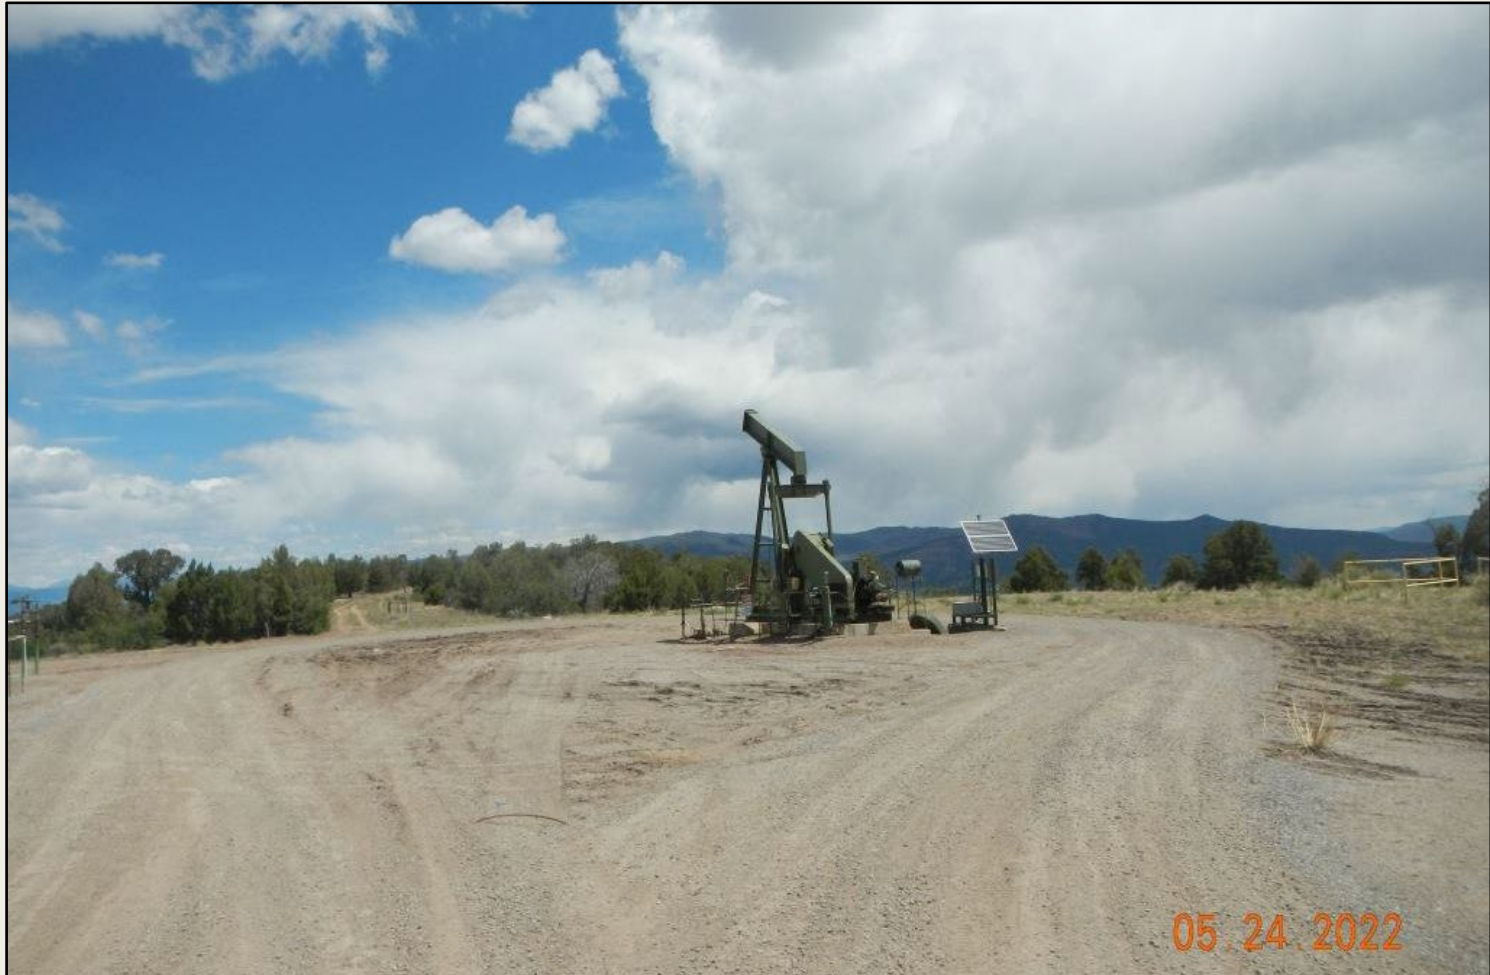
Photo 1. View of the project area from the southern entrance facing center. .

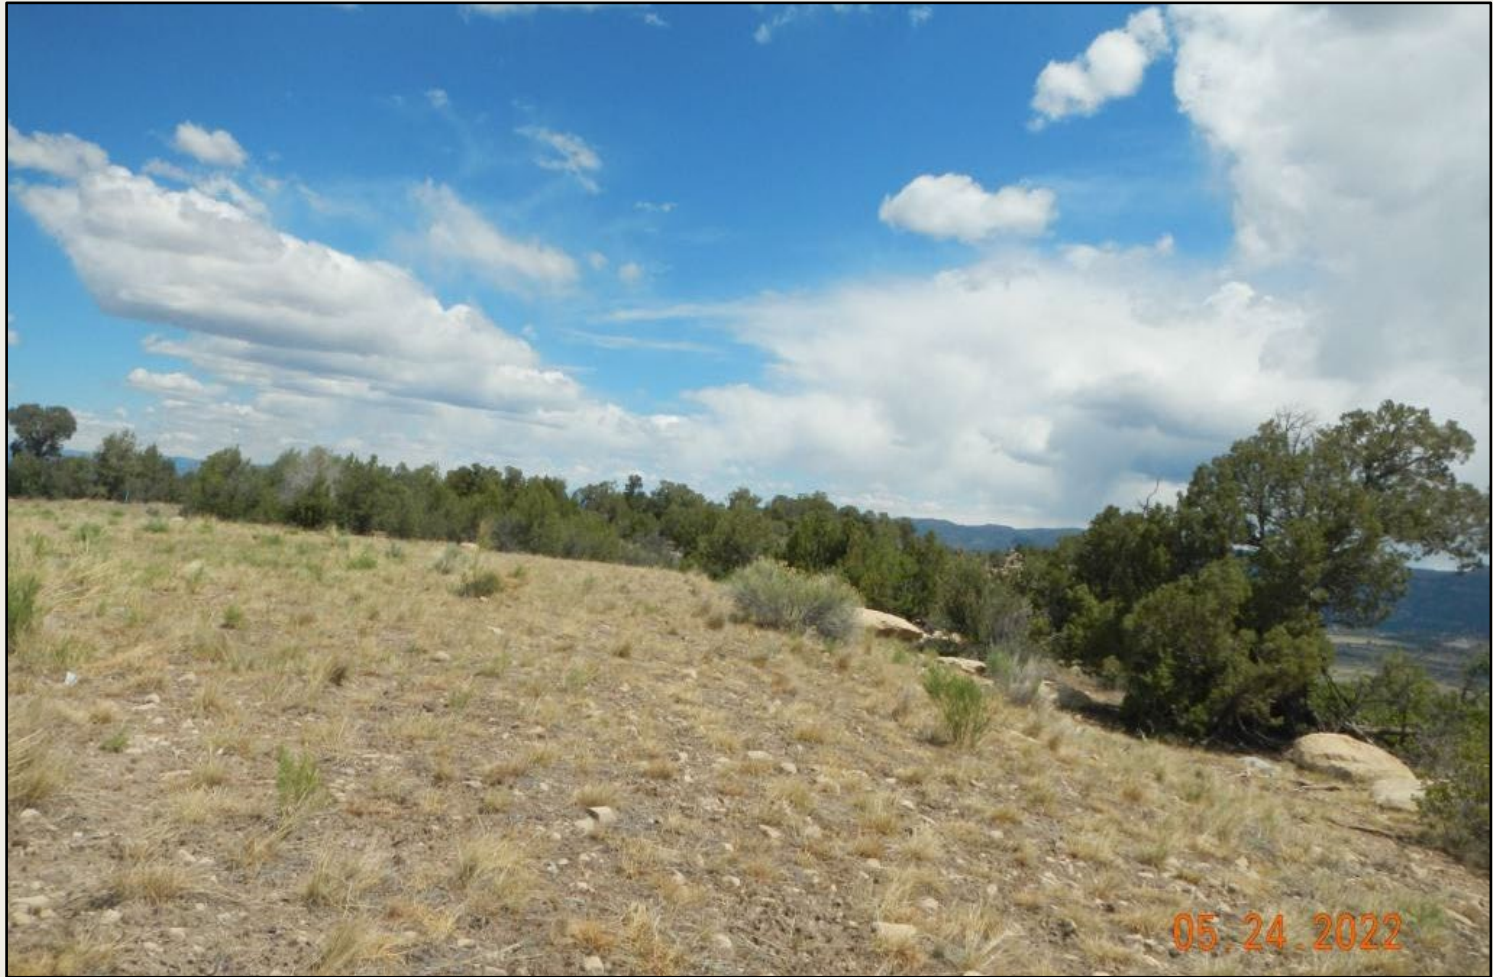
Photo 2. View of the eastern project area from the southeastern corner facing northward. Revegetation is progressing within crested wheatgrass, western wheatgrass, and sand dropseed.

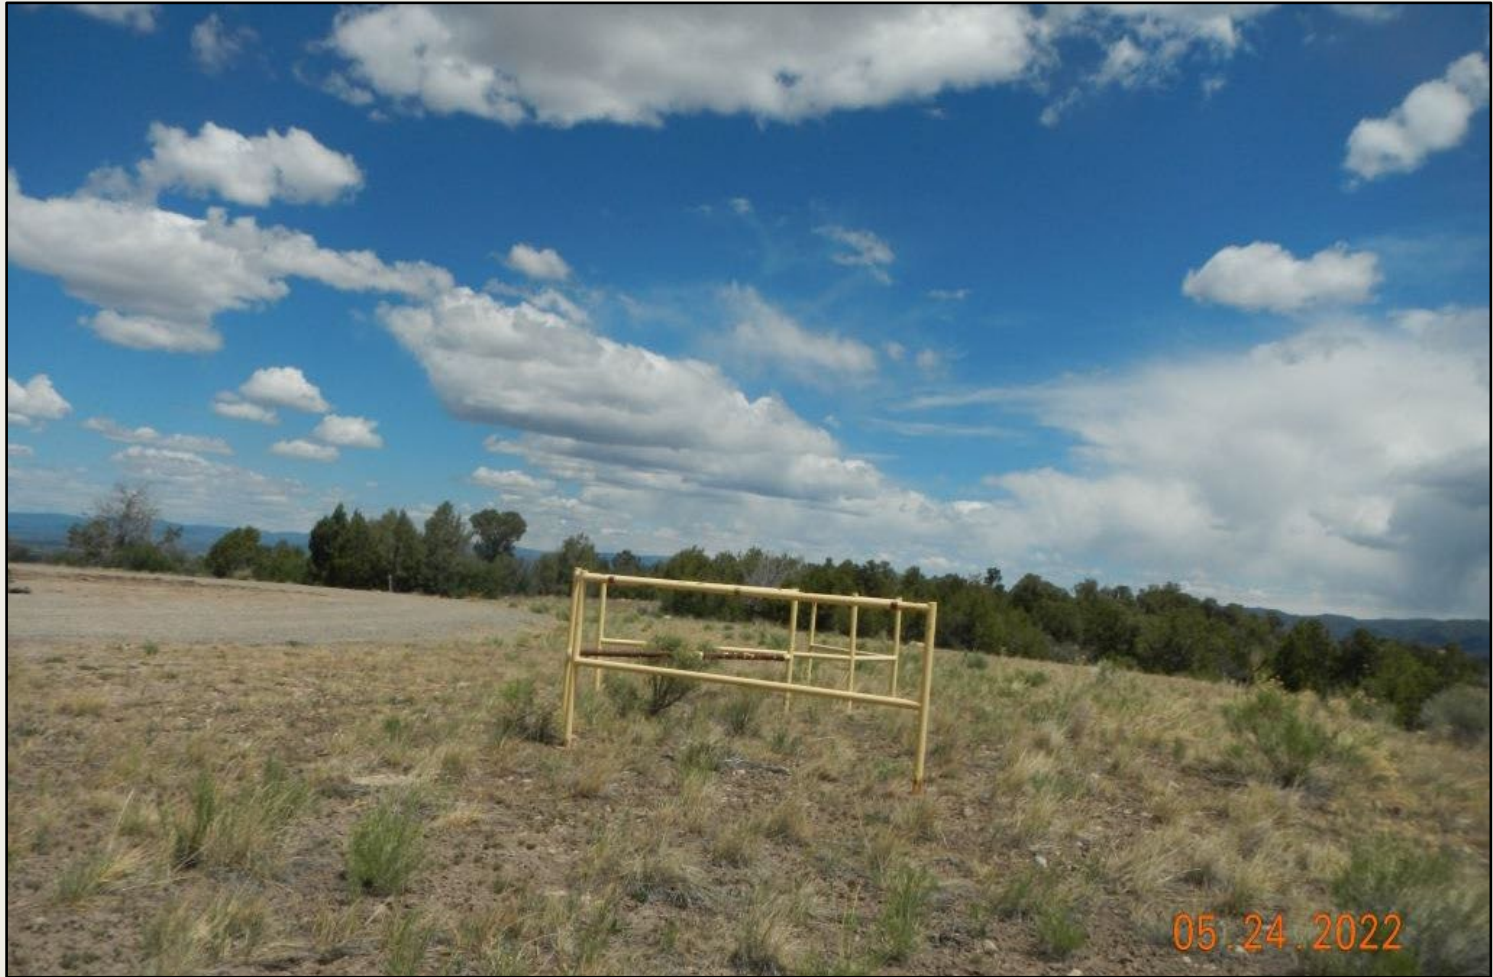
Photo 3. View of unused equipment stored in the eastern project area, needs to be removed.

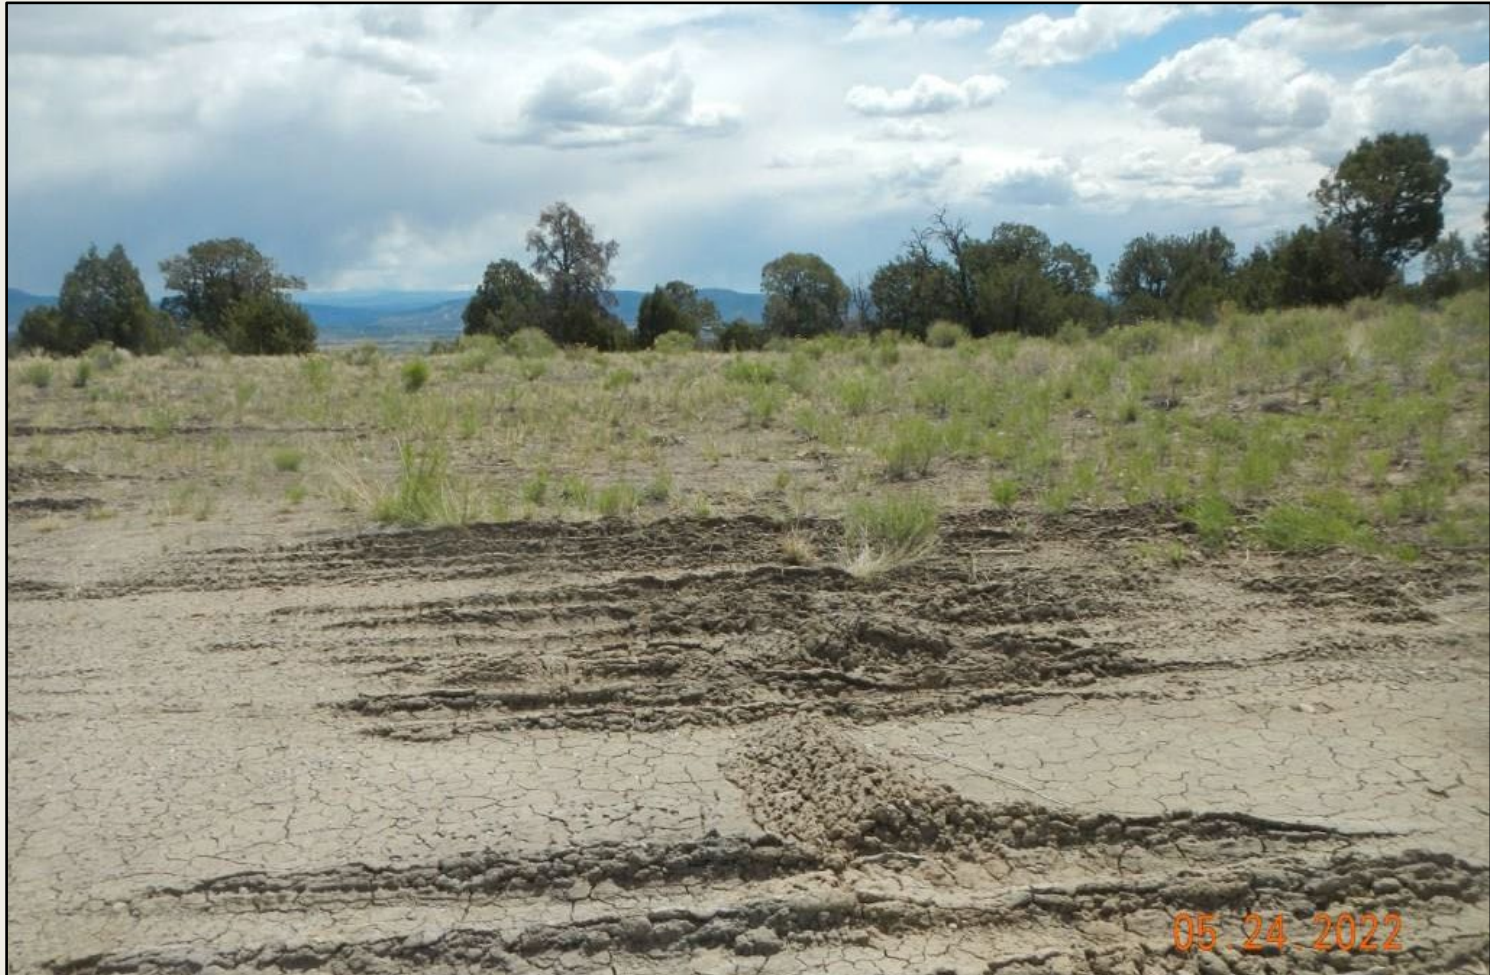
Photo 4. View of vehicle tracking observed within the interim reclamation area, resulting in damage to vegetation and site degradation.

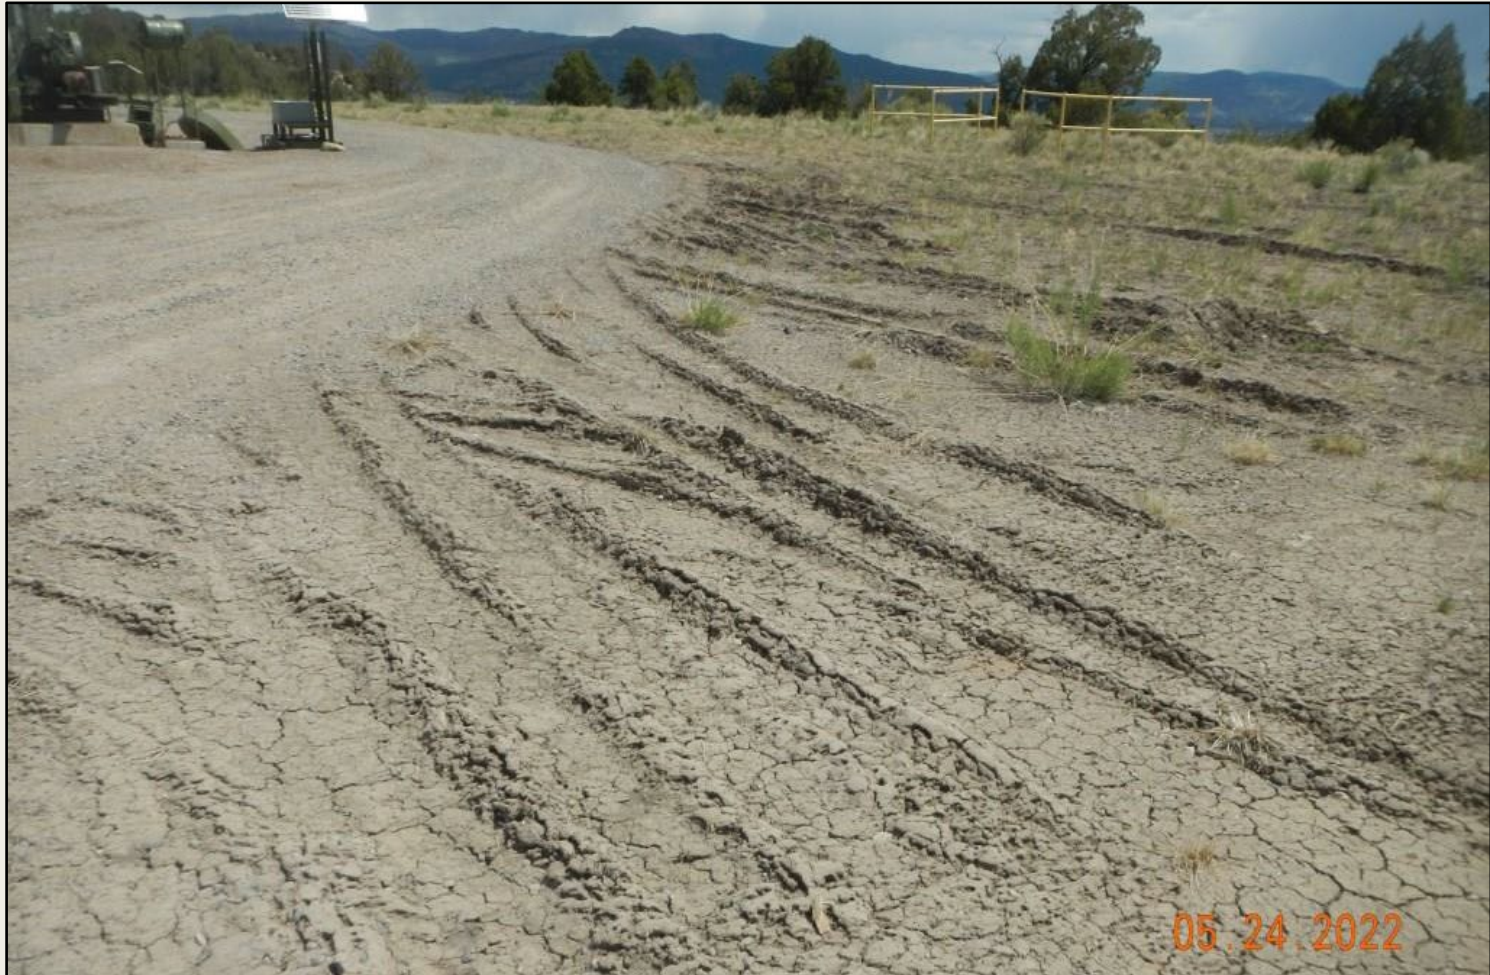
Photo 5. View of more vehicle tracking observed within the interim reclamation area, resulting in damaged vegetation.

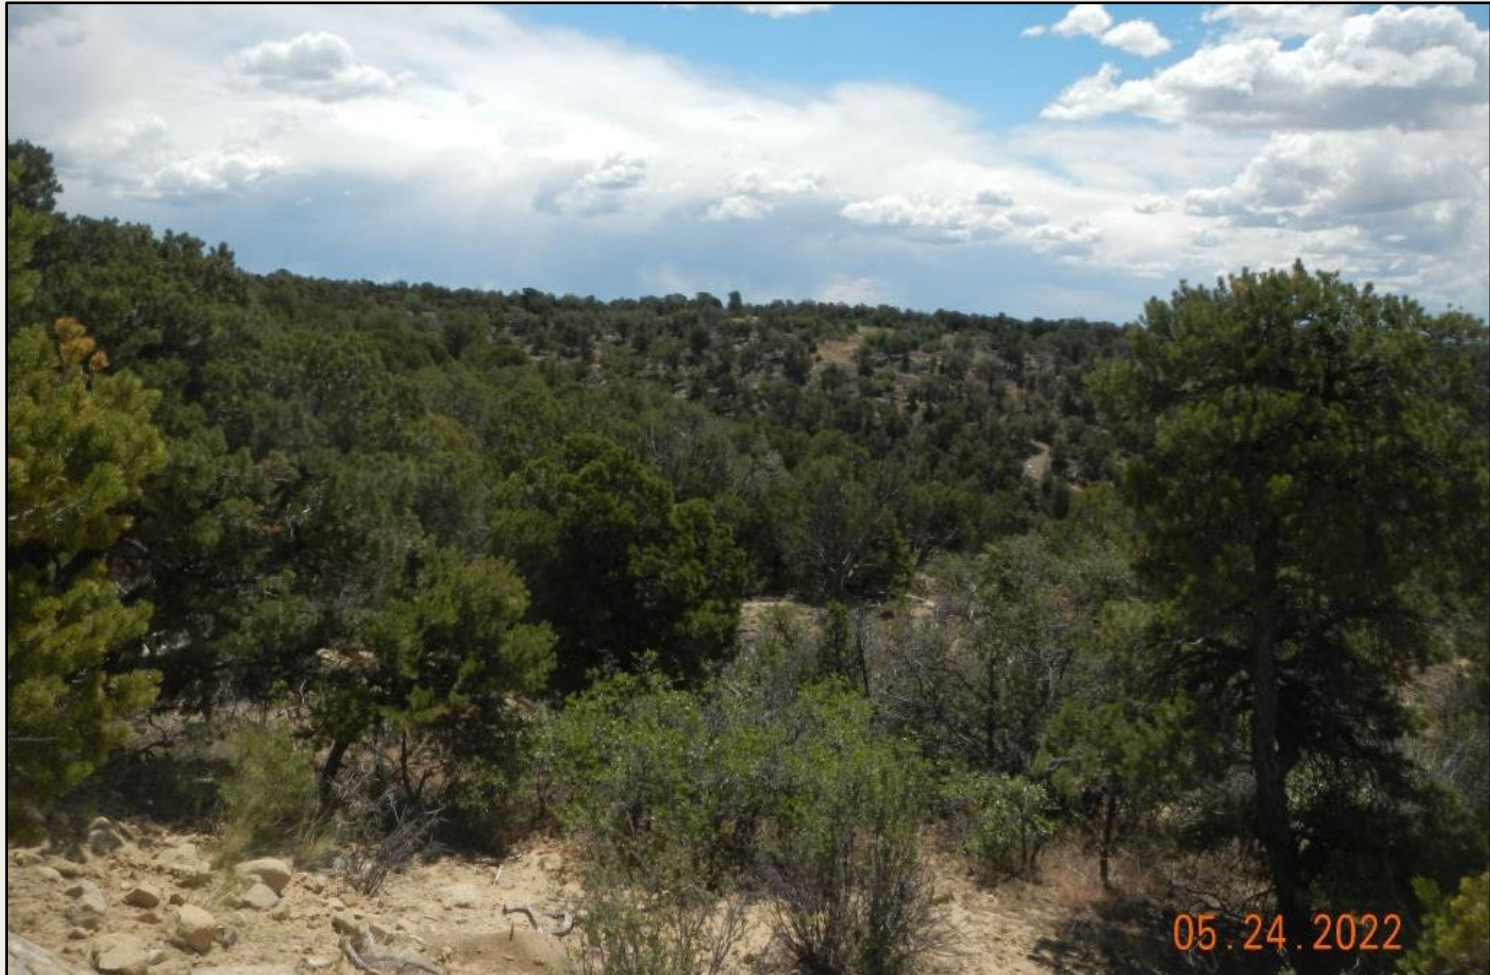
Photo 6. View of reference area comprised of pinyon and juniper woodland with gambel oak, Indian ricegrass, antelope bitterbrush, mountain mahogany, and sulfur flower.
