TEP
Brynildson 13C
Location # 335379

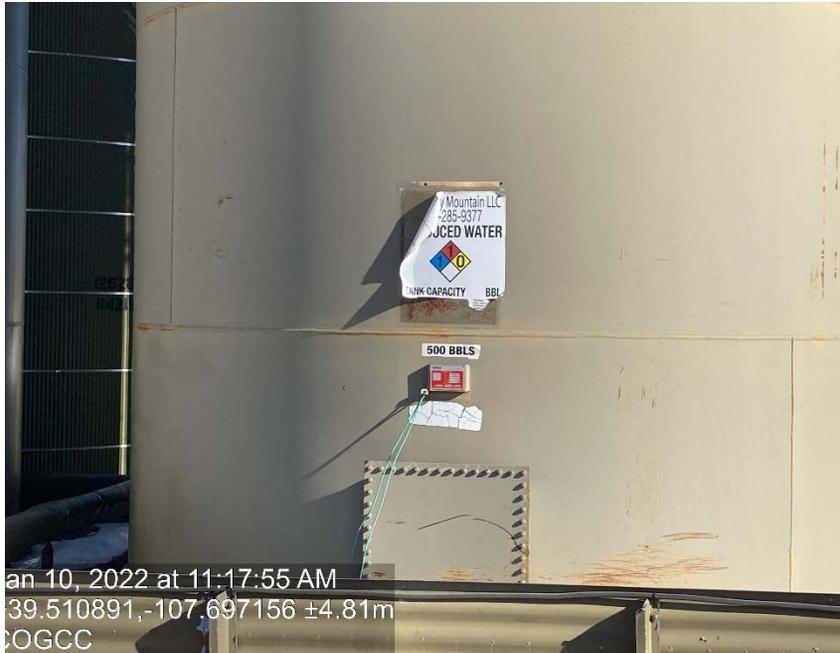
Previous inspection of tank label

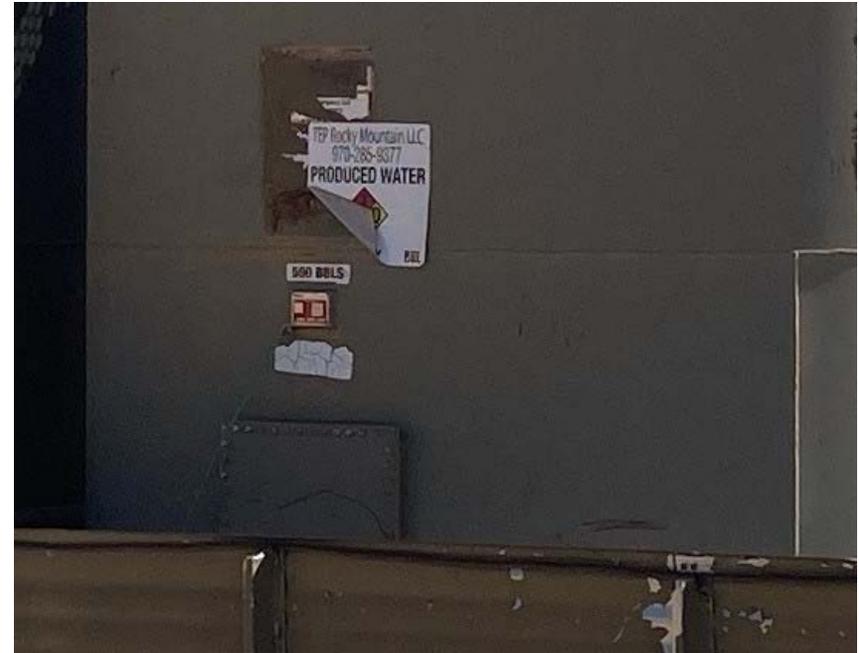
Recent inspection of tank label

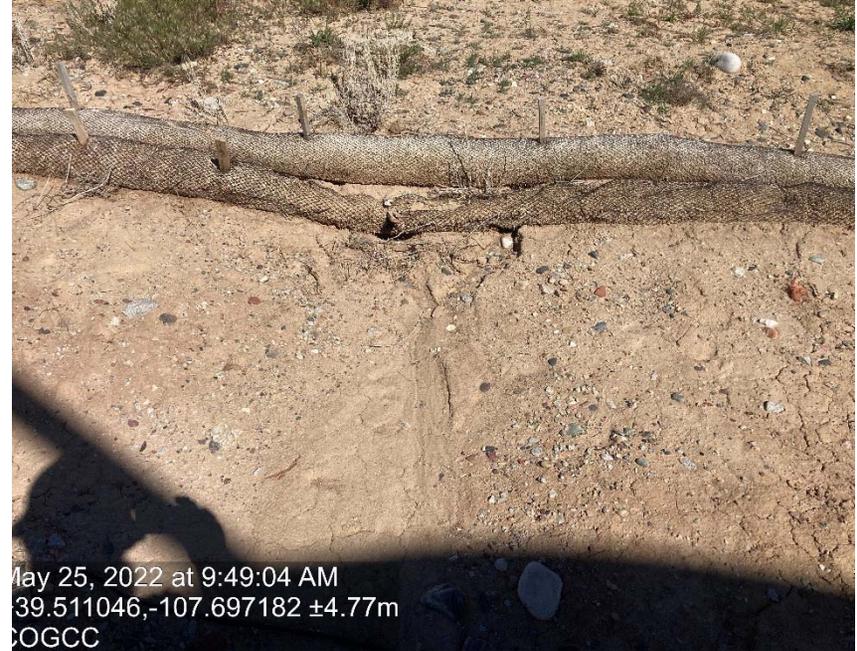
BMP's Failing and debris

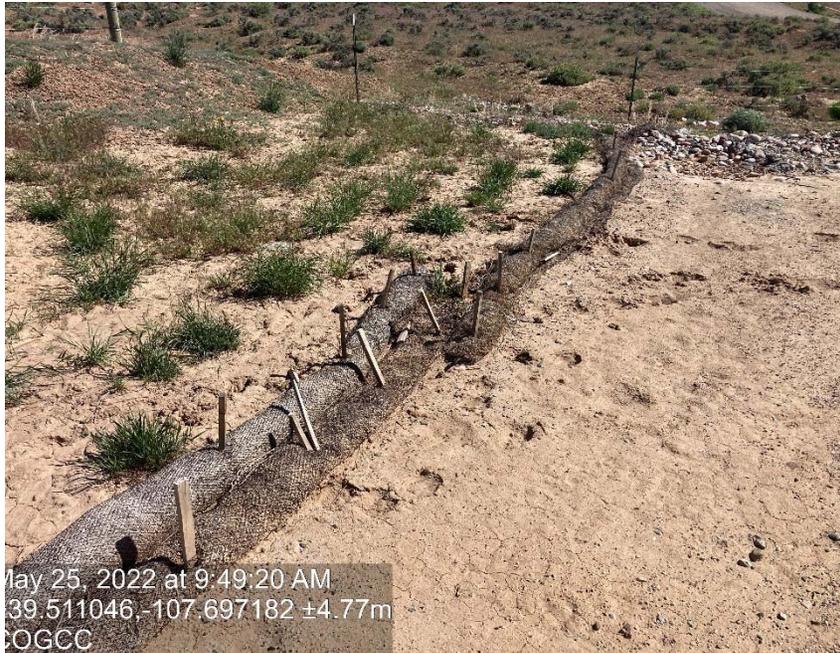
BMP's Failing and debris

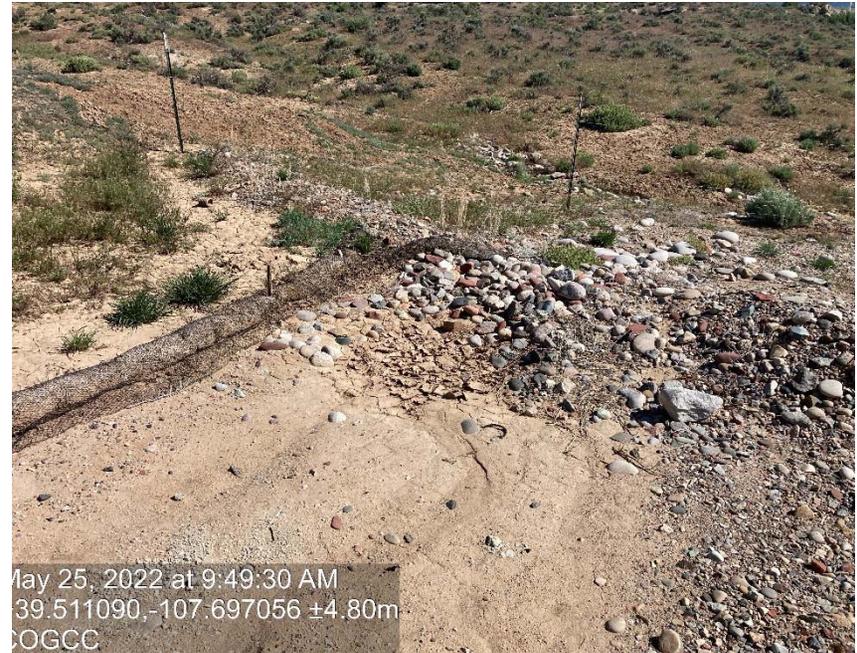
BMP's Failing and debris

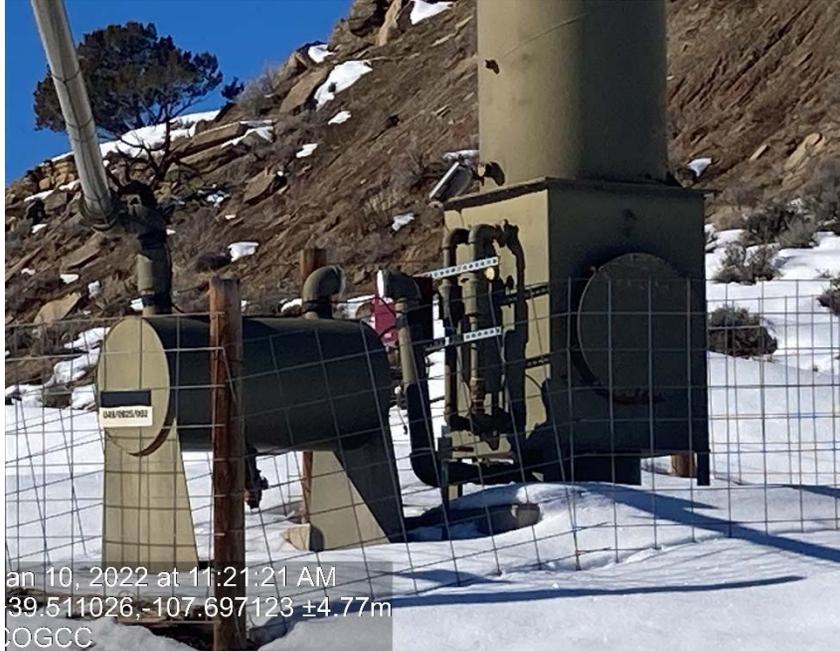
Previous photo of stored equipment

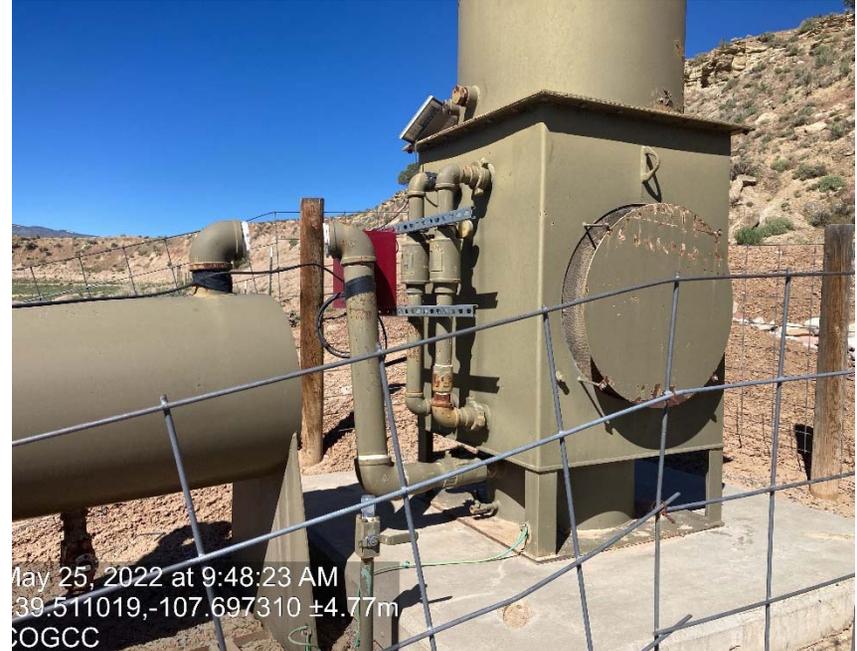
Recent photo of stored equipment

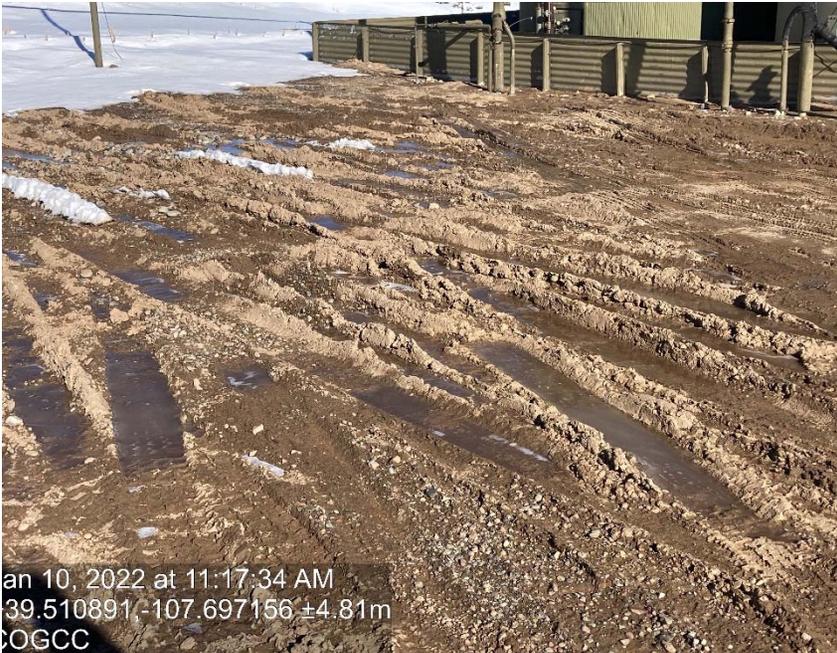
**Previous inspection of Lack of stabilization/
compaction/ degradation**

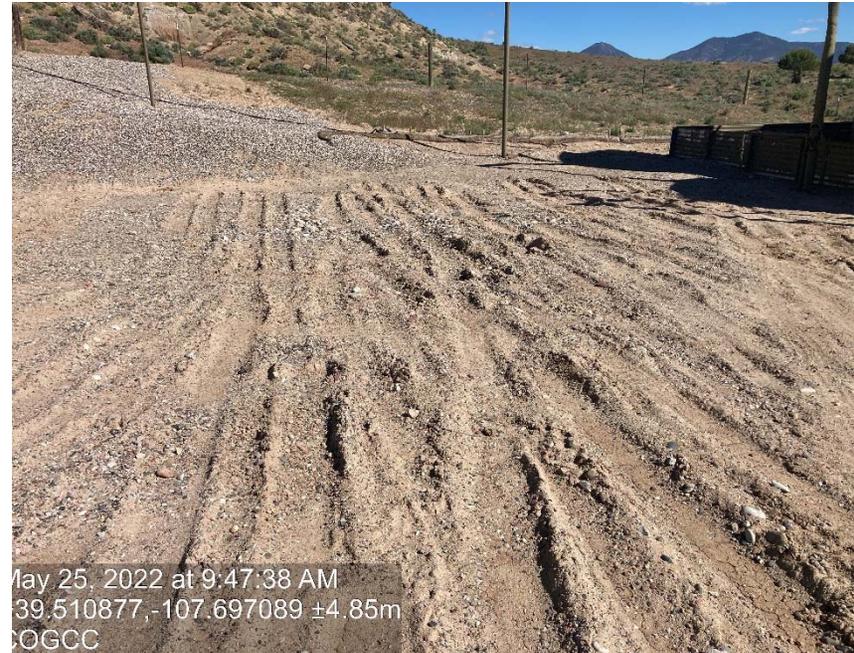
**Recent photo of Lack of stabilization/ compaction/
degradation**

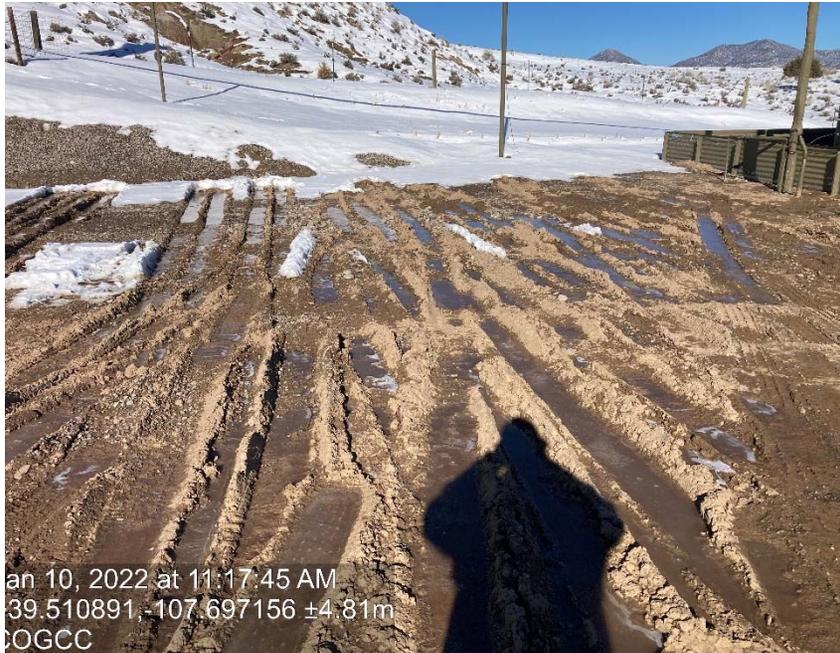
**Previous inspection of Lack of stabilization/
compaction/ degradation**

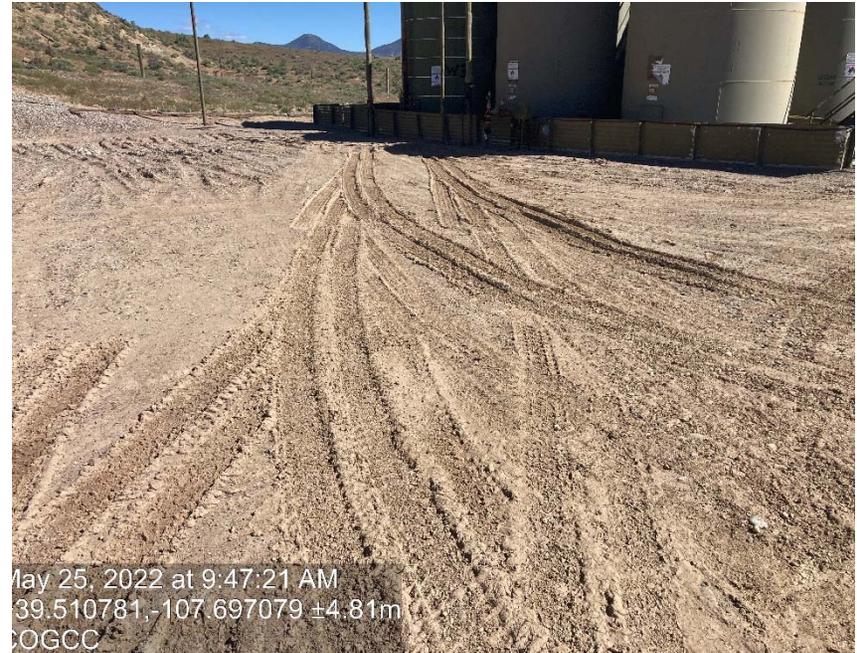
**Recent photo of Lack of stabilization/ compaction/
degradation**

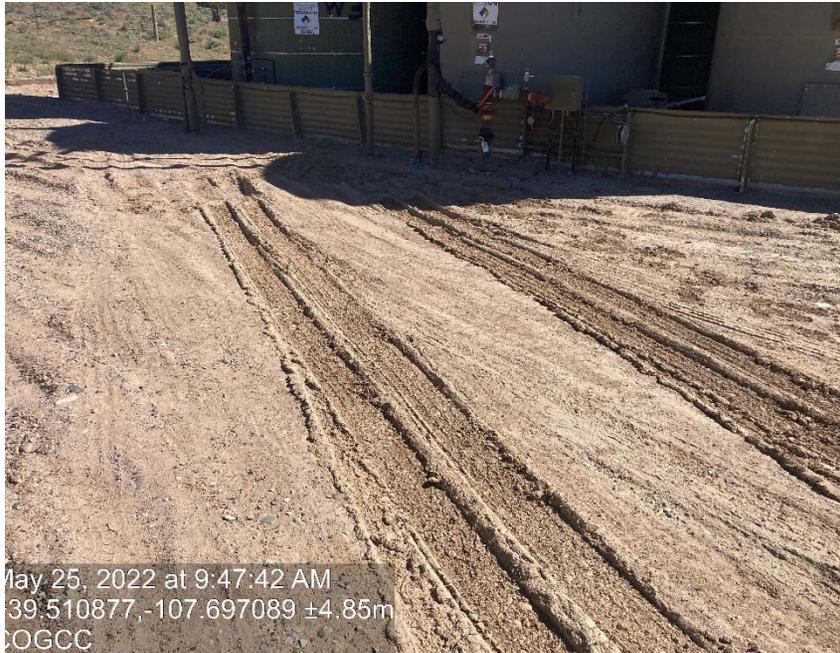
Lack of stabilization/ compaction/ degradation

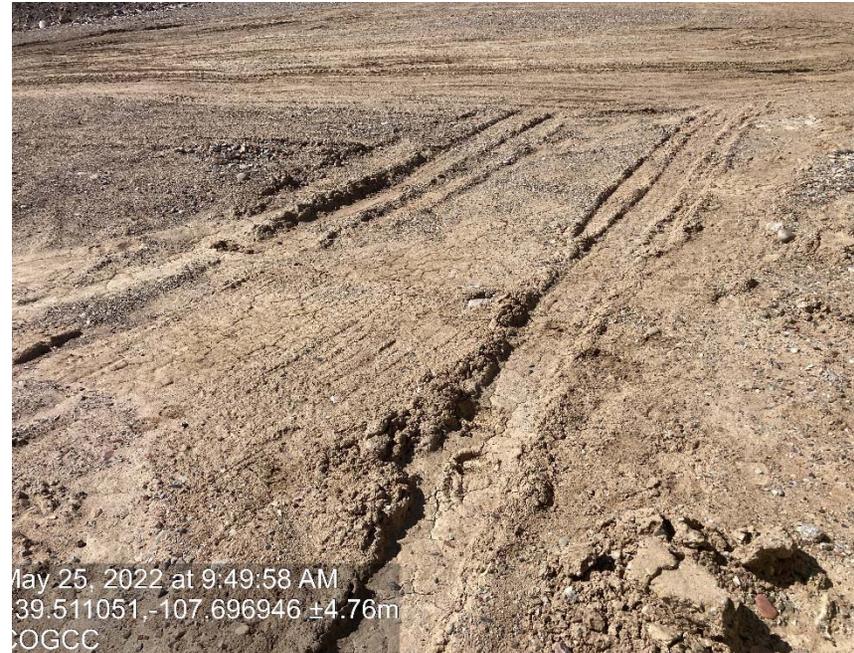
Lack of stabilization/ compaction/ degradation

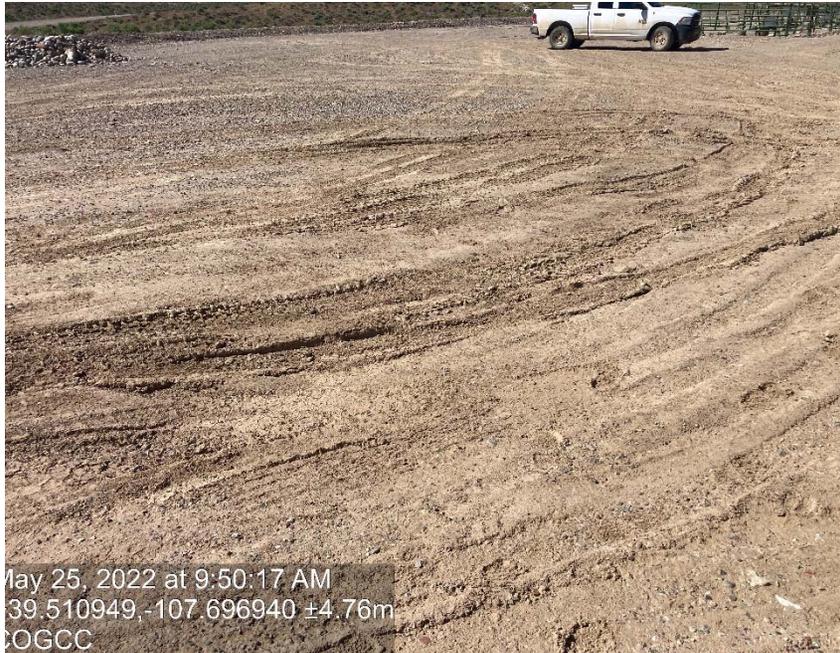
Lack of stabilization/ compaction/ degradation

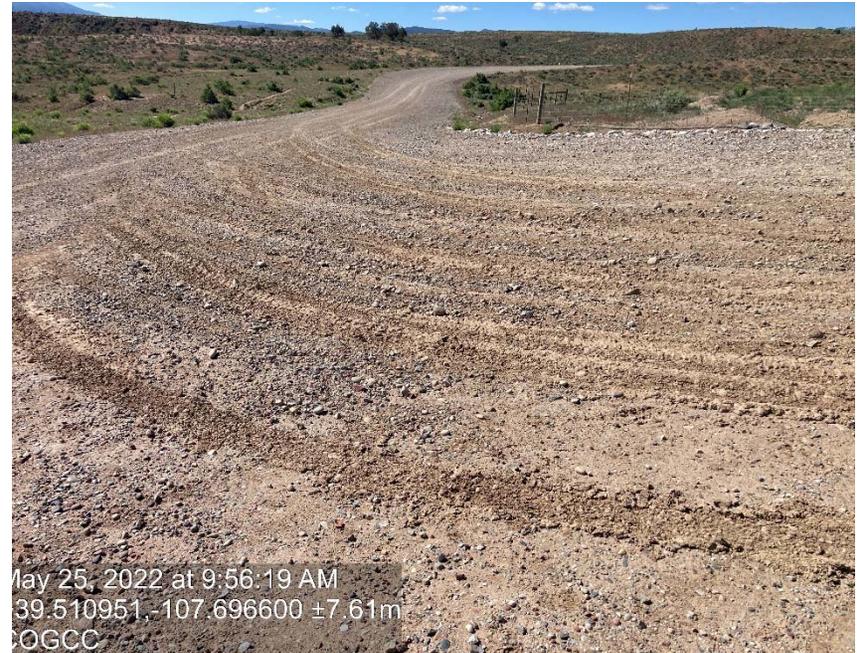
Tracking

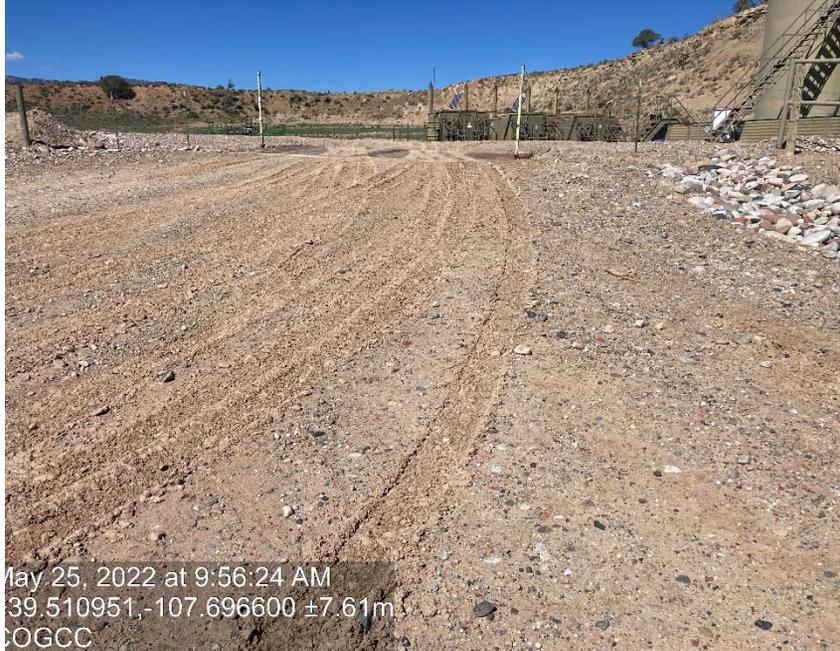
Tracking

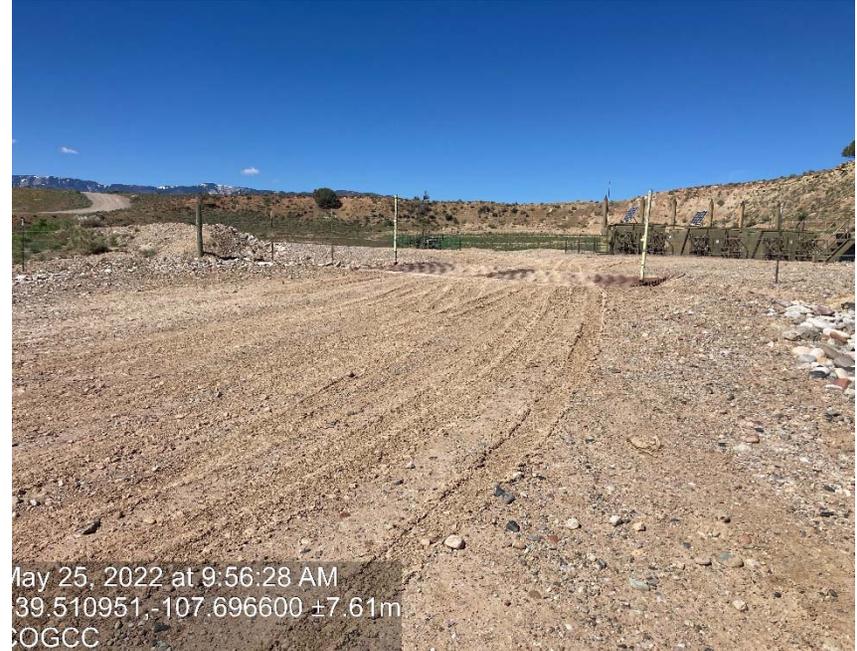
Tracking
