**Inspection Photos**  
**Location Name: William Lansdown #1**  
**Location ID: 317613**

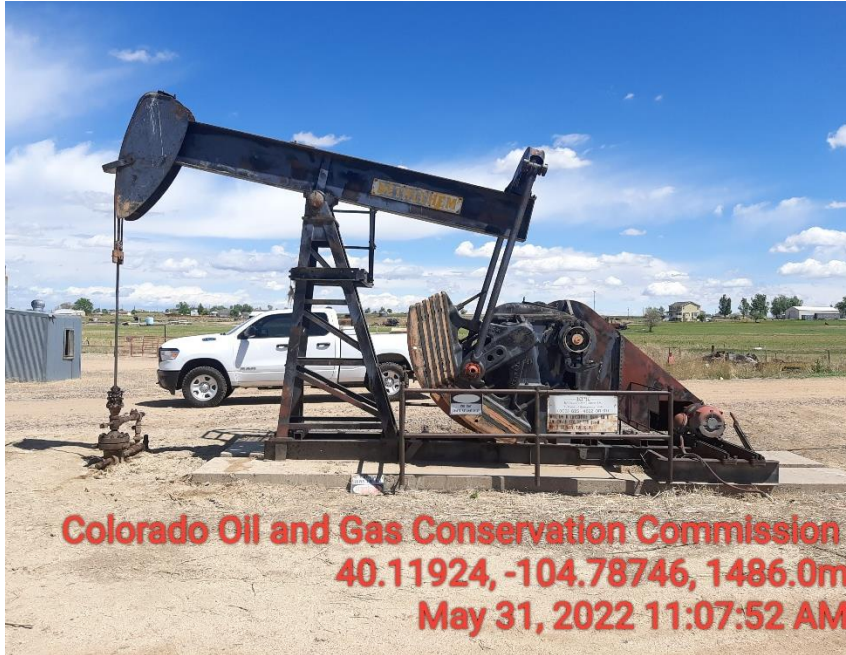
**Photo 1 Well head**

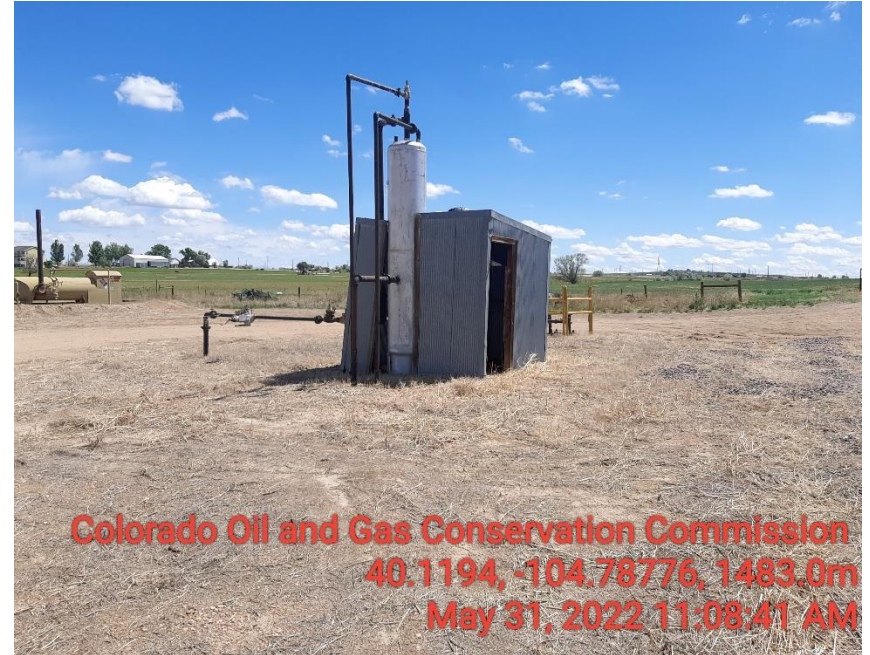
**Photo 2 Unused equipment vertical separator**

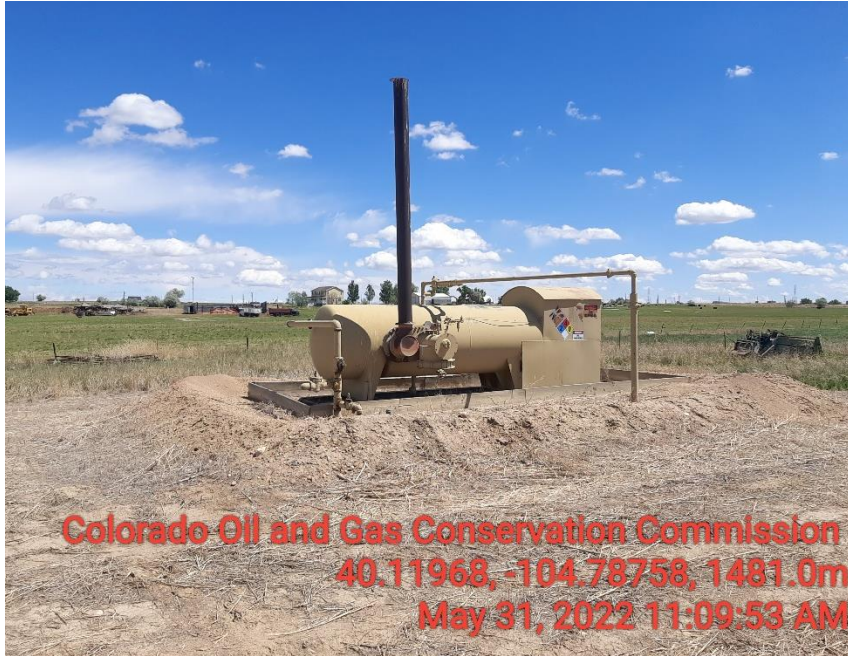
**Photo 3 Hoz sep**

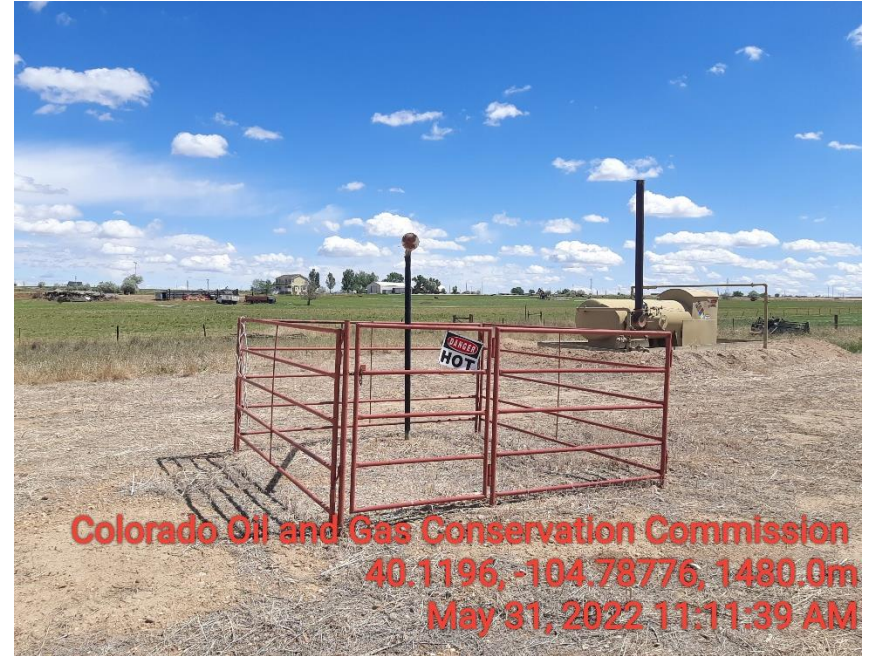
**Photo 4 riser missing LOTO**

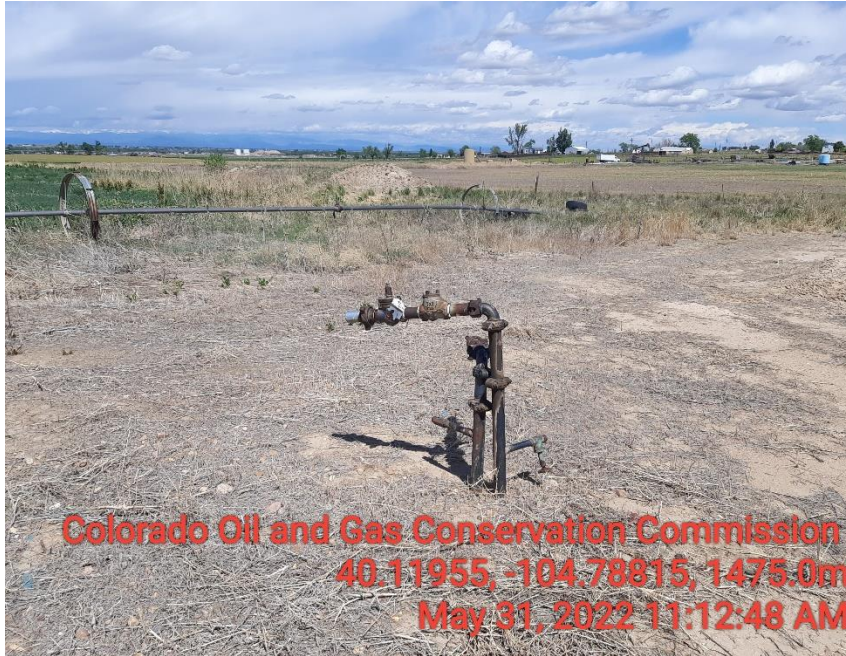
**Photo 7 Risers not LOTO**

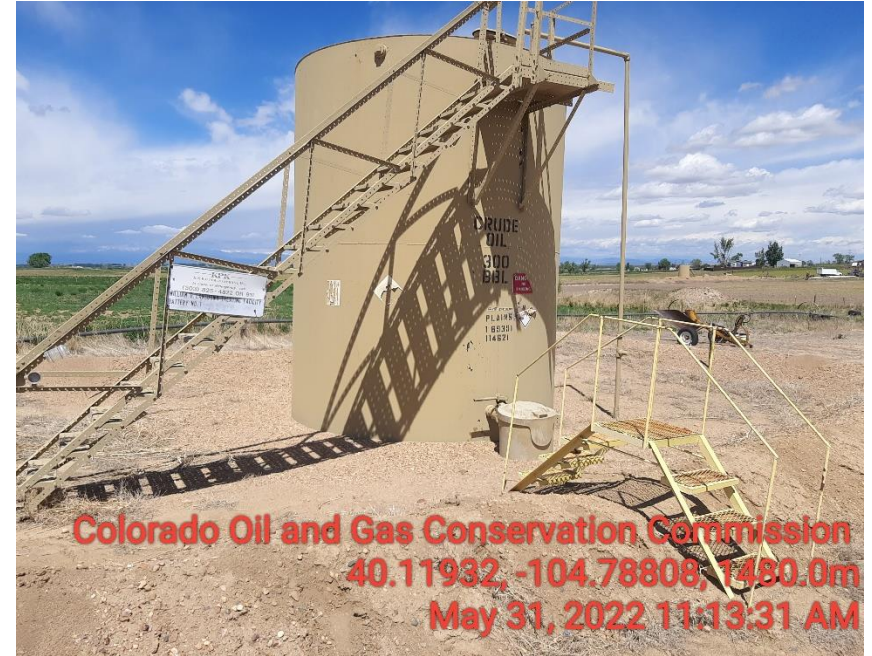
**Photo 8 Crude oil tank. NPPA placard faded and peeling off.**

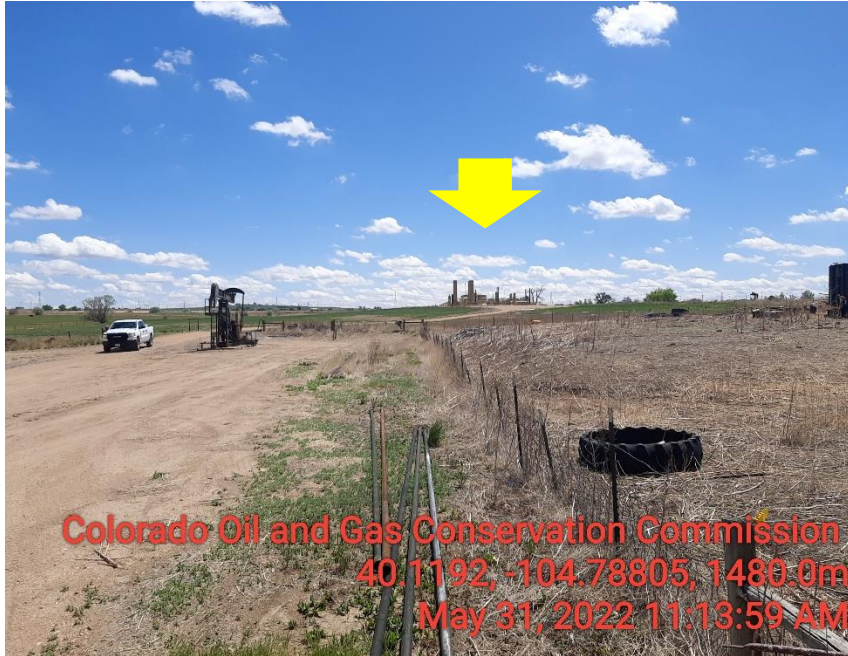
**Photo 9 this is a shared road access with OXY operating company.**

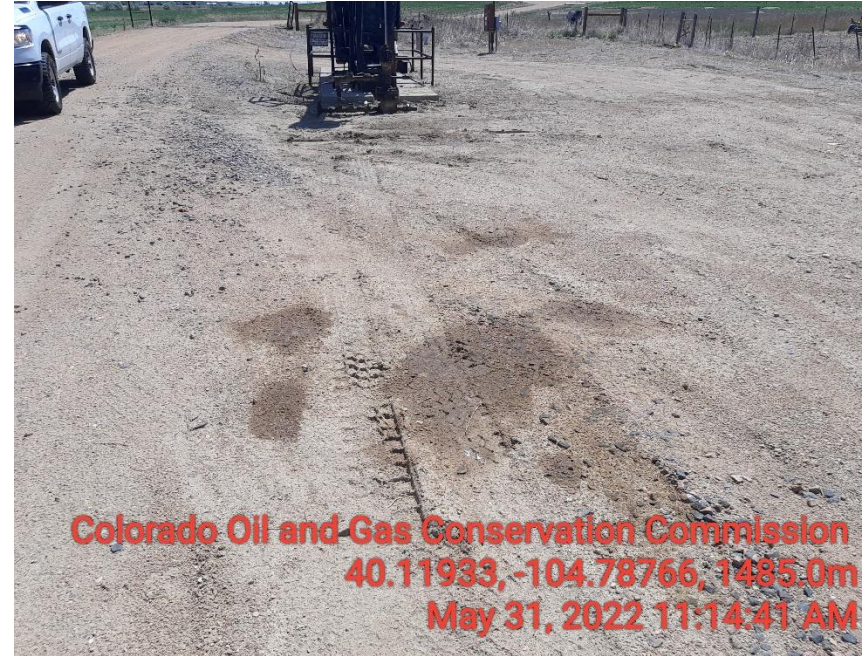
**Photo 10 Stained soil in front of well head**

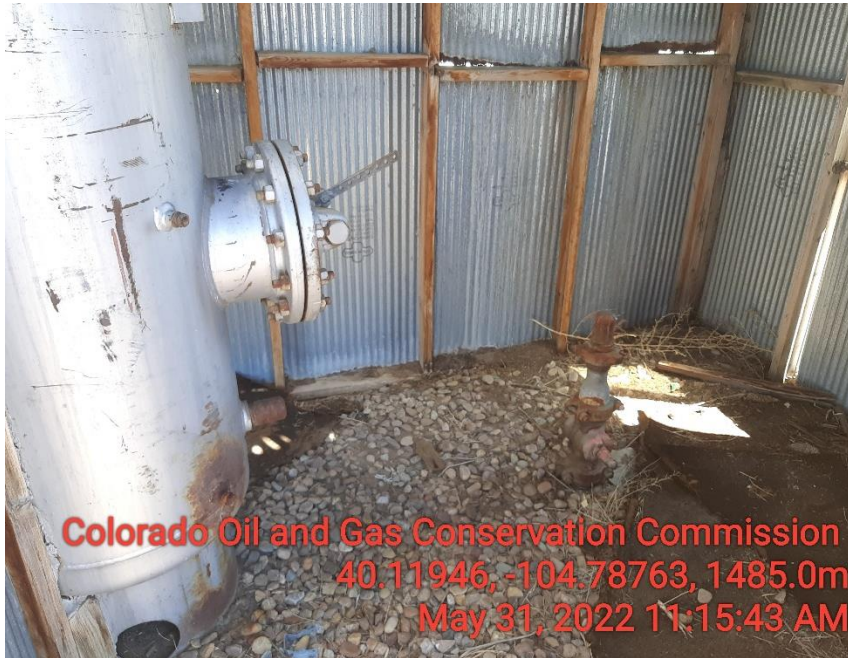
**Photo 11 unused equipment and not LOTO riser**

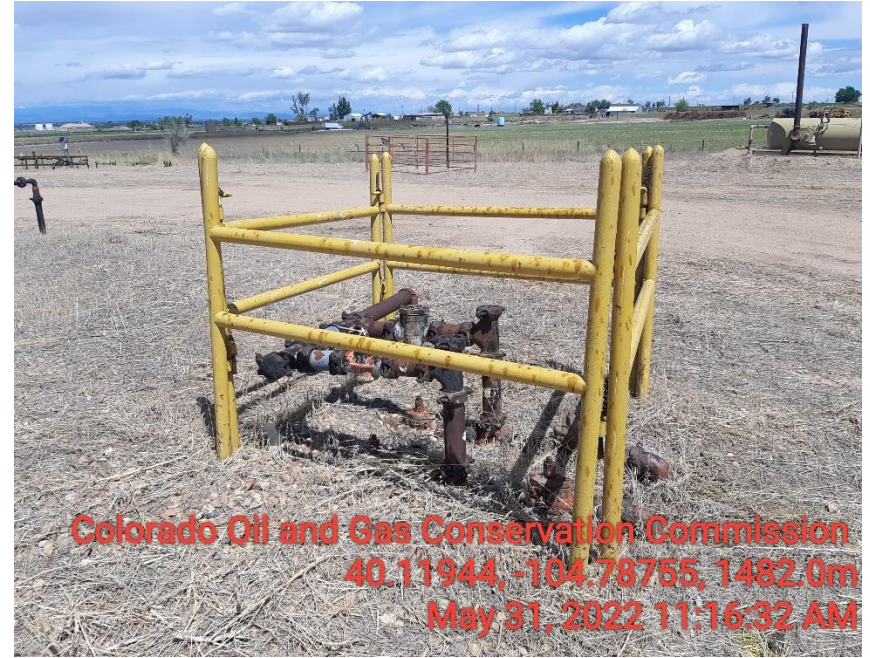
**Photo 12 Risers not LOTO**

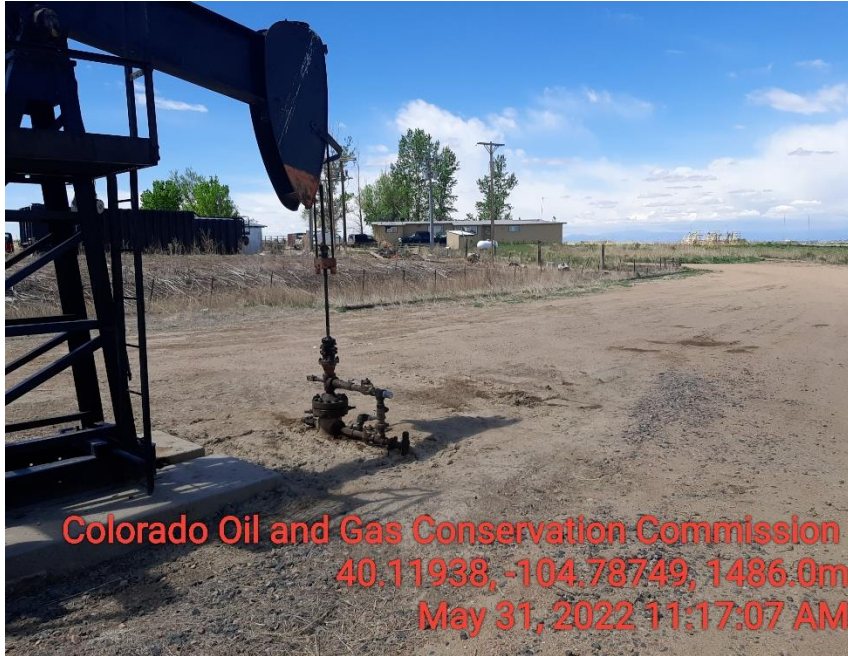
**Photo 13 Road access shared with resident. Stained soil in front of well head**
