Inspection Photos

API: 071-09920

Operator: TWIN BRIDGES RESOURCES LLC

Inspection Date: 5/31/2022

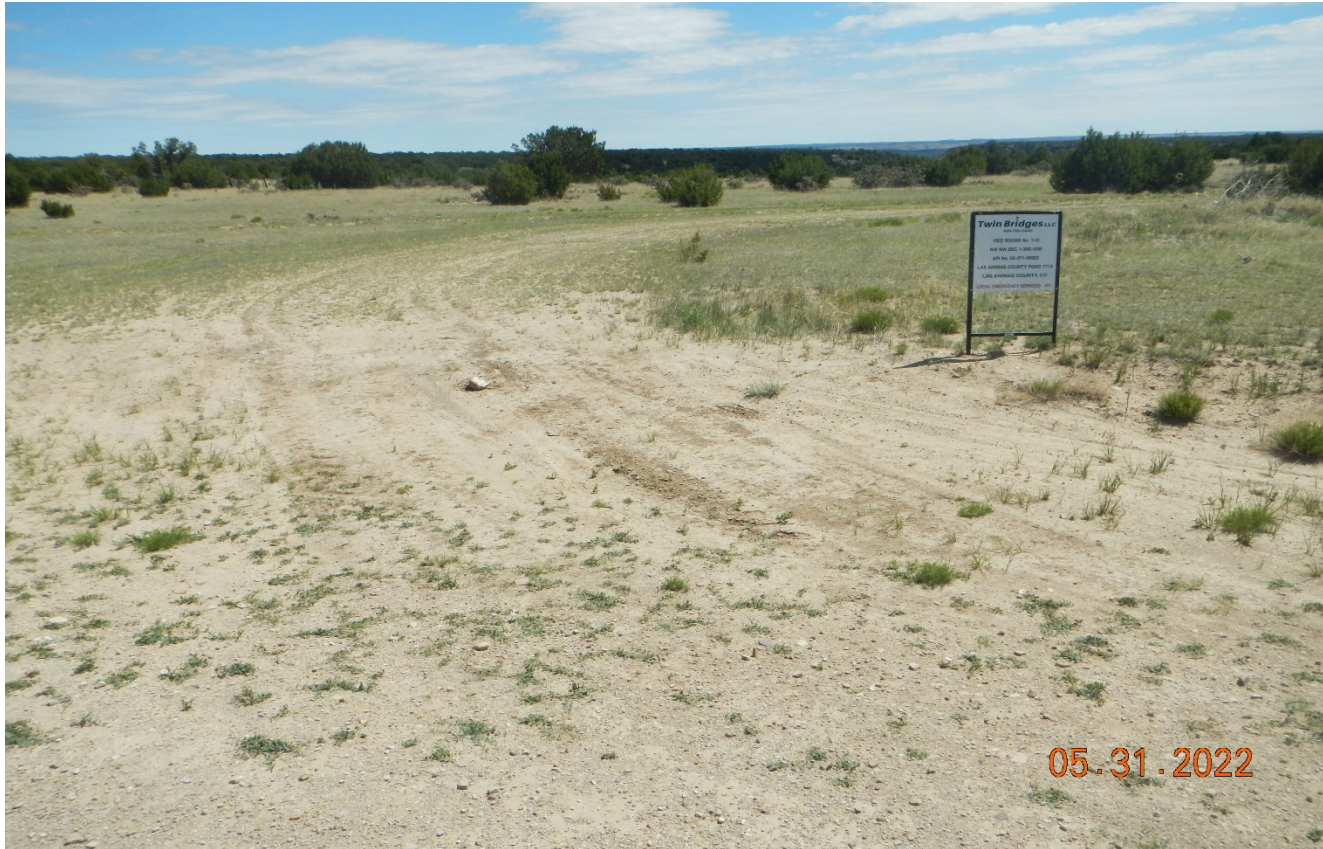
Photo 1. Facing southeast at the entrance of the access road. Sign is posted at entrance.

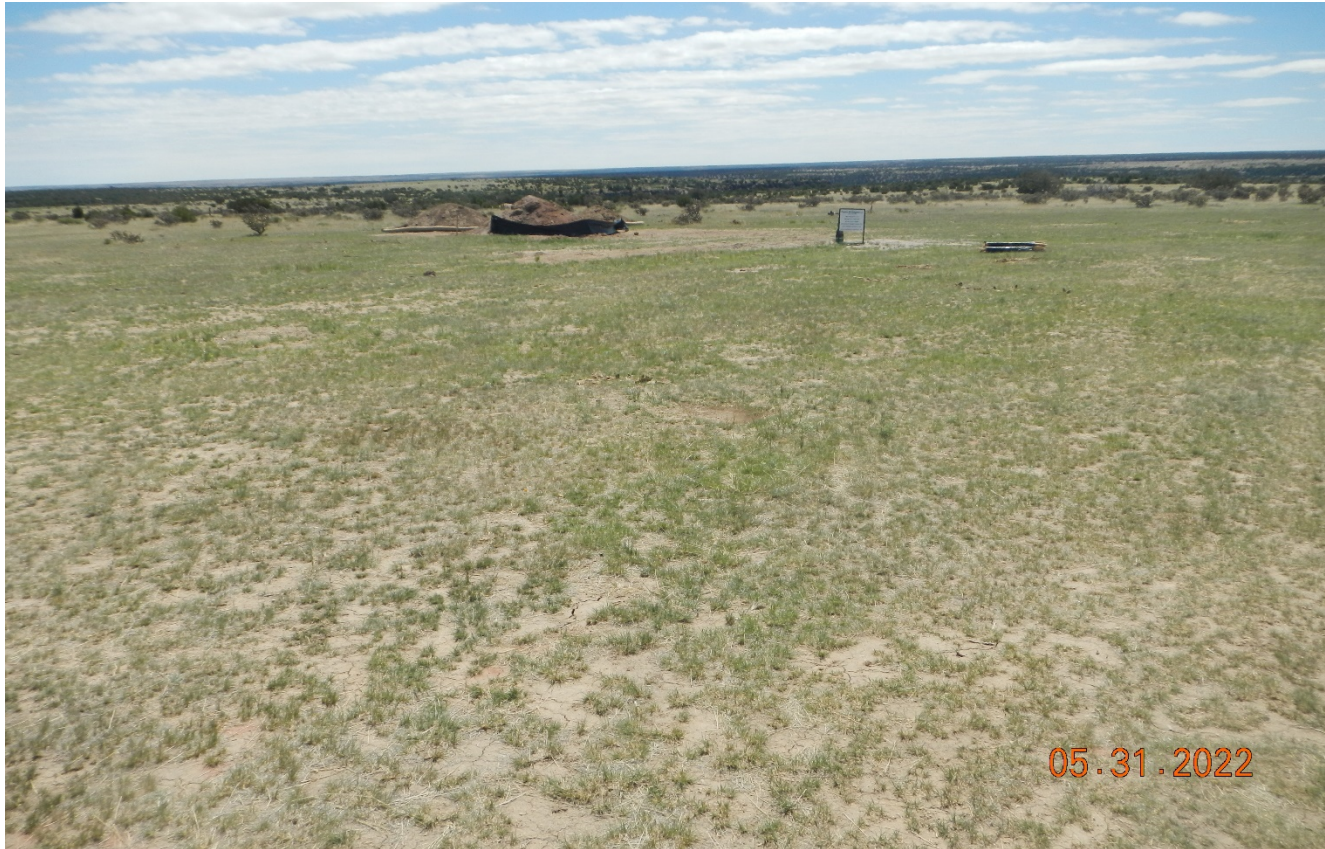
Photo 2. Facing southeast toward the location.

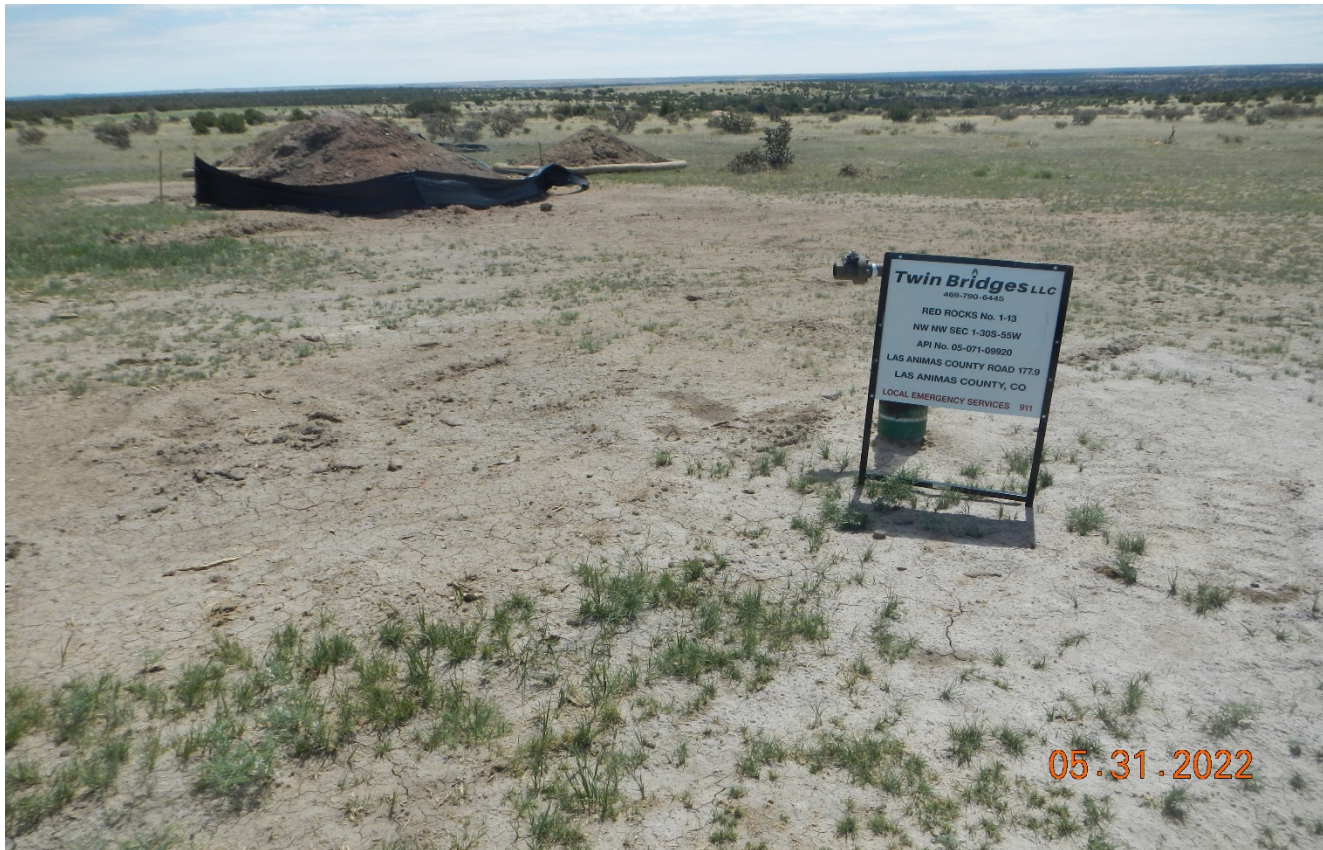
Photo 3. The well has been drilled at the location.

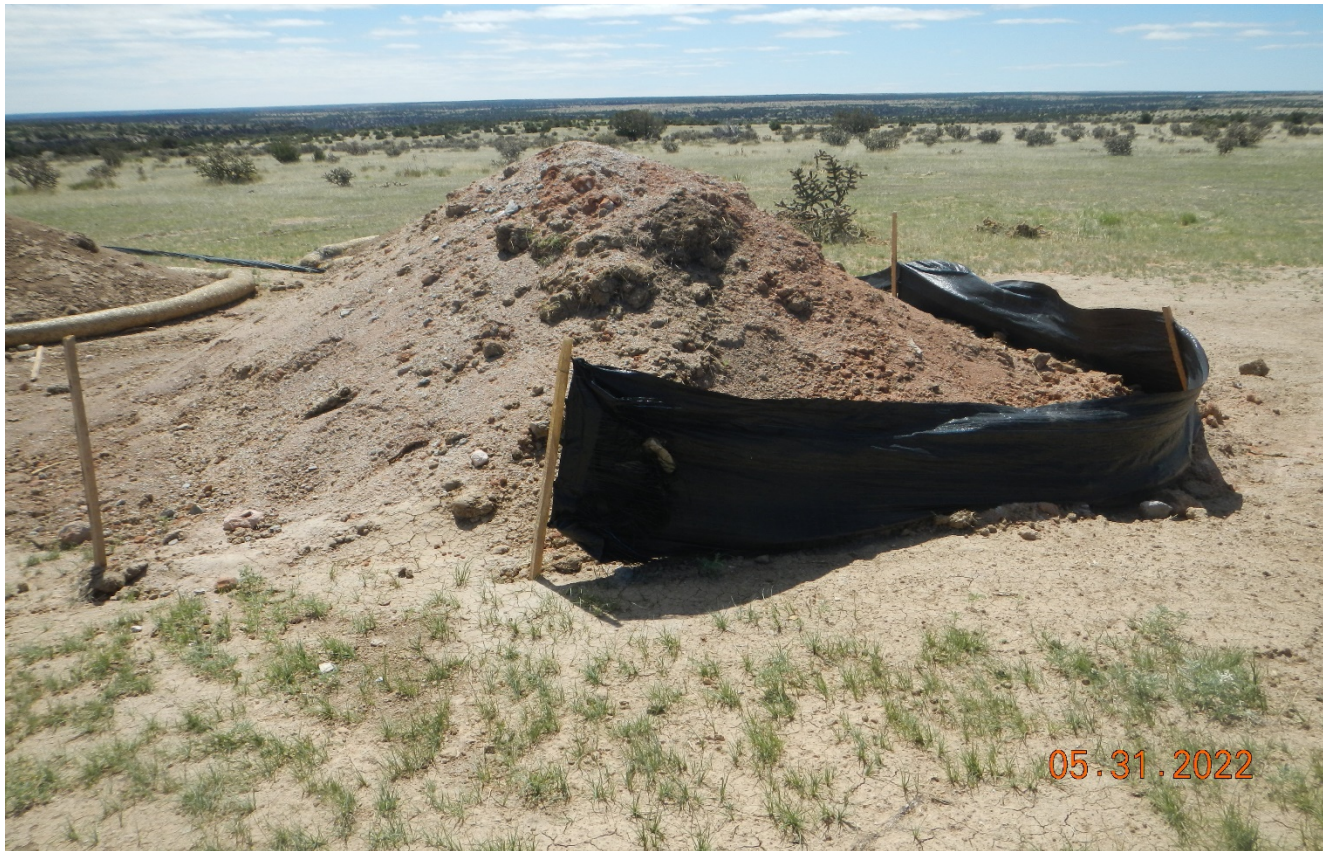
Photo 4. There is inadequate stormwater controls down gradient and around the cuttings pile. The silt fence is not properly installed or maintained.

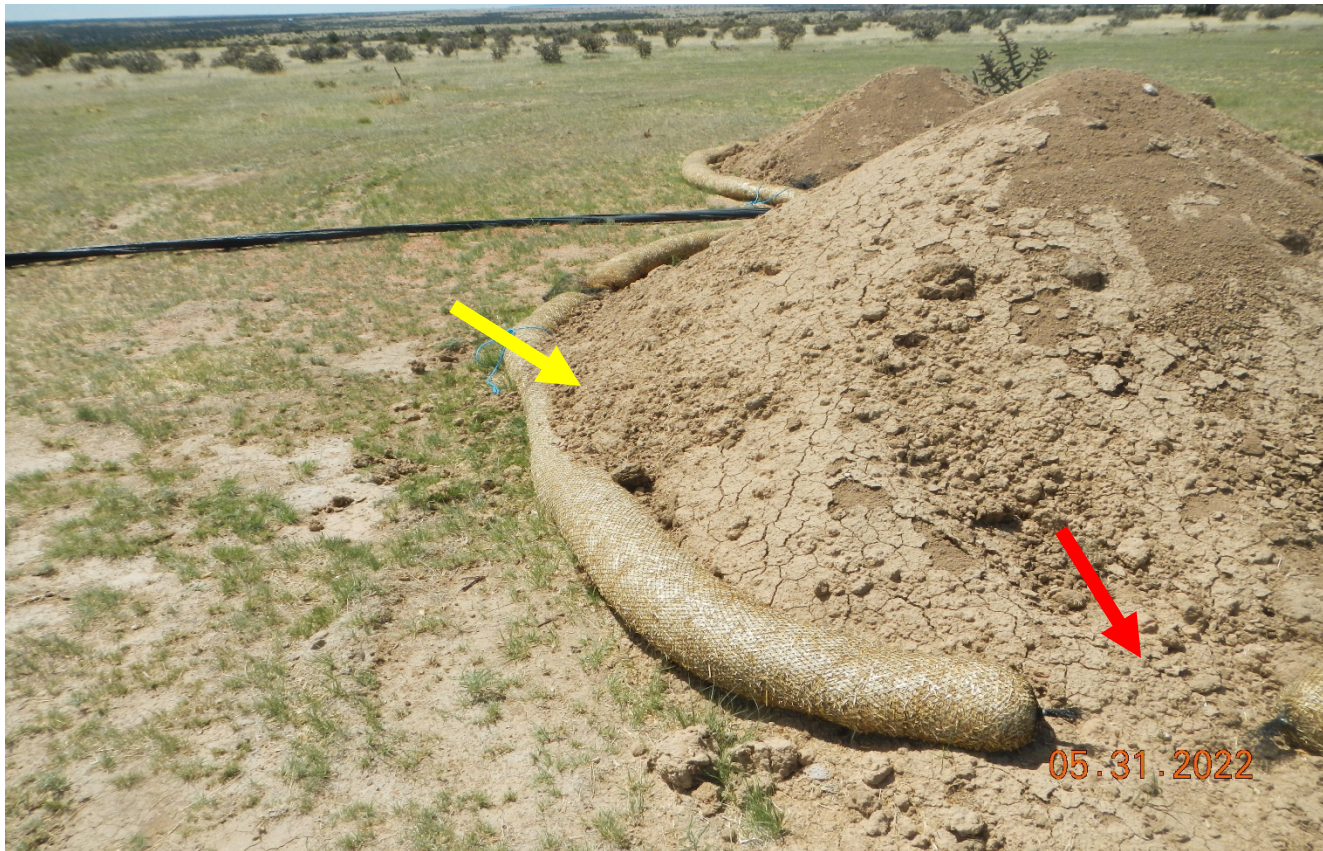
Photo 5. The straw wattles around the soil pile are not properly staked down. Soils is overtopping the wattles shown at yellow arrow and there is a space between the wattles at red arrow. Stormwater controls need to be installed per good engineering practice.

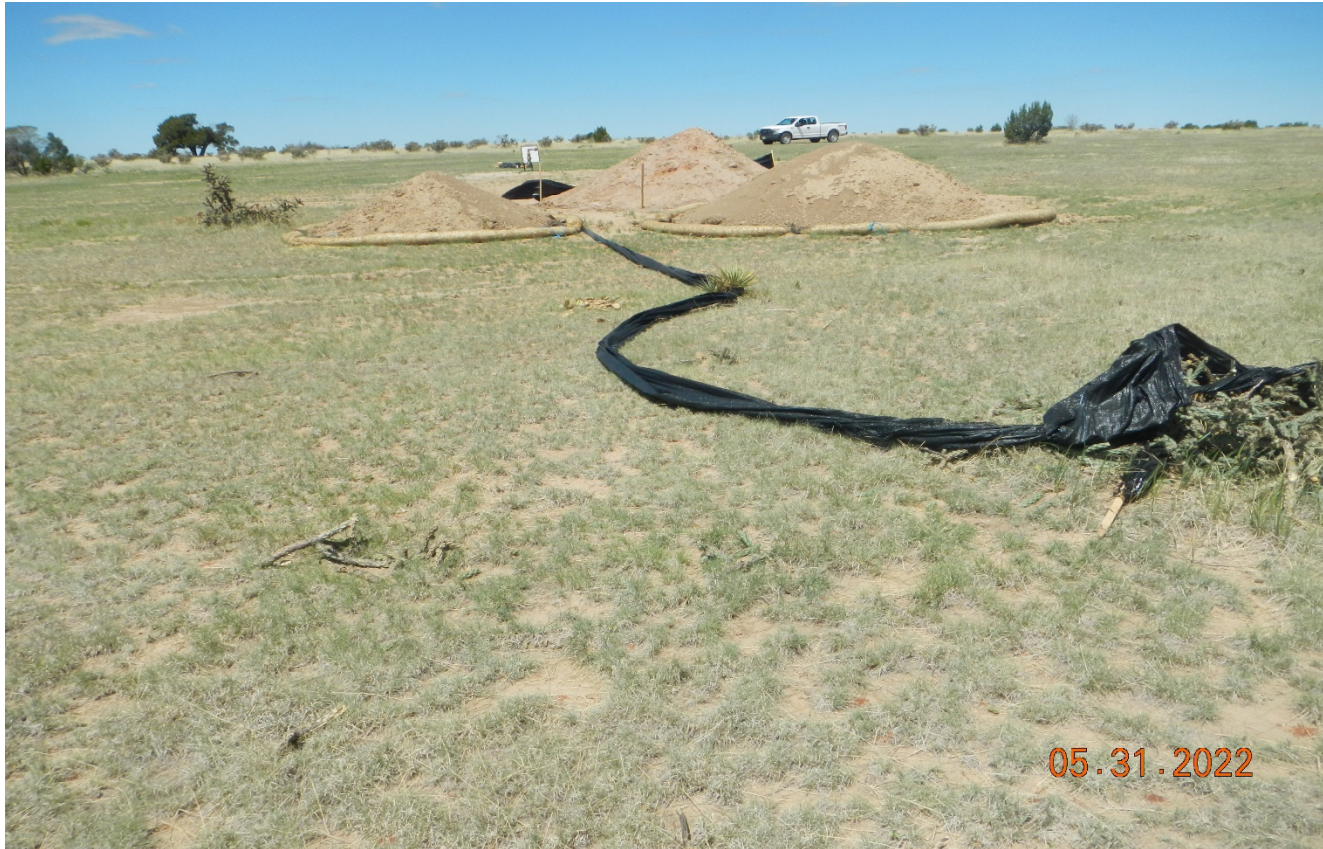
Photo 6. The silt fence is strung across the location.
