## Inspection Photos

Location Name: Semler #2, Herrera #1A, IGE 138, IGE 137

Location ID: 311925

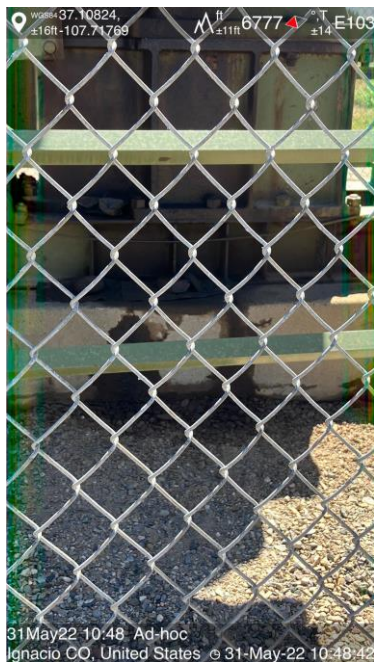
**IMG 11**  
**IGE 137 oily fluid**

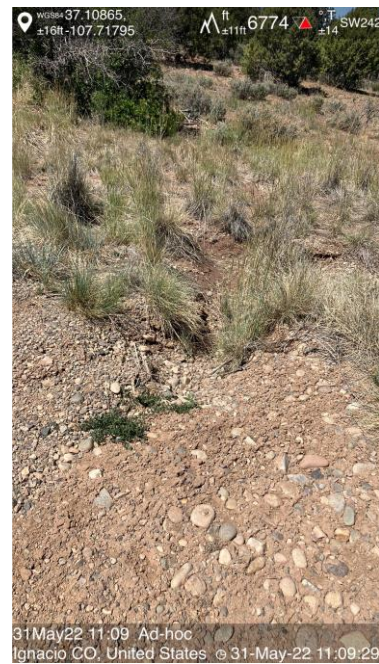
**IMG 16**  
**Erosion encroaching on wellpad**

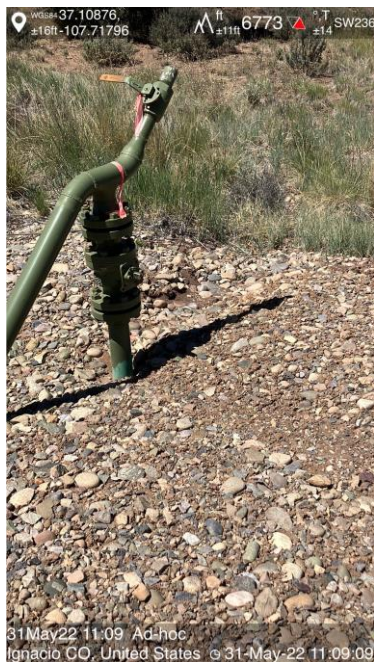
**IMG 17**  
Erosion encroaching on well pad

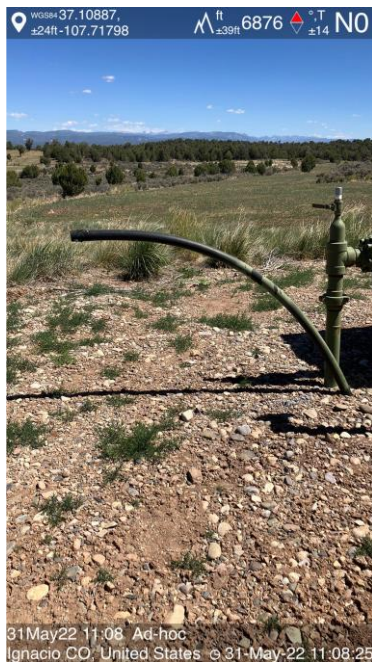
**IMG 19**  
**Unused open ended flow line**

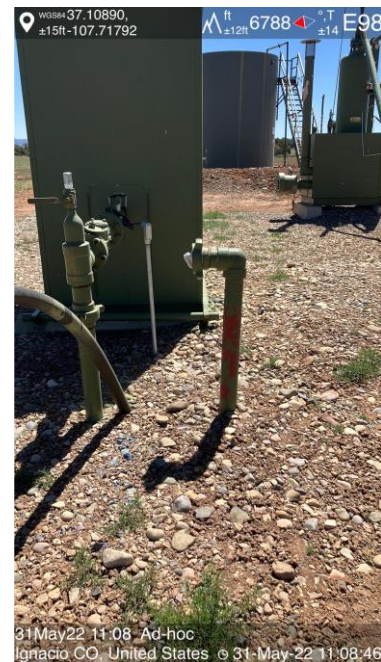
**IMG 20**  
**Unused flow lines**

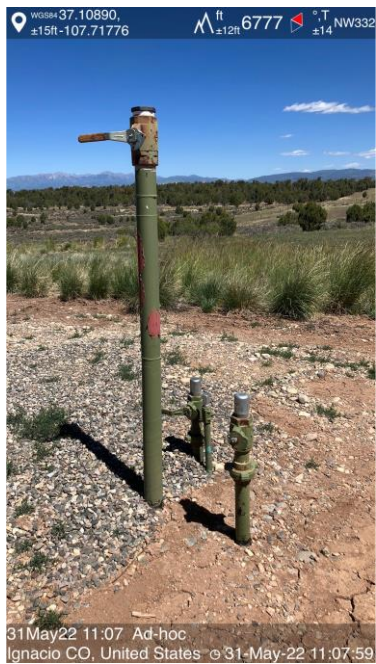
**IMG 21**  
**Unused flow lines**

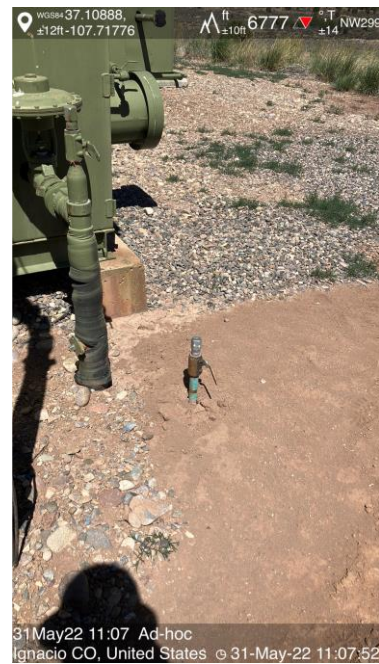
**IMG 22**  
**Unused flow line**

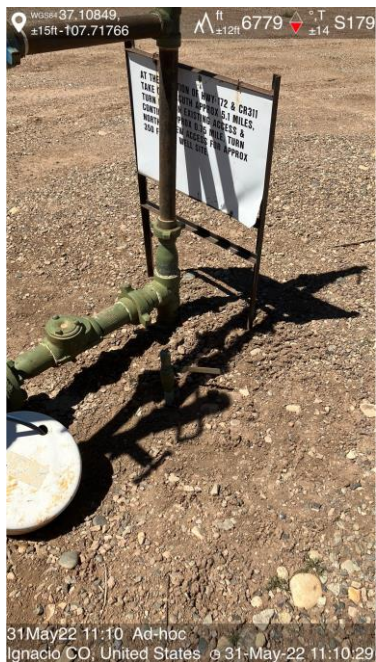
**IMG 23**  
**Unused flow line**

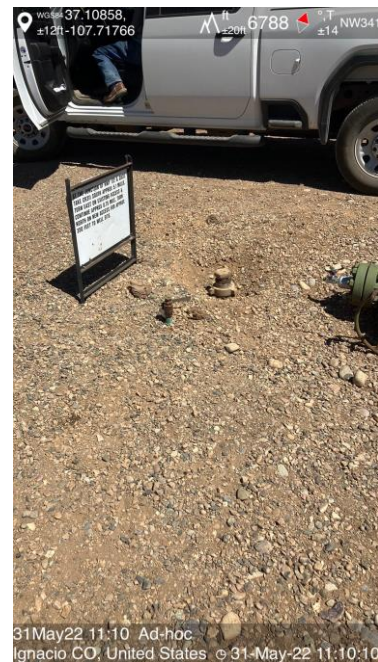
**IMG 24**  
**Unused flow lines**
