Inspection Photos  
Location Name: Ignacio 33-8 027  
Location ID: 326435

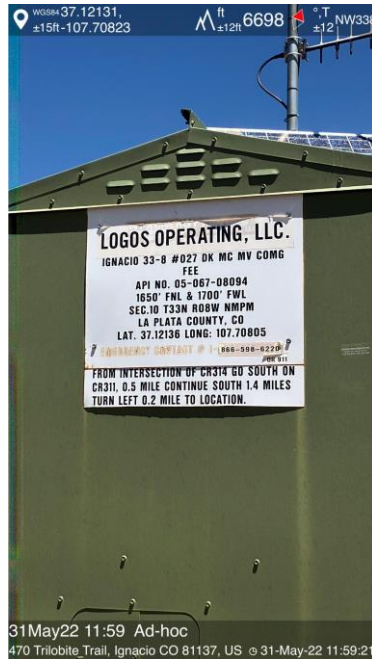
IMG 01  
Well Sign

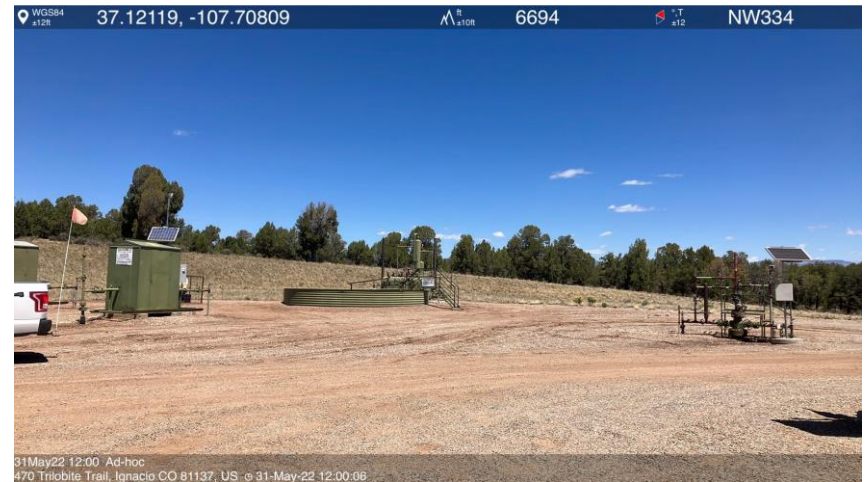
IMG 02  
Site overview

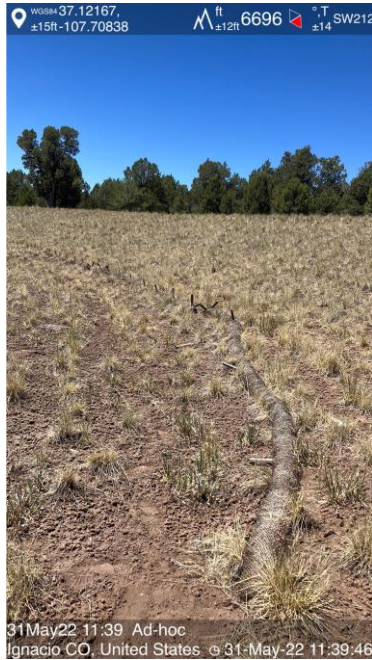
**IMG 03**  
**Wattles**

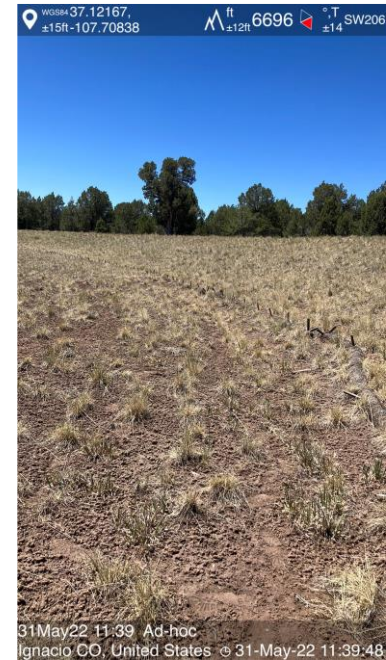
**IMG 04**  
**Wattles**

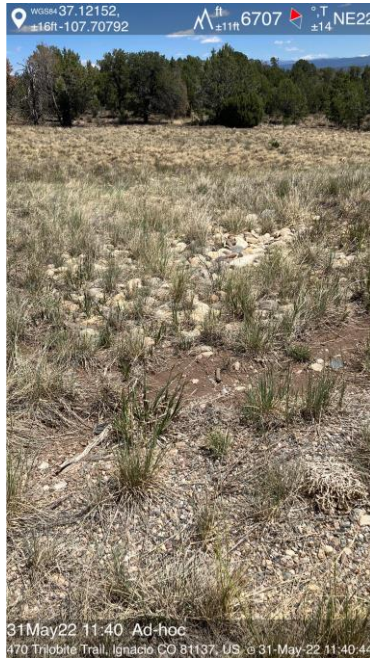
**IMG 05**  
**Rip Rap**

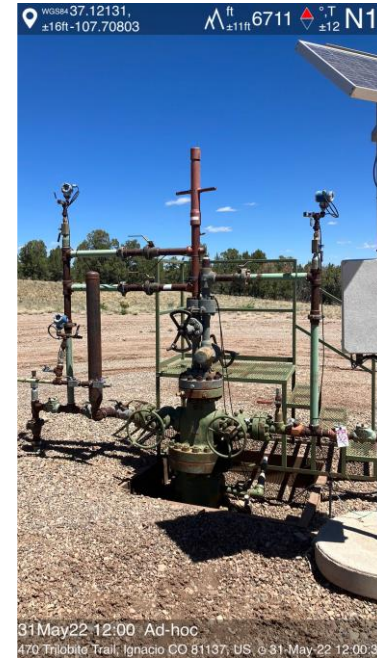
**IMG 06**  
**Well head**

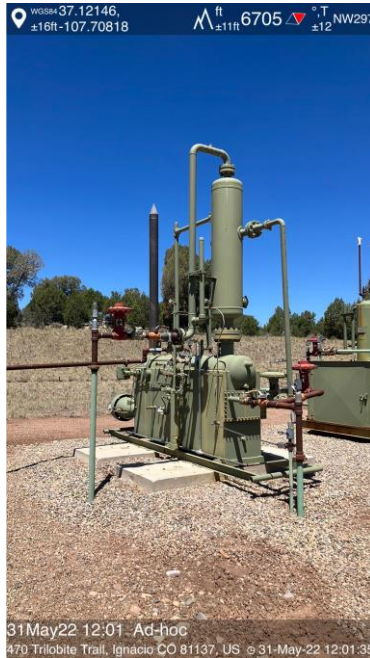
**IMG 07**  
**Vertical Separator**

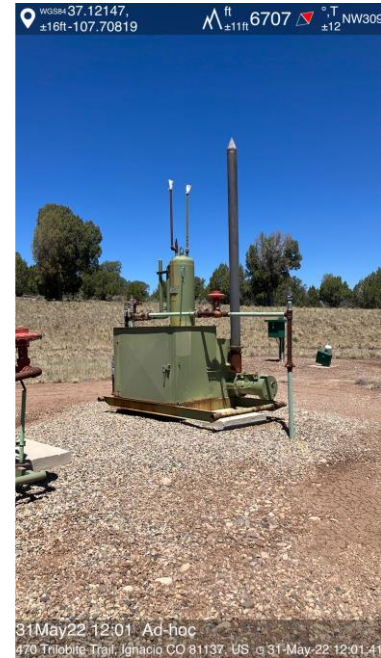
**IMG 08**  
**Vertical Separator**

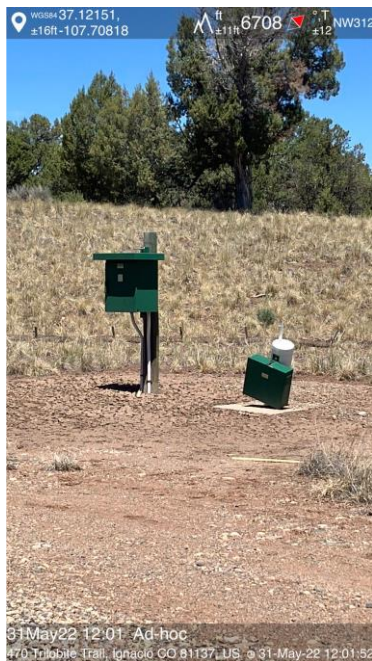
**IMG 09**  
**Cathodic Protection**

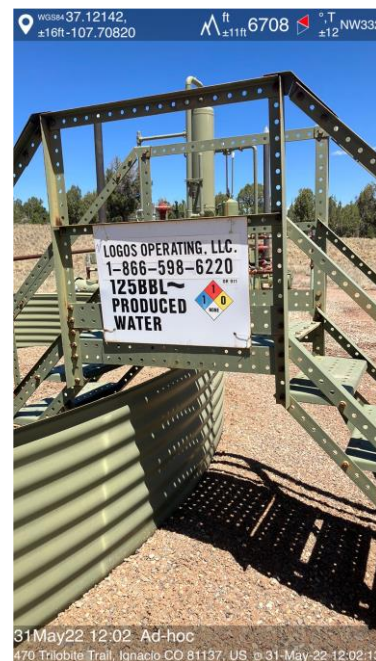
**IMG 10**  
**Tank Sign**

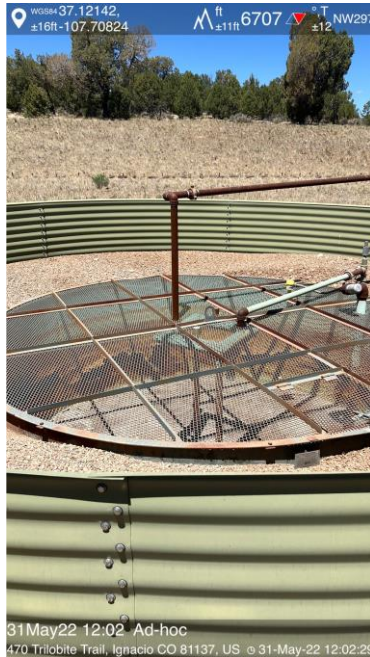
**IMG 11**  
**Produced water tank**

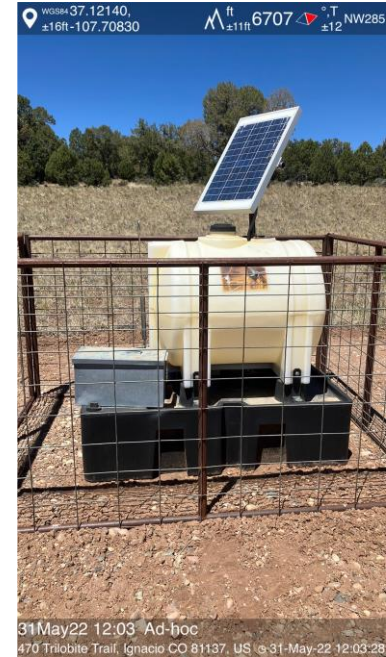
**IMG 12**  
**Scale corrosion inhibitor sign is deteriorated and NFPA sign is illegible**

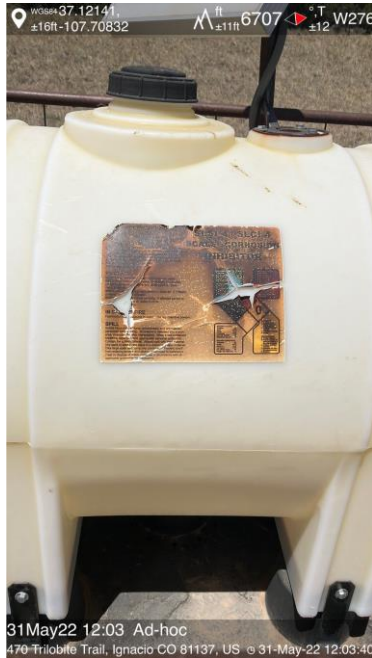
**IMG 13**

**Scale corrosion inhibitor sign is deteriorated and NFPA sign is illegible**

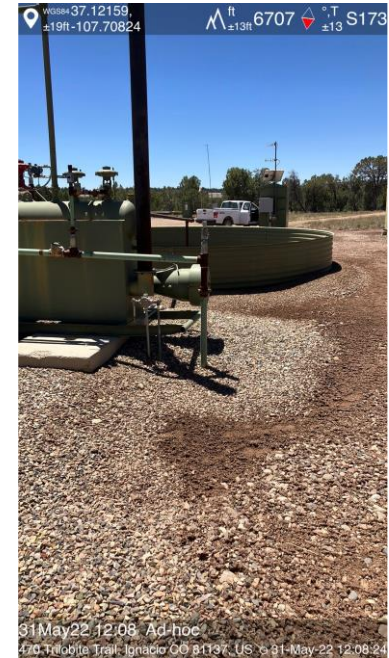
**IMG 14**

**Site photo**

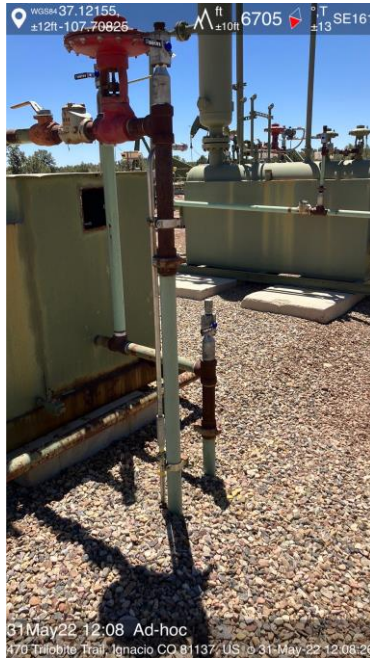
**IMG 15**  
**Flow lines**

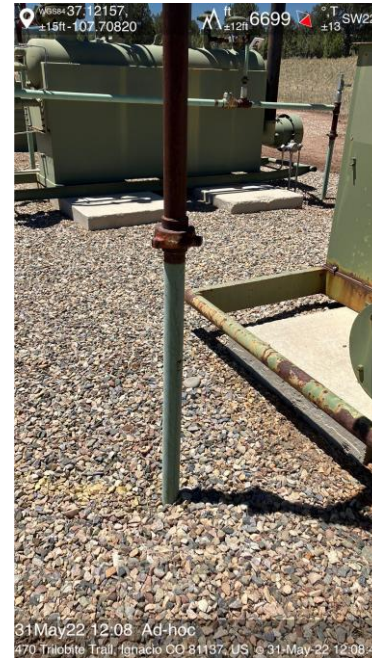
**IMG 16**  
**Flow line**

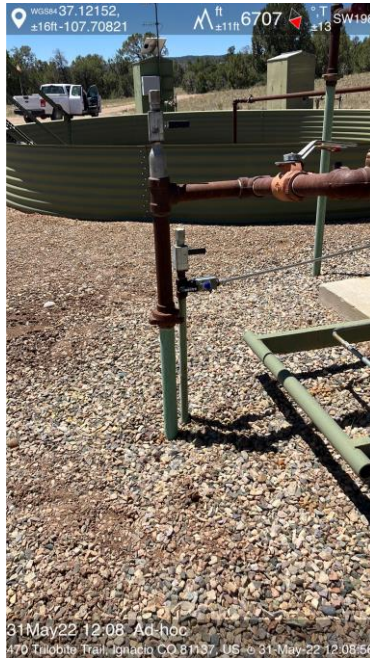
**IMG 17**  
**Flow lines**

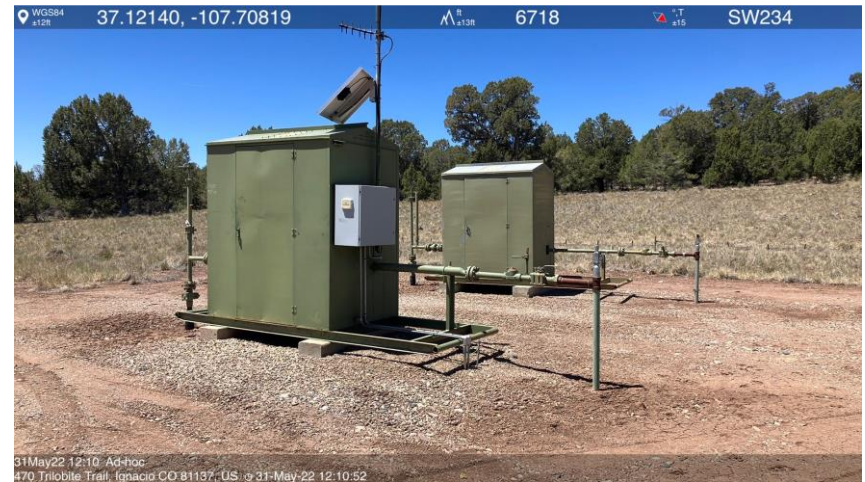
**IMG 18**  
**Meter houses**
