Inspection Photos

API: 071-09475

Operator: OGRIS OPERATING LLC

Inspection Date: 6/1/2022

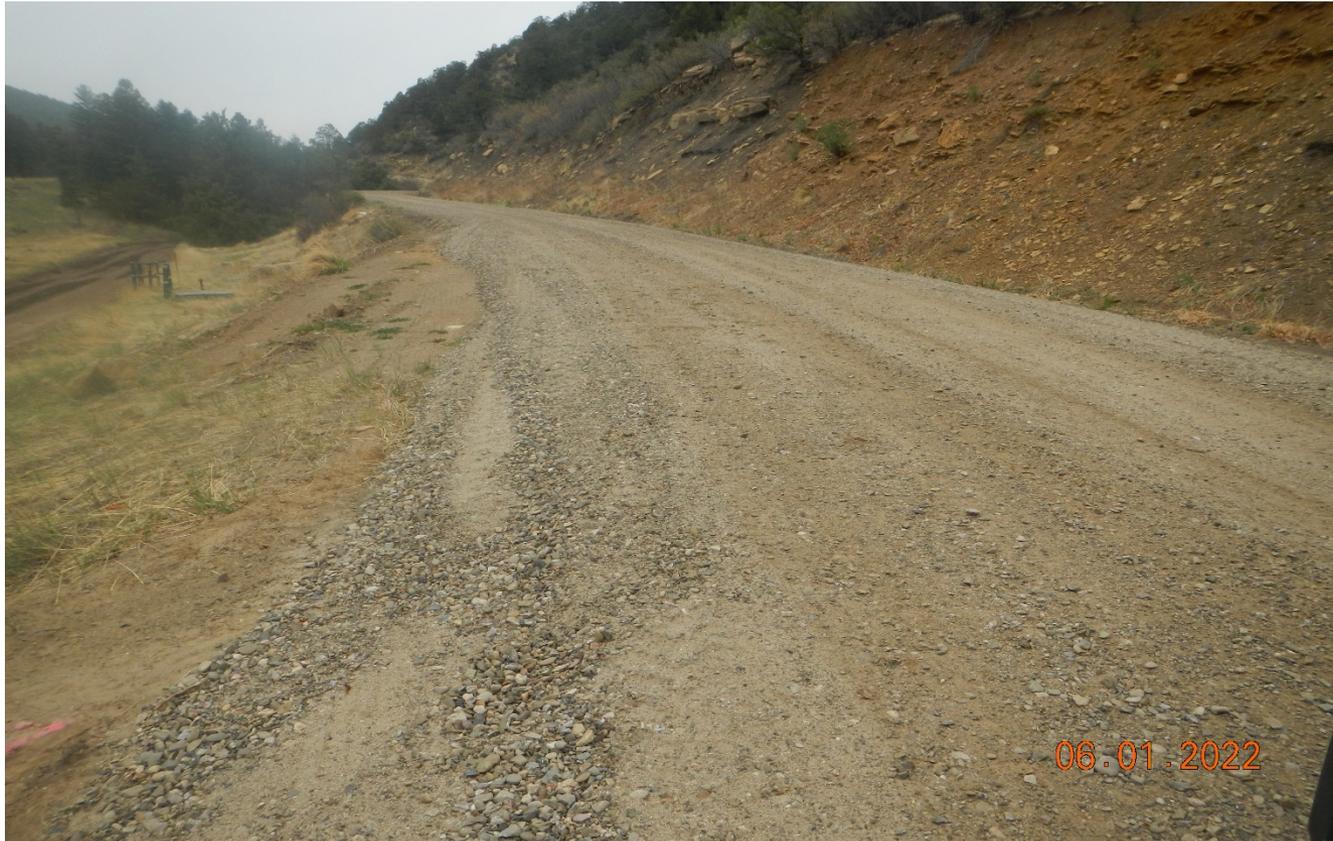
Photo 1. Facing west along the main access road. There has been additional gravel applied along the road.

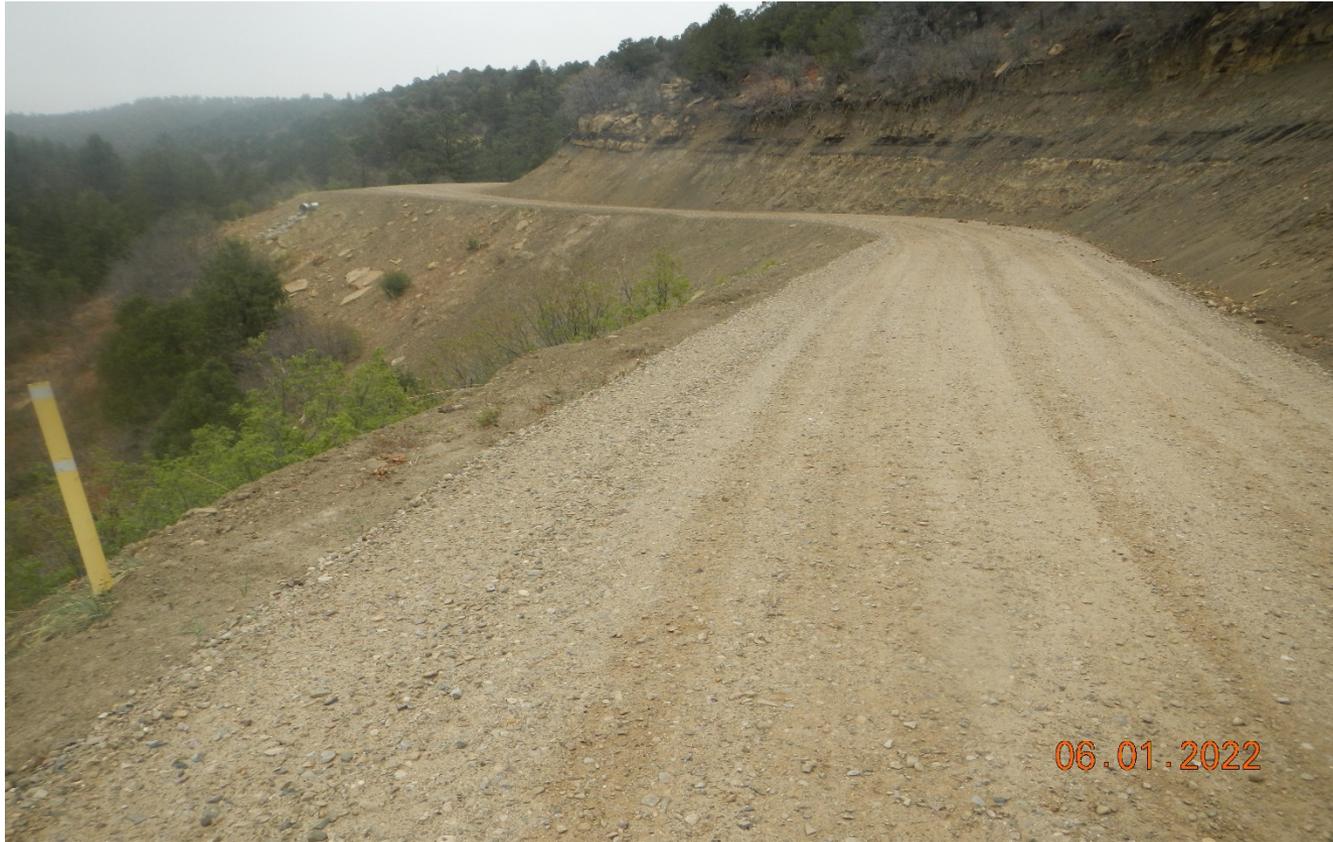
Photo 2. Facing west. The road sides has been regraded and erosion repaired.

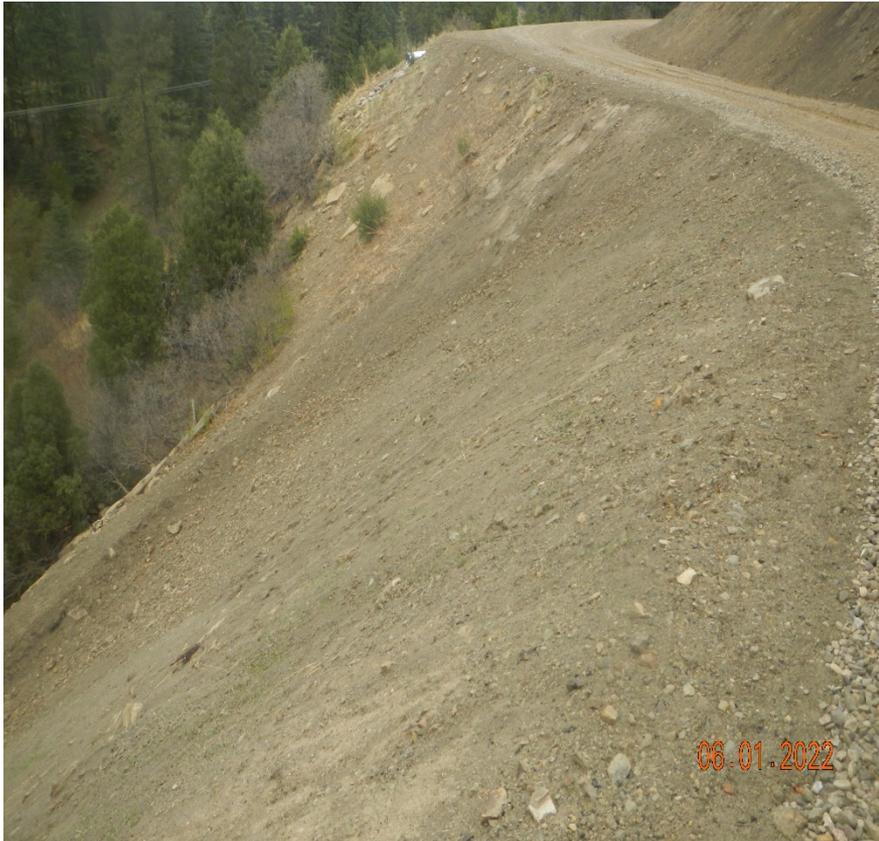
Photo 3. The slope of the road side was regraded and seeded. A berm was installed at the toe of slope. This area needs to be monitored for stabilization and may require additional BMP's.

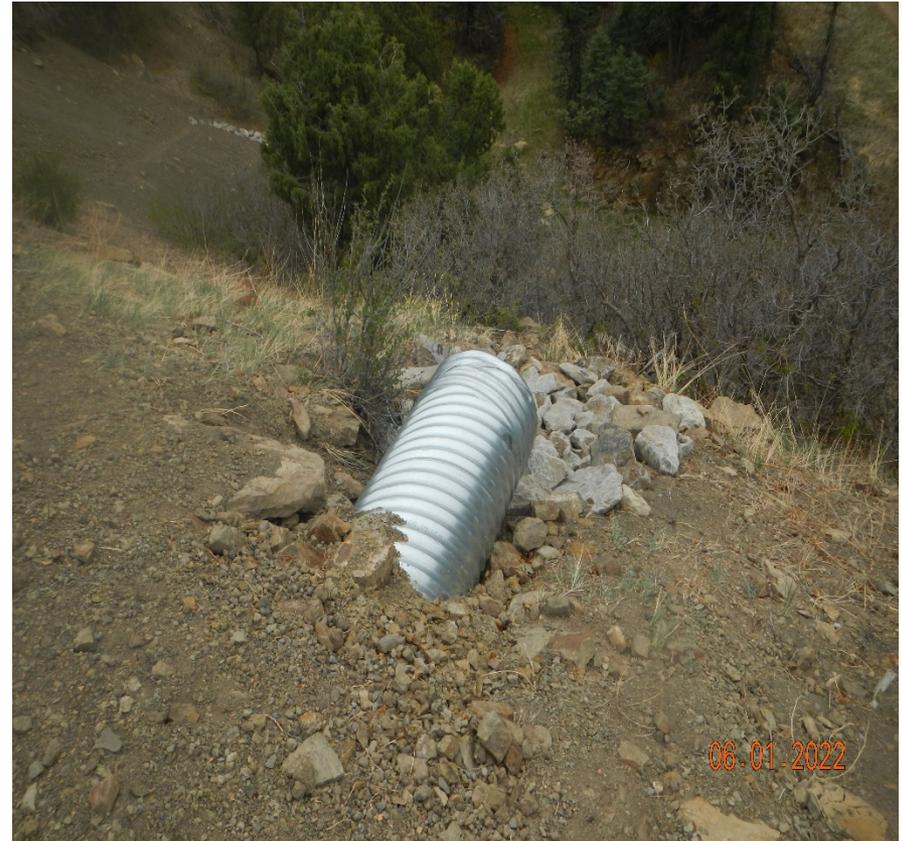
Photo 4. A new culvert has been installed with outlet protection.

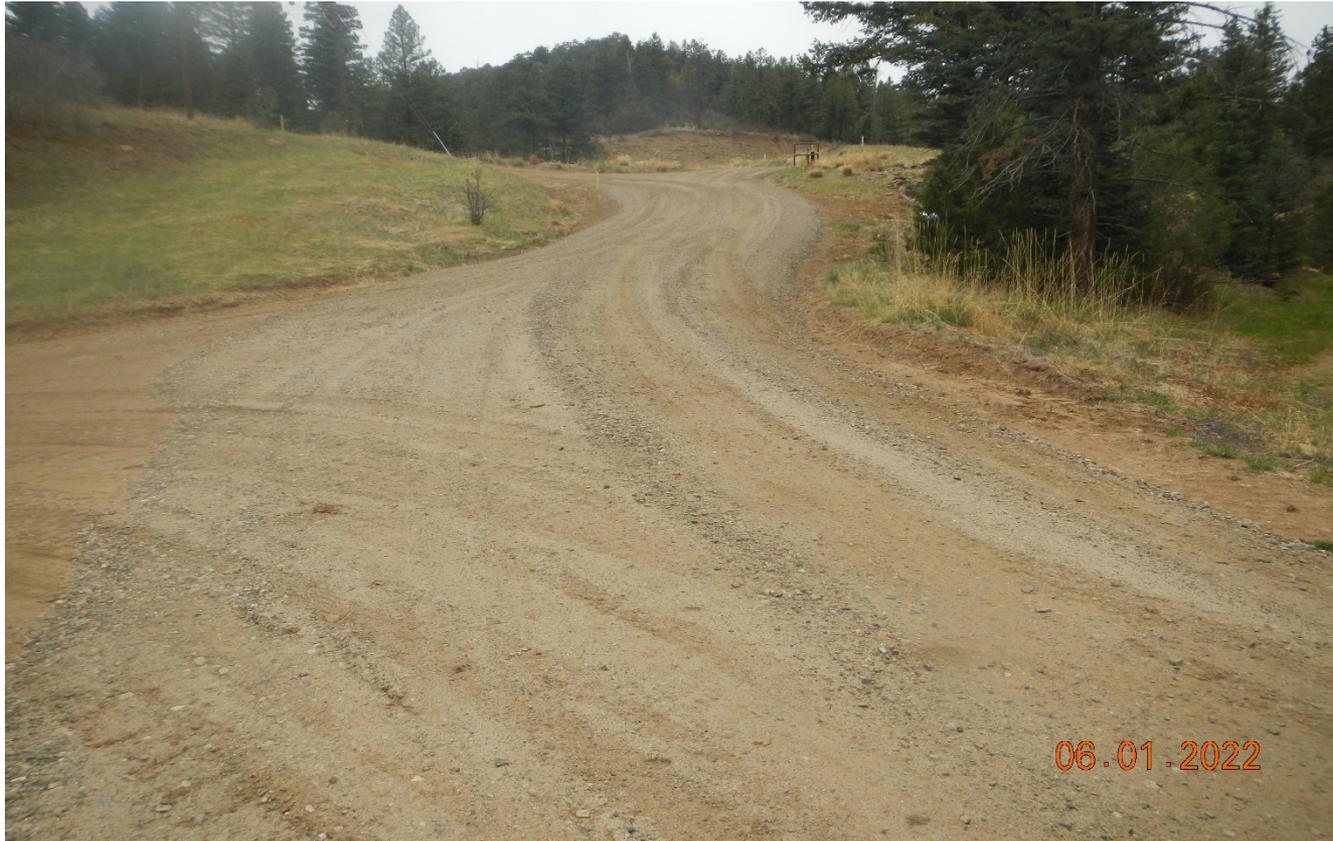
Photo 5. Facing northwest near the wellsite. There was a new culvert installed near the location where frequent stormwater issues was observed.

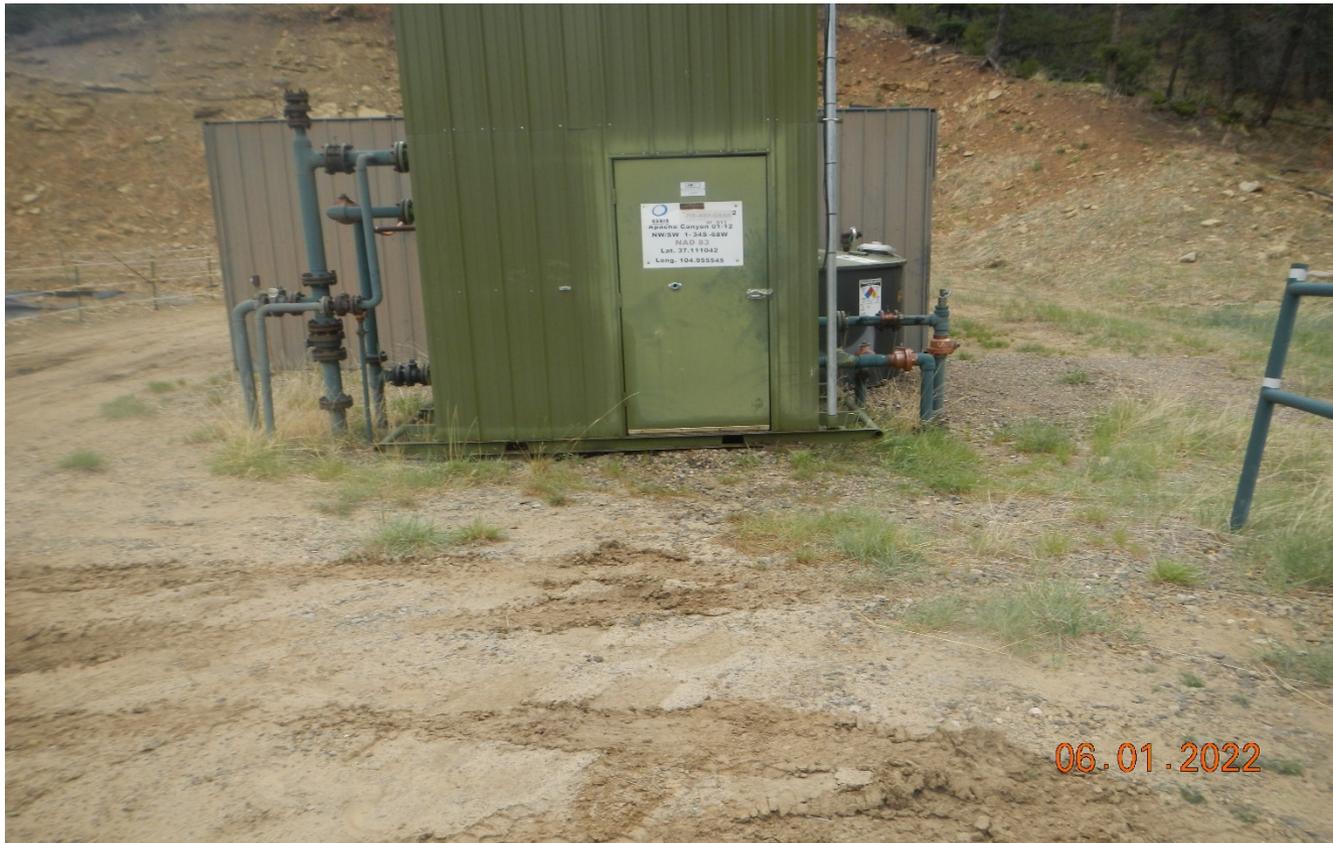
Photo 7. The leak at the shed was repaired and cleaned up.
