**LASSO OIL & GAS LLC**  
**CONTINENTAL-63S100W 16SWNW**  
**Location # 315156**

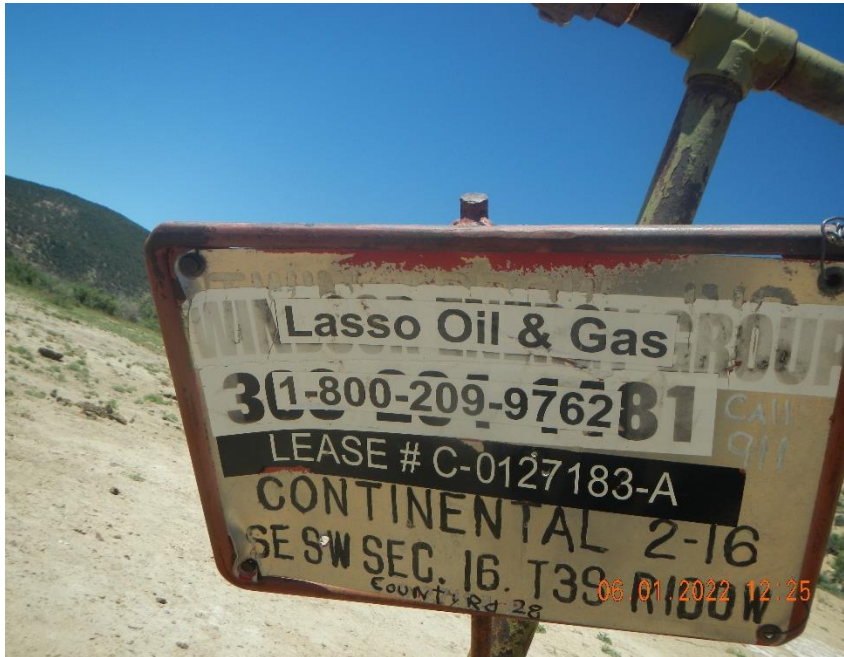
Sign missing information. No API #. No EMS contact  
(911) Legal description does not match COGCC records.

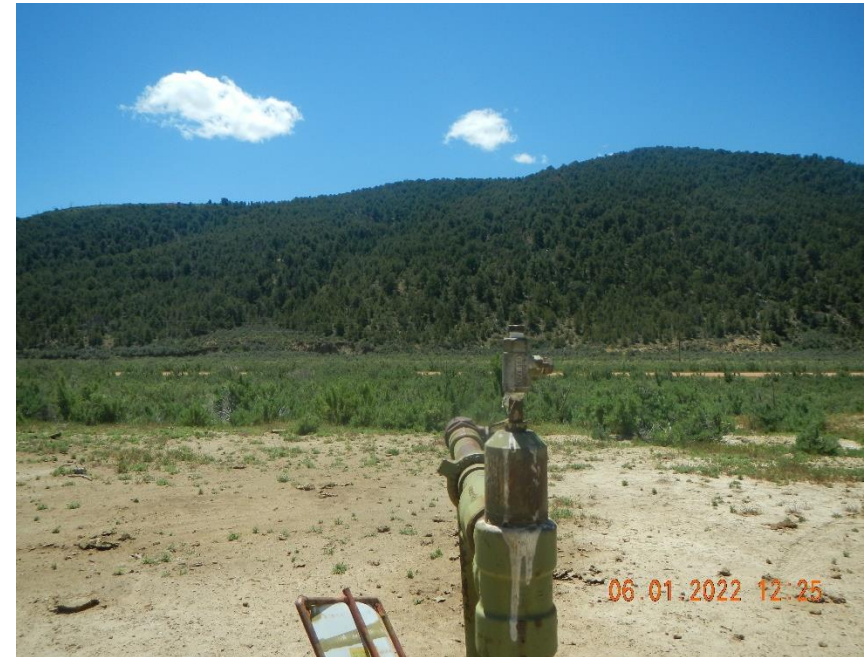
Leaking gauge removed and replaced with valve  
with a plug.

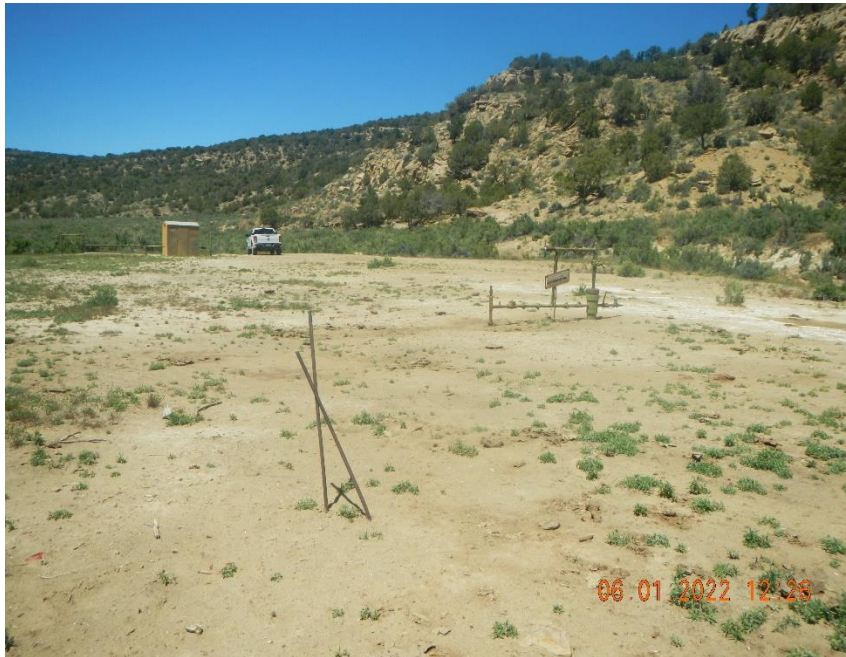
**2 rods in the ground. Purpose unclear.**

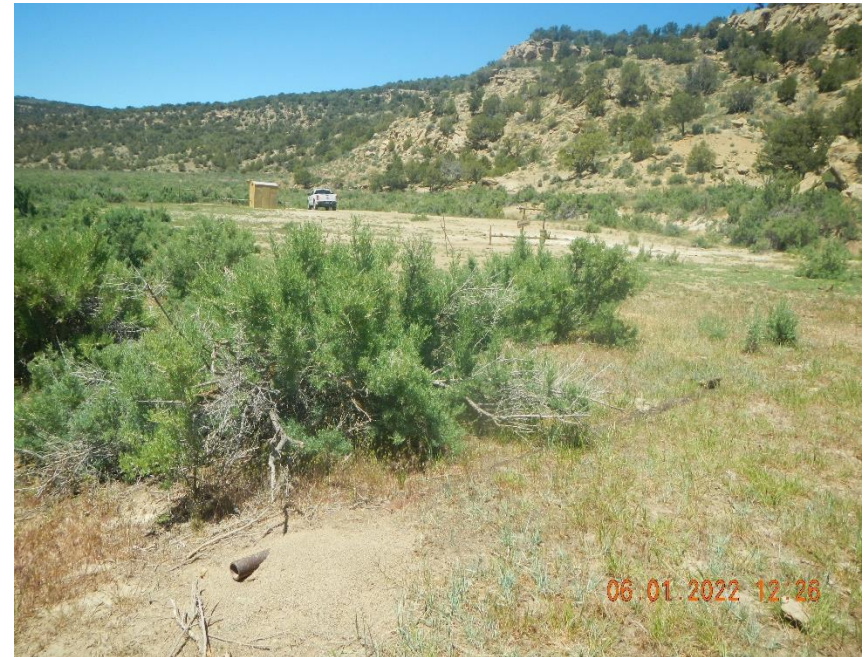
**Unused pipe.**

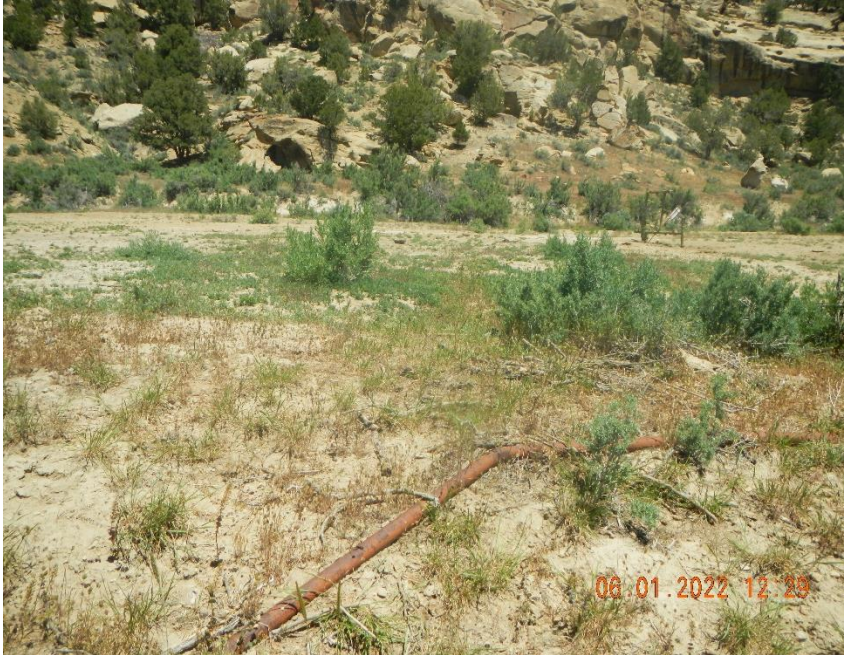
**Unused pipe.**

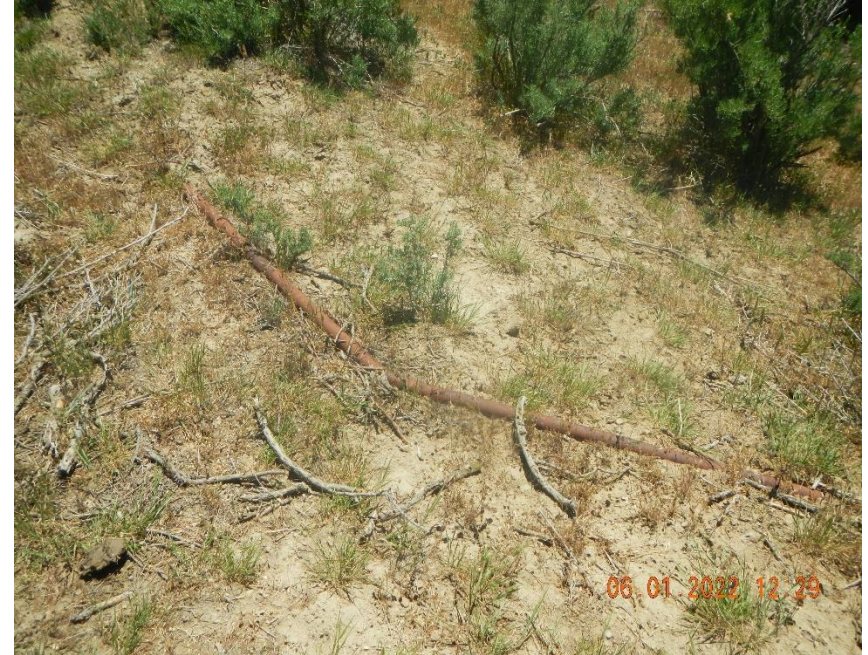
**Unused pipe.**

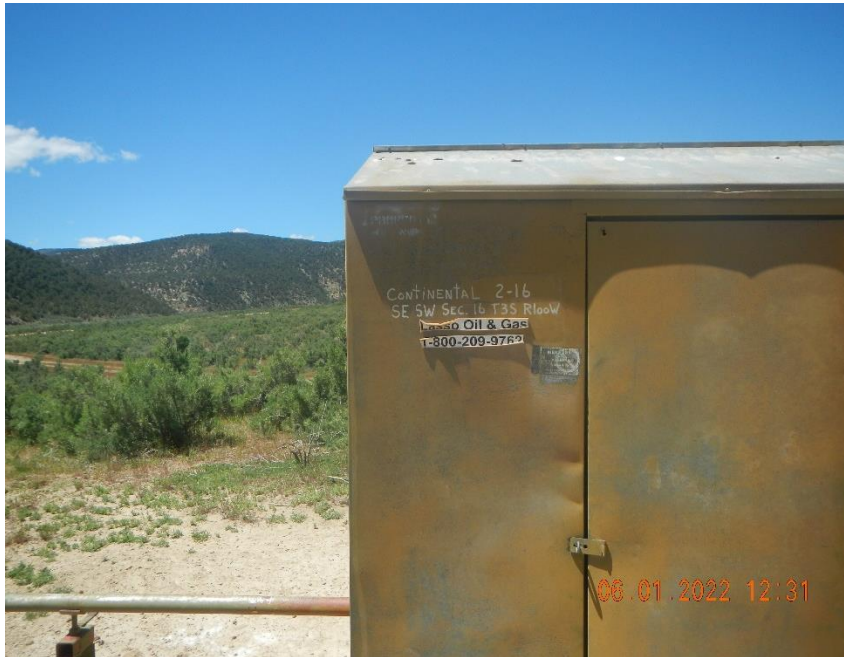
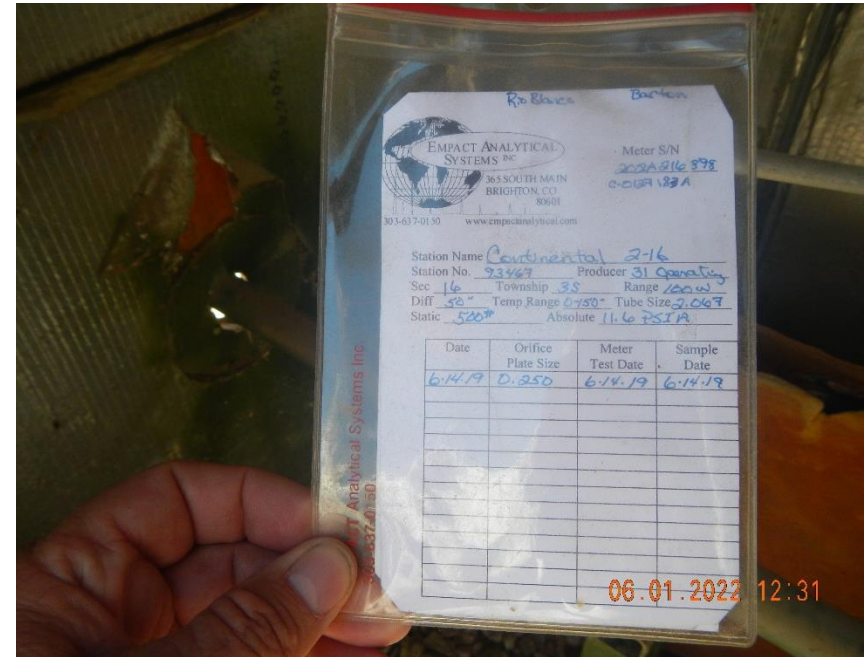
**Most recent meter calibration on 6-14-2019.**

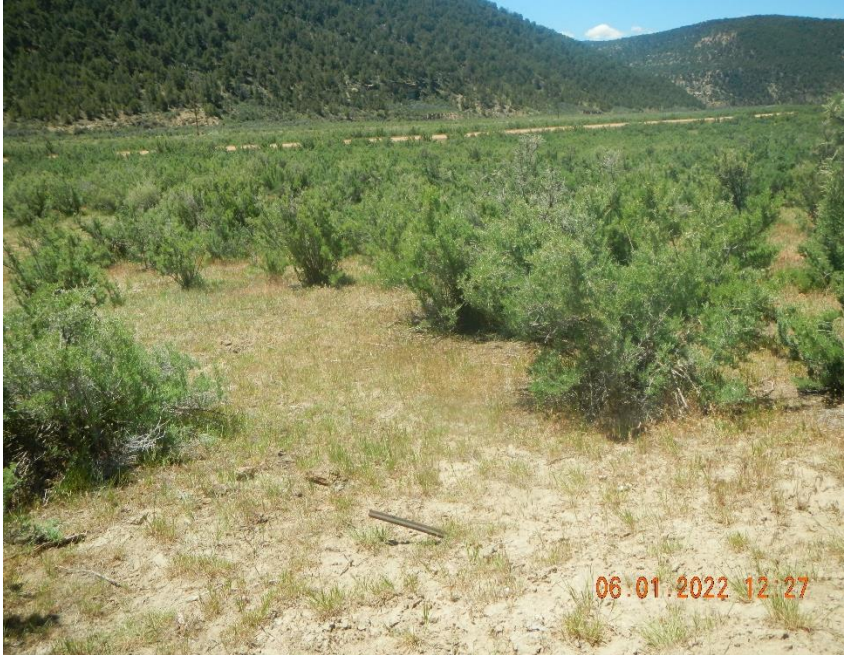
**Marker is knocked over and not brightly colored.**

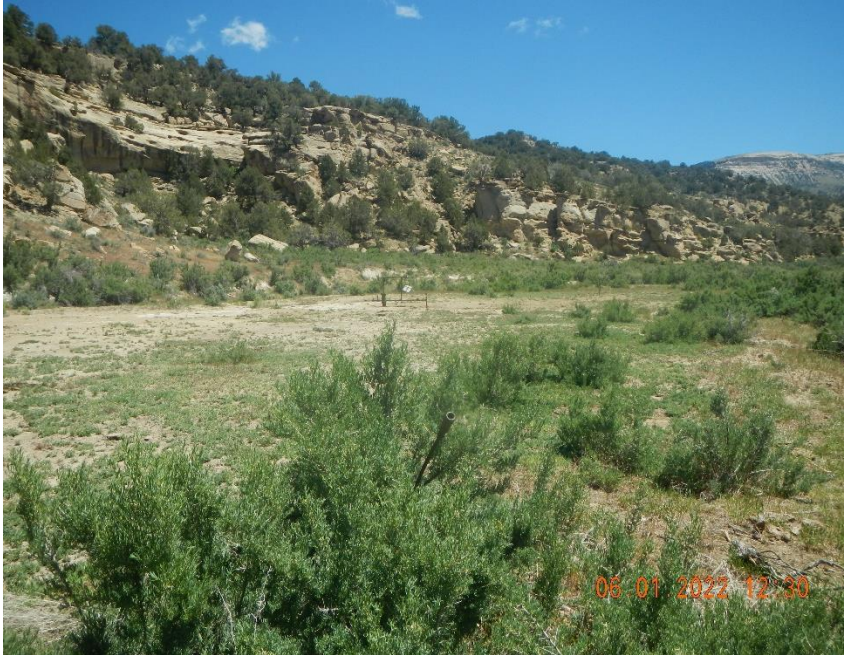
**Marker not brightly colored.**

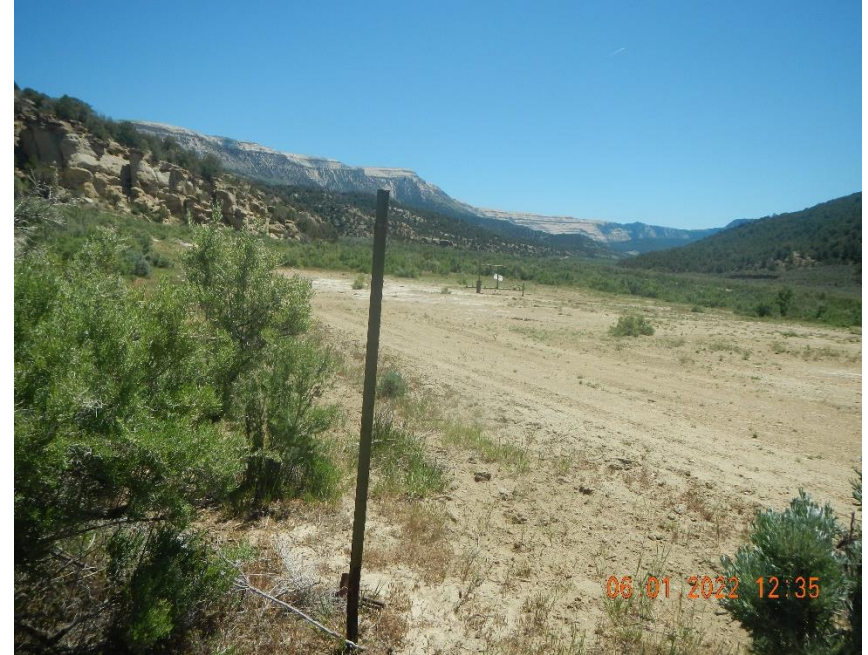
**Marker not brightly colored.**

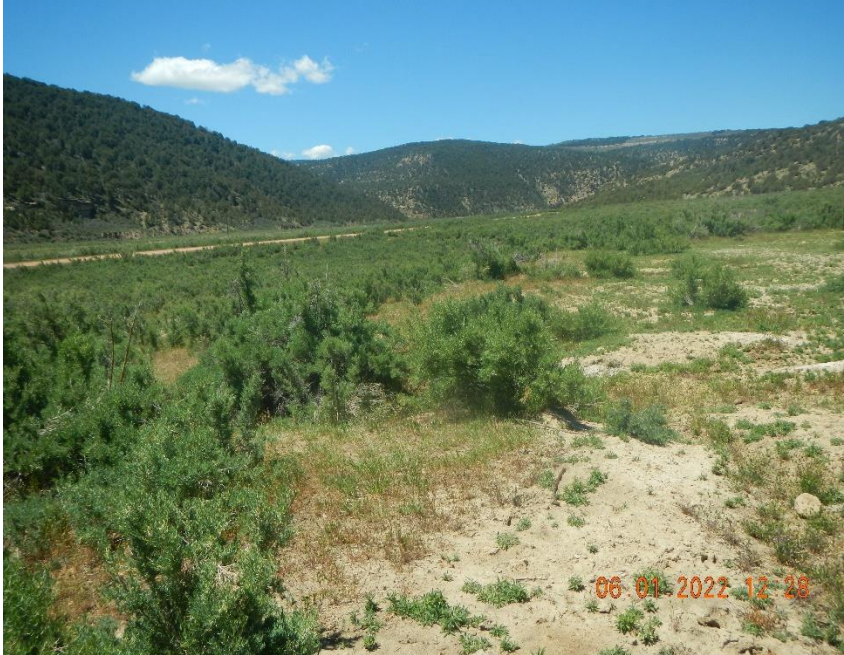
**Storm water erosion on south edge of location.**

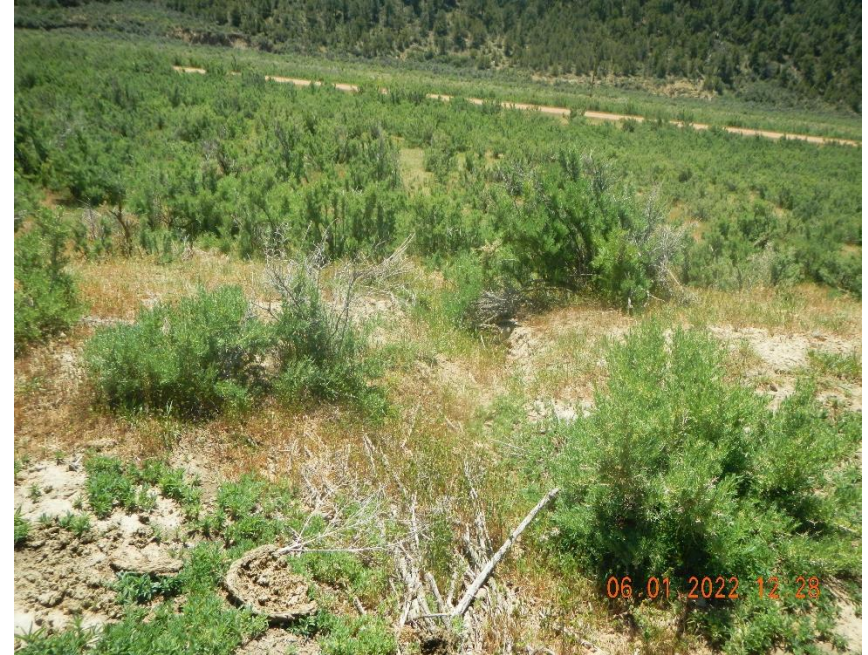
**Storm water erosion on south edge of location.**

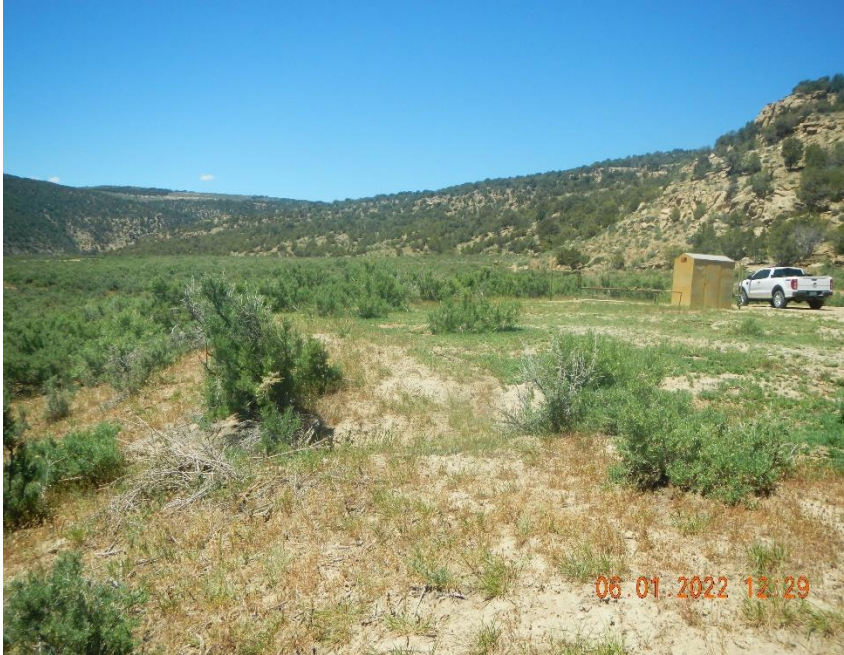
**Storm water erosion on south edge of location.**
